SUBJECT: LER 90-012-00:on 900826,overspeed trip of steam-driven
 auxiliary feedwater pump during testing.W/901120 ltr.

Subject: Docket No. 50-361
30-Day Report
Licensee Event Report No. 90-012
San Onofre Nuclear Generating Station, Unit 2

SAN ONOFRE NUCLEAR GENERATION STATION	DOCKET NUMBER	LER NUMBER	PAGE
UNIT 2	05000361	90-012-00	2 OF 11

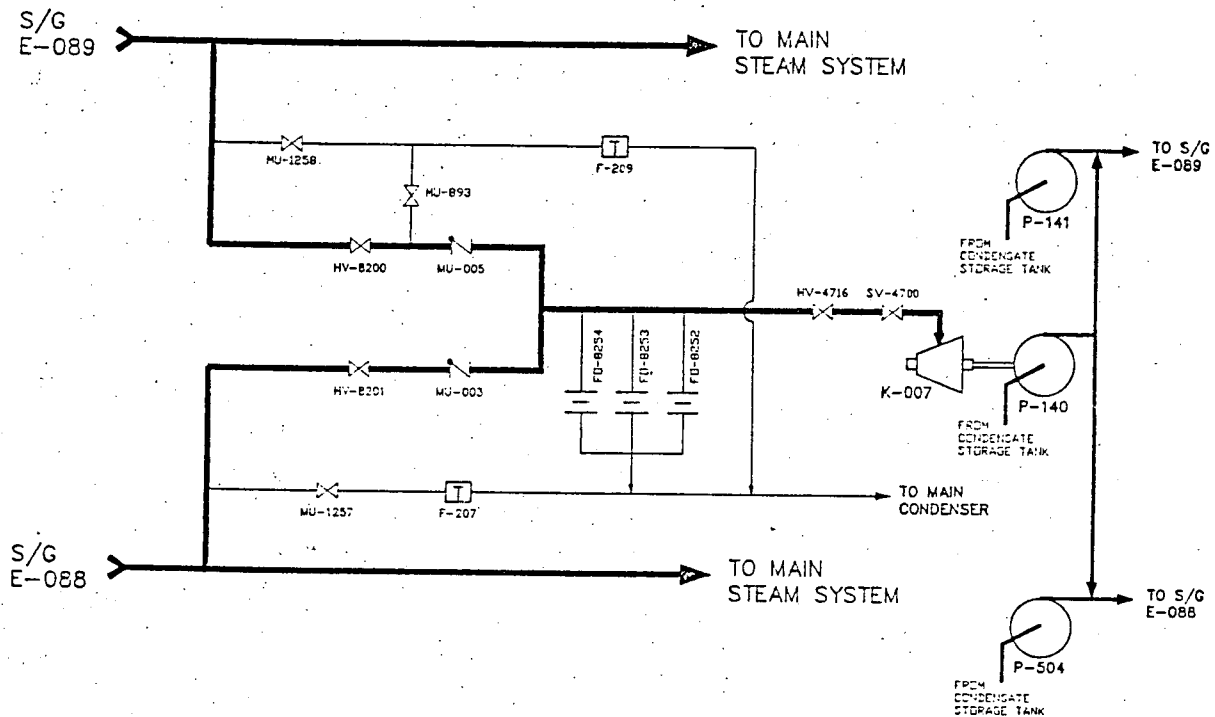
FIGURE 1

Steam traps F-207 and F-209 [TRP] remove condensed steam from portions of the main steam piping upstream of HV-8201 and HV-8200, respectively (F-209 also removes condensed steam from portions of main steam piping downstream of HV-8200). MU-1257 isolates F-207 from the main steam piping upstream of HV-8201, and MU-1258 isolates F-209 from the main steam piping upstream of HV-8200. In addition, three drain lines off the common steam supply piping to K-007 are installed with in-line flow orifices (FO-8252, FO-8253, and FO-8254) to continuously extract any condensed steam which may accumulate in the common line. These condensation removal features are provided since during normal plant operation, K-007 is in the standby mode. (See Figure 1.)

AFWPT STEAM SUPPLY DRAIN SYSTEM
