SUBJECT: LER 88-010-01:on 880506,inoperability of both emergency chilled water sys trains due to low freon level.

LICENSEE EVENT REPORT (LER)

SAN ONOFRE NUCLEAR GENERATION STATION UNIT 2	DOCKET NUMBER 05000361	LER NUMBER 88-010-01	PAGE 2 OF 10
---	---------------------------	-------------------------	-----------------

Subject: Docket Nos. 50-361
30-Day Report
Licensee Event Report No. 88-010, Revision 1
San Onofre Nuclear Generating Station, Units 2 and 3

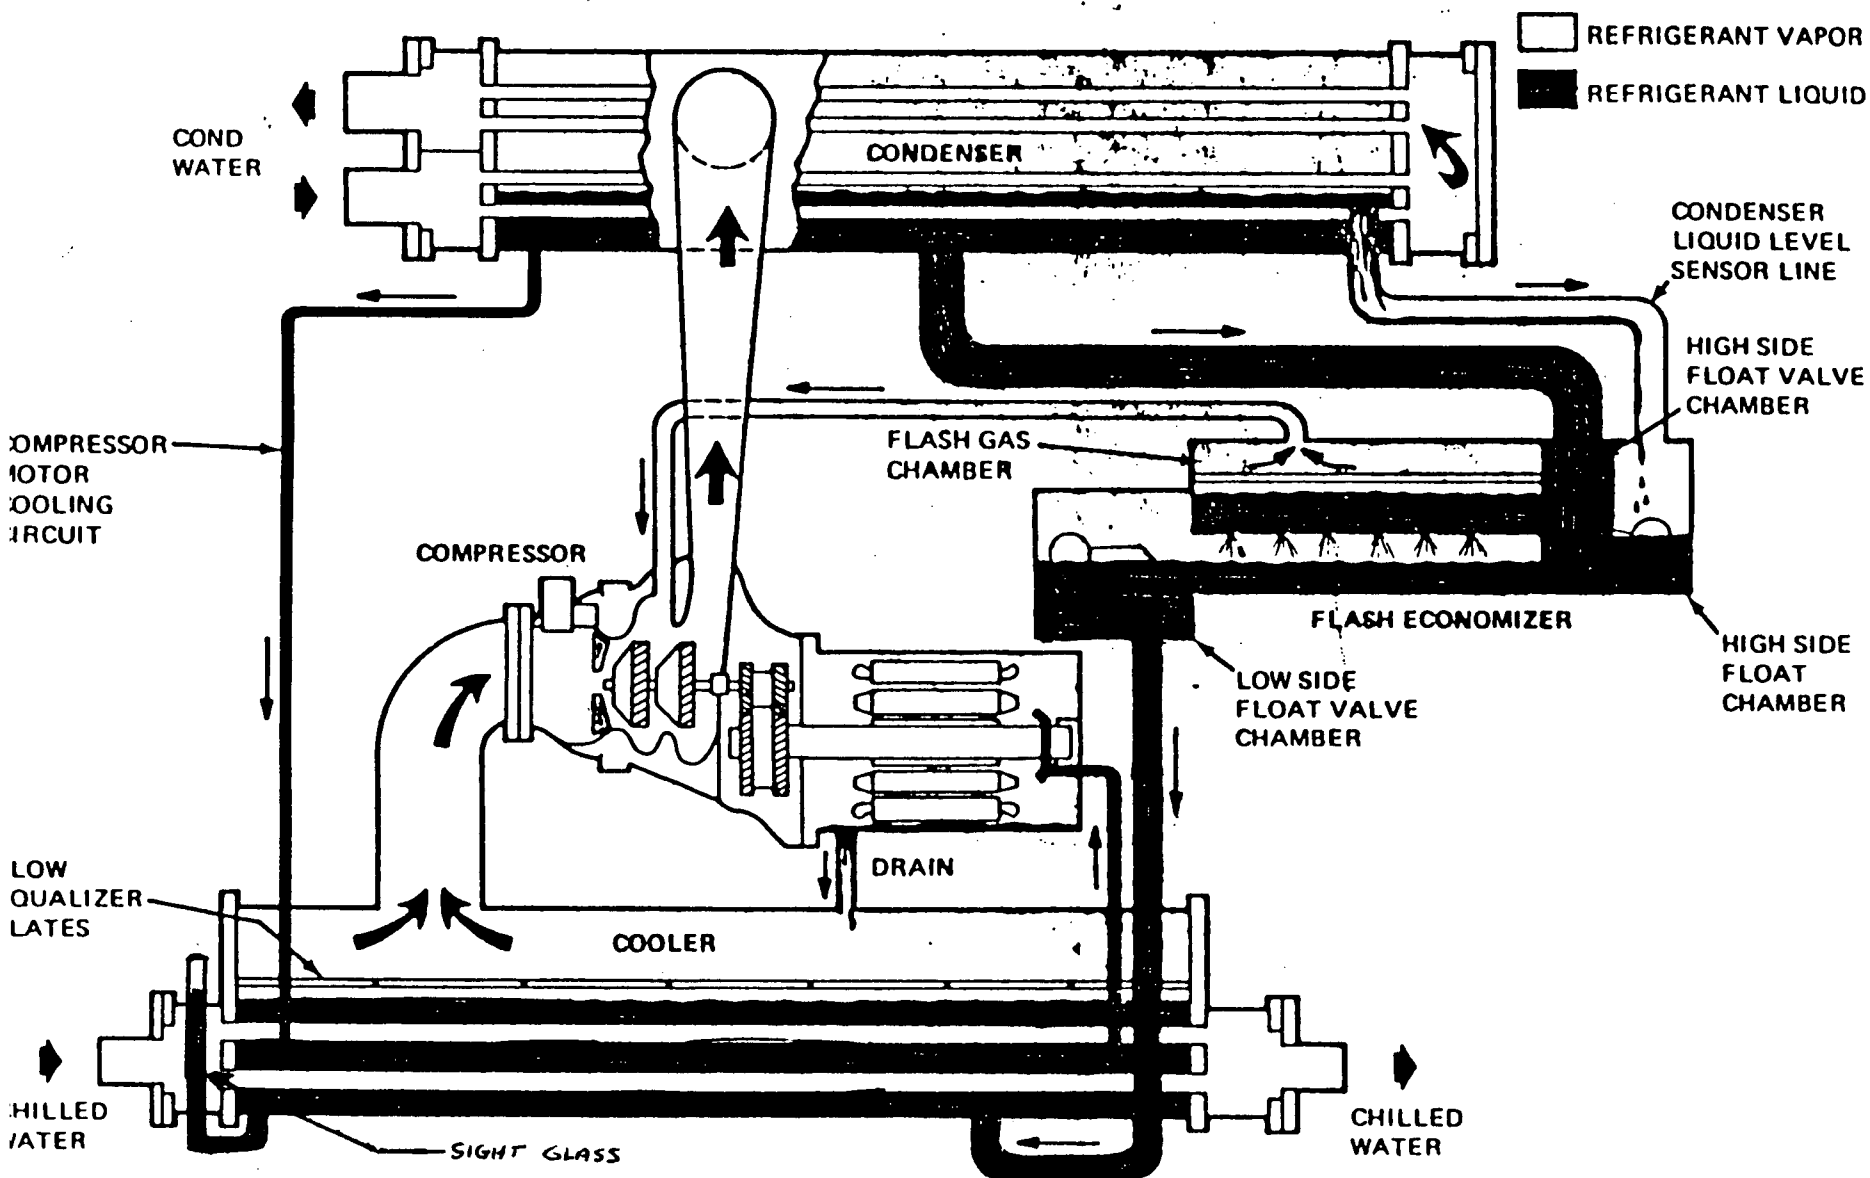
PAGE 10 OF 10

The chillers were initially charged and factory tested by the vendor for full rated (400 ton) heat removal capacity. SCE purchased the chiller with a factory option of a freon level sight glass. The sight glass is located on the cooler section near the cooling coils [see diagram page 10]. The level of freon in the
