SUBJECT: RO:on 890112,Unit 2 shut down due to failure of motor on
 auxiliary feedwater pump 2P-141.Photographs enclosed.

SUBJECT: Docket No. 50-361
Auxiliary Feedwater Pump Motor
San Onofre Nuclear Generating Station
Units 2 and 3

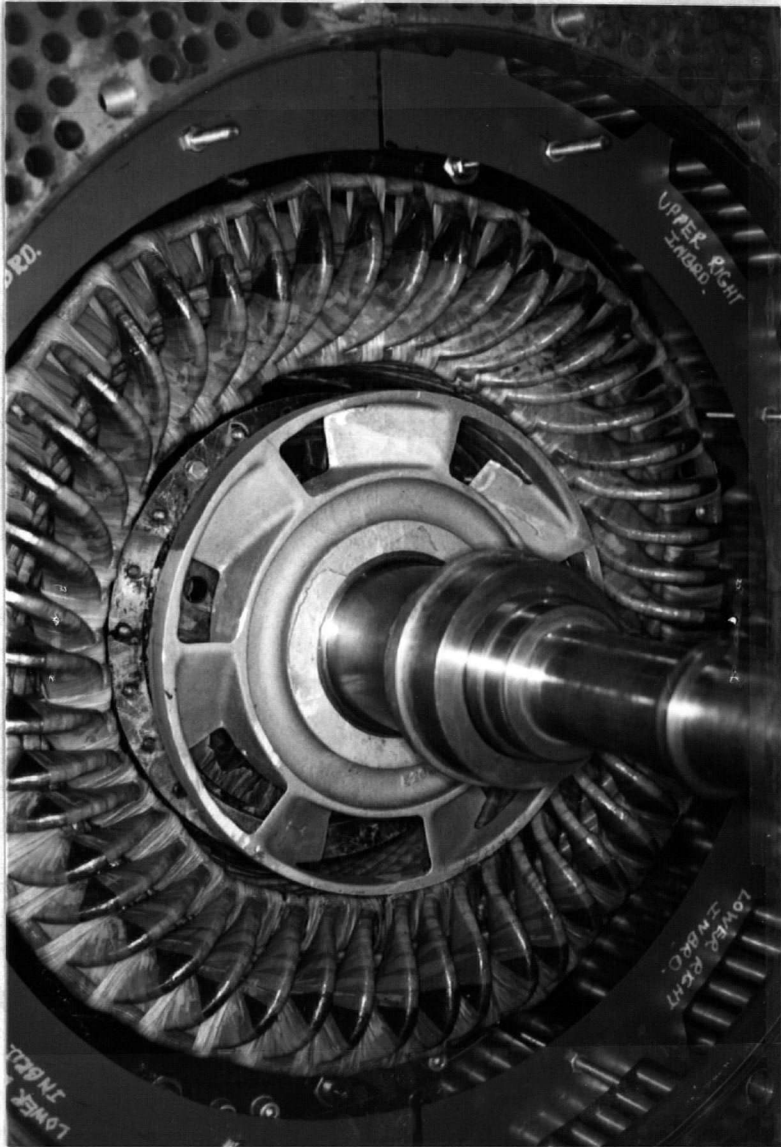
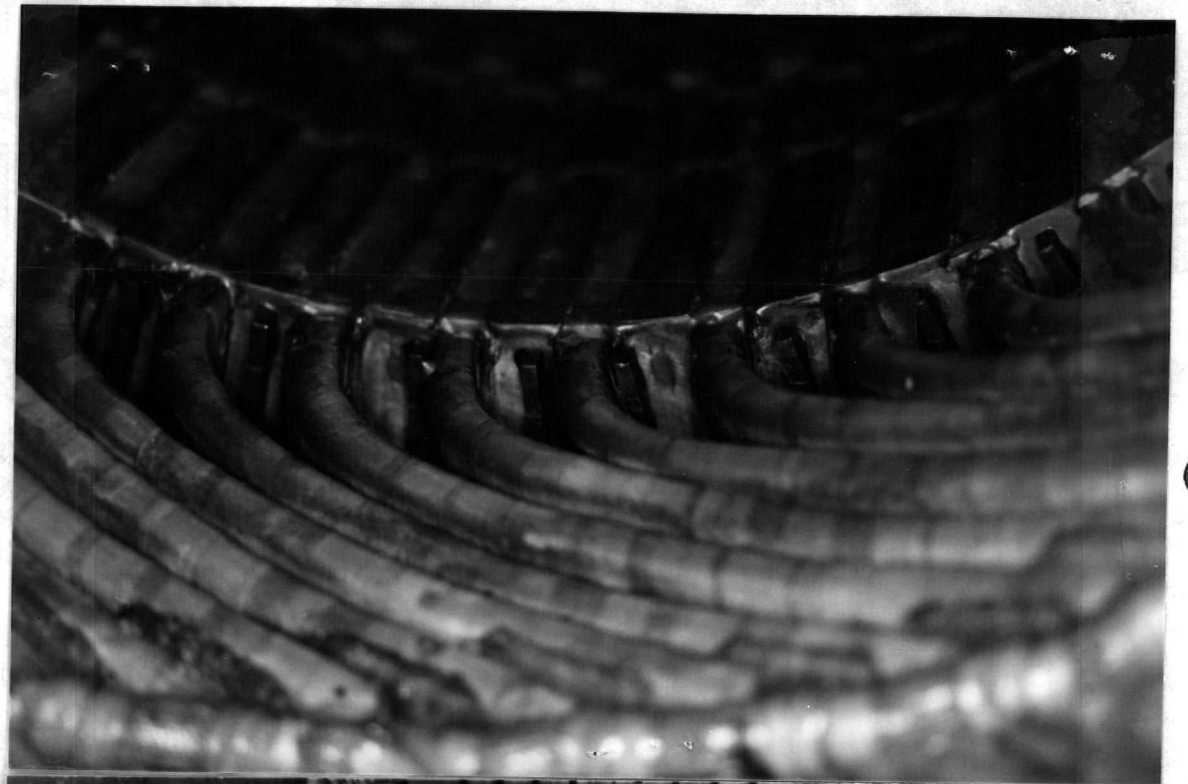
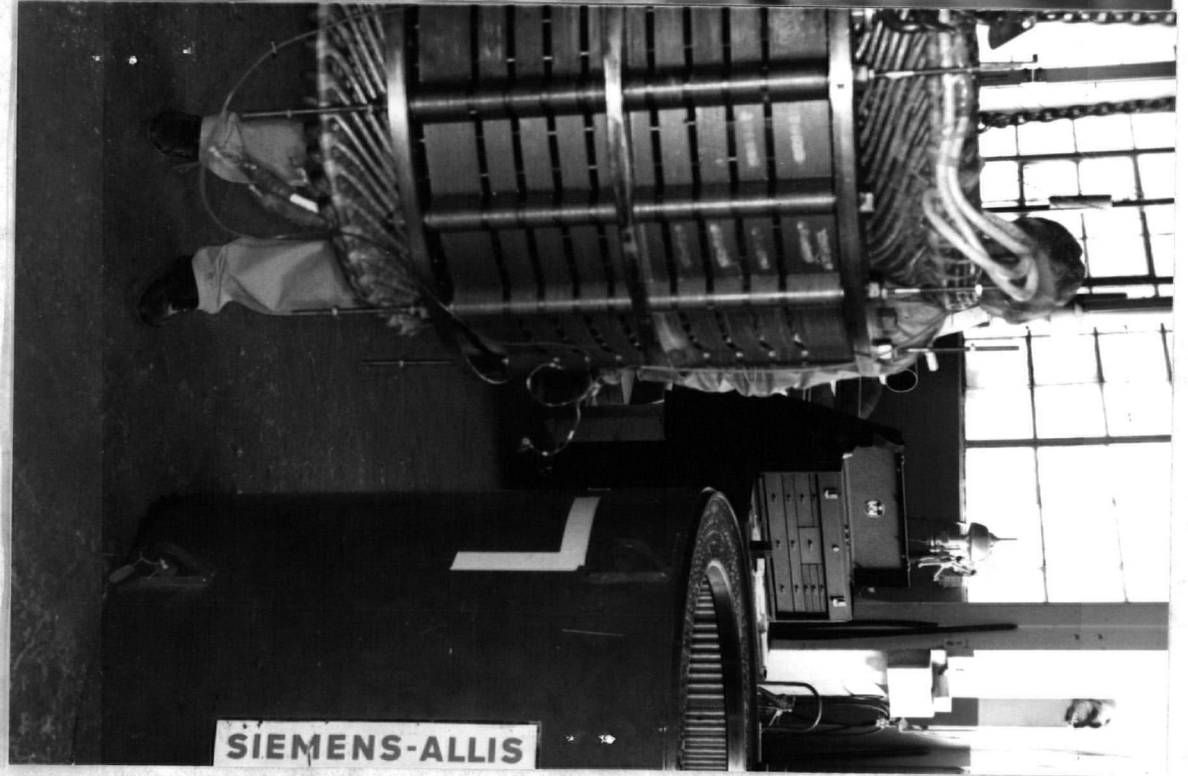
On January 12, 1989, San Onofre Unit 2 was shut down due to failure of the motor on auxiliary feedwater pump 2P-141. The motor was removed from the pump and sent offsite for inspection and repair. The inspection revealed that the motor failure was due to failed welds on at least two core lamination stiffeners allowing them to move freely within the motor interior and damage the stator winding.

On January 25, 1989, SCE met with the San Onofre Units 2 and 3 NRC Resident Inspector and Project Manager to discuss the results of our inspections and our plans for repair of the motor. As discussed during that meeting, it is concluded that the root cause of the stiffener failure is attributed to welding and quality control procedures at the time of manufacture. Although at the time of the January 25 meeting it was anticipated that the stator would be rewound, a new stator was subsequently obtained from the original motor manufacturer, Siemens-Allis, and is being installed in the motor. Repair and testing was completed on February 6, 1989.
