Subject: Docket Nos. 50-361 and 50-362
San Onofre Nuclear Generating Station
Units 2 and 3

STATUS REPORT ON THE
INVESTIGATION OF THE DEWATERING SYSTEM
SEPTEMBER 21, 1978

The purpose of this report is to document the status of the investigation and actions being performed on the dewatering system at the San Onofre Units 2 and 3 construction site. This report provides a summary of the work accomplished between the period of May 27, 1978 and September 1, 1978 with the exception of the final disposition of Well 8, which was documented under a separate transmittal to the NRC.

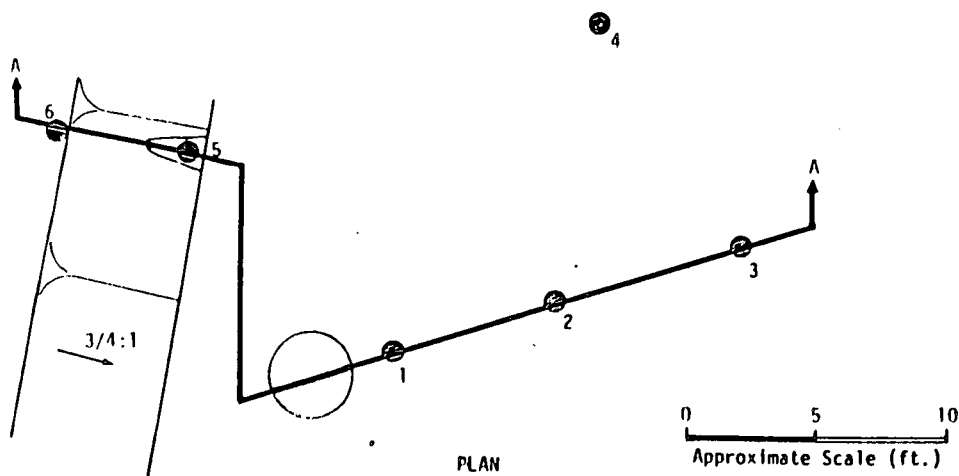
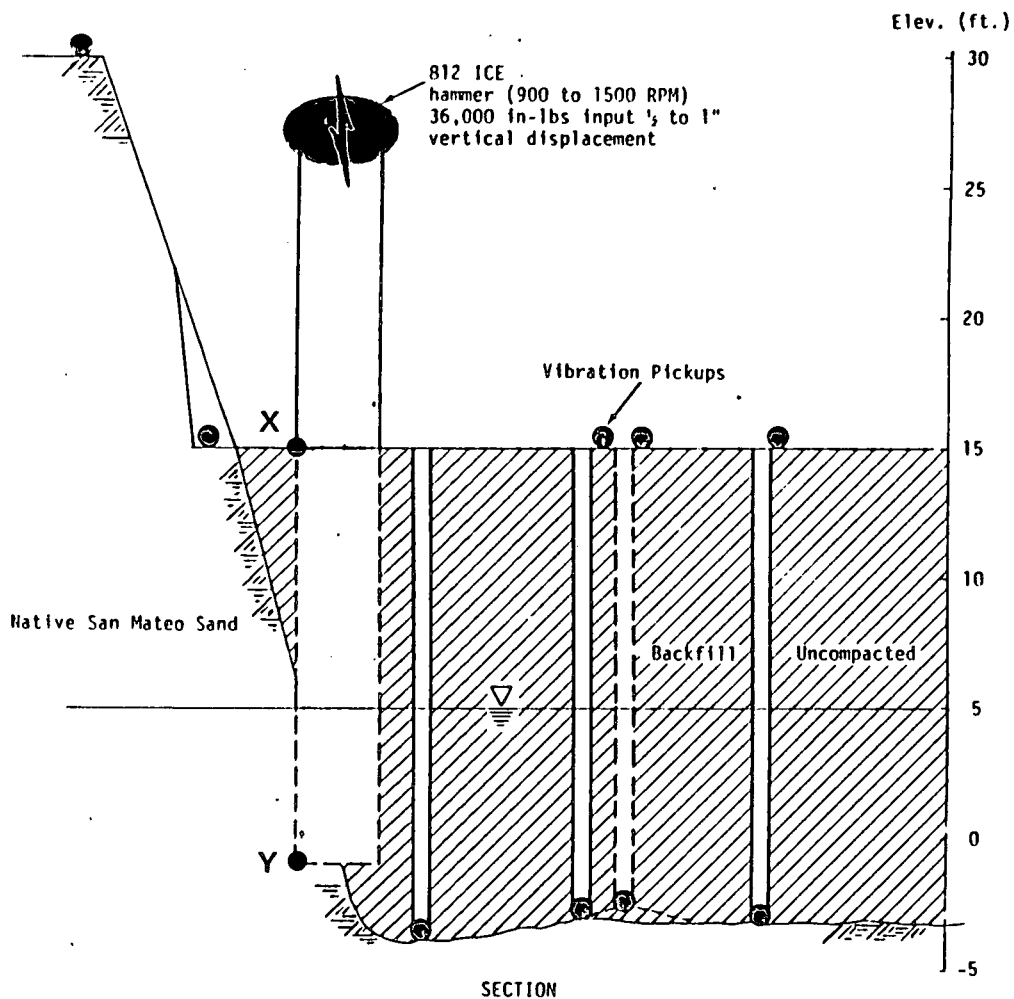
Fig. **7**

Vibration measurements were made in the field during the driving of an open end steel casing through loose soil into native San Mateo Sand. The purpose was to develop data on the level of vibrations that were induced into the ground at Well 6 during installation of a 36-inch diameter casing. The test was carried out on the west side of Turbine Building No. 3 in the area used for the previously reported grout testing program. A plan and cross-section of the vibration monitoring program are shown on Figure 2. Basically, the test consisted of driving a casing from position X to position Y on Figure 7 (cross-section) and monitoring vibration at the points indicated.

The vibrations were monitored by particle velocity sensing instruments with maximum amplitudes ranging from about 0.1 to greater than one inch per second. The corresponding acceleration amplitudes of motion were calculated to be as high as 1.0g. It is intended that the vibration levels will be correlated to the Well 6 casing driving records to predict the amplitudes and number of load applications induced into the soil in the vicinity of Well 6 during casing driving. These data are presently being analyzed and the results will be reported concurrently with, or subsequent to, the transmittal of the results of the field exploration at Well 6.

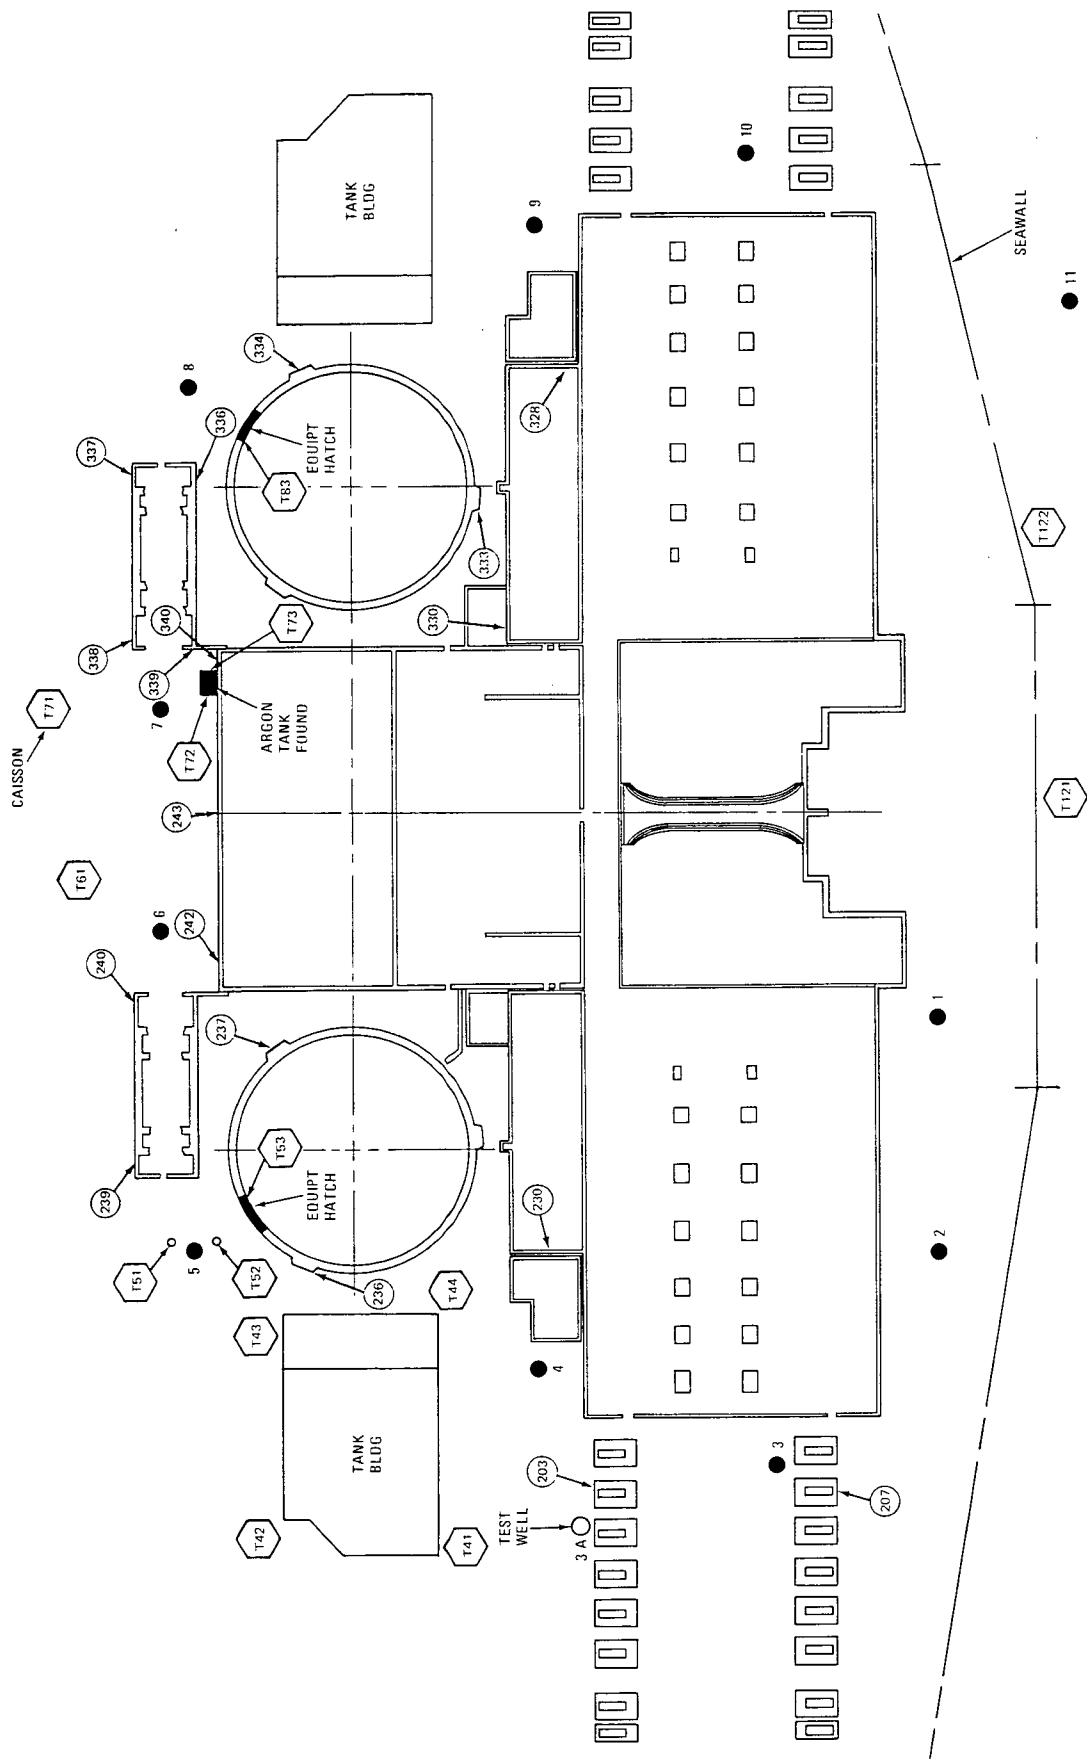
DEWATERING SYSTEM SETTLEMENT
 OBSERVATION PROGRAM
 FIGURE 8

A settlement observation monitoring program is being used to monitor the settlement of structures or components which are founded above or around those dewatering wells which have not been investigated and demobilized to date. The settlement monitoring system contains 43 observation points, 31 of which have been installed to date. Most of the observation monuments not yet installed will be located on the Unit 3 Electrical Tunnel and Tank Building when these structures are completed. For reference, Figure 8 is included to show the physical location of the various settlement observation monuments in current use.

A review of the settlement observation data indicates that no significant settlement or uplift has been observed to date.
