STATUS REPORT ON THE
INVESTIGATION OF THE DEWATERING SYSTEM
OCTOBER 27, 1978

The purpose of this report is to document the status of the investigation and actions being performed on the dewatering system at the San Onofre Units 2 and 3 construction site. This report provides a summary of work accomplished during the month of September 1978.

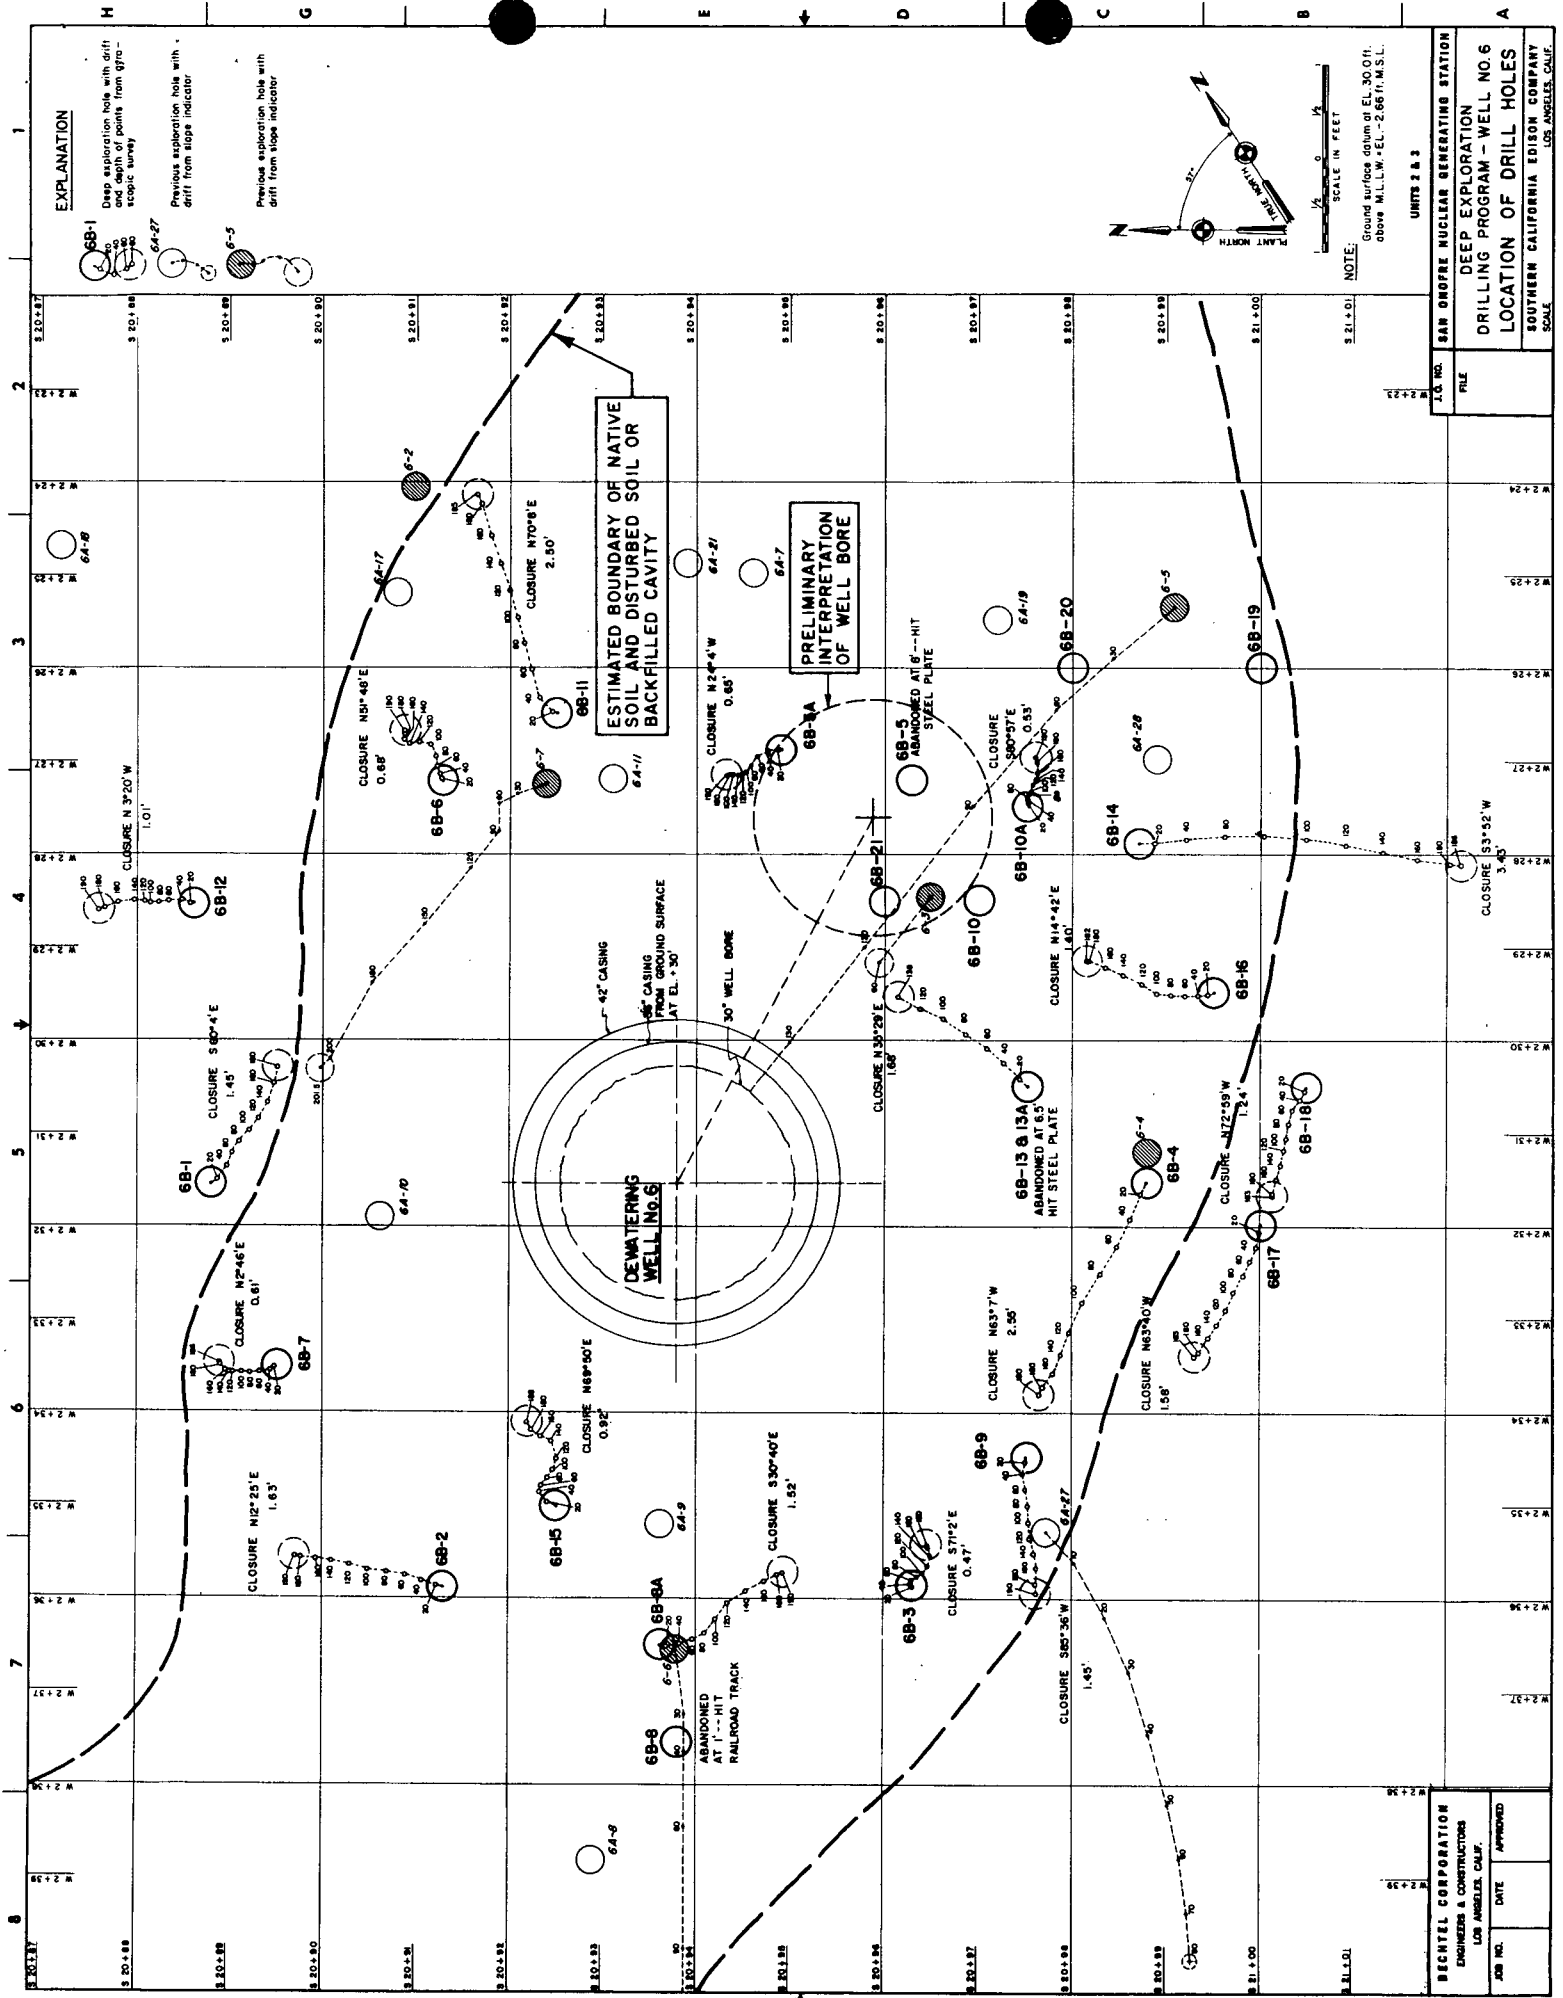
FIGURE 4

Three additional holes have been proposed in the deep exploration drilling program to supplement the 18 holes documented in the May to August Status Report dated September 21, 1978. The locations of these

holes (6B-19, 20 and 21) are shown on Figure 4. To date, 6B-19 has been completed to 190 feet and work is in progress on 6B-20. The drift of 6B-19 was not determined because the drill rods became stuck in the hole while attempting to drill from 190 to 200 feet.

Boring 6B-19 encountered San Mateo Formation from 10 feet to 78.5 feet and from 120 feet to 190 feet. Disturbed material was encountered from 78.5 feet to 120 feet. Within the disturbed material PVC cuttings were encountered between 103 and 110 feet which suggests that another drill hole was encountered, and well gravel was encountered in the sample taken at 116 feet. A preliminary evaluation of these findings suggests that this boring encountered a slight enlargement of the well bore which may have formed during the construction phase. Based on these and other data from the exploration/grouting program, a preliminary interpretation of the bottom of the well bore and direction of drift of the well has been made and is shown on Figure 4. A summary of the logs of borings completed to October 1 is presented in tabular form in Figure 5.

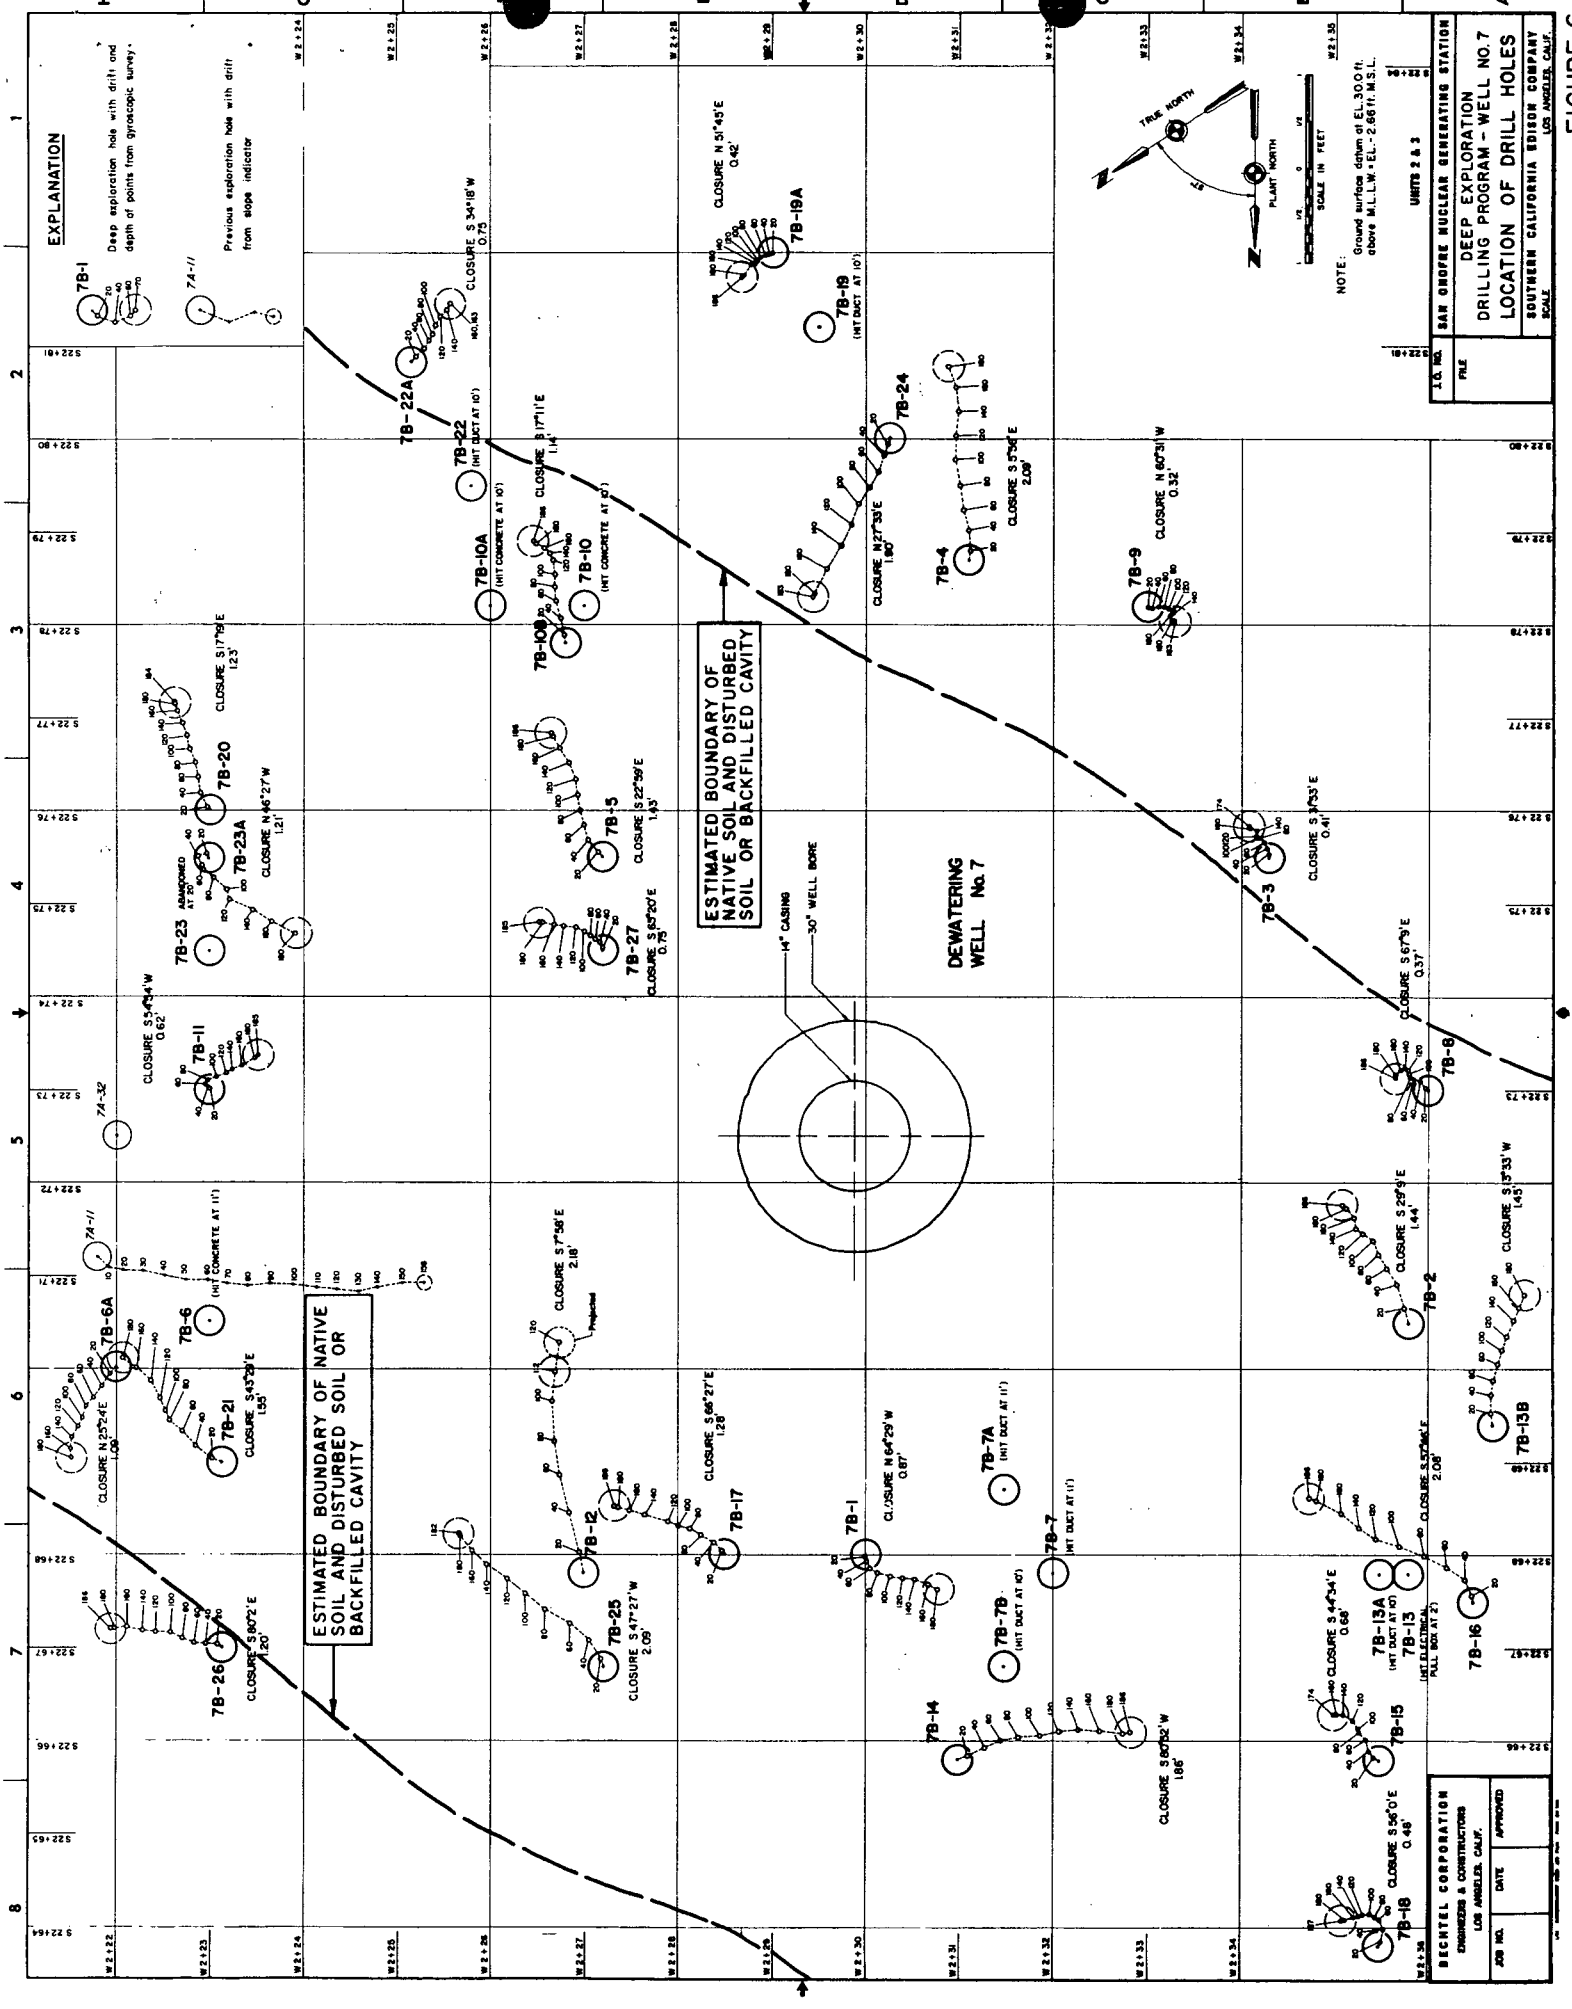
FIGURE 6

The locations of the 37 deep exploration holes are shown on Figure 6. A summary of the logs of borings is presented in tabular form in Figure 7. Of the nine borings completed during September to the design depth of 200 feet, four (7B-19A, 7B-22A, 7B-24 and 7B-26) have encountered native material below 13 feet in depth. The maximum depth at which disturbed material was encountered in these borings was 145 feet in Hole 7B-20. The N-value of the material in this disturbed interval (140 to 145 feet) is 48 blows per foot which is considered dense sand.

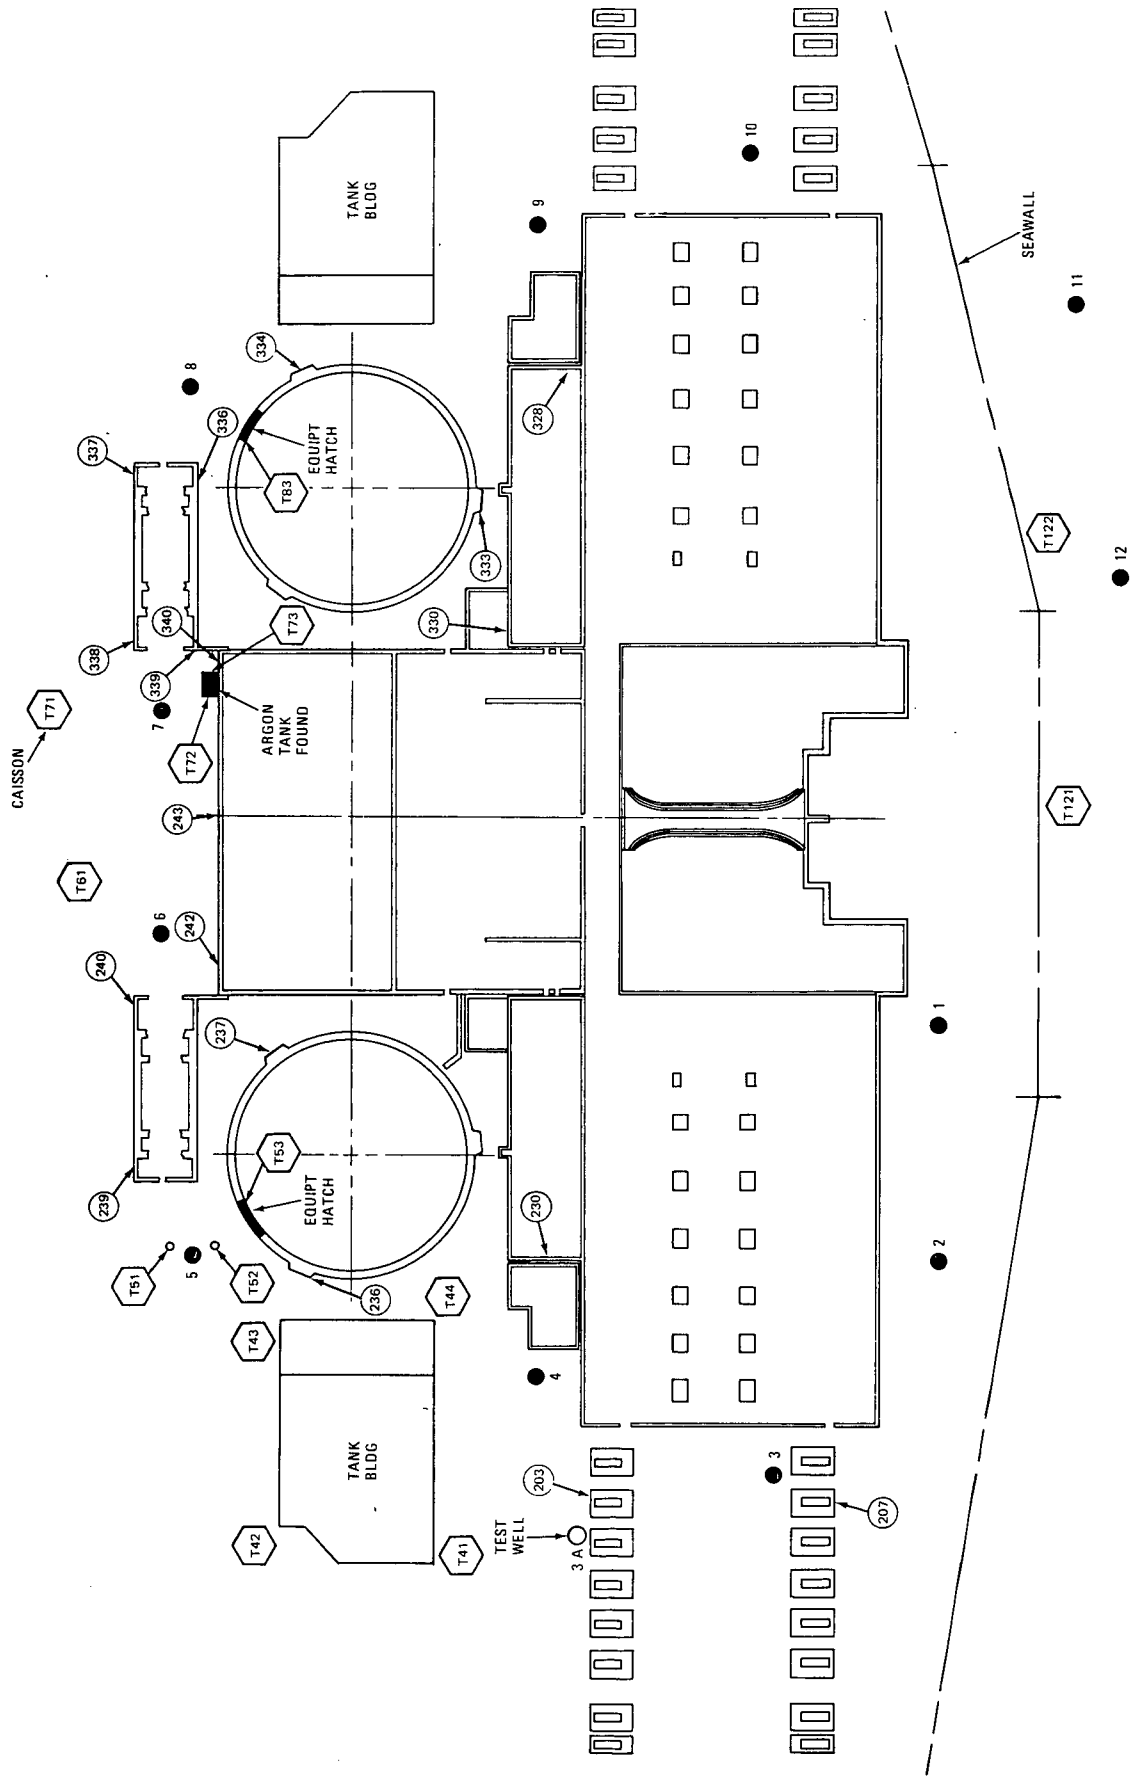
DEWATERING SYSTEM SETTLEMENT
OBSERVATION PROGRAM FIGURE 8

A settlement observation monitoring program is being used to monitor the settlement of structures or components which are founded above or around those dewatering wells which have not been investigated and demobilized to date. The settlement monitoring system involves 43 observation points, 31 of which have been installed to date. Most of the observation monuments not yet installed will be located on the Unit 3 Electrical Tunnel and Tank Building when these structures are completed. For reference, Figure 8 is included to show the physical location of the various settlement observation monuments in current use.

A review of the settlement observation data indicates that no significant movement has been observed to date.
