AEOD/C204

SAN ONOFRE UNIT 1
LOSS OF SALT WATER COOLING EVENT
ON MARCH 10, 1980

Office for Analysis and Evaluation
of Operational Data

July 1982

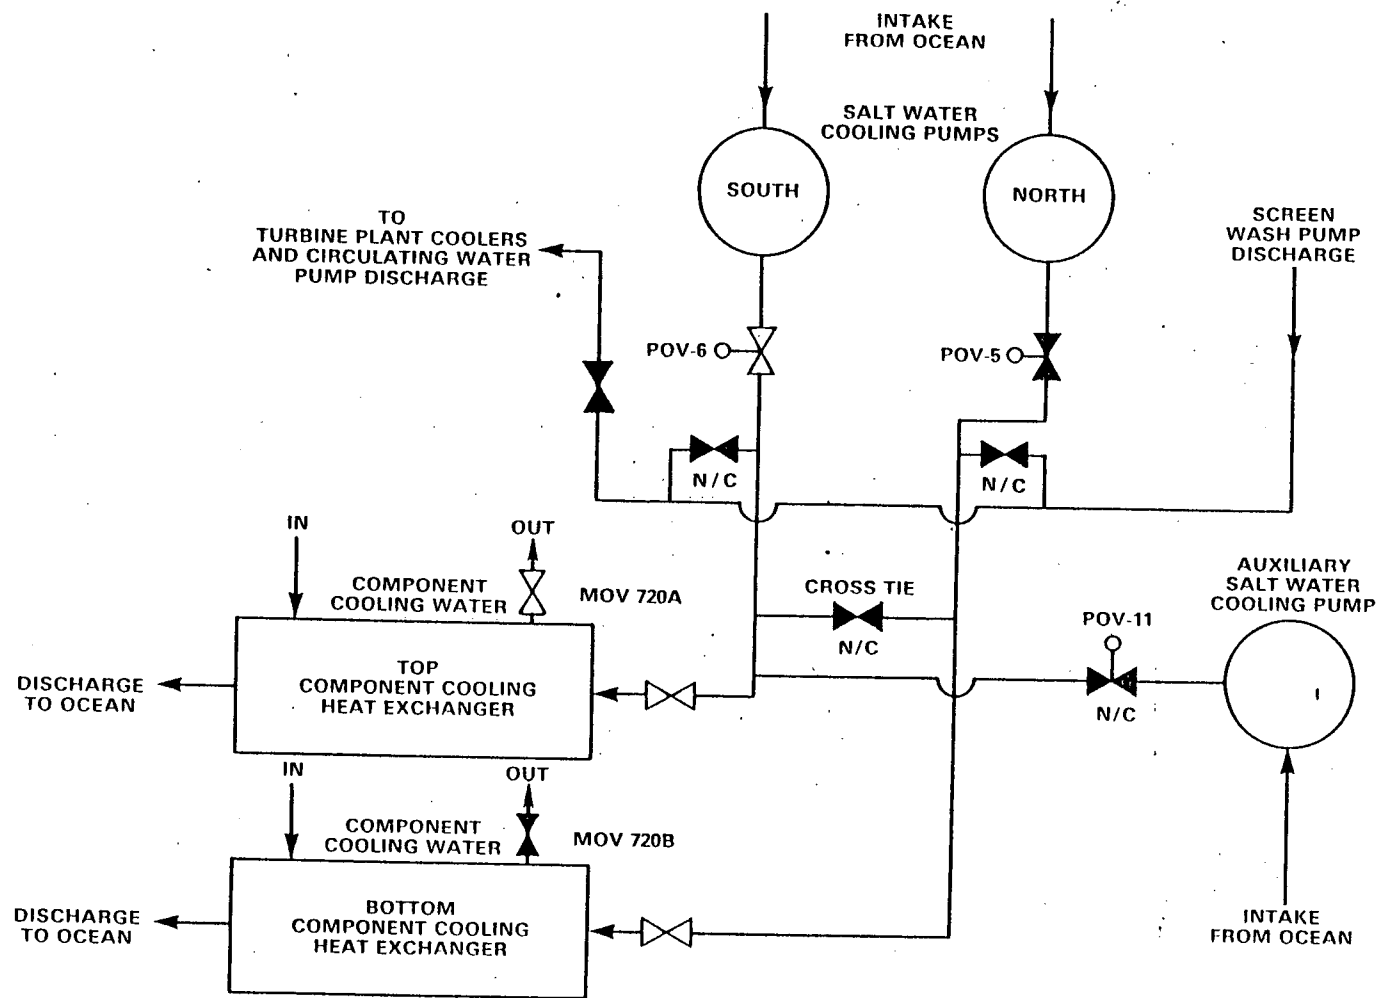
Figure 1 Salt water cooling system.

As shown in Figure 1, in addition to the two (north and south) SWC pumps, the SWC system has an auxiliary SWC pump which serves as a backup and has the same flow capacity (4620 gpm design) as the north and south SWC pumps. The auxiliary SWC pump can be aligned to either CCW heat exchanger. (The auxiliary SWC pump is normally aligned to the top CCW heat exchanger, but can be realigned to the

The SWC pump discharge valves (POV-5 and 6) are double-acting, air-driven, butterfly valves which are supplied instrument air by solenoid valves. There are no check valves in the SWC pump discharge lines; consequently, failure of the idle pump's discharge valve in the open position would allow a reverse flow if the cross-tie valve is open or if the auxiliary SWC pump is in operation.*

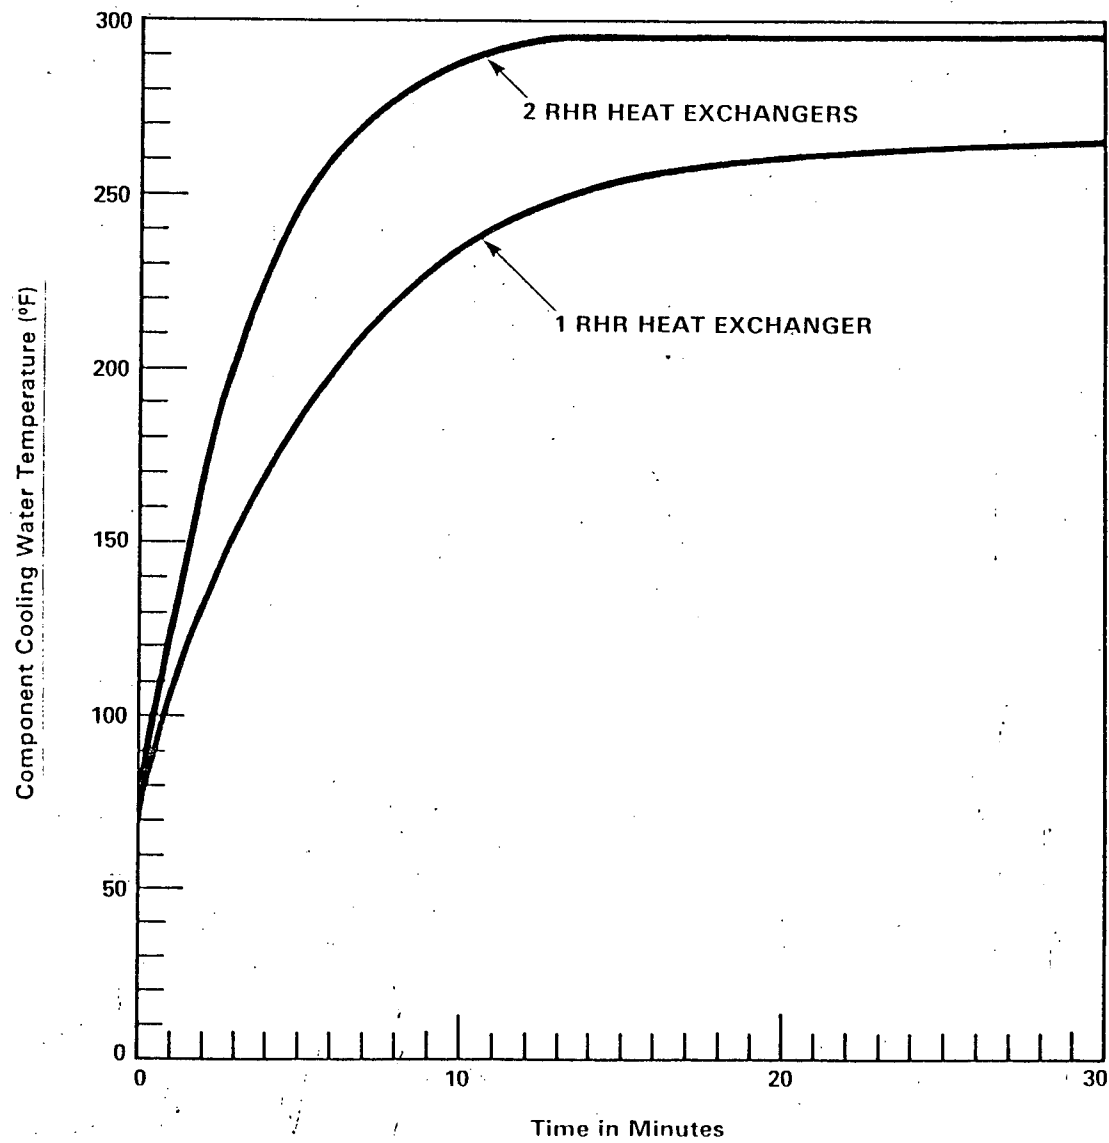
Figure A-1 Component cooling water temperature during a loss of all salt water cooling at the start of RHR cooling.

Based on this information, the modes of operation of greatest concern for loss of the SWC system are when the RHR system is in operation during normal shutdown and during main steamline break accident conditions. In accordance with NRC's request (Ref. A-4) the licensee performed scoping analyses of plant performance with degraded salt water cooling under accident conditions (Ref. A-5). The bottom line of the analyses was that if there is a total loss of salt

water cooling shortly after the plant's RHR system is actuated (for the case of normal shutdown or a main steamline break), the CCW system would reach its limiting temperature of 200°F within three to six minutes. Temperature plots for the two cases of total loss of salt water cooling appear in Figure A-1.* As seen on this figure for the case of cooldown with two RHR heat exchangers, the CCW would approach 290°F in ten minutes; for the case of cooldown with one RHR heat exchanger, the component cooling water temperature would exceed 230°F in ten minutes. It should be noted that at some point the water in the component cooling water system will begin to boil and release steam through the head tank. An analysis to determine when this would occur was not done; however, CCW temperatures in excess of 230°F are considered physically unlikely.

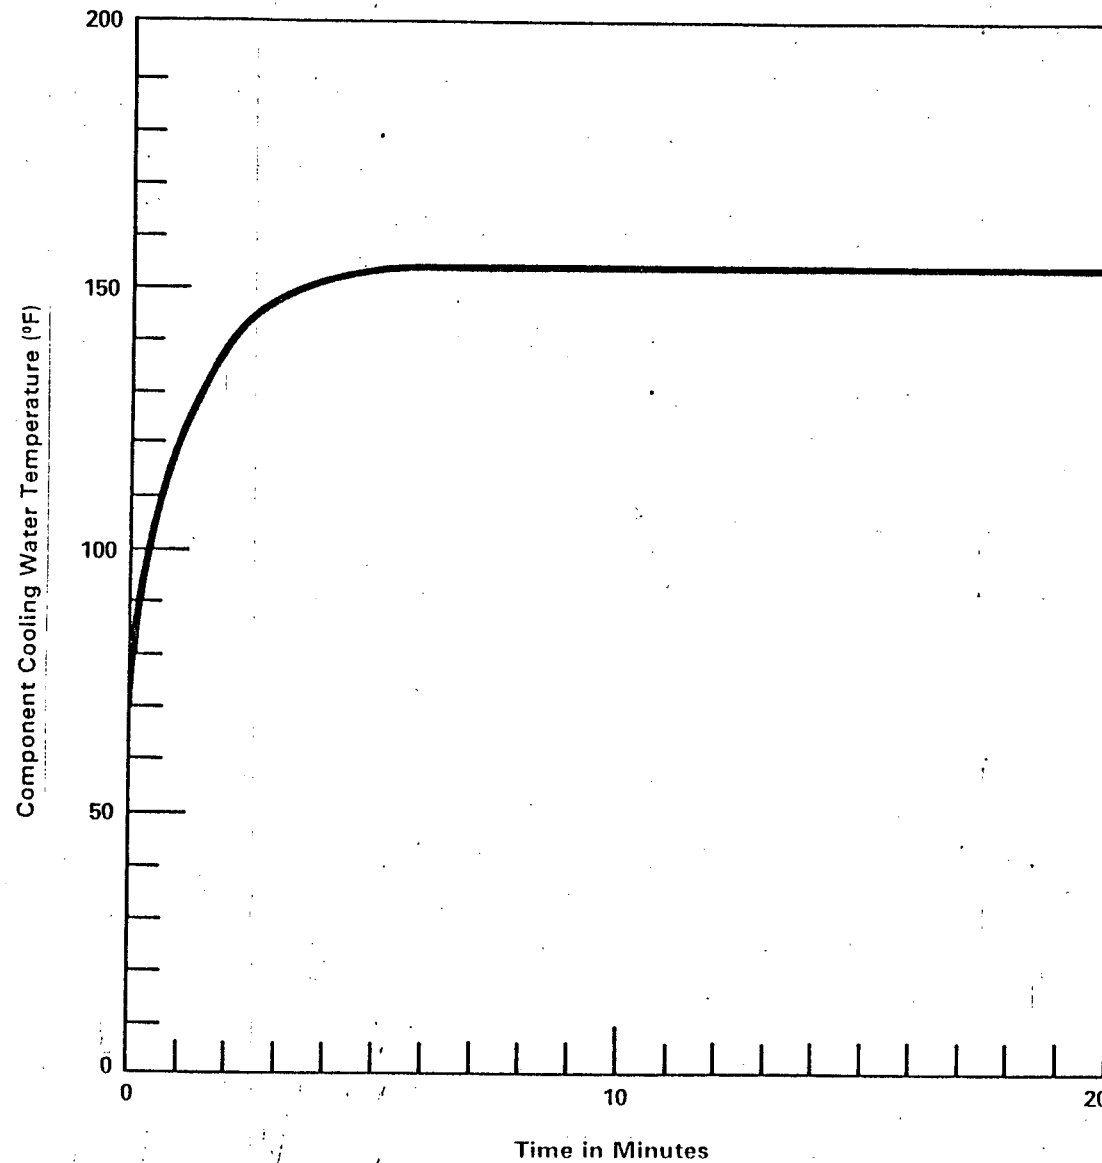
Figure A-2 Component cooling water temperature during a loss of one salt water cooling pump at the start of RHR cooling (2 RHR heat exchangers).

Another case of interest, but which is not as severe, is where one train of salt water cooling is lost shortly after the RHR system is actuated (with two RHR heat exchangers in operation). Results for this case appear in Figure A-2 and indicate that the CCW system reaches a maximum temperature of 150°F in about four minutes and stabilizes thereafter. It is not known how long the plant can sustain this temperature without equipment damage; nonetheless, operator action could be taken to decrease the heat load to the CCW system* and thus decrease its temperature to more acceptable levels.

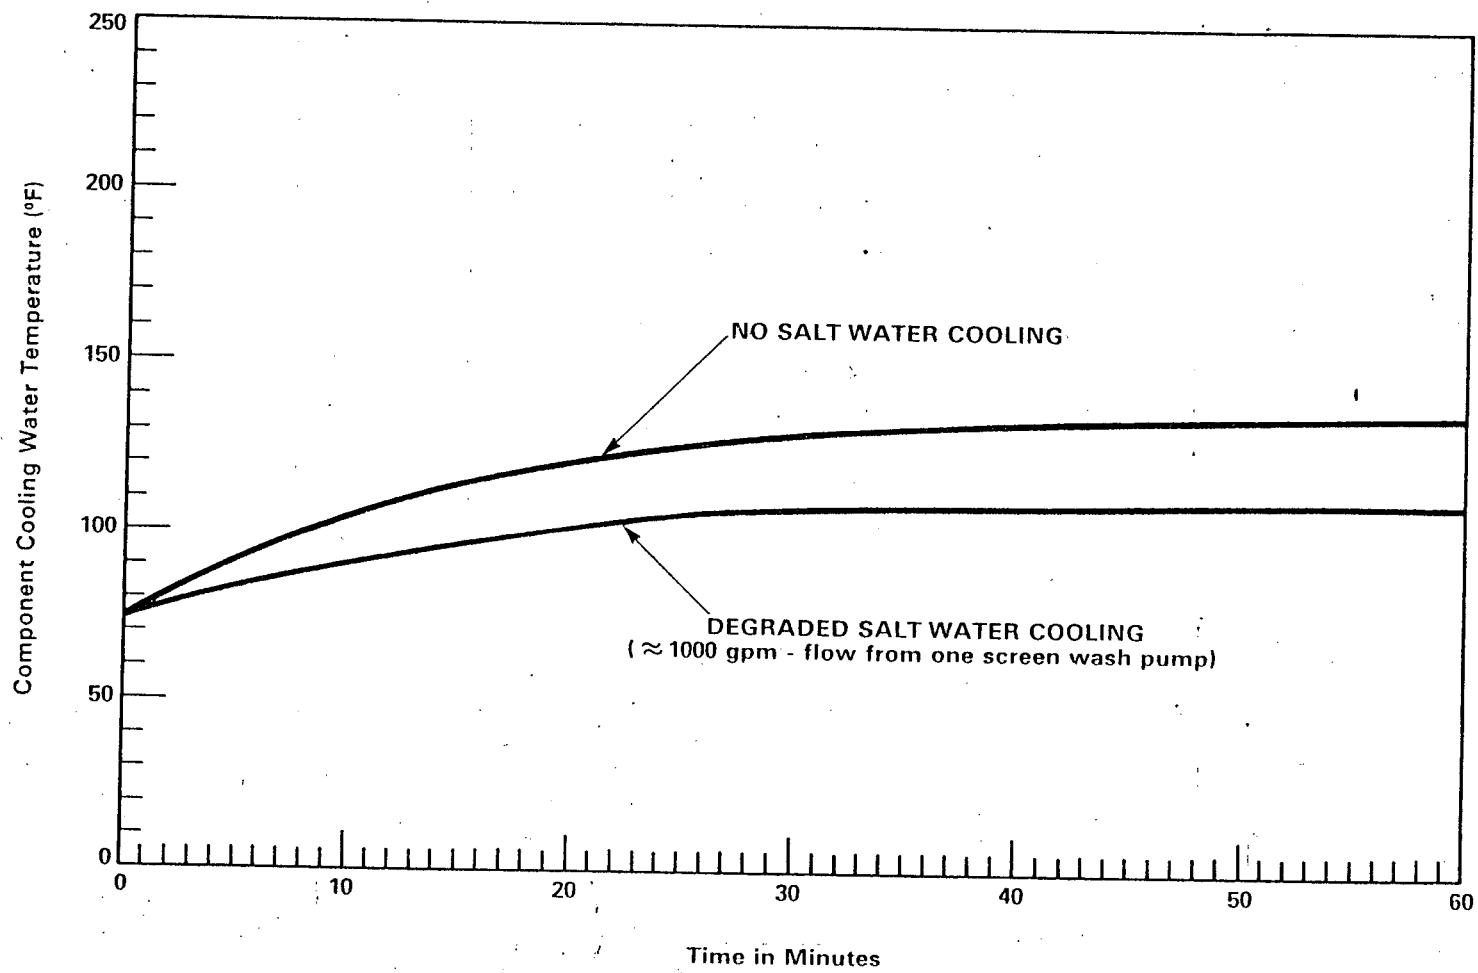
Figure A-3 Component cooling water temperature during a LOCA with degraded salt water cooling.

Two additional cases of interest that were calculated included a large LOCA with no salt water cooling and a large LOCA with 1000 gpm salt water cooling (corresponding to the flow of one screen wash pump). The results of these analyses (Figure A-3) showed that for a LOCA the loss of salt water cooling does not result in significant consequences; i.e., for a large LOCA with no salt water cooling, the CCW temperature reaches 120°F in 20 minutes and levels off at 130°F in about one hour. For the LOCA with one screen wash pump operational, the maximum CCW temperature levels off at about 95°F in about 25 minutes.

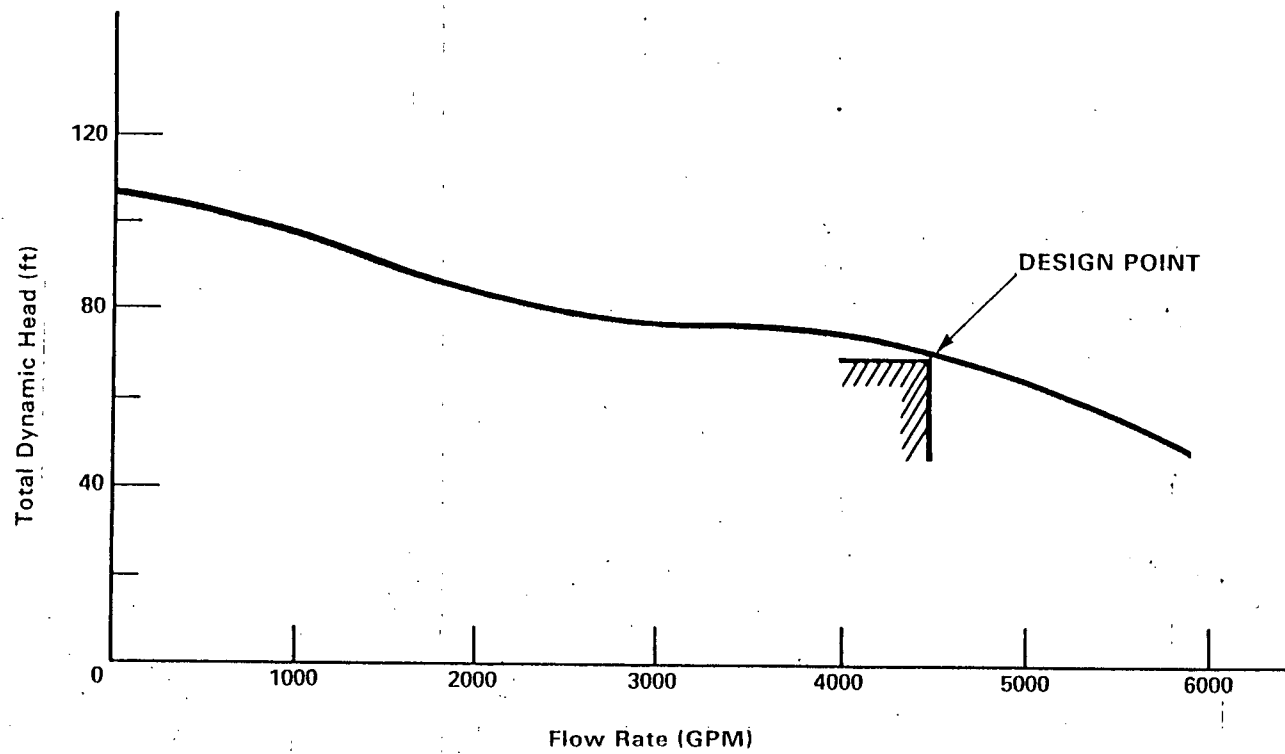
Figure C-1 Salt water cooling pump performance curve.

As noted in Appendix C, the IST data for flow and ΔP for the SWC pumps can be subject to large errors because ΔP is obtained from tide height (for many tests reference elevation was included incorrectly), and because the SWC pump performance curve is very flat in the range where the inservice testing is performed (250 gpm/ft of head).

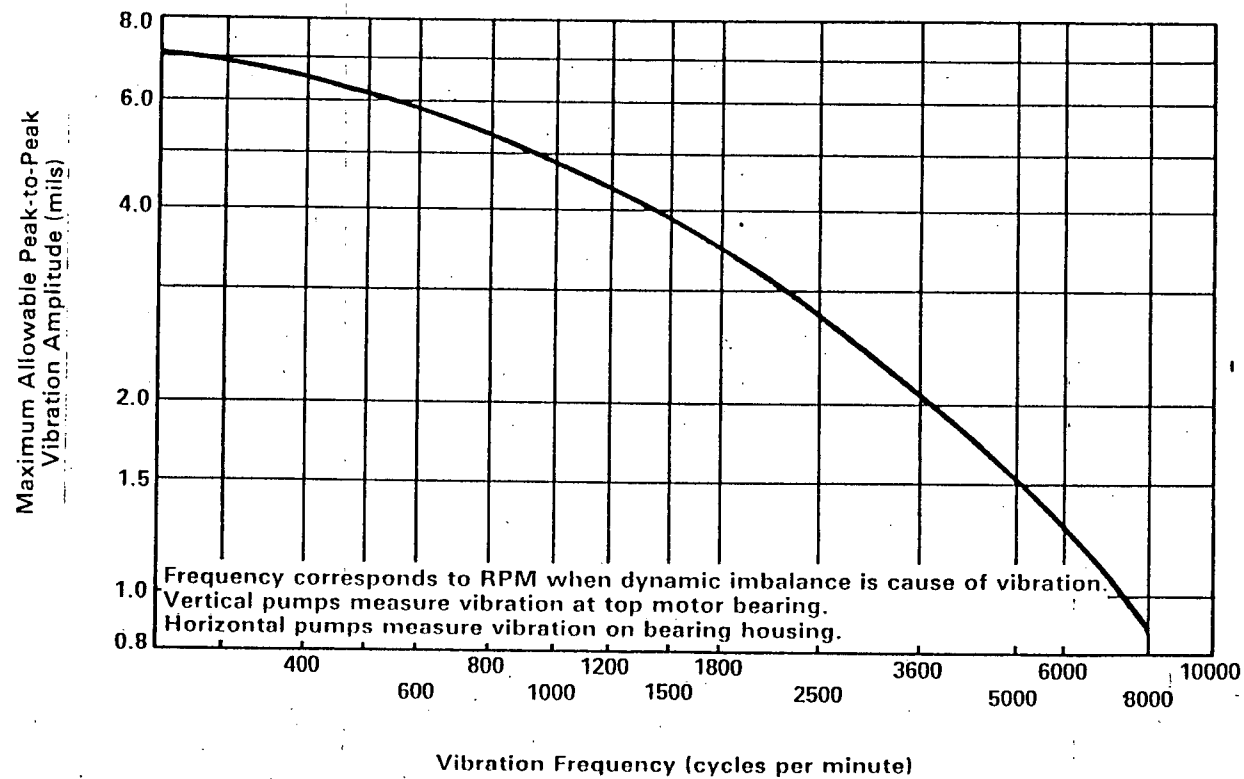
Figure C-2 Hydraulic Institute curve for pump shaft vibration testing.

A significant deficiency in the SWC system IST program resulted from the licensee's request and NRC interim approval of an exemption from pump bearing vibration testing. In view of the large number of SWC pump failures, reconsideration of the exemption, or a "detailed review" as mentioned in NRC's December 22, 1977 approval letter, appears to be appropriate now.

As part of the IST Program, the licensee measures vibration of the thrust bearing at the top of the drive motor. This data is used in accordance with ASME section XI IST requirements to determine when the pump shaft requires investigation and/or corrective action. The Hydraulic Institute's Standard Curve (see figure C-2), the "General Machinery Vibration Severity Chart" (Ref C-13), and other similar references are used as guides to determine acceptable vibration levels.

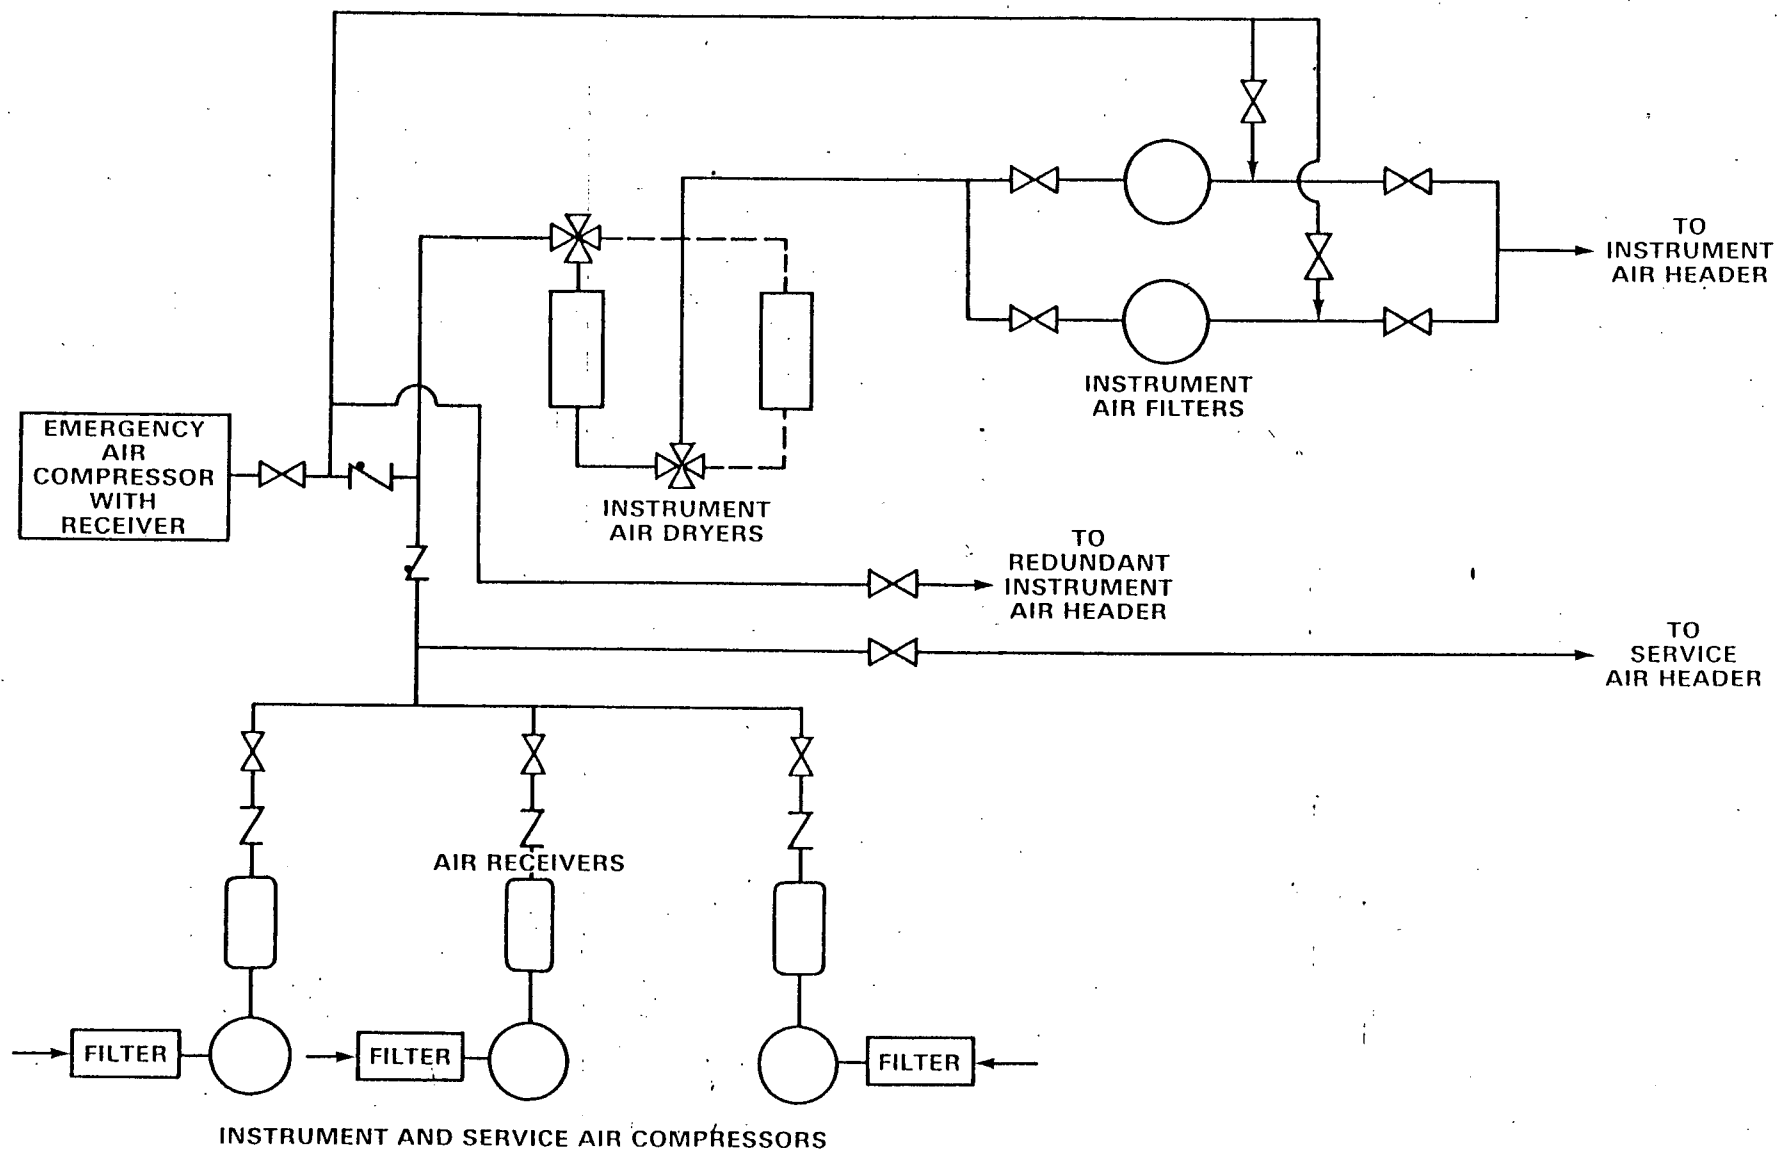
Figure D-1 Schematic diagram of the compressed air system.

The licensee's examination of the instrument air system revealed that desiccant had migrated throughout the system. A massive blowdown and cleanup operation was necessary to assure that all 130 safety-related pieces of equipment which are connected to the instrument air system would not malfunction due to desiccant or other air system contaminants. The possibility of common cause failure due to a contaminated instrument air supply has not been analyzed for San Onofre (or for any other plant to our knowledge).

As noted in Appendix D, instrument air which is provided by the emergency air compressor is not necessarily filtered. Such operation may pose a common cause failure potential for much safety-related equipment. The issue of contamination of both trains of safety-related equipment caused by the emergency air supply has been discussed with the licensee. We are presently unaware of any plans for corrective action.

The air dryers, through which instrument air is routed, are vertical tanks containing silica gel desiccant material in bulk form. It is believed that, due to the prolonged use between replacement of the air dryers at San Onofre, the desiccant broke down into small fragments (Ref. D-1). Some of the fragments

migrated from the tanks to the filters downstream. These filters, which also contained desiccant in bags, were initially effective in removing the small desiccant fragments from the air. However, the desiccant fragments gradually coated the filters, thereby increasing the pressure drop across the filters. This increased pressure drop caused increased bypass flow around the filters, and the small desiccant fragments eventually appeared downstream. Desiccant fragments then migrated throughout the instrument air system to areas inside containment, the auxiliary building, and the intake structure.

- (3) The plant's entire instrument air system has been blown down. New desiccant has been installed, as has a new air filtration system including instrumentation to measure the pressure drop across the filters. The licensee's preventive maintenance program will address the condition of the desiccant.
