SUBJECT: Forwards info summarizing feedwater ring damage, discussed at NRC 810731 meeting. Proposed feedwater ring mods render auxiliary feedwater initiation test unnecessary. Final design details for repair will be provided.

Subject: Docket Nos. 50-361 and 50-362  
San Onofre Nuclear Generating Station  
Units 2 and 3

SAN ONOFRE UNIT 2 FEEDWATER RING DAMAGE

PRELIMINARY REPORT OF CONDITION OF  
FEEDWATER PIPE ASSEMBLY  
IN  
SAN ONOFRE UNIT 2, NO. 2  
STEAM GENERATOR

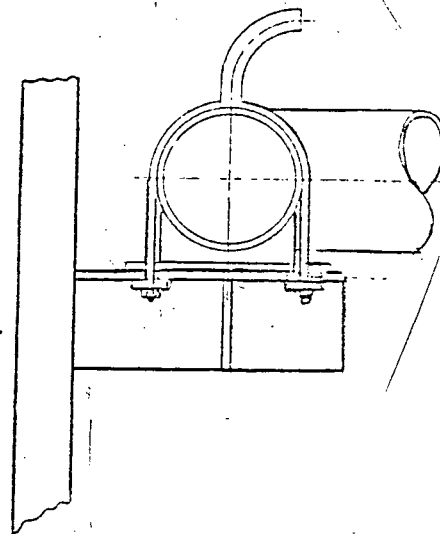
Detail of Feedwater ring  
Support bracket

The feedwater pipe assembly is supported on four (4) brackets. These brackets are welded to the pressure boundary with full penetration welds. The brackets are located at the 90°, 166°, 194° and 270° locations. The feedwater nozzle and water distribution box is located at the 0° position.

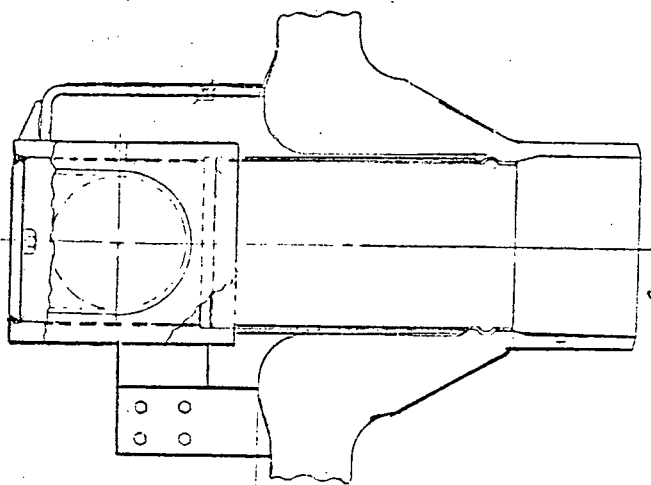
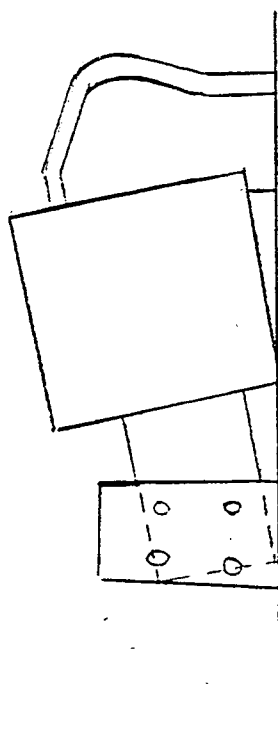
Rotation in the  
plane of the  
paper. (Note: the  
rotation is greatly  
exaggerated)

deformed condition

— All four bolts sheared off.

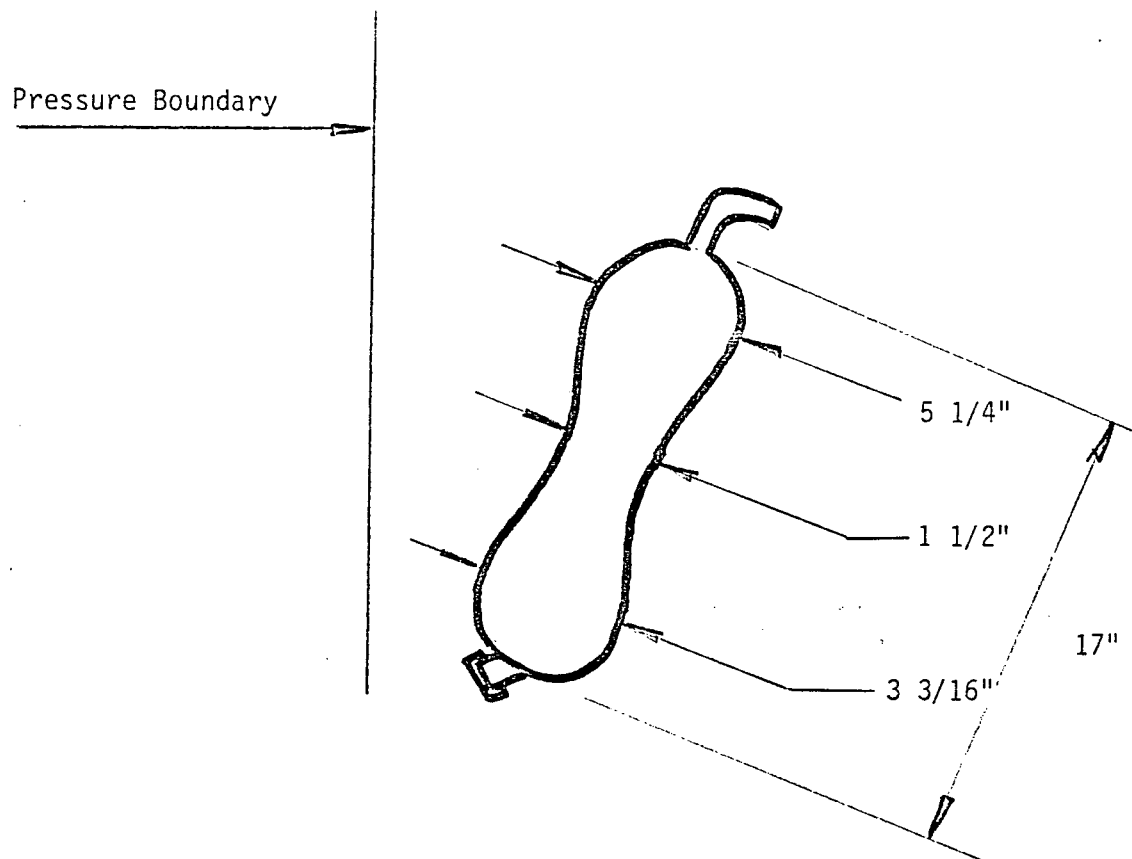
The visual deformation of the feedwater ring starts approximately 10" from the water distribution box (Pipe ovality checks indicate that the deformation starts about 2" from the box). The sketch below describes the condition of the pipe between J-Tubes 4 and 5.

The above condition is typical up to J-Tube 9 after which the deformation switches from vertical to horizontal.

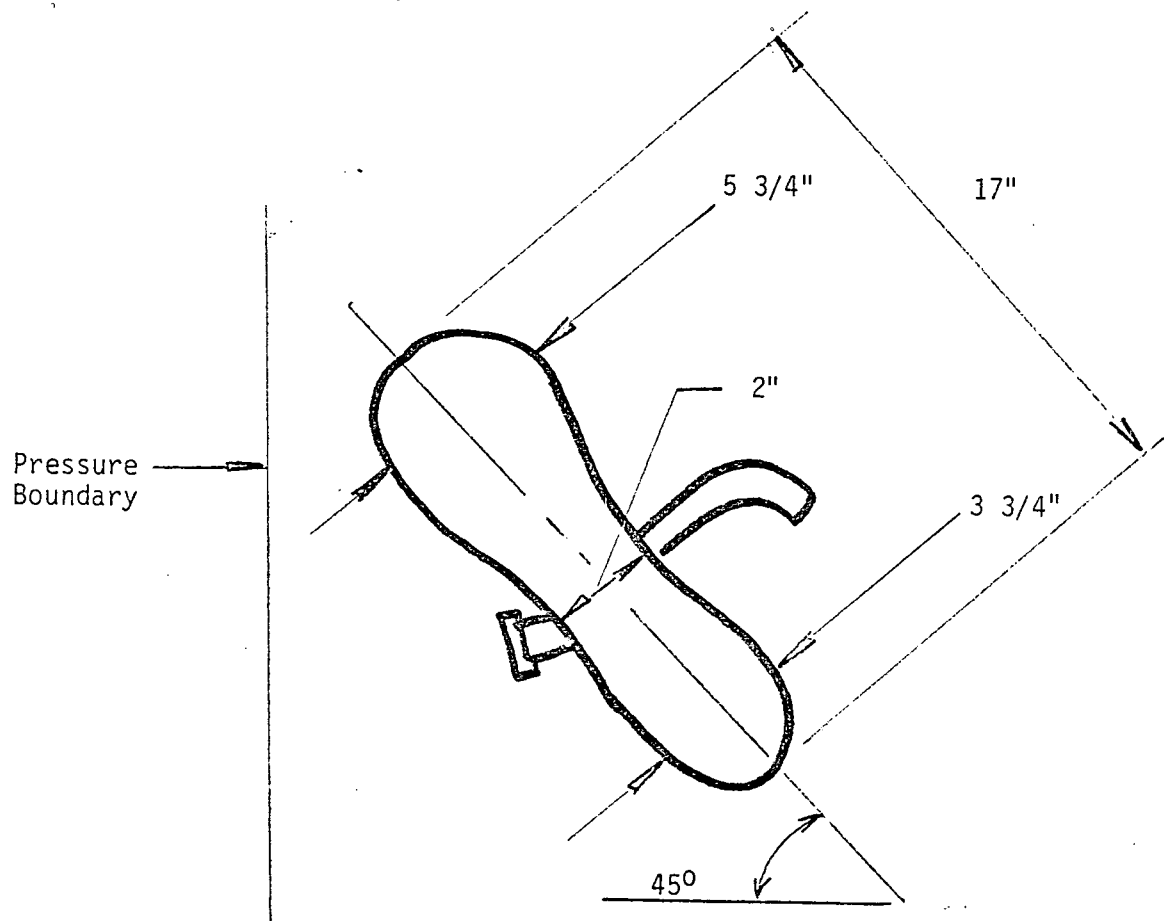
The sketch below describes the condition between J-Tubes 9 and 10.

The above cross section is typical until approximate J-Tube 19 (cross section is rotating counter clockwise as J-Tube 19 is approached. J-Tube is located immediately prior to the 90° support bracket). At this location the pipe regains the original round shape. This condition remains to the end of the pipe section. There is no apparent deformation of the end plate.

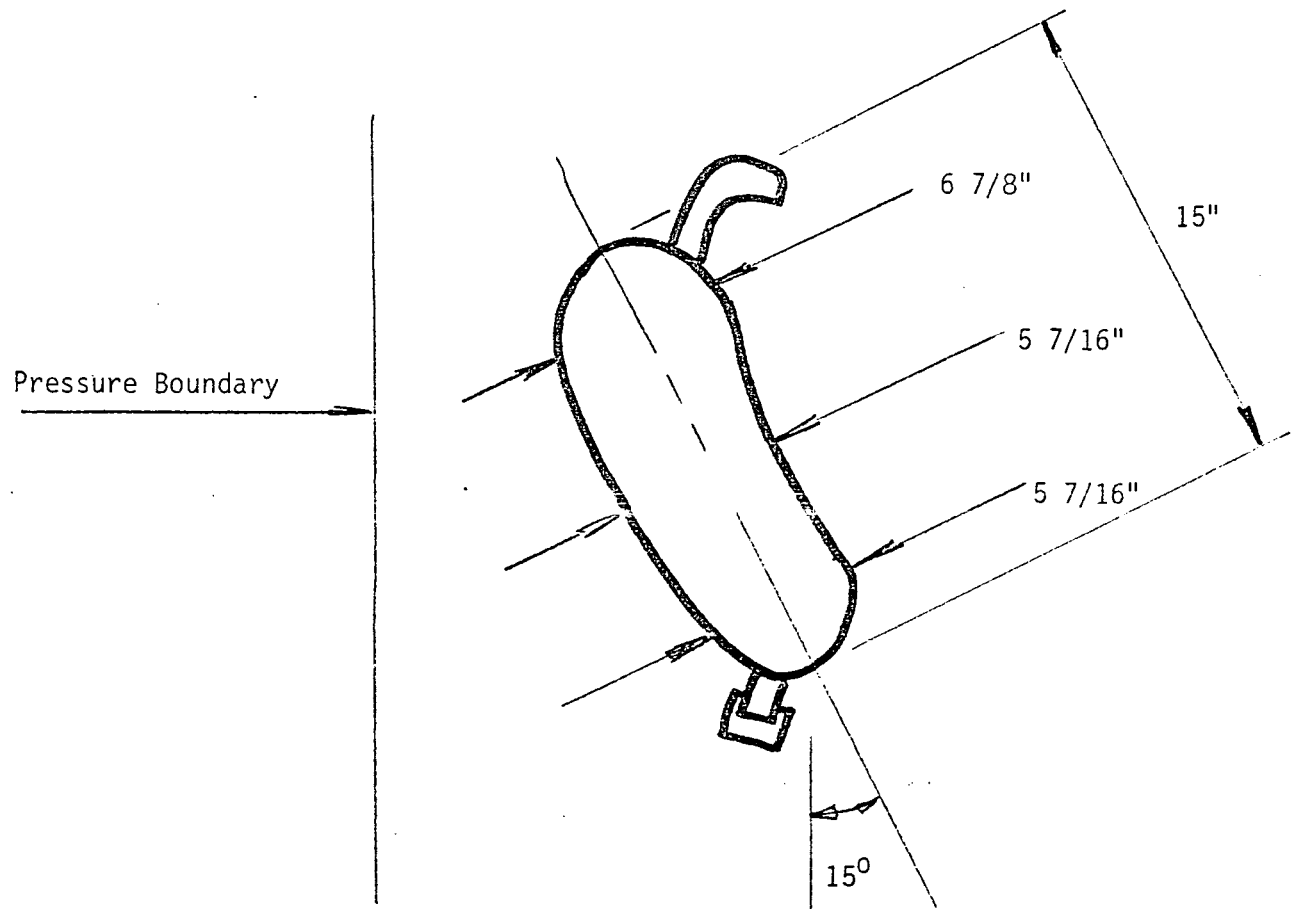
The visual deformation starts about 18" (between J-Tubes 2 and 3) from the water distribution box. The sketch below depicts the pipe cross section between J-Tubes 4 and 5.

The above cross section remains past J-Tube 6. The deformation switches from vertical to horizontal between J-Tubes 7 and 10. Past J-Tube 10 the deformation is horizontal. The sketch below depicts the pipe cross section between J-Tubes 14 and 15.

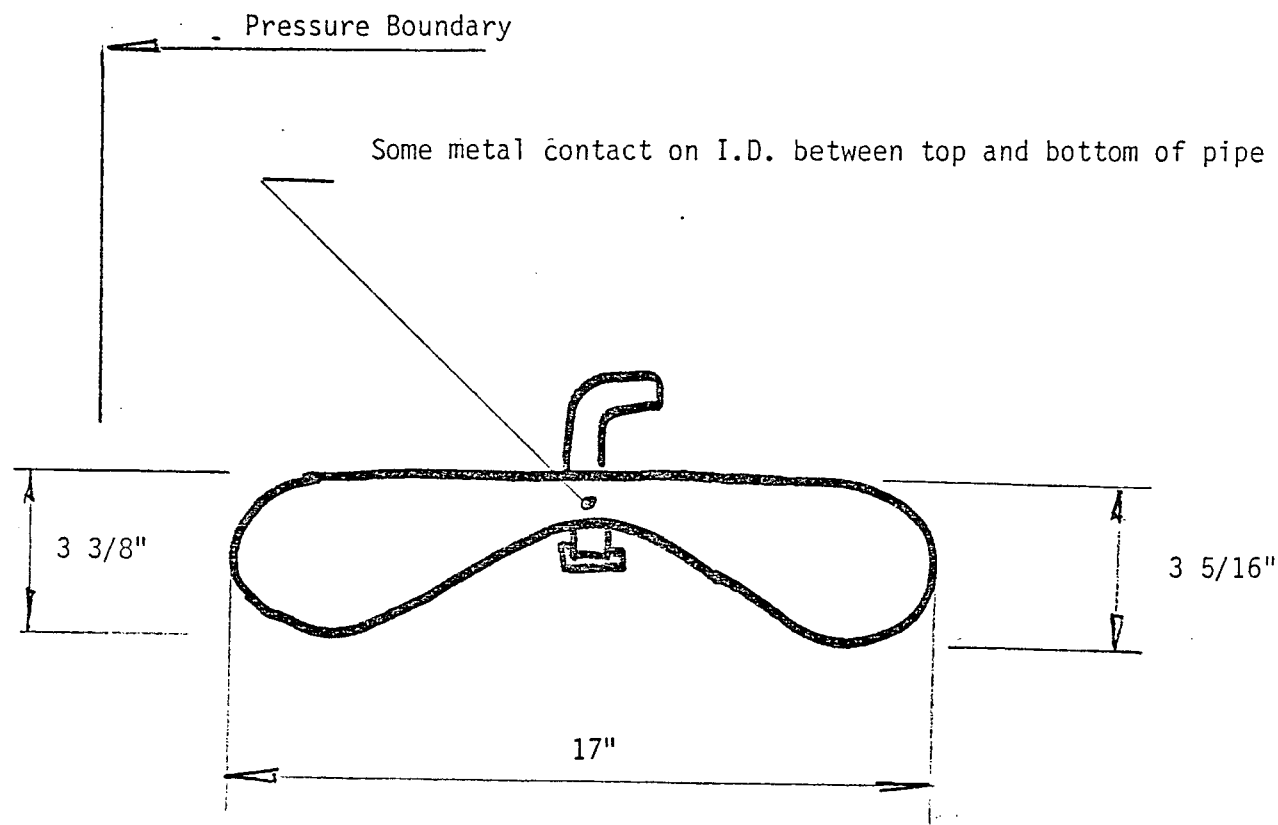
This condition is typical (although less crushing) up to J-Tube 20. Past J-Tube 21 the ring regains its original circular cross section.

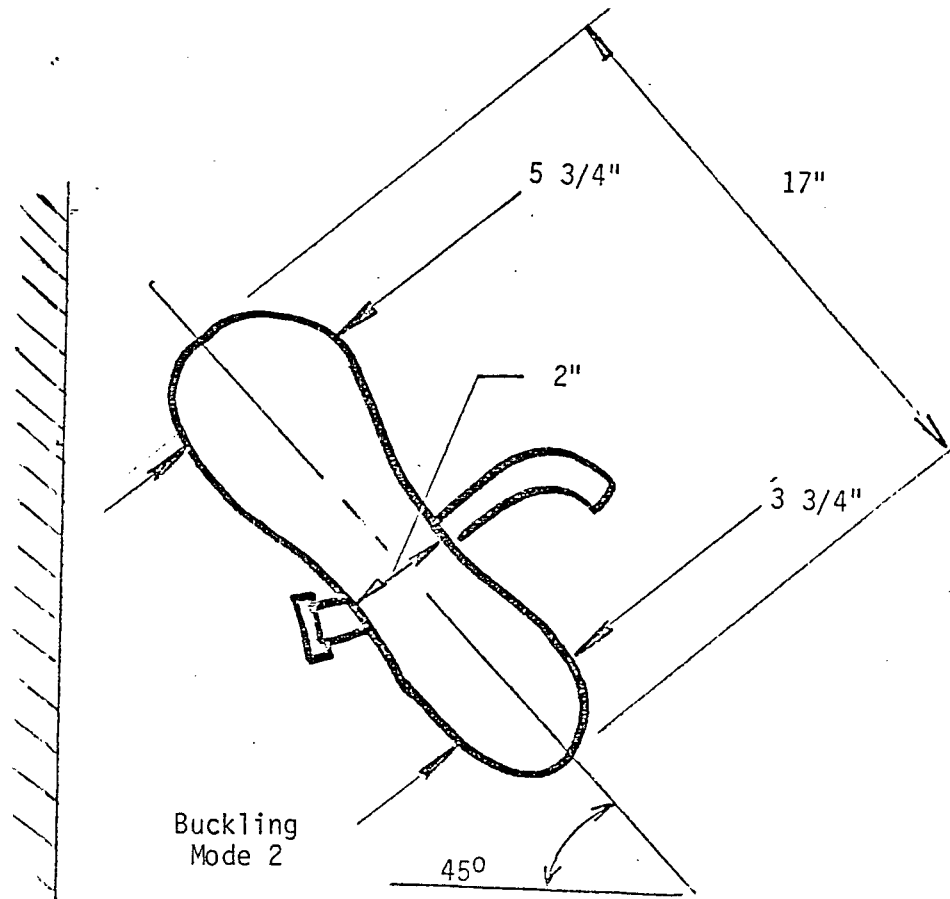
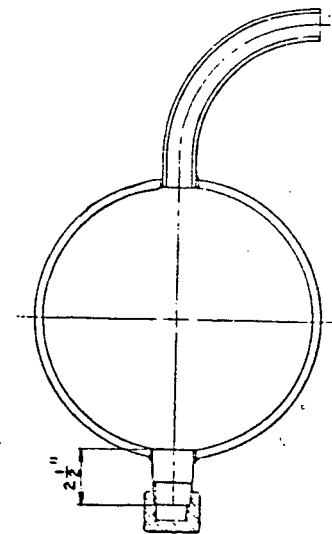
# FEEDWATER SPARGER COLLAPSE MODE

DAMAGE MECHANISM: SUDDENLY APPLIED DIFFERENTIAL PRESSURE

- (A) OVALITY
- (B) VARIATION IN THICKNESS
- (C) HOLES IN THE PIPE
- (D) UNBALANCED  $\Delta$  P LOADING

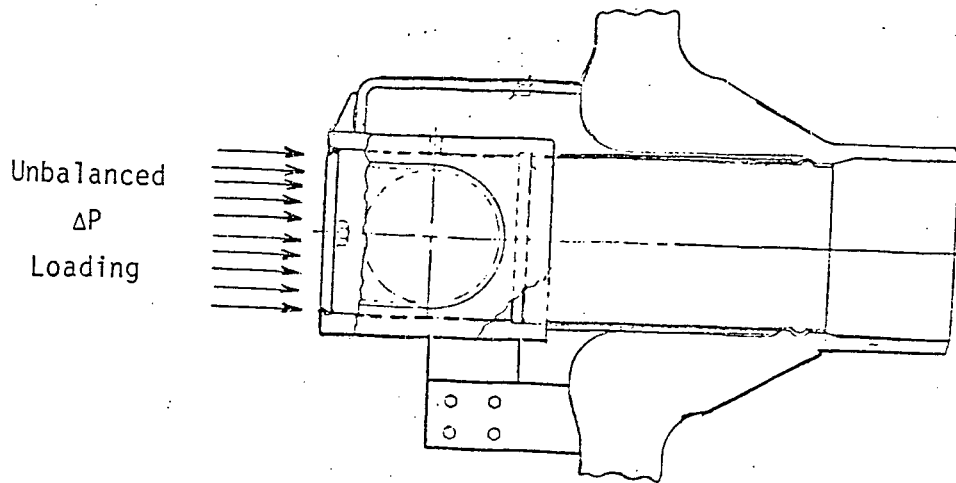
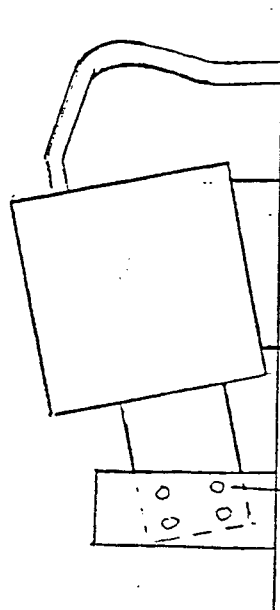
Rotation in the  
plane of the  
paper. (Note: the  
rotation is greatly  
exaggerated)

deformed condition

All four bolts sheared off.
