POTENTIAL FINDING REPORT
SONGS 2&3 SEISMIC DESIGN VERIFICATION

PFR NO. 2408-PFR-F003

AFFECTED ITEMS: 408 volt Motor Control Centers (MCC). Seismic Category I (BPC Spec. S023-302-4 + B Addendum)

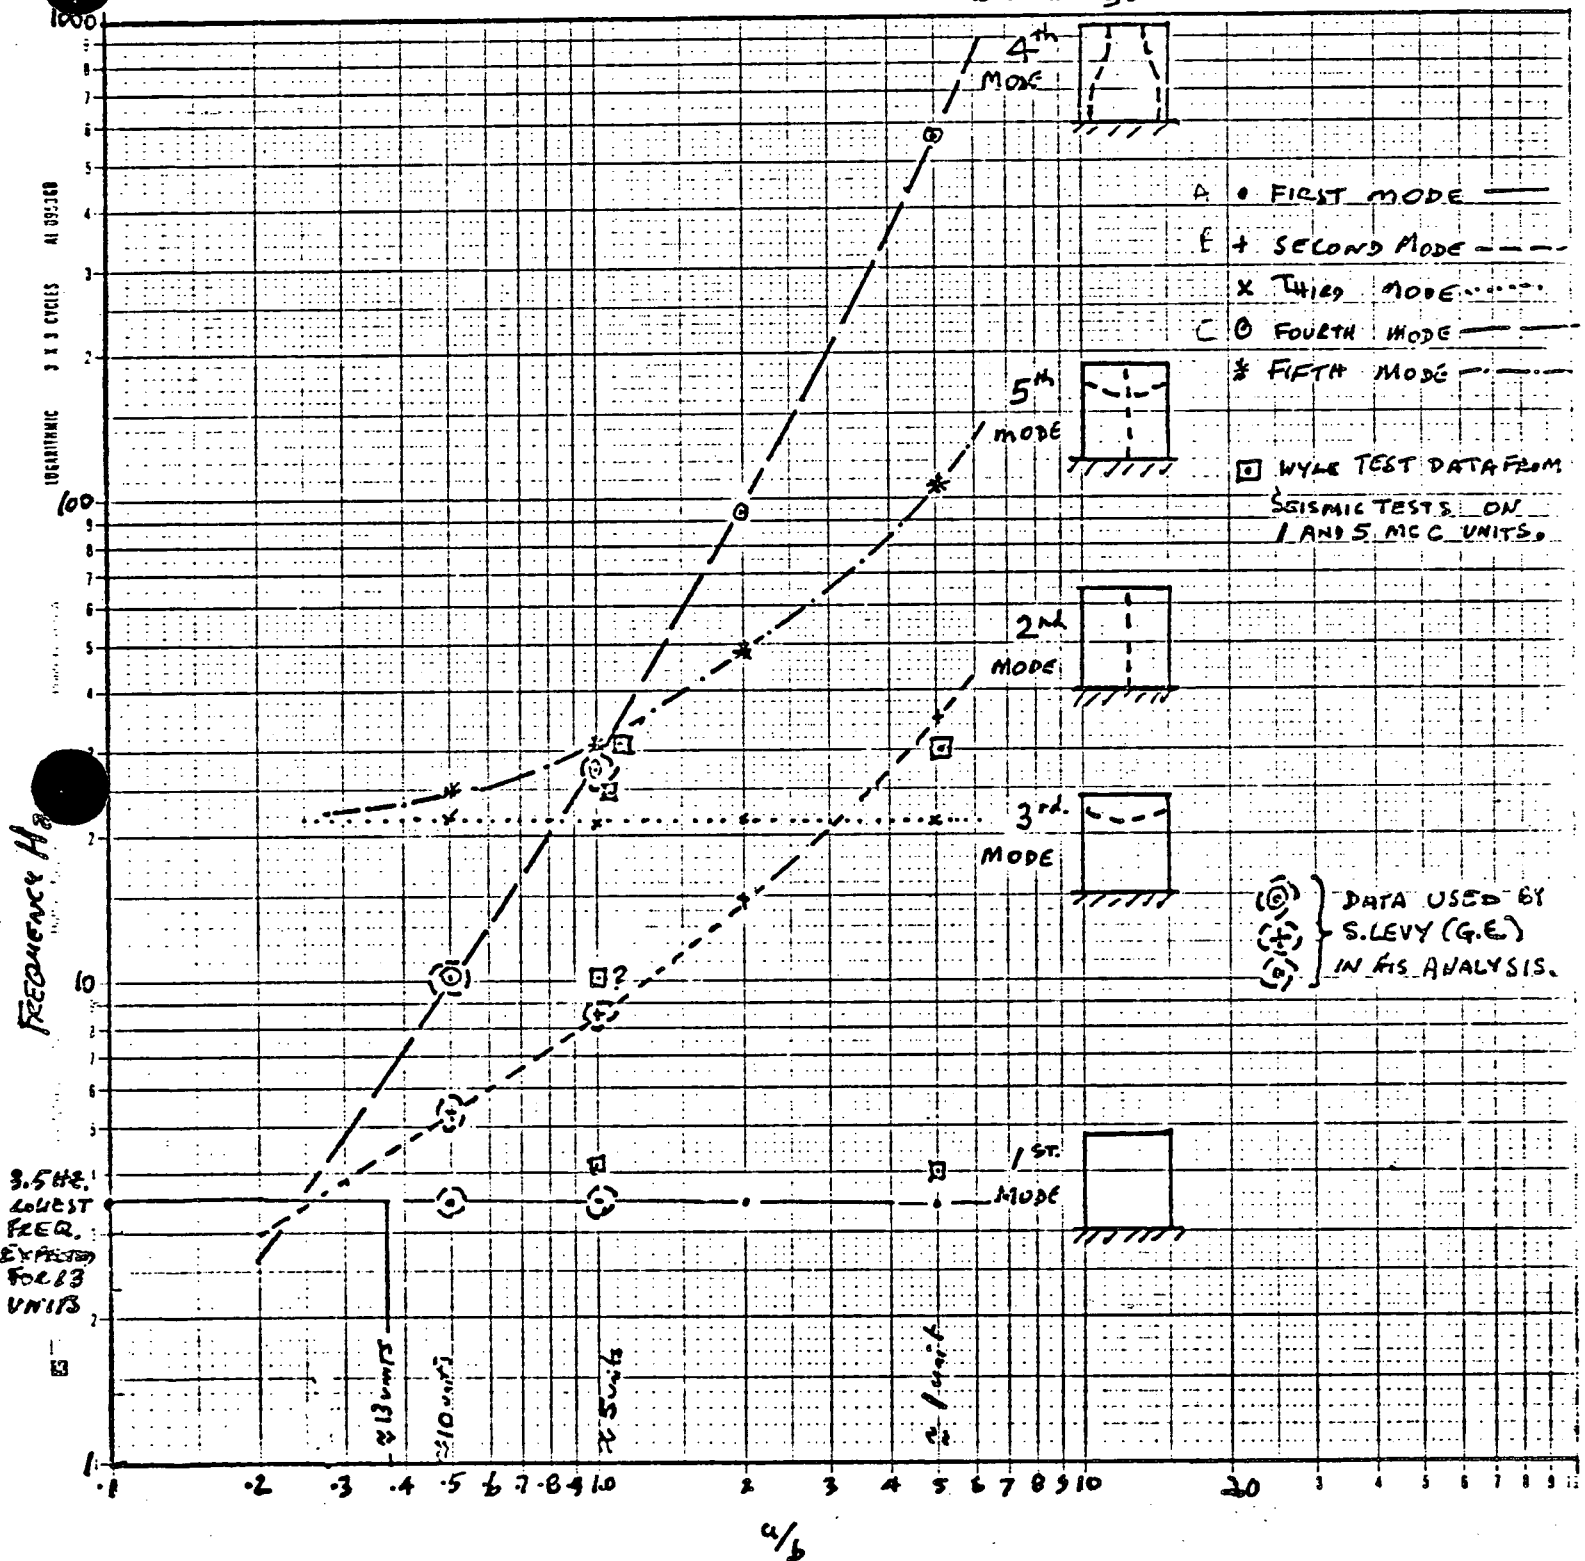
FIGURE 1

Information on the vibration of cantilevered rectangular steel plates shows that, for certain modes of vibration, long plates are not necessarily stiffer than short plates.

PLOT OF NATURAL FREQUENCIES FOR CANTILEVERED RECTANGULAR PLATES
 (FROM HARRIS & CREDE VOL. I. PAGE 7-31 TABLE 7.8 - DATA TAKEN
 FROM M.V. BARTON. JOURNAL OF APPLIED MECHANICS, JUNE 1951).

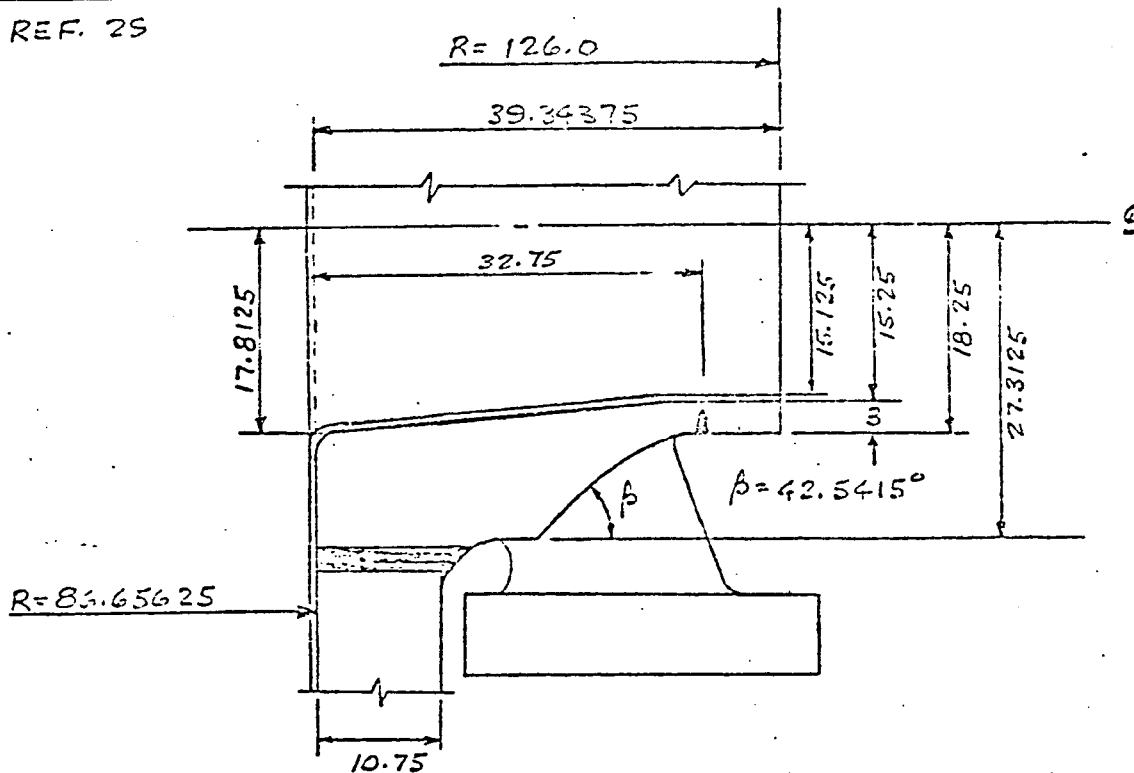
A. GEOMETRY

On sheet 4 of 30 (RS-201 of Ref. 1) the geometry and the corresponding material properties are presented for the nozzle. Three different materials are listed. On sheet 17 of 30 (RS-201 of Ref. 1) the locations for specific points of analysis are given. Cut No. 1 is of particular interest because it lies in the material that has the lowest stress allowables of the three material types mentioned above. Now when the maximum stresses for normal operating conditions were checked with the allowables (Sh 23 of 30), the appropriate material was used for Cut No. 1. But when the check was made for the faulted conditions at Cut No. 1 (Sht 21 of 35, RS-205 of Ref 1), a comparison of stresses was made using the wrong material stress allowables. This is also the case on sheet 23 of 35 (RS-205 of Ref. 1). A larger stress allowable was used instead of the appropriate allowable for Cut No. 1.

Reply: The values for S_m on pages 21 and 23 of RS-205 were checked and were found to be in error. The correct value used is $S_m = .7S_u = .7(70) = 49$ ksi. The value used is $S_m = .7S_u = .7(80) = 56$ ksi. This error will be corrected.
