SUBJECT: LER 90-005-01:on 900510,steam generator feedwater sparger  
 damage.W/901116 ltr.

Subject: Docket No. 50-362  
Supplemental Report  
Licensee Event Report No. 90-005, Revision 1  
San Onofre Nuclear Generating Station, Unit 3

LICENSEE EVENT REPORT (LER)														
Facility Name (1) SAN ONOFRE NUCLEAR GENERATING STATION, UNIT 3										Docket Number (2) 0   5   0   0   0   3   6   2			Page (3) 1   of   0   7	
Title (4) STEAM GENERATOR FEEDWATER SPARGER DAMAGE														
EVENT DATE (5)			LER NUMBER (6)			REPORT DATE (7)			OTHER FACILITIES INVOLVED (8)					
Month	Day	Year	Year	Sequential Number	Revision Number	Month	Day	Year	Facility Names			Docket Number(s)		
0   5	1   0	9   0	9   0	0   0   5	0   1	1   1	1   6	9   0	SONGS, UNIT 2			0   5   0   0   0   3   6   1		
OPERATING MODE (9) 6			THIS REPORT IS SUBMITTED PURSUANT TO THE REQUIREMENTS OF 10CFR (Check one or more of the following) (11)											
POWER LEVEL (10) 0   0   0 ////////////////////			<input type="checkbox"/> 20.402(b)			<input type="checkbox"/> 20.405(c)			<input type="checkbox"/> 50.73(a)(2)(iv)			<input type="checkbox"/> 73.71(b)		
			<input type="checkbox"/> 20.405(a)(1)(i)			<input type="checkbox"

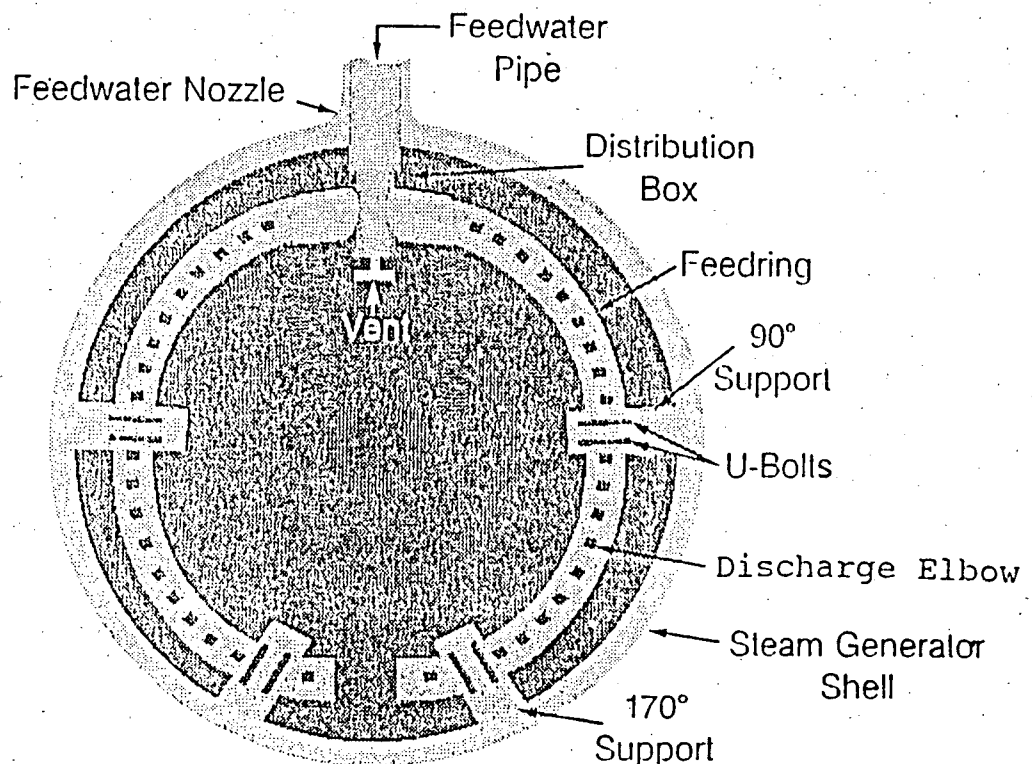
Top View of Feeding

Feedwater enters the SGs through the feedwater nozzle and travels into the feedwater inlet distribution box where it is channeled into the feeding which distributes feedwater around the periphery of the SG. A 3 inch elbow and Tee vent assembly is attached to the upper portion of the innermost (flat) end of each distribution box. In addition to being supported by the feedwater nozzle via the distribution box, the feeding is supported by four supports located within the SG. It is attached to these supports by eight U-bolts, two on each support. The supports are welded to the SG shell. Feedwater exits the feeding via discharge elbows, which are mounted on the top of the feeding and direct feedwater away from the SG shell. See figure below.
