LTR-PAFM-10-50-NP
Revision 0

**Section XI Flaw Evaluation of Indication Recorded on
RC-32-MRCL-AIII-03 of the Point Beach Unit 1
Inlet Nozzle to Pipe Weld**

March 2010

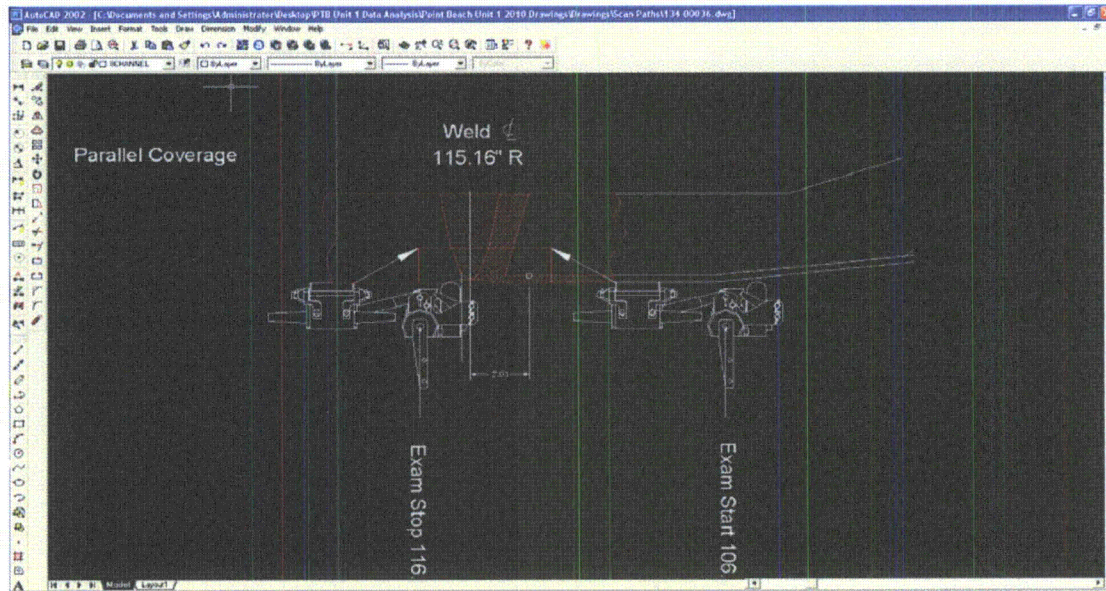
During Phased Array (PA) ultrasonic detection examinations on RC-32-MRCL-AIII-03 (Elbow to Inlet Nozzle at 328.5°) dissimilar metal weld (Cast Stainless Elbow with Stainless weld & Stainless buttering), an indication was recorded at 18 inches from top dead center (TDC) and 2.1 inches from the weld centerline on the nozzle side of the weld in the nozzle forging and approximately 0.9 inches from the buttering. This indication can be seen in the "toward", "away", "clockwise", and "counterclockwise" directions, indicating that it is volumetric in nature (e.g., slag inclusion). The indication orientation is predominantly circumferential in nature. During the previous 10-Year Reactor Vessel examination in 1998, two (2) indications were recorded in this region and sized to be allowable due to being "buried" (subsurface).

Sizing scans were performed with the specified PA search unit, which assisted with the characterization of the indication. The sizing scans characterized the indication as being 0.71 inches long and 0.505 inches in through-wall dimension (18.10% a/t). The cladding thickness (not counted) is 0.25 inches, and the nominal pipe thickness (minus clad) is 3.27 inches. The surface "S" dimension was conservatively considered to be zero (0) to account for near-surface uncertainties.

Based on current findings, it is considered that this indication or group of indications is most likely to be embedded fabrication flaws; however, it is being evaluated as a surface-connected flaw due to the proximity to the inside surface. The location is actually near to the buttering of the nozzle, and also near to the clad-to-base metal interface, as shown in the sketch of Figure 1.

Figure 1: Inspection Volume of the Region of Interest, and Location of the Indication

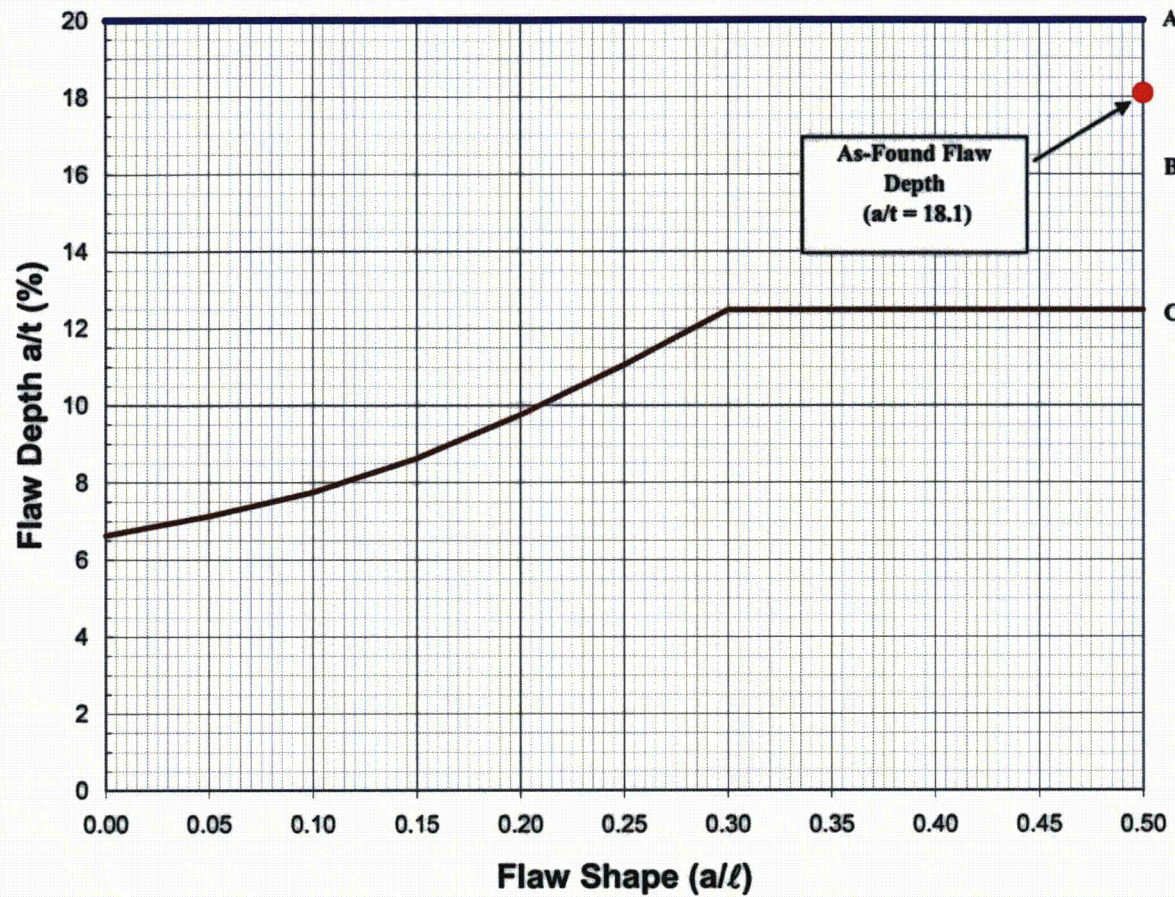
In preparation for the reactor vessel inspections, a set of flaw evaluation charts had been prepared for the reactor vessel weld regions [1,2], and the indication was compared with these flaw evaluation results, and found to be acceptable for further service without repair. The flaw evaluation chart of interest is Figure A-6.3 of reference 1, which is provided in an updated version as the last figure of this technical note, with the indication plotted.

It will be seen from Figure A-6.3 of WCAP 11477 [1] that the allowable depth for any indication, regardless of shape, is at least 20 percent of the wall thickness. The allowable depth line is across the very upper edge of the figure. This line is the result of a direct application of the Section XI acceptance criteria.

Therefore, we see that the allowable flaw depth is very large, regardless of the flaw shape for this location. For conservatism the allowable flaw depth in the chart of Figure 2 has been cut off at $a/t = 0.2$.

The evaluation chart for surface flaws is shown in Figure 2, for circumferential flaws. Note that there are three lines in the chart, representing the acceptable length of service, 10, 20, and 30 years.

Figure 2 (Figure A-6.3) Evaluation Chart for Inlet Nozzle Safe-end to Nozzle Weld [1]
