Three Mile Island Unit 1  
Route 441 South, P.O. Box 480  
Middletown, PA 17057

THREE MILE ISLAND NUCLEAR STATION, UNIT 1 (TMI-1)  
RENEWED FACILITY OPERATING LICENSE NO. DPR-50  
DOCKET NO. 50-289

SUBJECT: LICENSEE EVENT REPORT (LER) NO. 2013-001-00  
"Reactor Coolant "B" Cold Leg Drain Line Flaw"

4. TITLE: Reactor Coolant "B" Cold Leg Drain Line Flaw

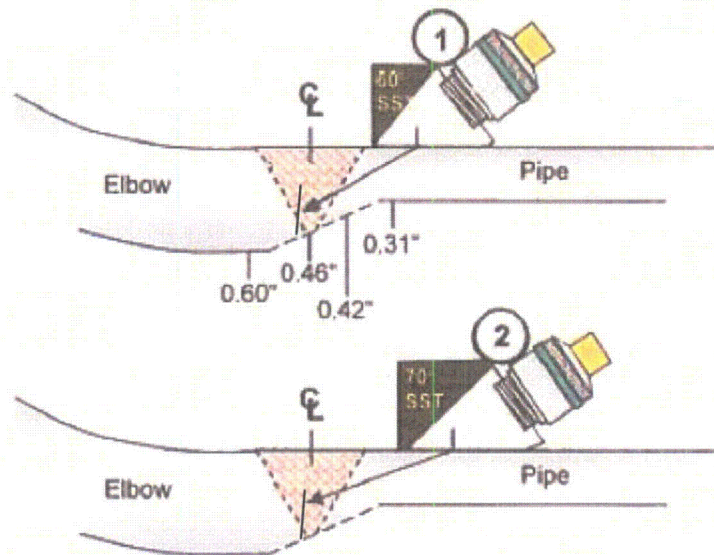
During T1R20 the “B” RCP cold leg suction drain elbow was examined using ultrasonic technology. At the weld designated as weld RC-289, an indication was found within the weld that initiated at the inside diameter (ID) and progressed approximately 66% through wall, toward the outside diameter (OD). The defect was verified using phased array technology and confirmed. The wall thickness at the defect was 0.460” and the defect was 0.280” in length leaving a remaining ligament of 0.180” (180 mils).

Weld RC-289 - NDE report diagram from 2013 discovery. The crack location, black line, is at the tip of the arrow.

ASME Section XI 2004, subsection IWB, paragraph IWB-3514-2 requires the acceptable flaw depth to be less than 12 ½% of measured wall thickness. The maximum wall loss that would have been allowable at this location was 57.5 mils. Based on 280 mils of wall loss measured, the crack was greater than the code allowable limit and the flaw was required to be removed. The fitting was shipped to B&W for destructive analysis to determine the failure mechanism. A new and similar fitting was welded in place. The weld that replaced RC-289 was performed under shop conditions and was radiographed. No indications were noted from the installation Non-Destructive Examination (NDE).

The apparent root cause that RCS weld RC-289 was found cracked in T1R20 was that a resultant stress, composed of multiple smaller stresses focused by weld geometry, initiated a crack in RC-289. This crack was driven through the weld by stresses from plant heatup, cooldown, and thermal fatigue.

Determine the source of the stress that is initiating the crack through the application of the following testing: Strain gauges, thermography, temperature measurement, and laser scanning.

If the crack source can be found and stopped, actions will be created to eliminate the source of the cracking.

If the crack source cannot be determined, actions will be created to determine if proactive replacement is warranted.
