LR-N14-0009

Salem Nuclear Generating Station Unit 2  
Renewed Facility Operating License No. DPR-75  
NRC Docket No. 50-311

Subject: Response to Request for Additional Information Regarding Steam Generator  
Tube Inspection Conducted During the Fall 2012 Nineteenth Refueling Outage  
Salem Nuclear Generating Station, Unit No. 2 Docket No. 50-311  
(ML13330A585)

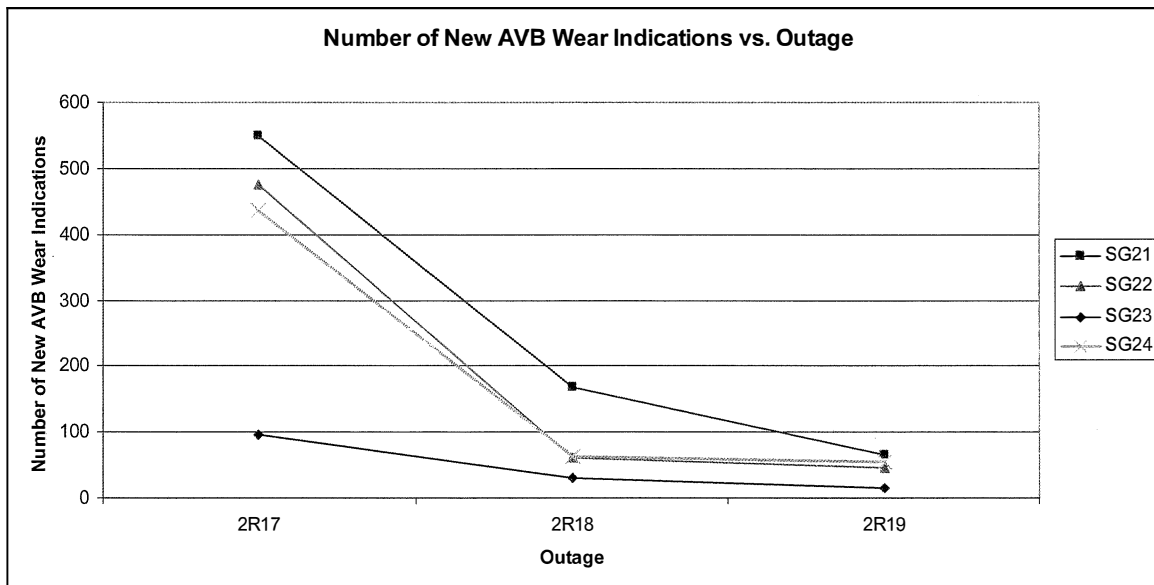
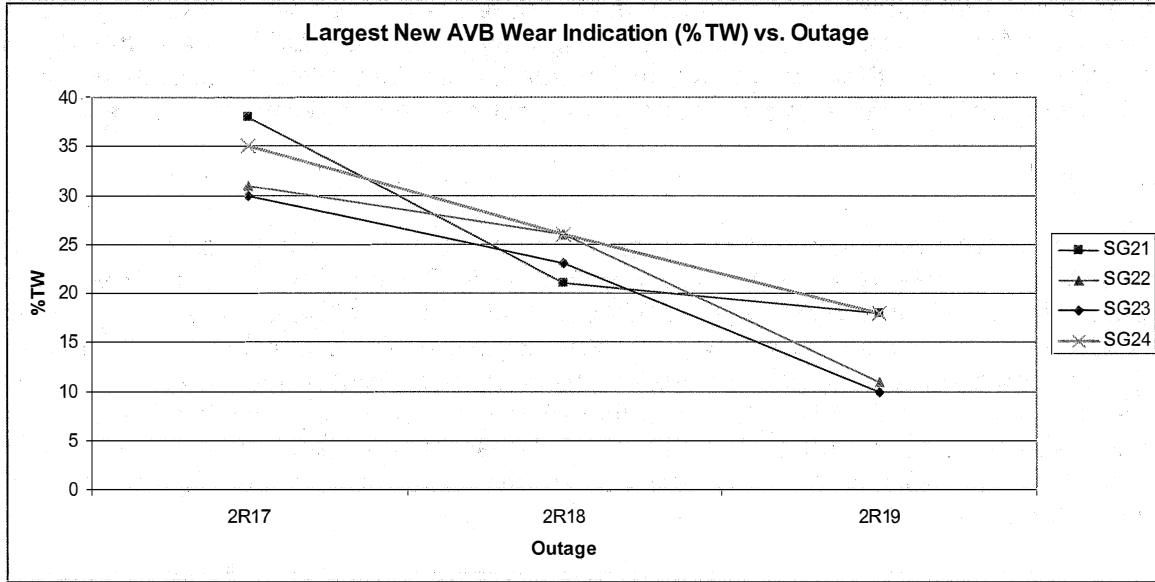
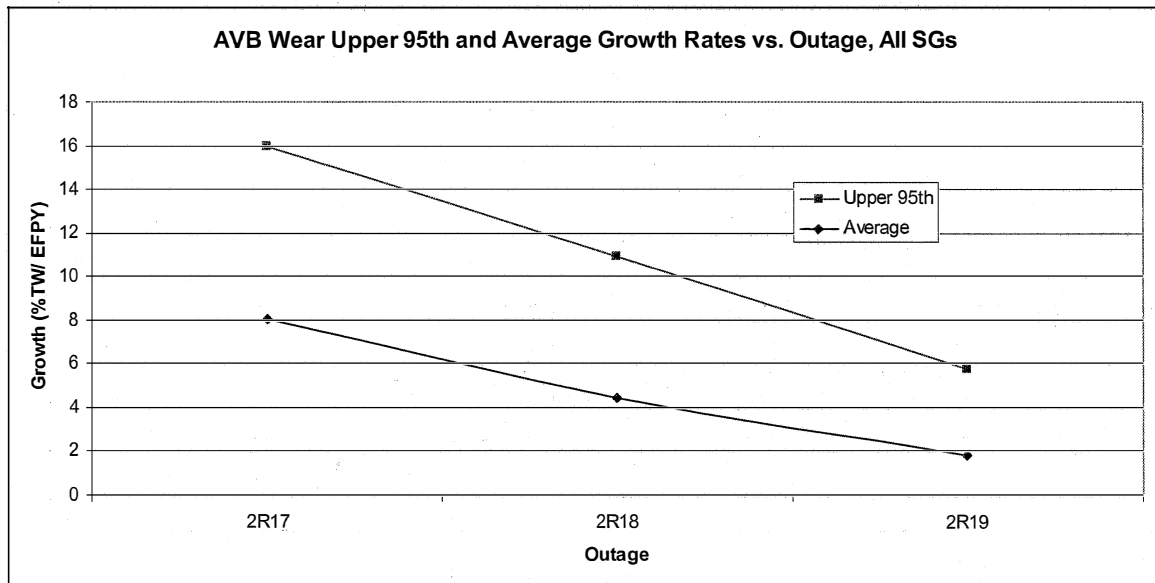
Below are three graphs representing the trends for the number of new anti-vibration bar wear indications, the largest new AVB wear indication, and the AVB wear growth rates. The growth rate graph provides the trends with the upper 95<sup>th</sup> percentile growth rate and the average growth rate, for AVB wear indications with history (with exception of 2R17, since all indications in 2R17 are new). As shown in these graphs, the trends for the number of new anti-vibration bar wear indications, the largest new AVB wear indication, and the AVB wear growth rates at each inspection outage have continued to decline with each inspection outage. The findings of the 2R19 steam generator examination are bounded by the behavior projected in the cycle 19 operational assessment.
