**PSEG Nuclear LLC**

Salem Generating Station, Units 1 and 2  
Renewed Facility Operating License Nos. DPR-70 and DPR-75  
NRC Docket Nos. 50-272 and 50-311

**Subject: Response to Request for Additional Information (RAI 31 and RAI 32)  
– Relief Request SC-I4R-133, Alternative Repair for Service Water  
System Piping**

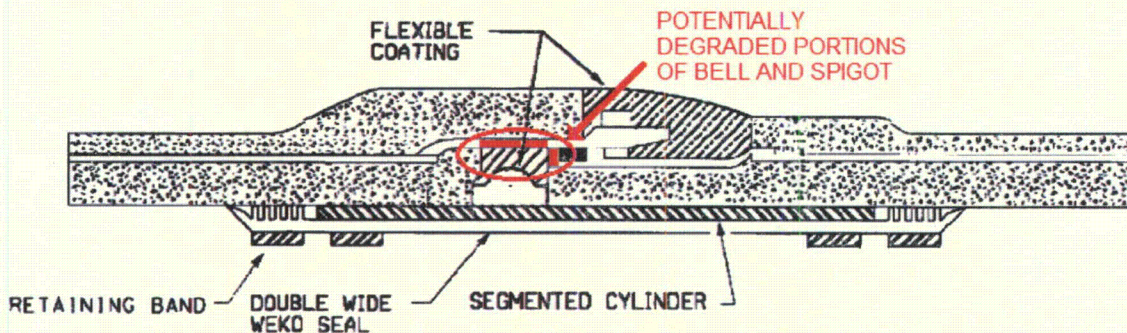
Figure 1 - Potential Areas of Degradation

- During construction of the service water system piping, the exterior of each bell and spigot joint was sealed with a pre-formed flexible sealant (e.g., Ram-Neck), which prevents ground water intrusion into the bell and spigot joint, even if the steel bell ring is degraded (see Figure 1). PSEG has excavated several buried service water pipe joints and has not identified any instances of degradation of the exterior joint sealant that would result in exposure of the joint to groundwater.

- Hoop Strength - The existing bell and spigot joint provides hoop strength to resist circumferential loads (e.g., internal pressure of the pipe). The WEKO seal repair includes a stainless steel plate (shown as "segmented cylinder" in Figure 1) that fits over the joint and is secured to the mortar interior of the piping by retaining bands. The stainless steel plate bears circumferential loads and removes the existing bell and spigot joint from the load path. Accordingly, the WEKO seal repair fulfills the hoop strength function of the bell and spigot joint.

c. Figure 1 highlights the portions of the bell and the portions of the spigot that could be degraded by exposure to service water. Figure 1 shows how these portions would be protected from future exposure to service water by the WEKO seal and a flexible coating. Additionally, the flexible coating on the outside of the joint provides protection from groundwater intrusion. Note that the portion of the spigot that is exposed to service water is not part of the load path for axial loading and is therefore not relevant for structural evaluations.

- PSEG cleans and coats the degraded bell ring as part of the WEKO seal repair. If there were any service water leakage past the WEKO seal, the coating would prevent further degradation of the bell ring from exposure to service water and provide another barrier to leakage (See Figure 1).
