Prairie Island Nuclear Generating Plant, Unit 1  
Docket 50-282  
Renewed License No. DPR-42

Response to Request for Additional Information on 2012 Steam Generator Tube  
Inspections from 1R28

### REQUEST FOR ADDITIONAL INFORMATION 2012 STEAM GENERATOR TUBE INSPECTIONS PRAIRIE ISLAND NUCLEAR GENERATING PLANT, UNIT 1 DOCKET NUMBER 50-282

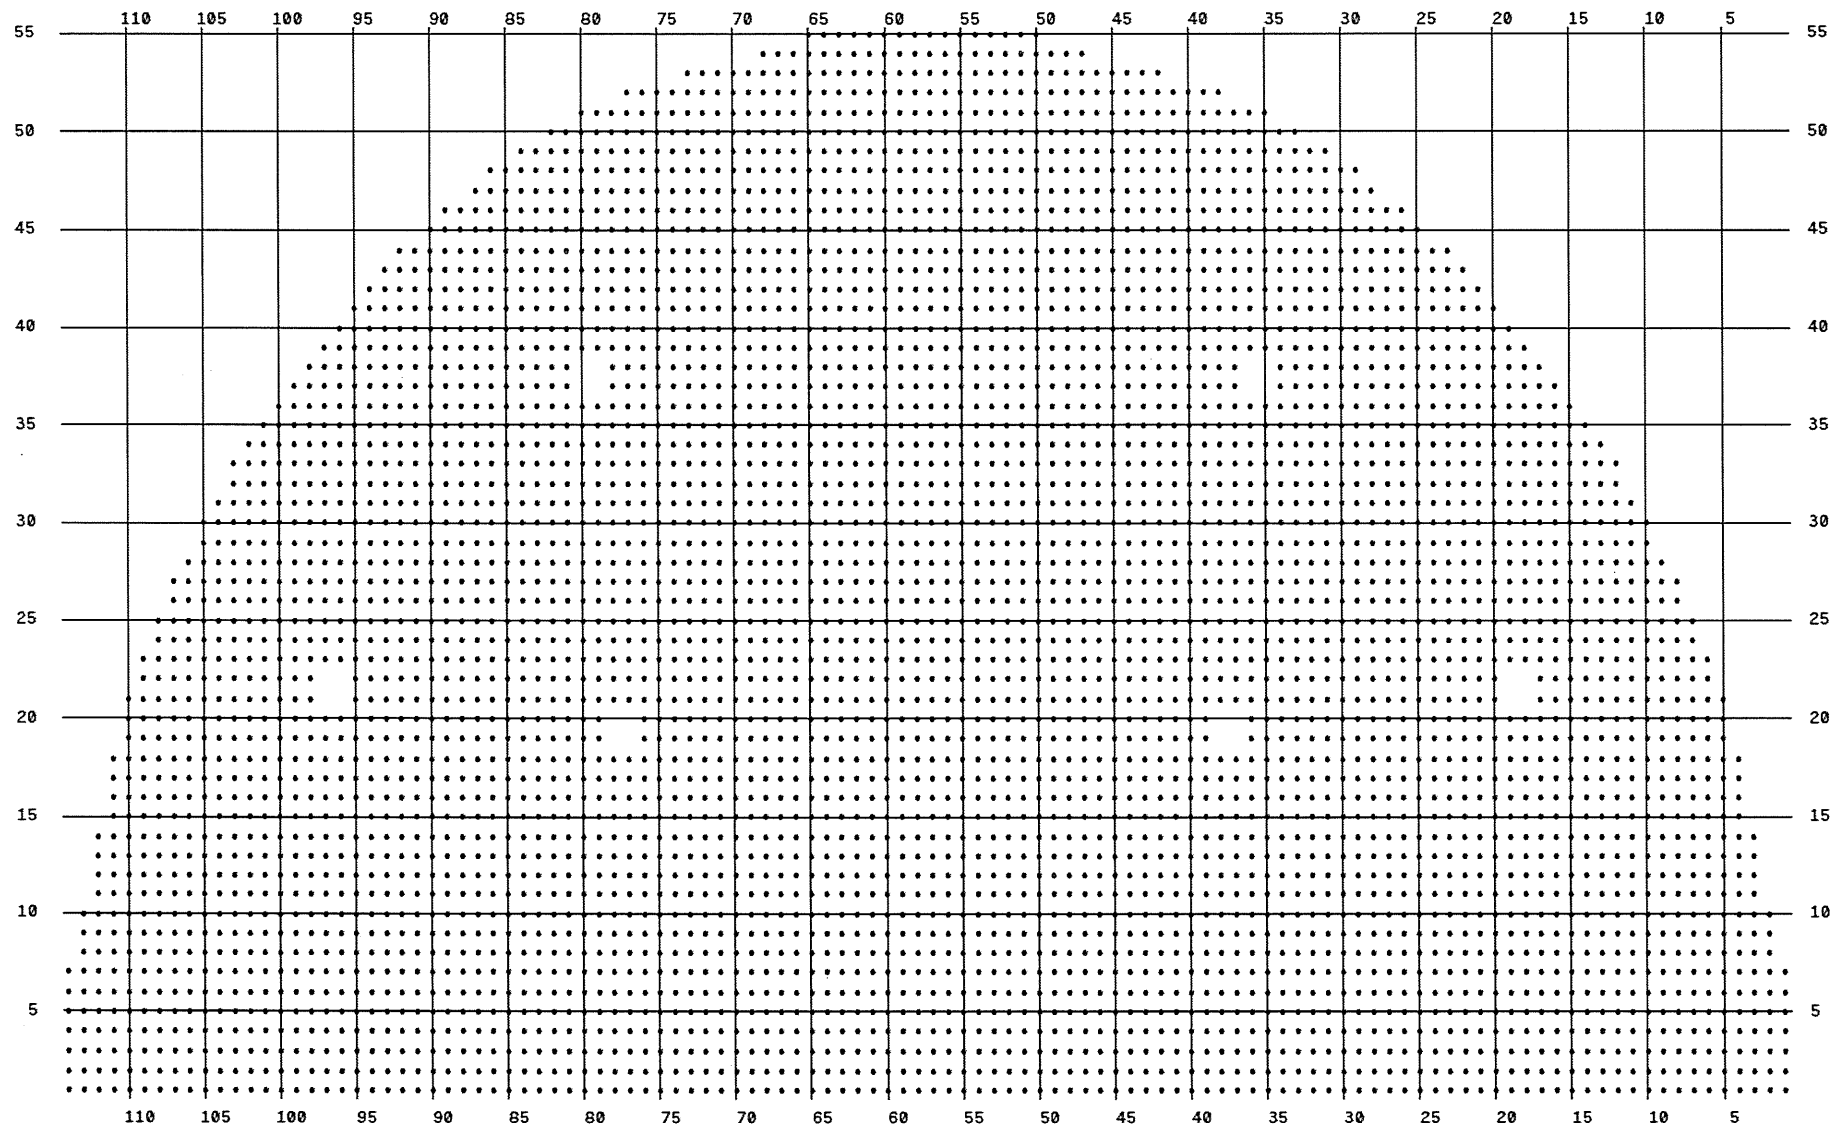
See the attached Figure 1 for a generic tubesheet map (tube array) of the installed Framatome Model 56/19 Replacement Steam Generators.
