San Onofre Nuclear Generating Station  
Augmented Inspection Team Debrief Notes  
March 29, 2012

**SONGS Unit 2**  
**Steam Generator Eddy Current Testing**  
**February 9, 2012**

**SONGS Unit 3**  
**Steam Generator Inspection and Eddy Current Testing**  
**February 10, 2012**

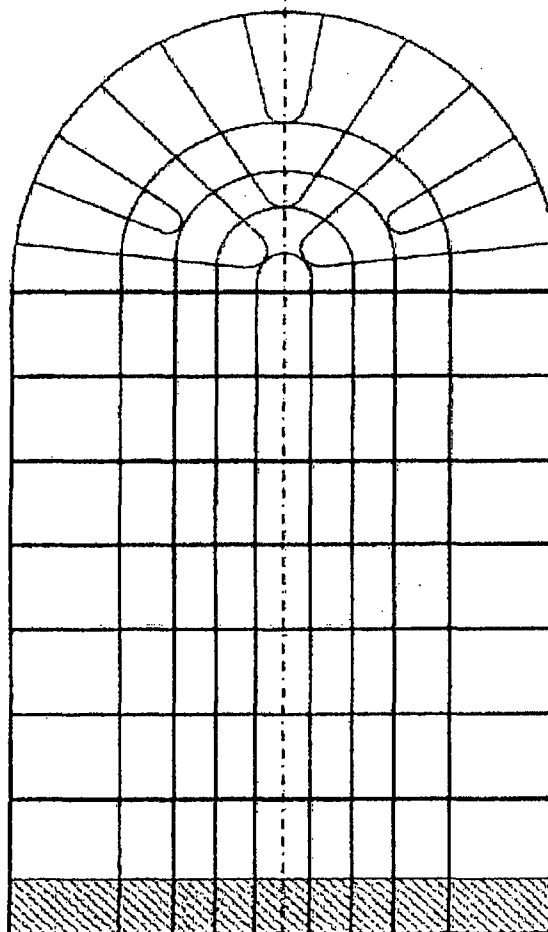
**Distribution of Indications**  
**SG88 Bobbin Data**

<10	10-19	20-29	>=30
B06	131	151	19	1
B05	108	104	16	
B04	85	29	1	
B03	29	6		
B02	2	1		
B01	1			
07H	5	7		
06H	6	6		
05H	9	8		
04H	21	14	1	
03H	9	4		
02H	4			
01H				
TSH

>=30	20-29	10-19	<10	
1	21	136	163		B07
1	14	122	130		B08
1	7	85	86		B09
	1	29	64		B10
		1	7		B11
			2		B12
		6	3		07C
		2	3		06C
			4		05C
		1	4		04C
			1		03C
			1		02C
					01C
					TSC

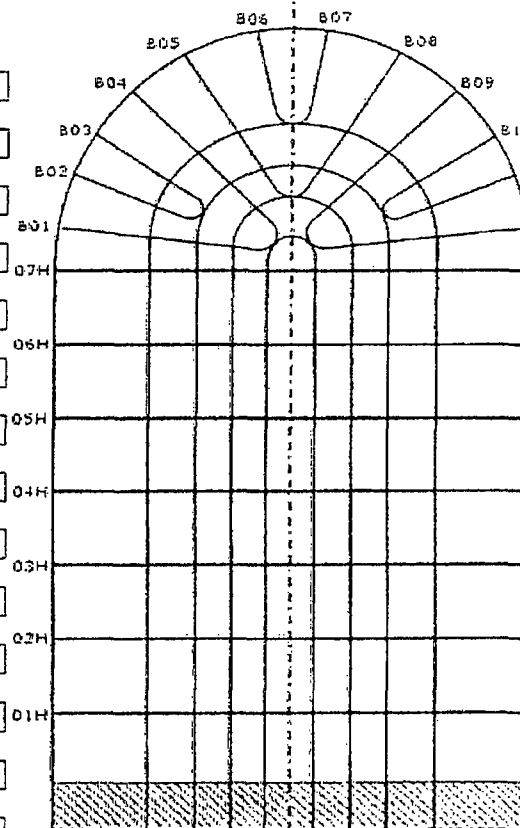
**TSP & AVB Wear Indications**  
**SG88 Bobbin Data**

<10	10-19	20-29	>=30
B06	154	158	20	1
B05	139	110	18	
B04	93	31	1	
B03	33	7		
B02	2	1		
B01	1			
07H	8	13		
06H	11	20		
05H	24	20		
04H	31	19		
03H	11	9		
02H	4			
01H				
TSH

>=30	20-29	10-19	<10
B07	1	21	145	194
B08	1	15	132	176
B09	1	8	88	94
B10		1	32	69
B11			1	7
B12				2
07C			7	6
06C			7	6
05C			1	5
04C			6	3
03C			5	1
02C			1	1
01C				1
TSC

>=30	20-29	10-19	<10	TOTAL INDICATIONS
4	84	813	1081	
9727				TOTAL INSPECTED

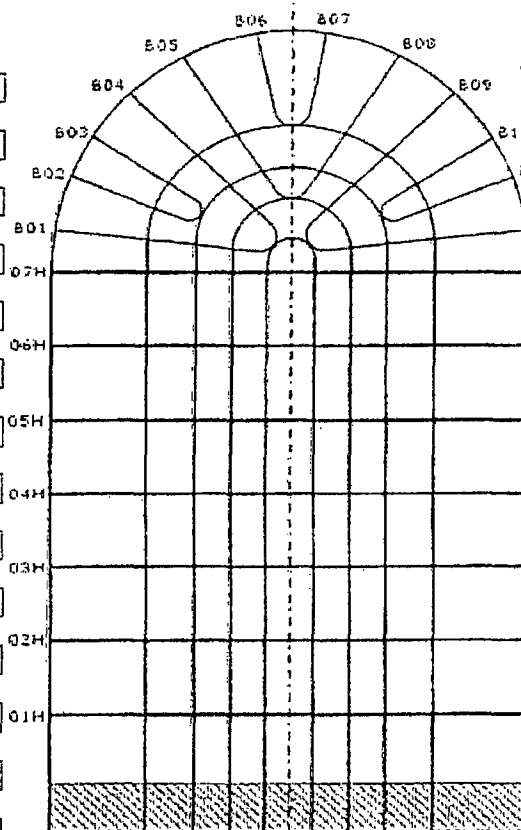
**TSP & AVB Wear Indications**  
**SG89 Bobbin Data**

<10	10-19	20-29	>=30
B06	274	228	20	
B05	221	134	9	
B04	131	54		
B03	75	10		
B02	11			
B01	5			
07H	16	19		
06H	11	15		
05H	10	10		
04H	8	6		
03H	2	2		
02H				
01H				
TSH

>=30	20-29	10-19	<10
B07		23	252	271
B08		17	213	268
B09		8	96	169
B10		1	25	60
B11			2	12
B12				2
07C		1	3	1
06C			5	
05C			8	2
04C			12	3
03C			5	
02C				
01C				
TSC

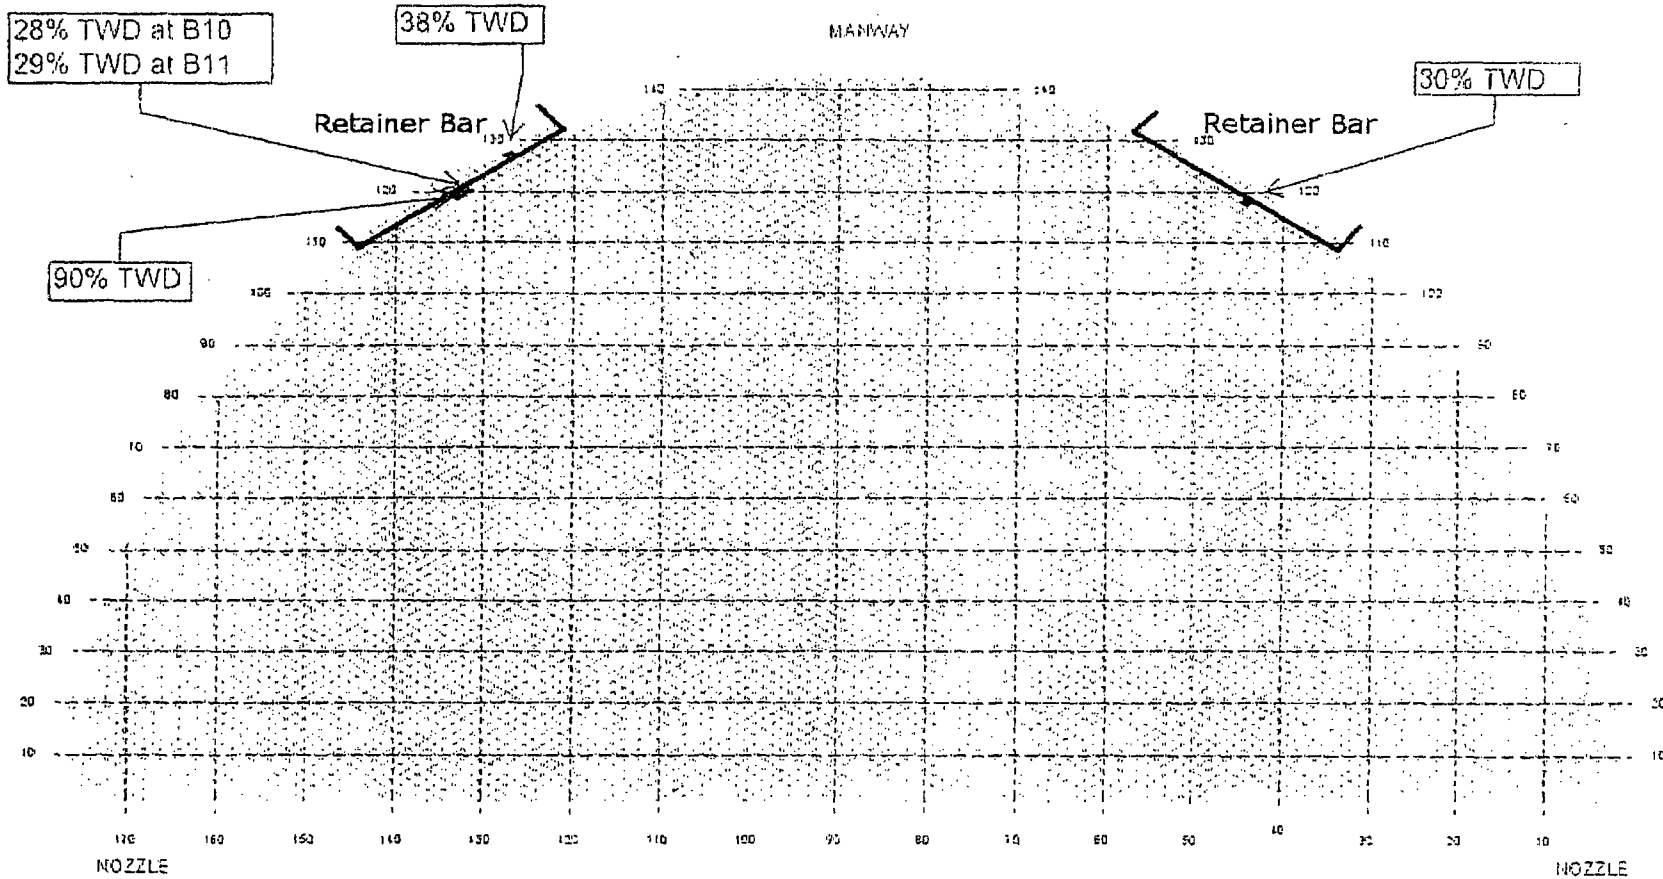
# SONGS Unit 2 SG89 Retainer Bar Wear Indications

GROUP TUBE#  
Retainer Bar Indications 4

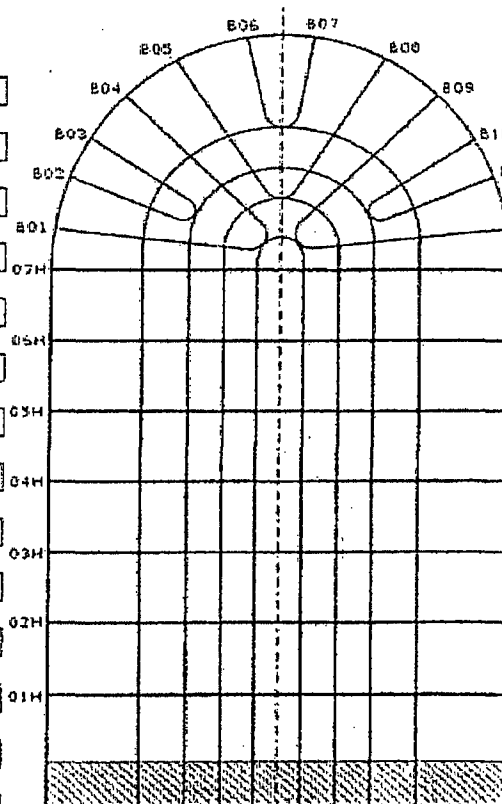
**TSP & AVB Wear Indications**  
**SG88 Bobbin Data**

<20%	20-34%	35-49%	>=50%
B05	473	20	1	
B05	416	18	1	
B04	303	25	1	
B03	220	24		
B02	125	16		
B01	98	11		
07H	63	28	49	58
06H	39	45	66	8
05H	50	79	2	
04H	56	64	3	
03H	57	32		
02H	47	3		
01H	24	25		
TSH

>=50%	35-49%	20-34%	<20%
B07			5	436
B08			1	361
B09			6	270
B10			3	239
B11			7	121
B12			20	97
07C	51	48	17	38
06C		46	61	35
05C		3	79	50
04C			47	68
03C			26	53
02C				11
01C				
TSC

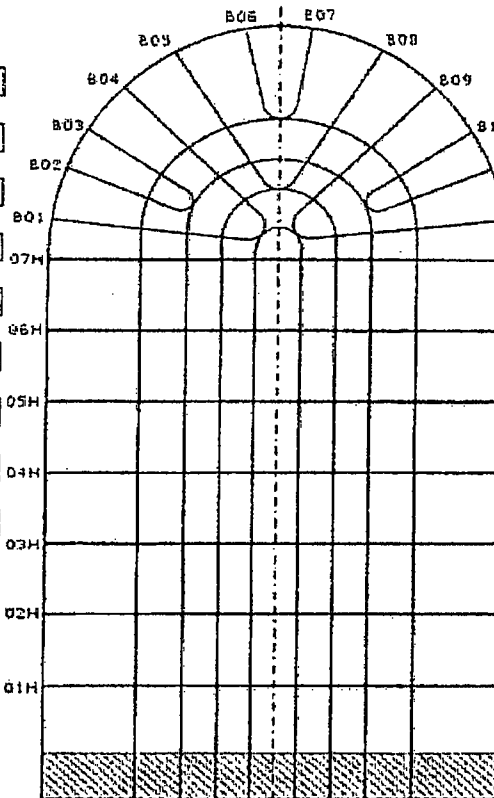
**TSP & AVB Wear Indications**  
**SG89 Bobbin Data**

<20	20-34	35-49	>=50
B06	428	5		
B05	373	10		
B04	324	21		
B03	195	2		
B02	131	3		
B01	116	1		
07H	29	33	39	
06H	32	74	46	
05H	63	87	7	
04H	67	27	1	
03H	63	19		
02H	71	8	1	
01H	42	22		
TSH

>=50	35-49	20-34	<20	
			2	384	B07
				340	B08
				263	B09
				134	B10
		1		77	B11
				86	B12
		44	38	10	07C
		48	65	32	06C
		2	40	76	05C
		1	55	70	04C
			11	54	03C
			6	30	02C
			1	32	01C
					TSC

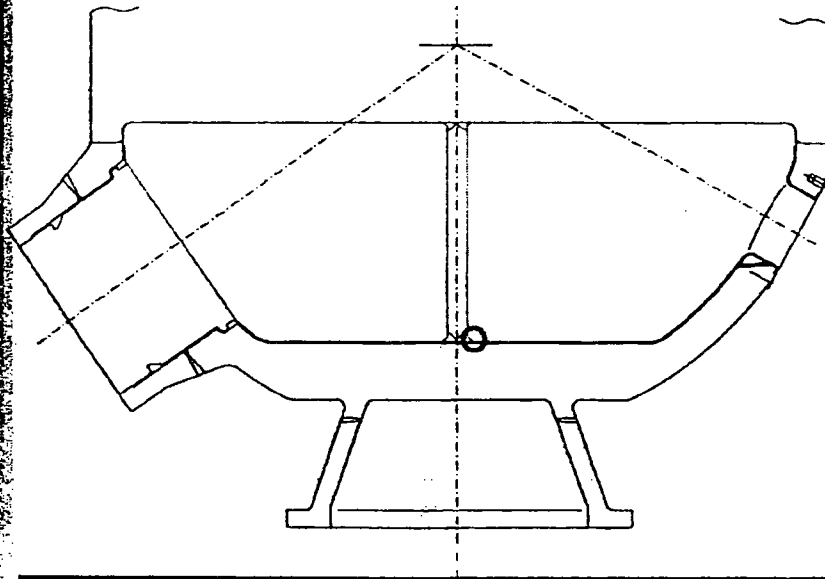
- Crack identified in 3B RSG during secondary side hydrostatic test

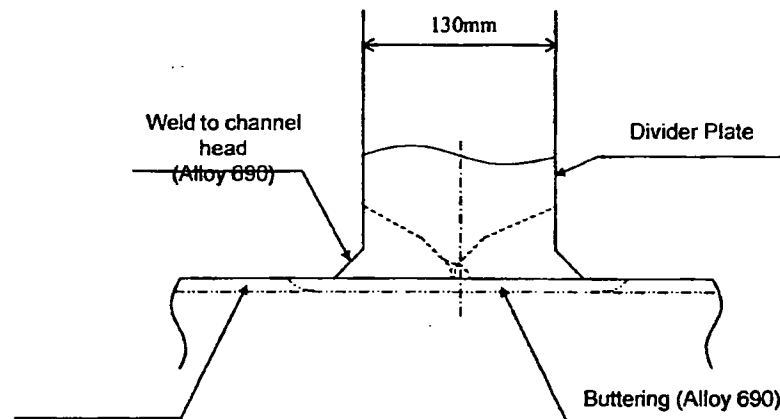
- Performed NDE (VT, PT & UT) of the divider plate weld from inside and outside the RSG
