Re: Summary of December 2013 Inspection, Lost Creek ISR Project, Permit #788

Wyoming Department of Environmental Quality (WDEQ)- Land Quality Division (LQD)
Inspection Memorandum

File: Lost Creek ISR, LLC – Permit 788

Date of Inspection: December 18, 2013

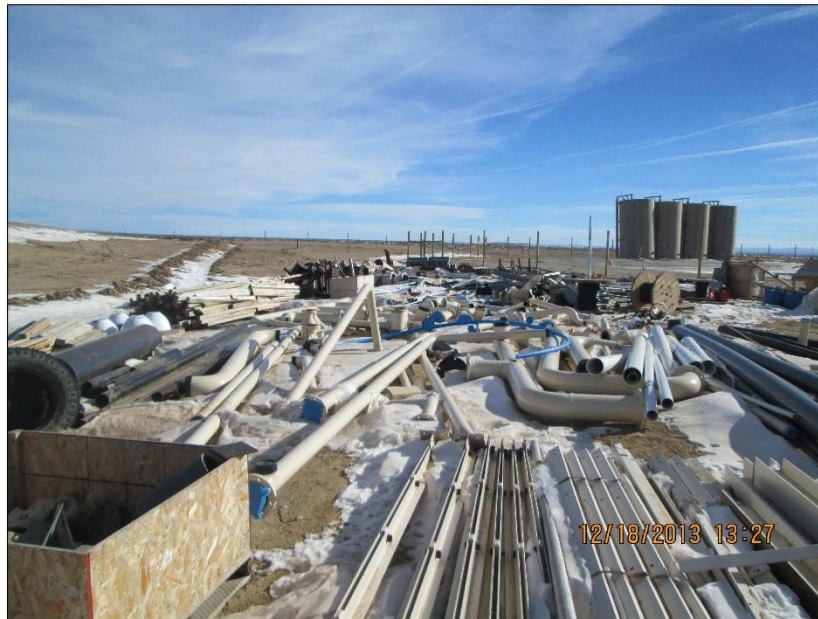
The equipment noted in the Annual Inspection as being stored in an informal laydown yard north of the ponds in the Plant Site area was located within and around the Diversion Ditch that runs along the northeast corner and eastern edge of the Plant Site. It is unacceptable to have equipment stored in this location. As of this Inspection, the equipment had not yet been moved. This action item is still in need of attention.

Photo Number 1: This depicts the laydown yard that has developed north of the ponds in the Plant Site. Much of this equipment has been placed within the channel of the diversion ditch that runs through the Plant Site’s eastern edge. This is unacceptable and these materials must be removed from this location. The diversion channel must be kept intact indefinitely. This view is looking east.

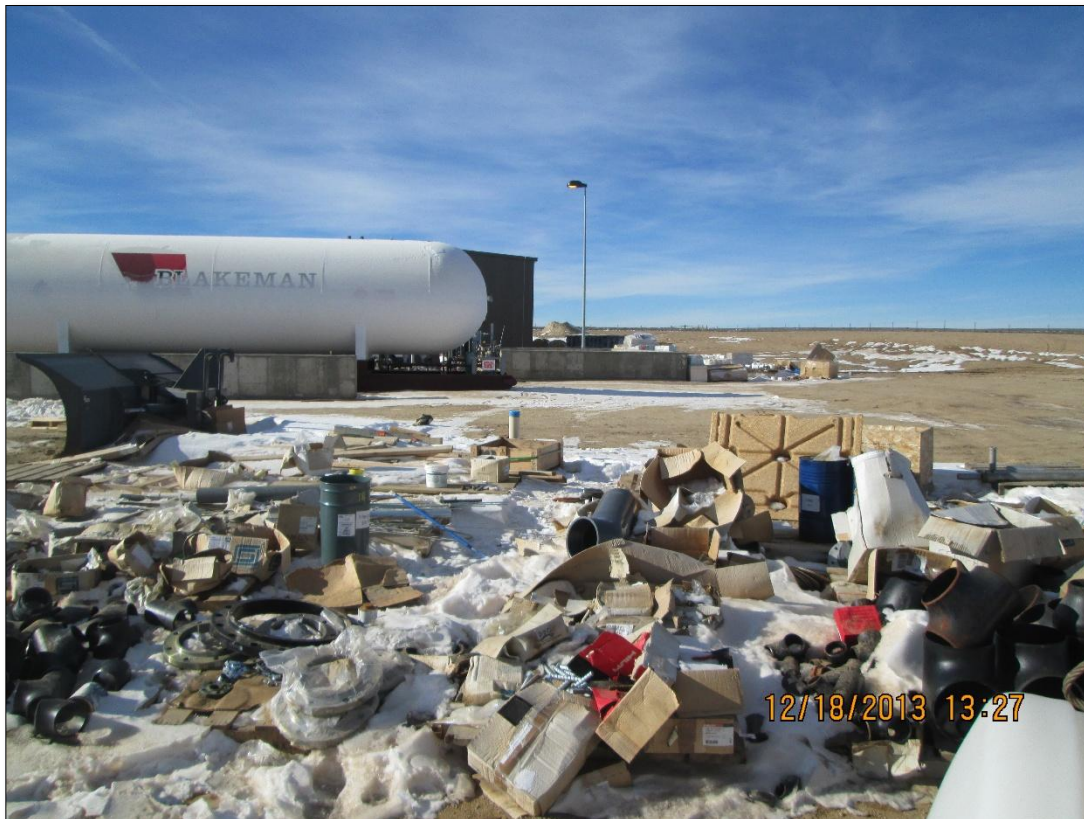
Photo Number 2: This is a view looking toward the west across the laydown yard depicted in Photo Number 1 above.

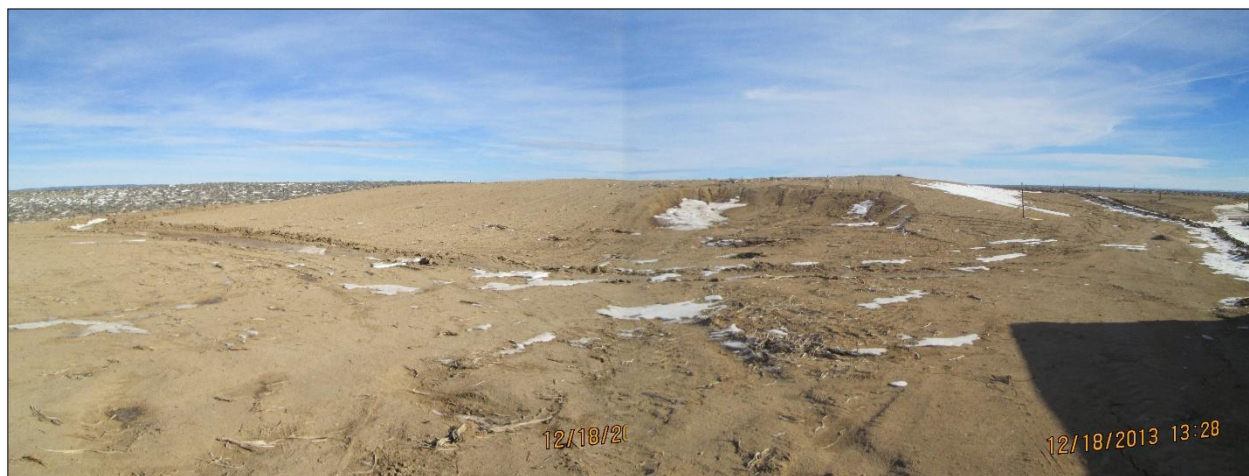
Photo Number 3: This depicts the west edge of topsoil stockpile TS-14 which is at the northeast corner of the Plant Site. A portion of this topsoil stockpile was used in the fall of 2013 for the reclamation of the land north of the shop building in the Plant Site. The toe ditch around this topsoil stockpile was noted as needing to be better defined in the last Inspection Report. It was noted as being better defined during this Inspection.

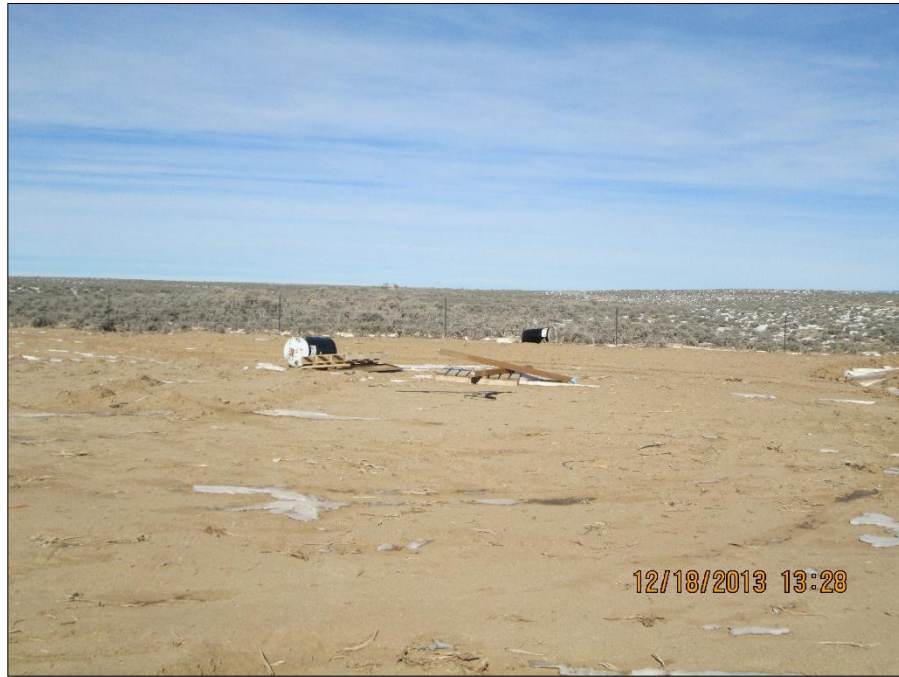
Photo Number 4: This depicts some stray items in the Plant Site (just west of TS-14) that need to be better contained: A couple of drums (presumed to be empty) and some pallets.

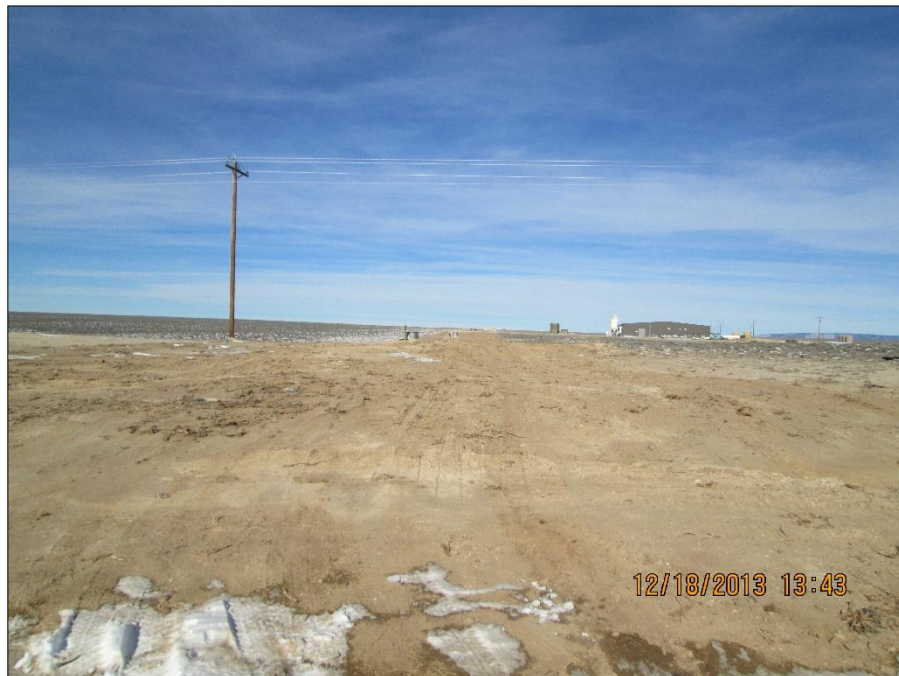
Photo Number 5: This is a view looking north along the main trunk line connecting MU1 to the Plant. This has been backfilled since the last Inspection. This photo was taken from the access road.

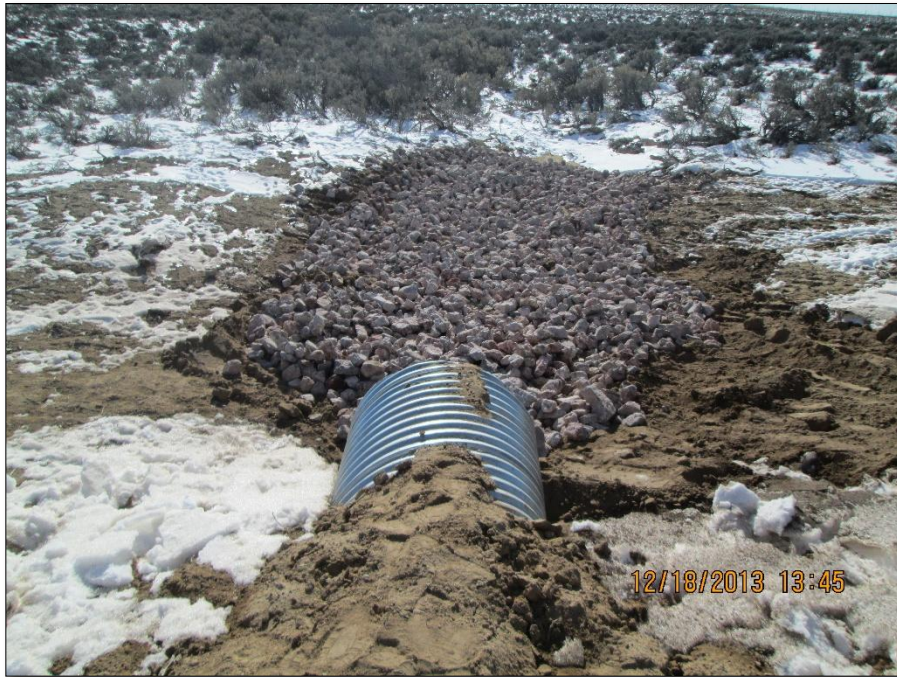
Photo Number 6: This depicts the recently emplaced rip-rap on the down gradient side of culvert CW-1.

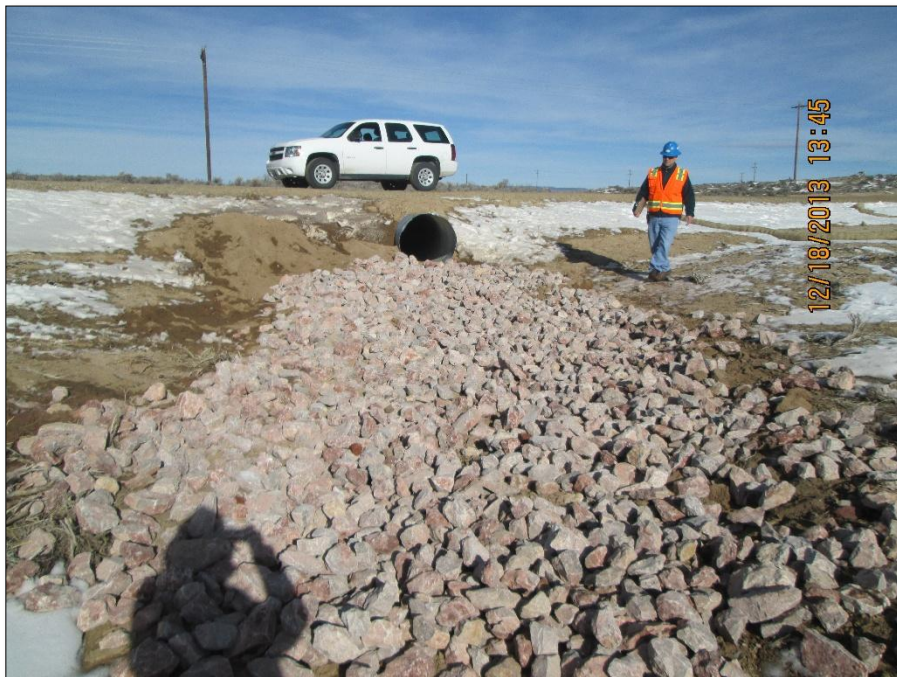
Photo Number 7: This is another depiction of the new rip-rap on the down gradient side of CW-1.

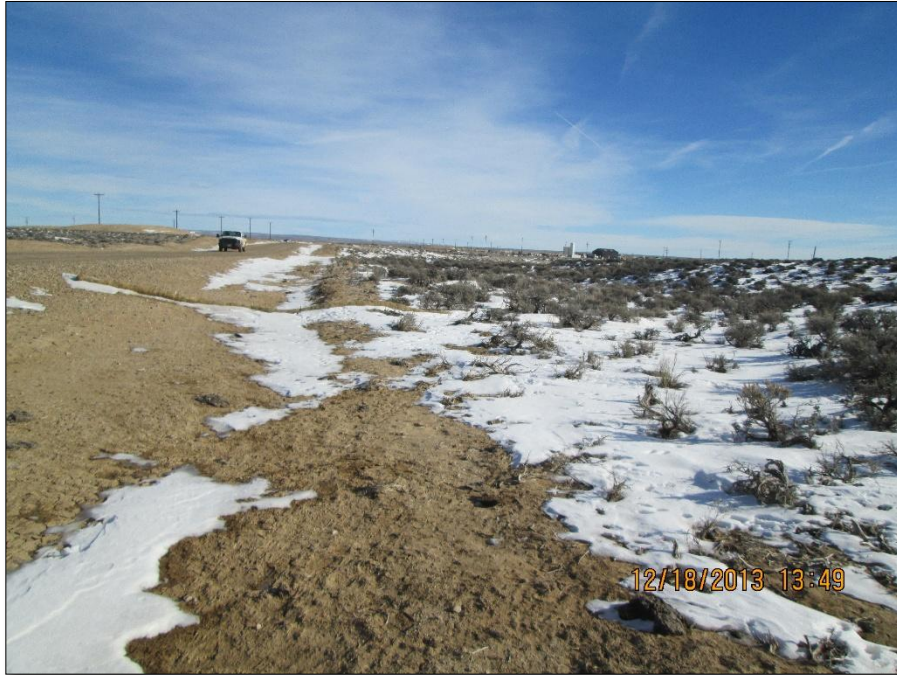
Photo Number 8: This depicts a newly-installed wattle down gradient from (east of) culvert CW-2. View is looking east.

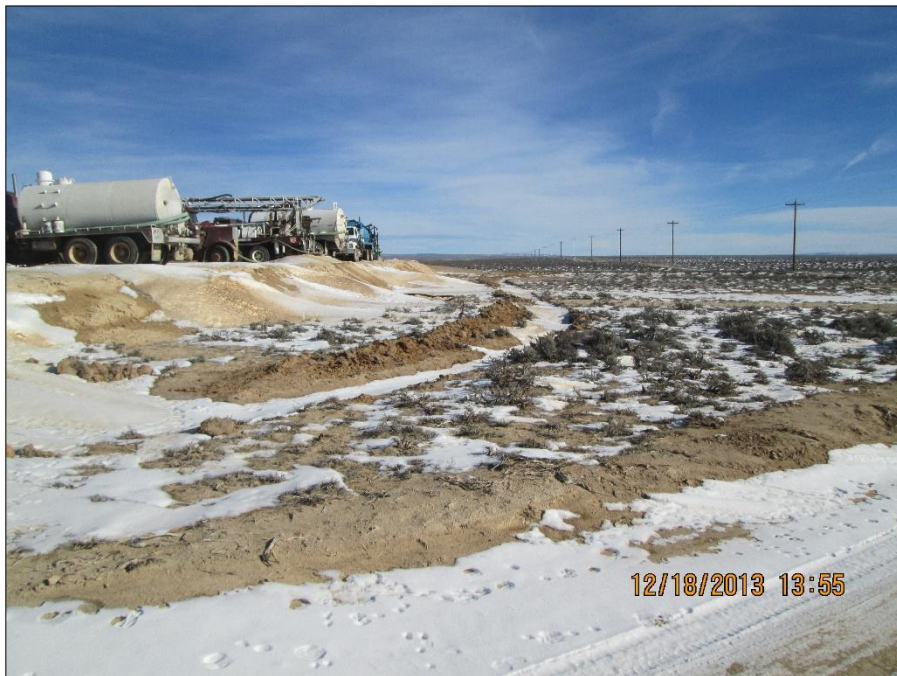
Since the last Inspection, a toe ditch had been installed on the south and west flanks of the DDW-3 drill pad. This was necessary to ensure that drill pad materials do not spill onto native ground. It is apparent that topsoil was not adequately stripped in advance of the south and west flanks of the DDW-3 drill pad. While nothing can be done to fix this oversight now, LCI staff are reminded that thorough topsoil stripping is a Permit commitment. Future DDW drill pads will need better oversight prior to their construction to ensure that no fill materials are placed on native lands.

Photo Number 9: This depicts the newly-installed toe ditch on the south edge of the DDW-3 drill pad.

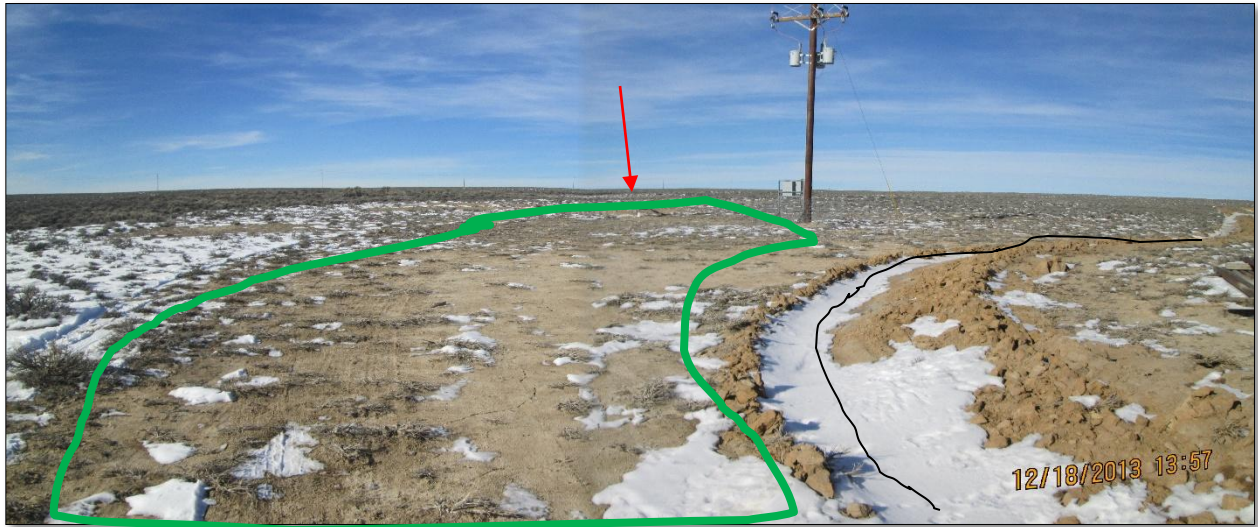
DDW-3: The travel route to the water supply well west of DDW-3 (LC1008W) and its associated turn around area should be well delineated to prevent vehicular traffic outside the travel route.

Photo Number 10: This depicts the water supply well (Well ID LC1008W) that is west of the DDW-3 drill pad. Its access route is in the foreground of this photo (area outlined in green). This travel route needs to be more clearly delineated to prevent vehicular traffic on native ground. The well head is located at the red arrow. The toe ditch along the southwest corner of DDW-3 drill pad is indicated by the black line.

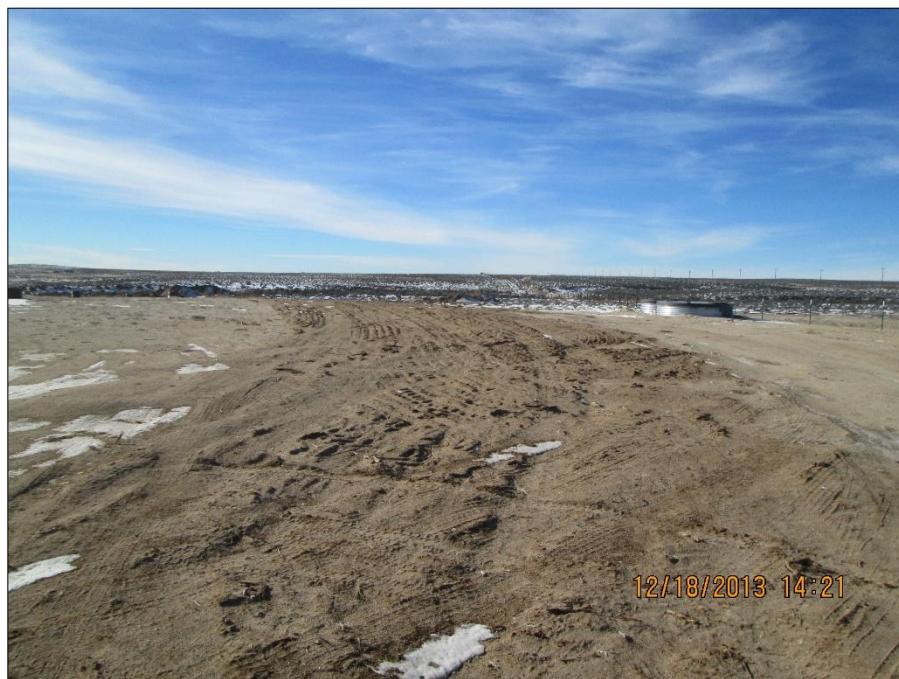
An example of field personnel driving outside an established travel route was noted at Header House 1. Just northwest of Header House 1, an arcuate swath of topsoil had been recently reapplied. Tire tracks were noted in the topsoil during this Inspection. It is recommended that the Mine Unit's travel routes be delineated with t-posts or some other means. This will be imperative when the denuded topsoil in Mine Unit 1 is scarified and seeded. For now, **the arcuate swath of ground in MU1 just northwest of Header House 1 that has had topsoil reapplied must be protected from vehicular traffic.**

Photo Number 11: This depicts a portion of the arcuate swath of ground in the northwest corner of MU1 where topsoil was recently reapplied. The excessive tire tracks on this topsoil speak to the dire need to delineate travel routes in MU1. This trampling of topsoil is an unacceptable practice.

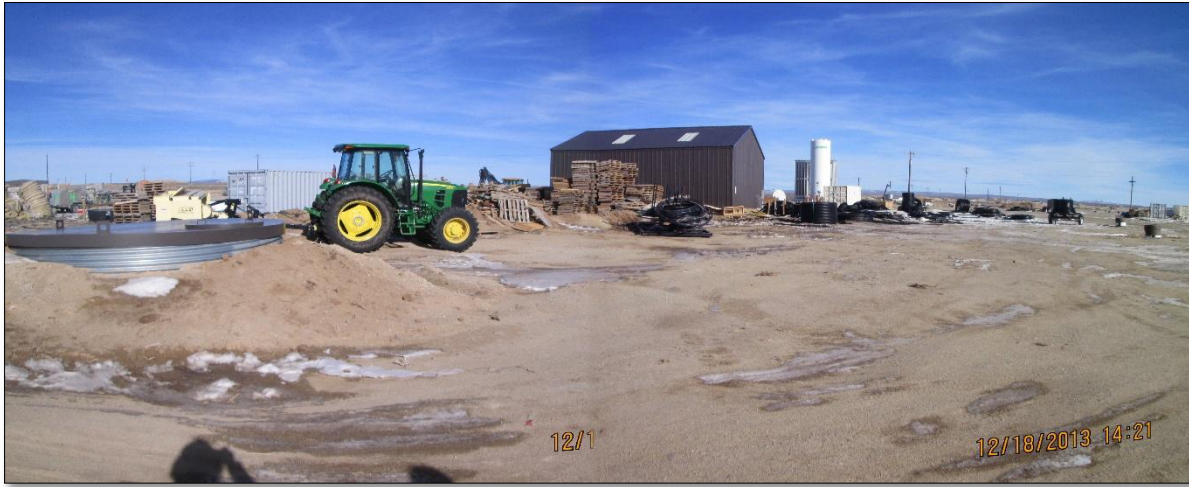
Laydown yard "creep": The south edge of the laydown yard (just north of MU1) has encroached (or "creeped") to the south such that it is outside its intended boundary and is now atop ground that is part of MU1. **This laydown yard "creep" needs to be reigned-in and controlled.** The laydown yard materials must either be moved back into the intended footprint of the laydown yard or the southern extent of the laydown yard must be delineated (with fencing) to prevent further "creep" southward.

Photo Number 12: This depicts the south edge of the laydown yard that is north of MU1. The brown structure is the maintenance shop within the laydown yard. When the laydown yard was constructed, the south edge of that structure (indicated by the red arrow) was in line with the south edge of the laydown yard. Since then, the laydown yard has encroached (or “creeped”) to the south and is now within the MU1 well field. The laydown yard’s southern boundary needs to be delineated so that it does not continue to encroach into MU1.

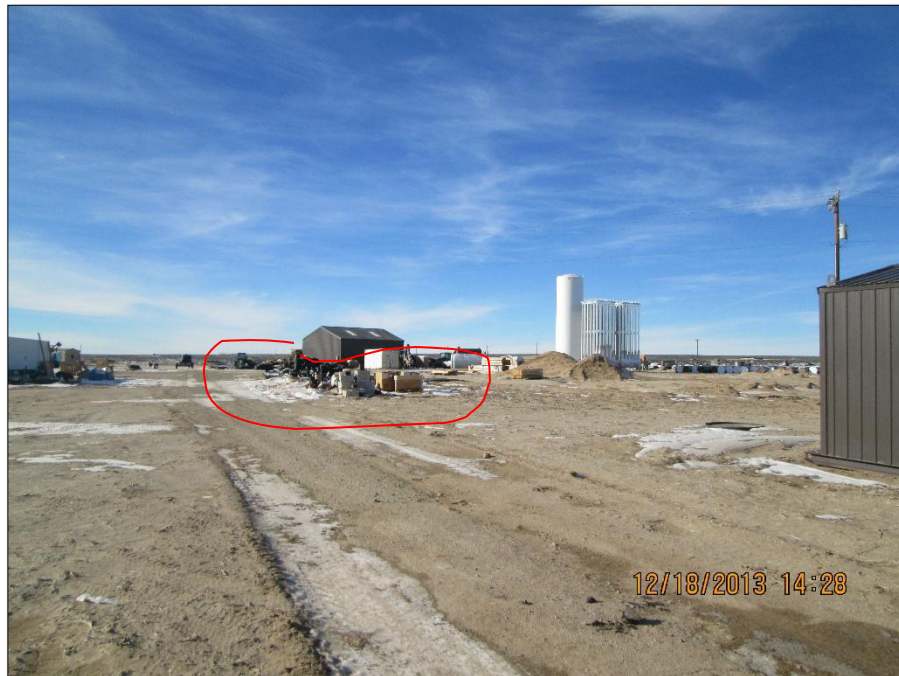
Informal Laydown yard in MU1: An informal laydown area southeast of the north entrance to MU1 has been established. It may be that this laydown area is temporary. Temporary laydown areas within a well field are authorized by the Permit. LCI is reminded that these laydown areas must be temporary and must not be allowed to grow unchecked. Whenever possible, the established laydown yard north of MU1 should be used for staging equipment.

Photo Number 13: This is a view looking west across the informal laydown area that is just southeast of the north entrance to MU1. Temporary laydown yards such as this are authorized by the Permit but they must not be allowed to remain permanent.
