Beaver Valley Power Station, Unit No. 1  
Docket No. 50-334, License No. DPR-66  
Addendum to the Beaver Valley Power Station, Unit No. 1, Near-Term Task Force  
Recommendation 2.3 Seismic Walkdown Report

**Addendum to  
Beaver Valley Power Station Unit 1  
Near-Term Task Force  
Recommendation 2.3  
Seismic Walkdown Report, Rev 1  
Dated September 4, 2013**

**November 1, 2013**

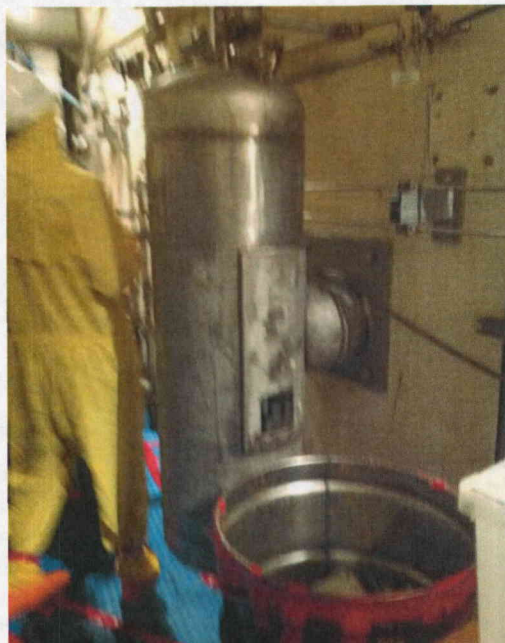
File Name: 1-67-934.jpg  
Description: Component ID Tag

File Name: 1-68-934.jpg  
Description: General View of Component

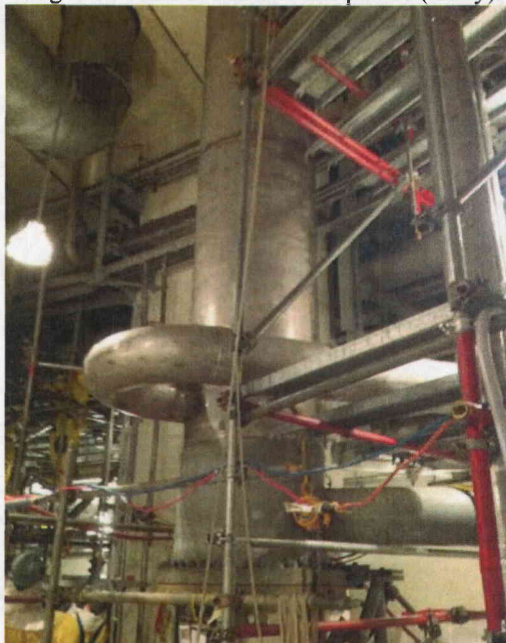
File Name: 1-67-891.jpg  
Description: General View of Component from Elevation 692

*Mild surface corrosion identified at the bottom plate of the heat exchanger. This is judged not to be a seismic/structural concern.*
