**STRUCTURAL INTEGRITY ASSOCIATES, INC. EVALUATION
FILE NO.: 1301525.301**

**MONTICELLO SHROUD SUPPORT STRUCTURE FLAW EVALUATION REVIEW
AND SUPPORT PLATE WELD INSPECTION RECOMMENDATIONS**

Monticello Nuclear Generating Plant Reactor Pressure Vessel Internals Support

Monticello Shroud Support Structure Flaw Evaluation Review and Support Plate Weld Inspection Recommendations

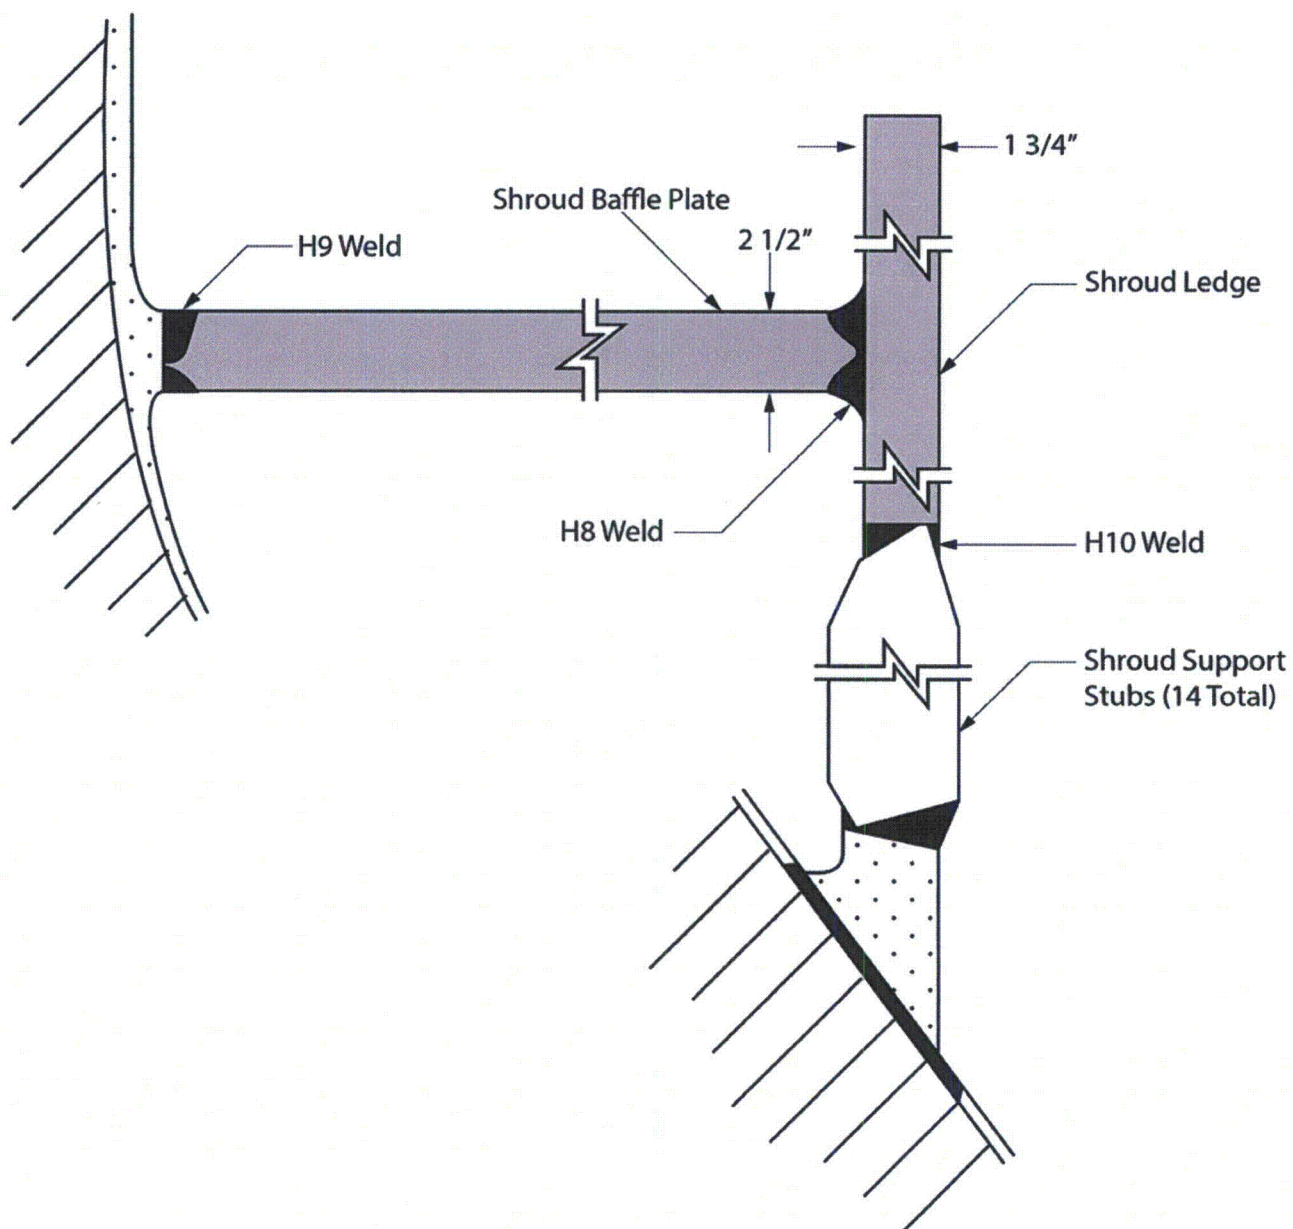
Figure 1. General Vessel Shroud Support Structure Attachment Configuration

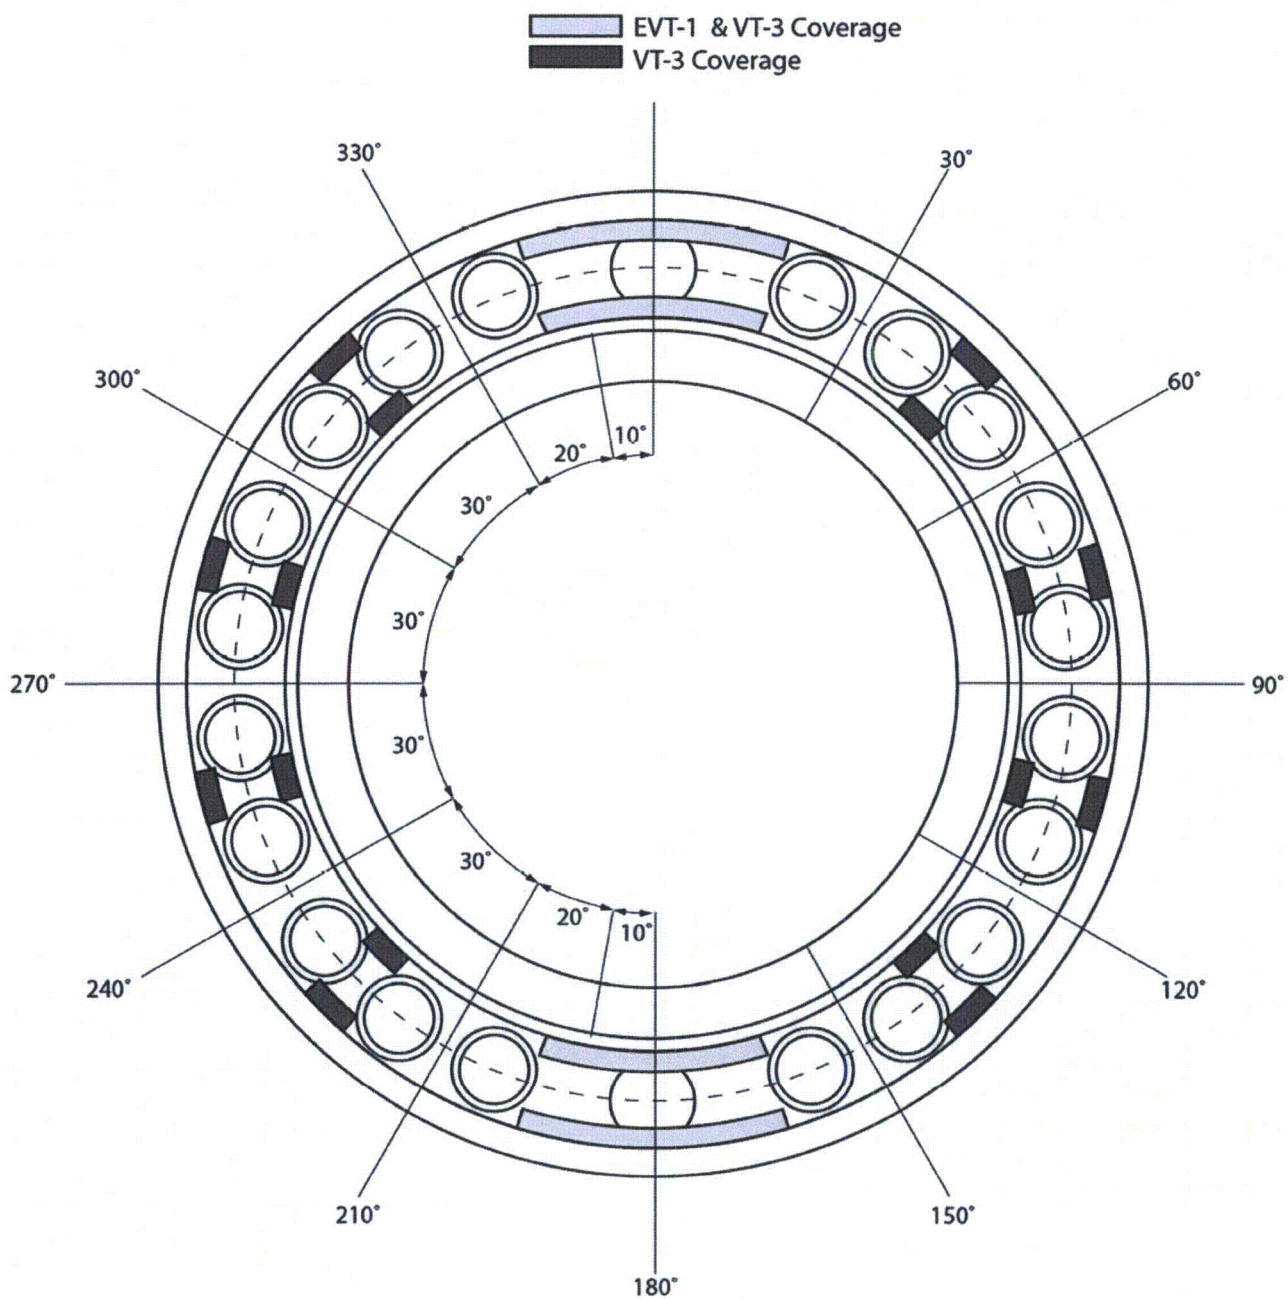
Xcel Energy has inspected the MNGP core support structure using remote visual examination methods. To perform these examinations Xcel Energy lowered cameras into the lower plenum area of the reactor vessel through the inlet nozzle of the jet pumps to perform inspections of the shroud support legs and the underside of the H8 and H9 shroud support plate. Since the cameras are lowered through a jet pump, inspection coverage is limited to the areas directly adjacent to the jet pump. Top side access of the H8 and H9 welds is more readily available in the regions between the jet pumps. Figure 2 provides an illustration of potential shroud support plate inspection locations.

Figure 2. Shroud Support Plate Inspection Illustration
