PNNL-22553

# Final Assessment of Manual Ultrasonic Examinations Applied to Detect Flaws in Primary System Dissimilar Metal Welds at North Anna Power Station

March 2014

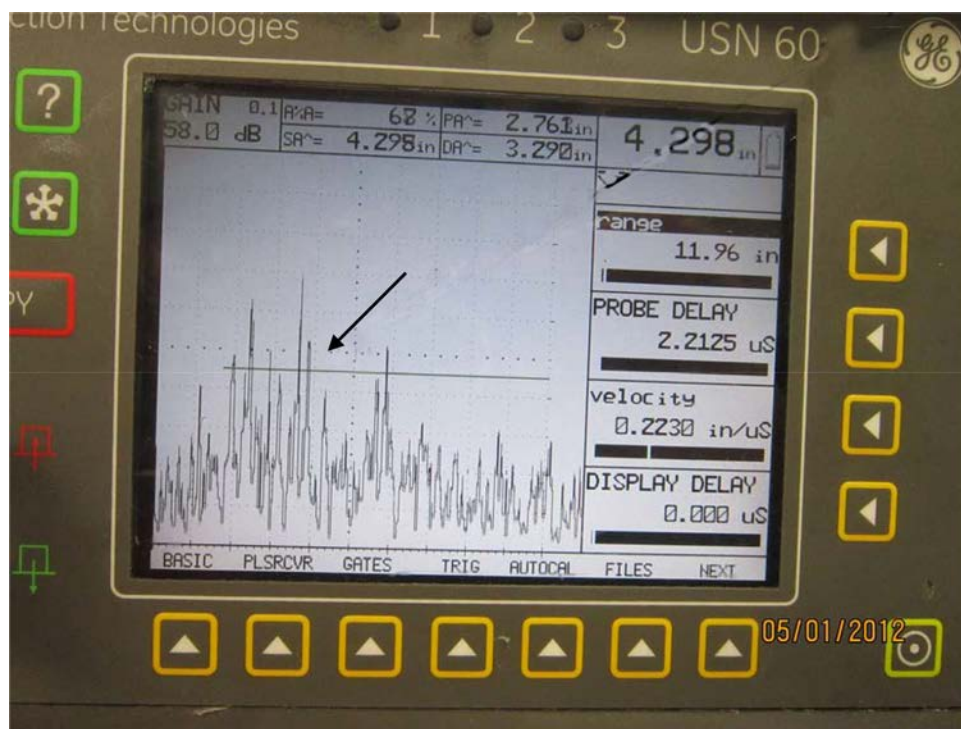
**Figure 4.2.** Mid-wall Fabrication Flaws or Implantation Artifacts Detected in NAPS-1 Mock-ups (as indicated by the arrow)

As a general observation, one would expect fewer inadvertent fabrication flaw, or implantation artifact, signal responses to be present. The UT responses from these imperfections impede detection and characterization of the axial flaws as cracks. Based on the site observations using the tandem probe configurations, there are many transient indications detected on the NAPS-1 mock-ups that interfere with targeted flaws; this makes it especially difficult for one to unequivocally determine the effectiveness of the inspection system to detect cracks. The placement of the axial flaws, in relative proximity to the locations of the circumferential flaws in these mock-ups results in challenging detection conditions because of implantation or fabrication artifacts.

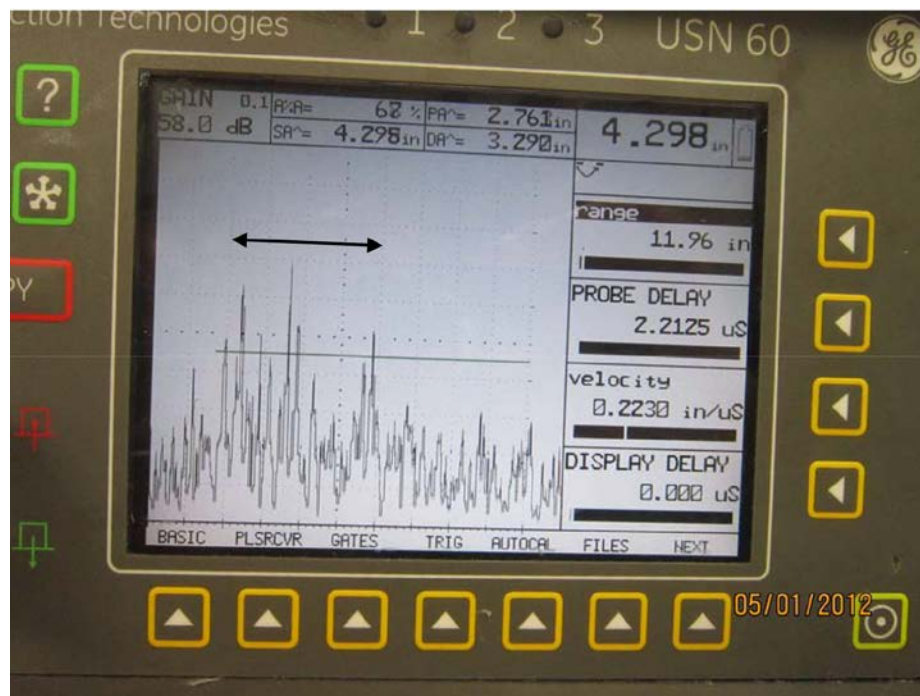
Two axial flaws were detectable with the LR probe (less so with RR), and the SNRs were poor. Each pair of tandem probes required careful manipulation (skewing) to approach a SNR of 2:1. Many larger fabrication/ implantation artifact responses were observed in DM-10 in contrast to those observed in DM-05; these were also found in the near vicinity of the axial flaw locations. The end-of-block response appeared somewhat higher in amplitude through the weld, which could indicate that the weld microstructure varies between DM-05 and DM-10. Figures 4.7 through 4.9 provide additional pictorial support of the discussion in this section.

**Figure 4.7.** Assumed DM-10 Fabrication/Implantation Flaws (shown within time base depicted by arrows)

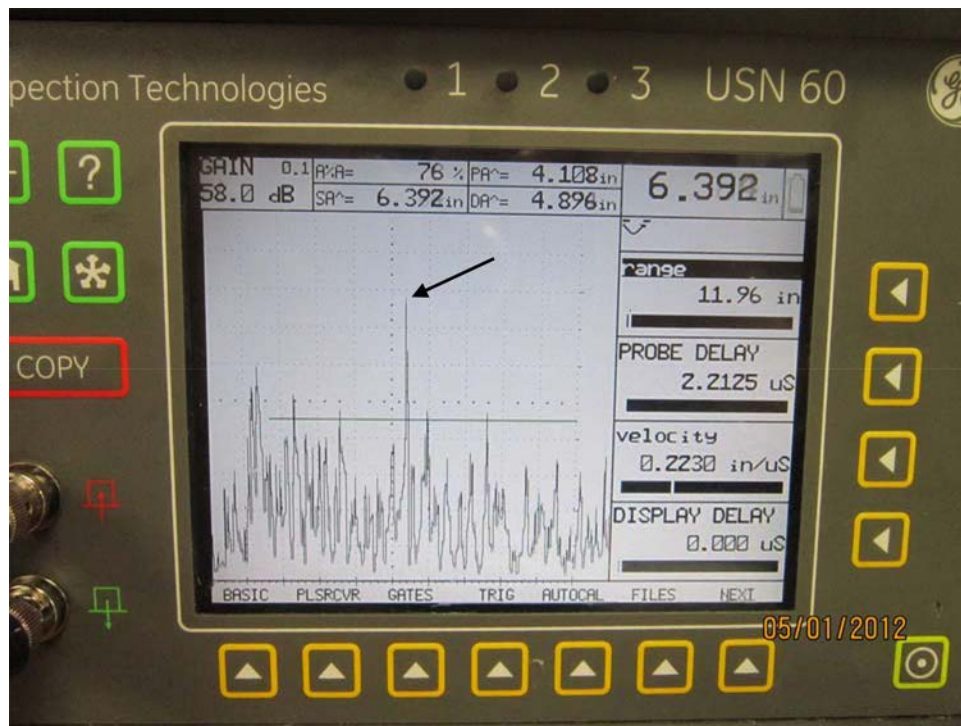
**Figure 4.8.** Assumed DM-10 17% Through-Wall Axial Flow with LR Probe

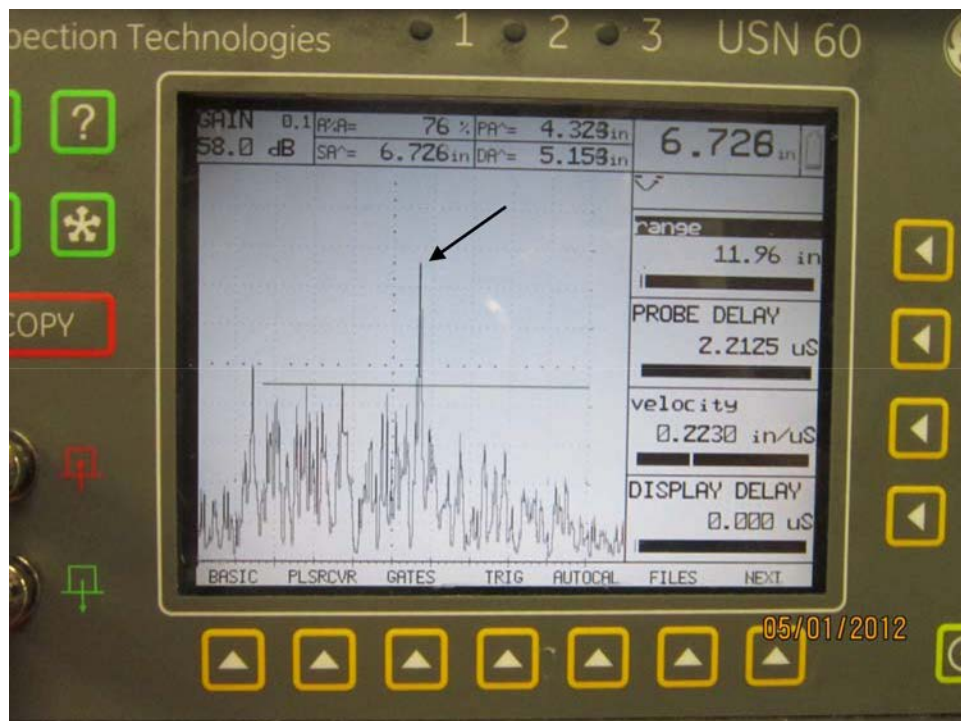
**Figure 4.9.** Assumed DM-10 51% Through-Wall Axial Flow with LR Probe

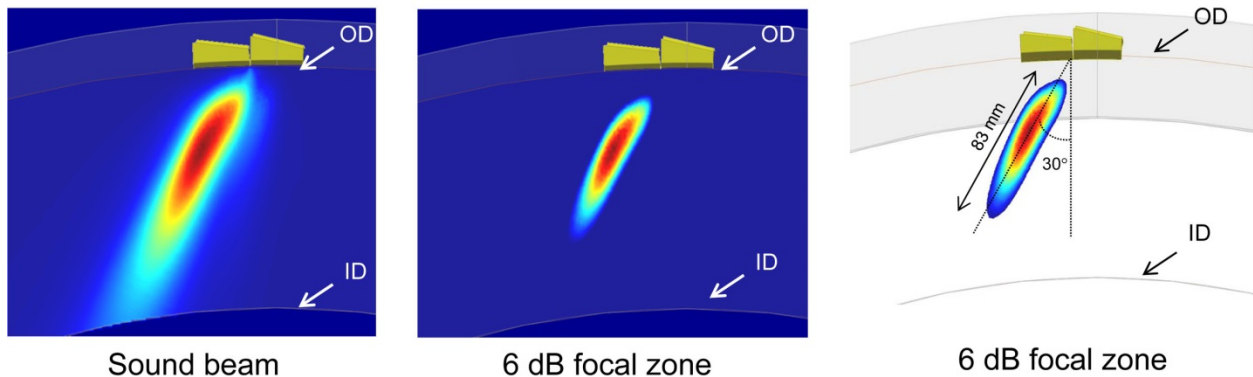
Sound field simulations showing the acoustic beam density generated by the tandem probe as modeled with the CIVA 10.1 software suite are displayed in Figure 5.5. CIVA was chosen for these simulations as this software platform supports a tandem probe configuration whereas UltraVision 3 [the software chosen to depict theoretical PA transmit-receive (TR) probe sound fields] does not as yet have this capability (see Section 6.0 of this report). As depicted, simulated sound field energy increases from blue to red. The left image shows an unfiltered sound beam in the specimen; OD and ID surface locations are indicated. The middle image has a  $-6$  dB filter (50% amplitude threshold) applied that highlights a  $-6$  dB focal zone. The right-most image in Figure 5.5 has the same  $-6$  dB filter applied, but without the full computational zone visible, emphasizing the insufficient extent of the  $-6$  dB focal zone (or high intensity sound field expected to produce 2:1 signal-to-noise ratios) to reach the desired specimen ID surface region. The model indicates that this probe configuration produces refracted longitudinal mode ultrasonic energy at a transmitted angle of  $30(41)$  degrees, with the maximum value of sound field intensity located at 44 mm (1.73 in.) from the OD along the metal path. The  $-6$  dB focal zone length along the metal path is 83 mm (3.27 in.) or only 56% of the entire through-wall metal path. The required metal path at  $30(41)$  degrees to reach the ID is approximately 148 mm (5.83 in.).

**Figure 5.5.** Sound Field Simulations and  $-6$  dB Filter

By applying a  $-12$  dB filter, the simulated sound field was projected to the specimen ID, and indicates the sound field energy to be substantially diminished in strength. A drop of 12 dB from the maximum sound intensity is a ratio of approximately 4:1. Therefore, only about 25% of the maximum beam intensity is predicted at the ID surface; this is optimistic, given the anisotropic nature of the weld microstructure. This reduced field intensity also predicts a poor signal-to-noise level for detection of ID surface-connected flaws via corner-trapped responses. These results suggest the tandem probe may potentially be suited for detection of specular or tip responses from flaws in the outer 60% of the material (which has only been modeled as a simple isotropic media), but is extremely limited for detection of ID-connected flaws in this specimen configuration.

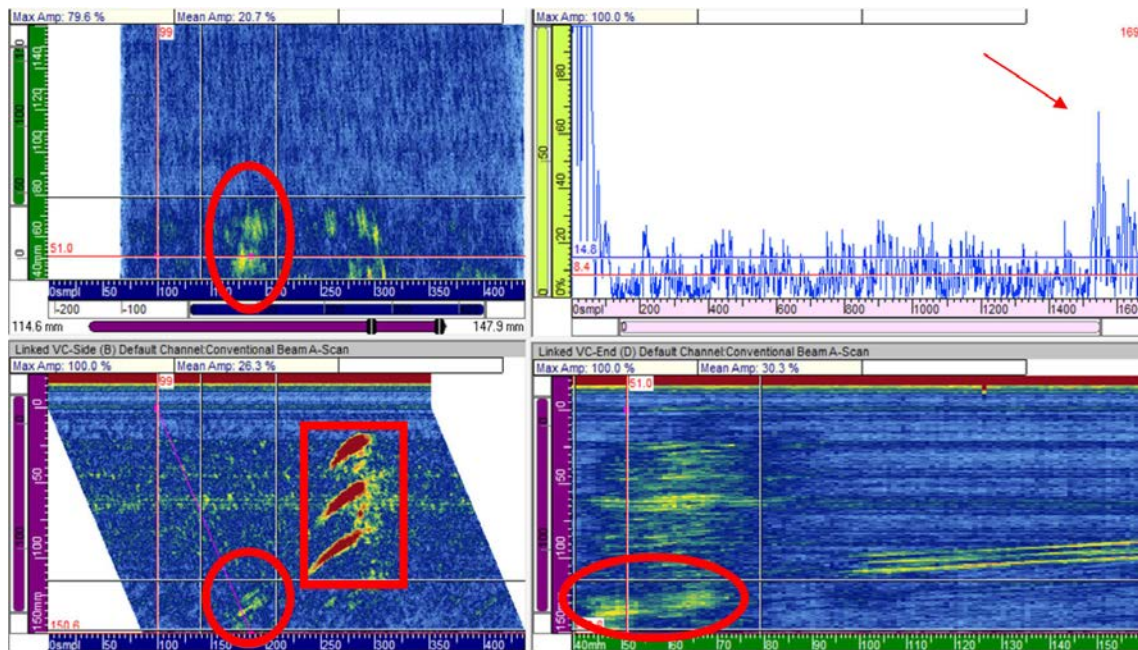
**Figure 5.12.** DM-05 CW Tandem Probe, Axial Flaw 1 (circled in red and noted by arrow in A-scan) and End-Drilled Hole Responses (boxed in red)

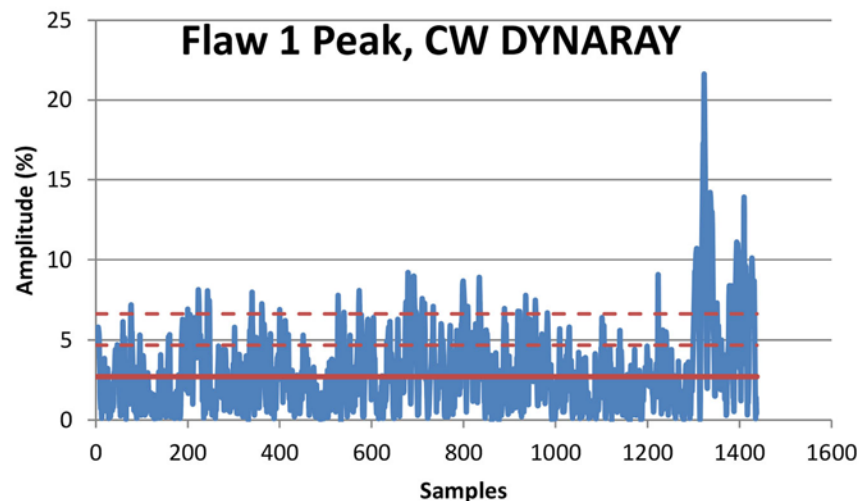
**Figure 5.13.** DM-05 Axial Flaw 1 Peak Response with the Tandem CW Probe. The average noise level is noted by the solid red line and the average +1 $\sigma$  and average +2 $\sigma$  noise levels are noted by the dashed lines.

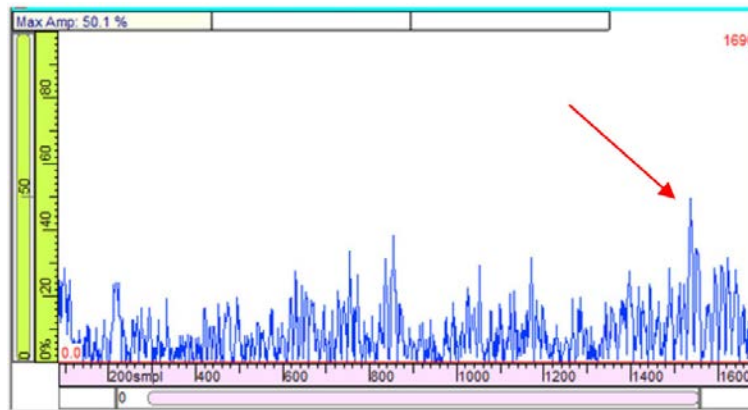
In a manual non-encoded examination, the operator observes the UT instrument screen and, in real time, assesses transient reflections while assuring the transducer is being properly manipulated; thus, a peaked reflector response may not be observed during successive manual scan paths. There can also be significant changes in the A-scans over small changes in probe position. For example, Figure 5.14 shows the data from flaw 1 at a scan position that was incremented by two samples [or 2 mm (0.08 in.)]. This response has a peak-to-mean SNR of 15.5 dB and a peak-to-peak SNR of only 2.1 dB. This response was more typical of the manual data presented in Section 4.0 where SNRs were reported to be at best 2:1 or 6 dB. Figure 5.15 shows the A-scan data with added horizontal lines for the mean, mean +1 $\sigma$  and +2 $\sigma$ . The SNR at the mean +2 $\sigma$  level was 3.3 dB.

**Figure 5.14.** DM-05 CW Tandem Probe, Axial Flaw 1 Response at a Scan Position 2 mm (0.08 in.) from the Image Peak Response. The arrow marks the flaw response in the A-scan.

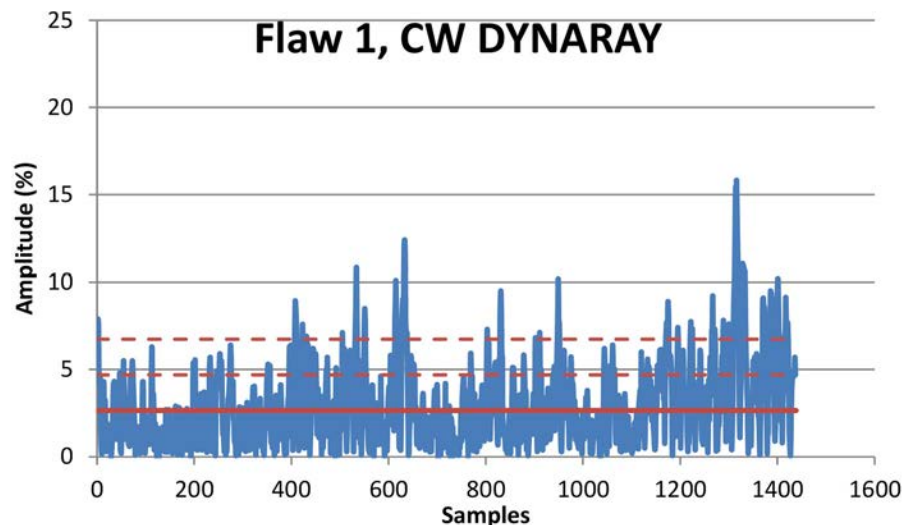
**Figure 5.15.** DM-05 Axial Flaw 1 Response with the Tandem CW Probe at a Scan Position 2 mm (0.08 in.) from the Image Peak Response. The average noise level is noted by the solid red line and the average +1 $\sigma$  and average +2 $\sigma$  noise levels are noted by the dashed lines.

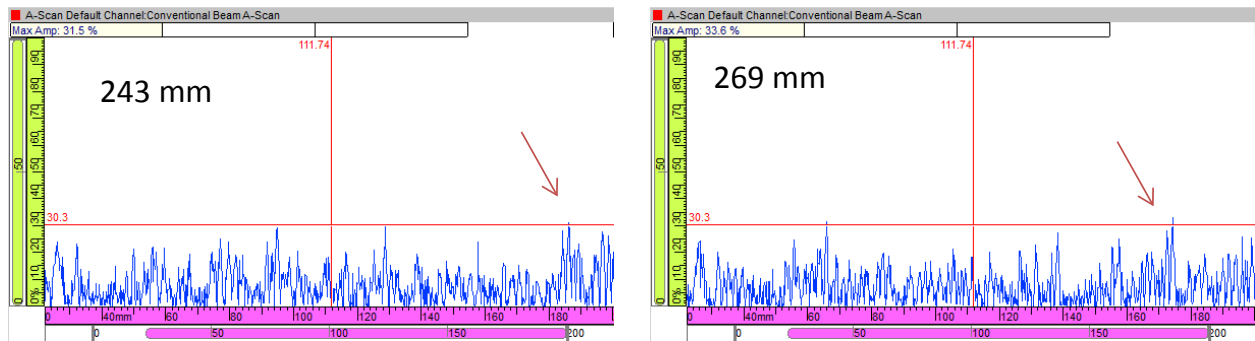
**Figure 5.17.** Responses at 50% Amplitude Level (-6 dB)

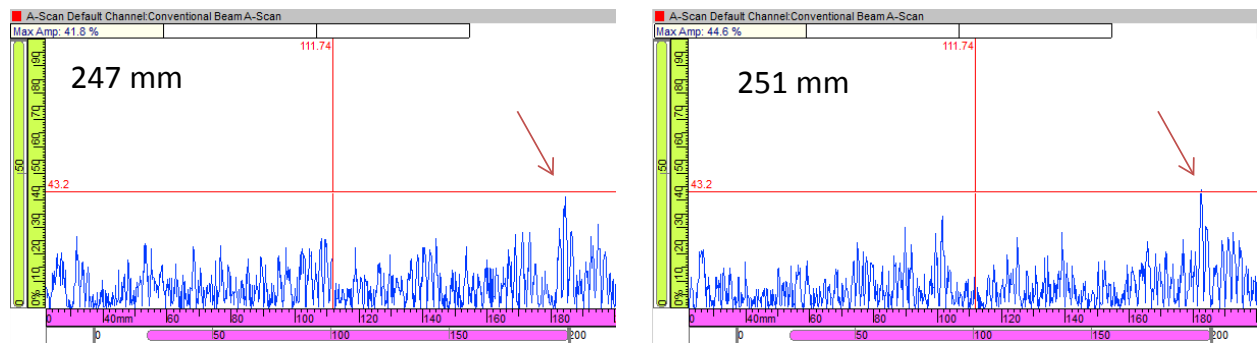
If the signal persistence is instead measured at a relatively higher amplitude level [-3 dB, or about 70% (43% FSH) of the peak flaw response] as displayed in Figure 5.18, the flaw end points are 247 and 251 mm (9.72 and 9.88 in.) for a 4-mm (0.16-in.) scan persistence. At this level, the flaw signal is detectable above the peak noise. However, at this persistence value, the flaw response is highly transient. Regardless of the amplitude one chooses for assessing flaw detection, at any value above the 50% (-6 dB) points, the flaw persistence, as measured in scanning time, is noted to be only a fraction of a second. As shown by laboratory measurements, and assuming a typical manual scan rate of 50.8 mm/sec (2.0 in./sec), flaw persistence for Axial Flaw 1 only equates to approximately 0.51 or 0.08 seconds, based on a 50% or 70% amplitude threshold level, respectively. This extremely short time window (persistence) for a flaw response to be observed during a manual scanning operation would not be expected to afford adequate or reliable detection.

**Figure 5.18.** Responses at 71% Amplitude Level (-3 dB)

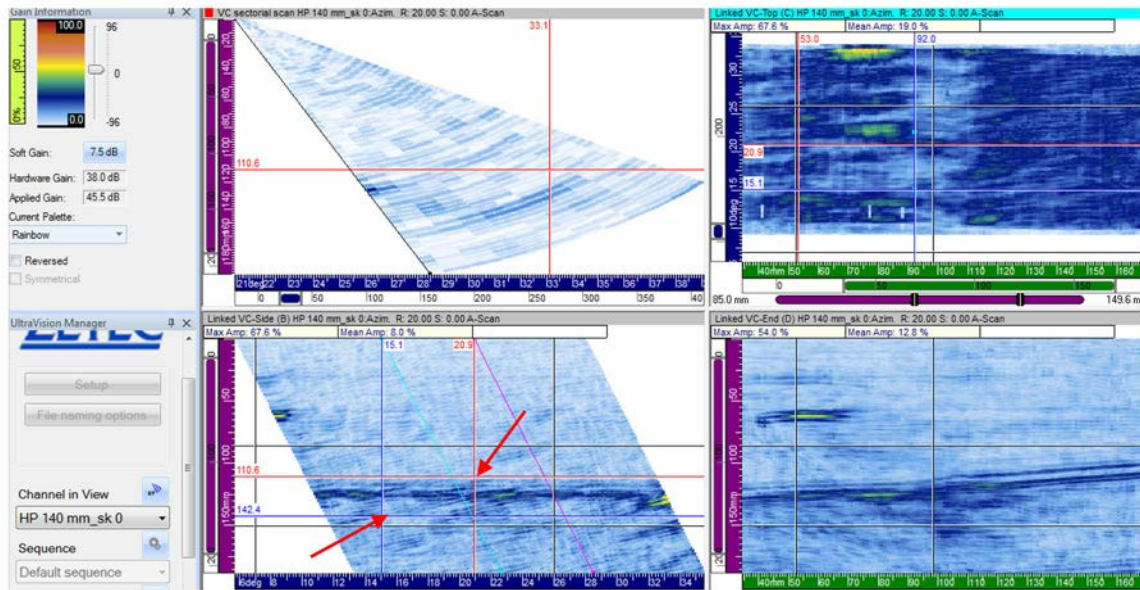
**Figure 6.12.** DM-05 B-scan Side View (bottom left) Outlines a Region for Circumferential Flaw 3. The response levels in this region are comparable to the baseline noise levels indicating no observed artifacts from the flaw implantation. Red arrows point to corners of the subject region.

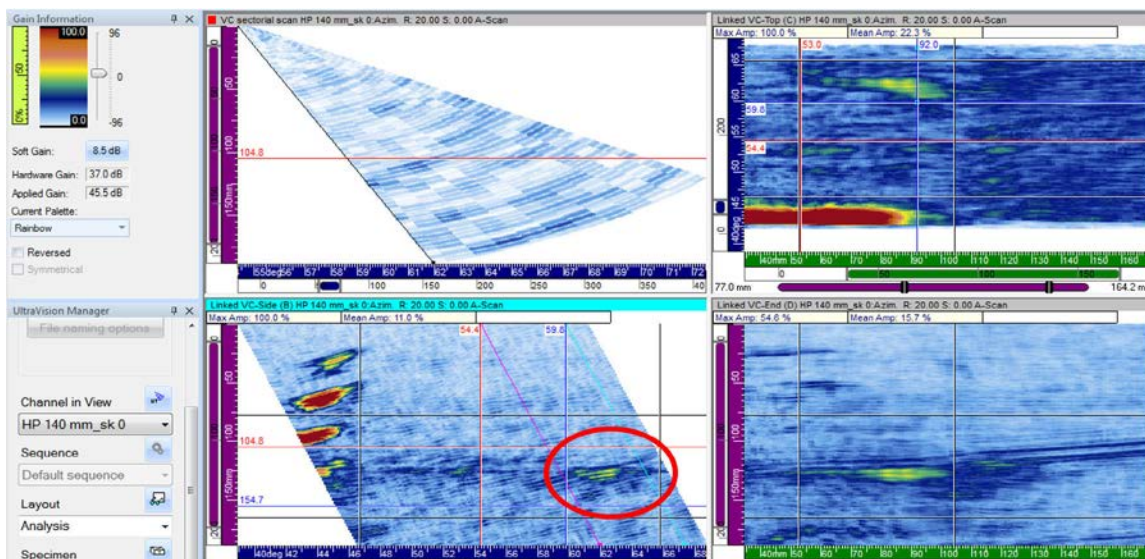
**Figure 6.13.** DM-05 B-scan Side View (bottom left) Displays an Artifact (circled) at Approximately 62 Degrees, Circumferential Flaw 4

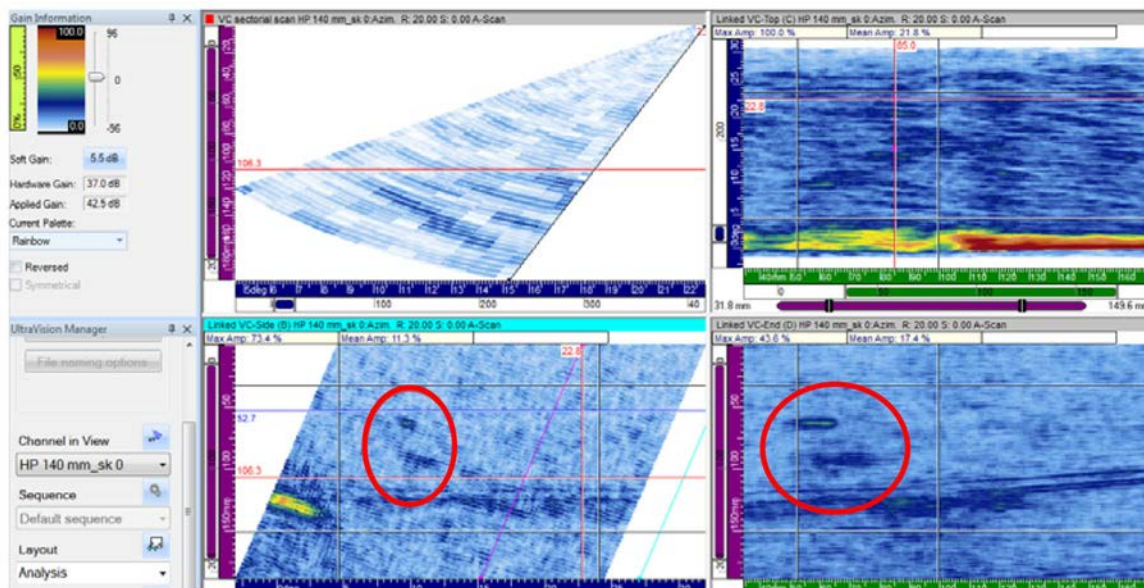
**Figure 6.17.** DM-05 CCW B-scan Side View (bottom left) and D-scan End View (bottom right) Show an Implantation Artifact at 10 Degrees (circled), Likely from Circumferential Flaw 3

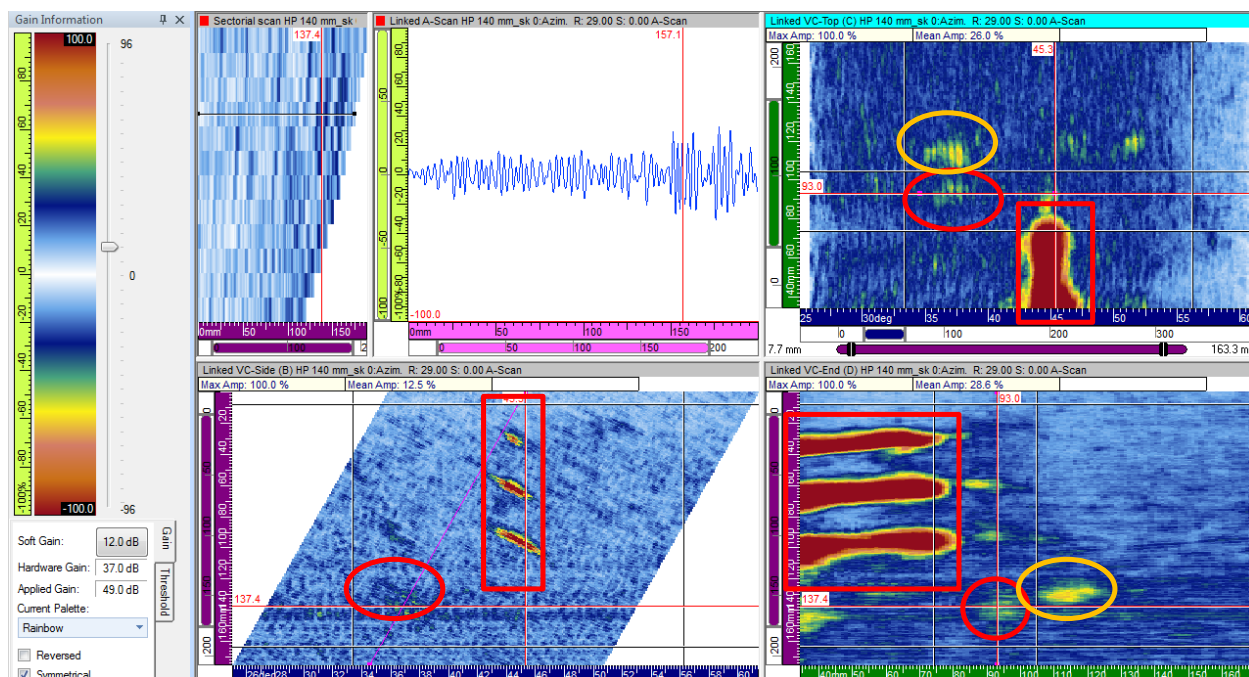
**Figure 6.26.** Mock-up DM-05 Axial Flaw 1 (circled in red), Three SDHs (boxed), and Artifact (circled in orange) that Extends into the Safe End Region. The scan is in the CCW direction with a 0-degree skew and half-path focusing at 140 mm (5.51 in.).

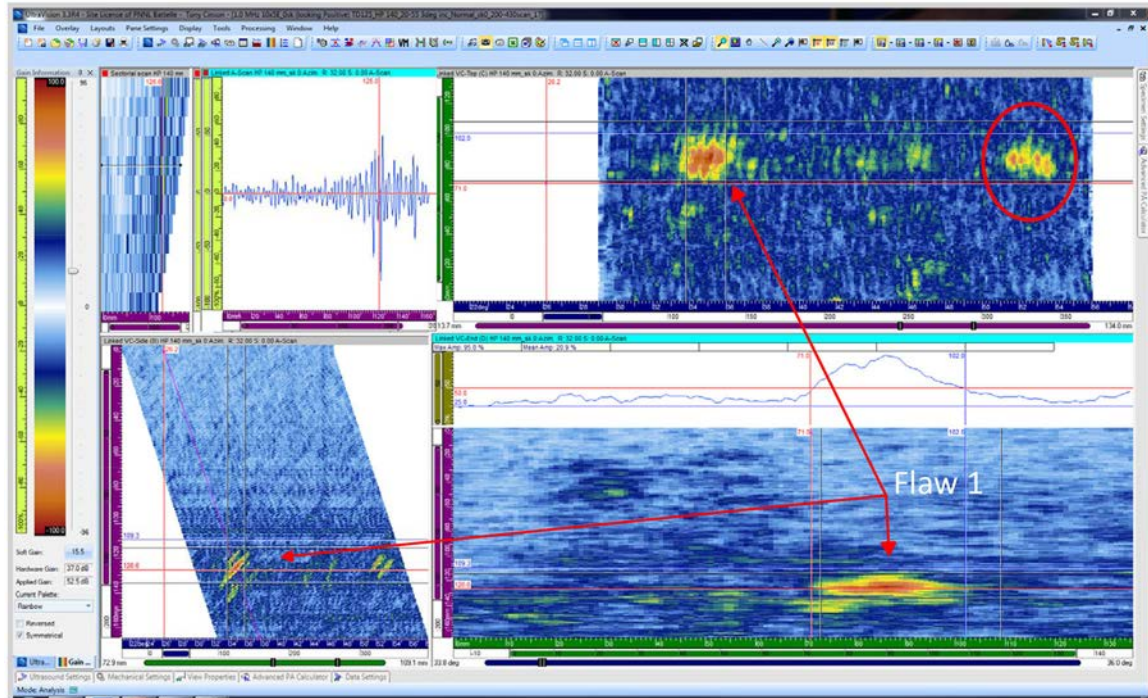
**Figure 6.27.** DM-05 CW Skew 0 View of Axial Flaw 1 Region with Implantation Artifact from Circumferential Flow 4 Circled in Red

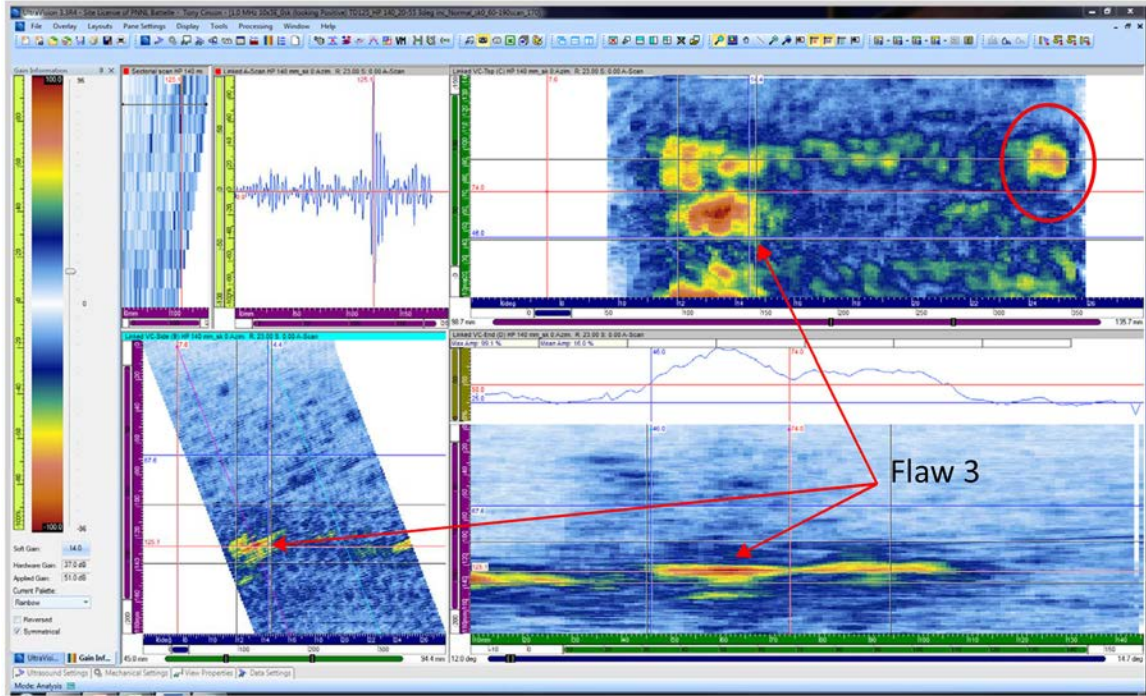
**Figure 6.28.** DM-10 CW Skew 0 View of Axial Flaw 3 Region with Bonus Indication Circled in Red

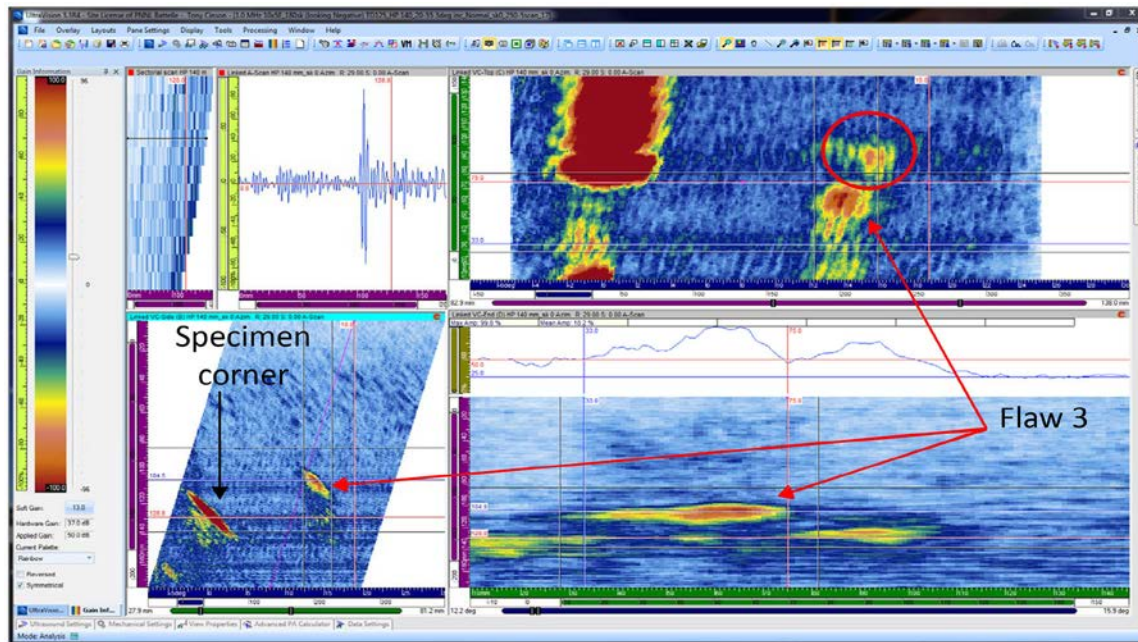
**Figure 6.29.** DM-10 CCW Skew 0 View of Axial Flaw 3 with Artifact Circled in Red

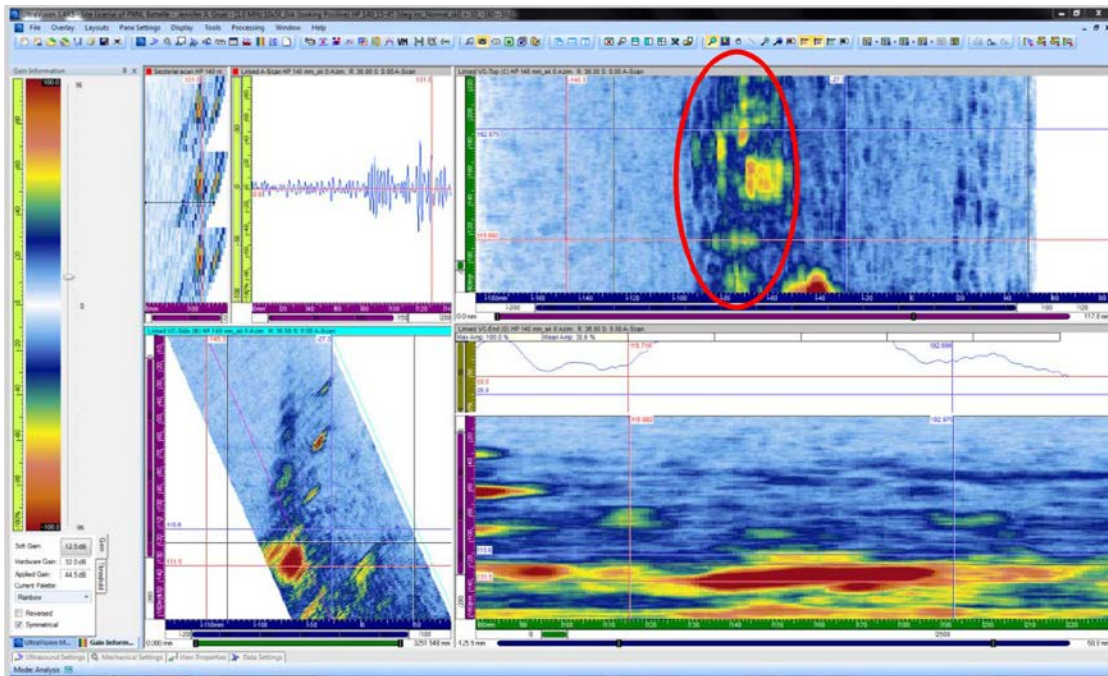
**Figure 6.30.** Skew 0 View of DM-05Weld Region Indications Adjacent to Circumferential Flaw 3 (all circled in red)

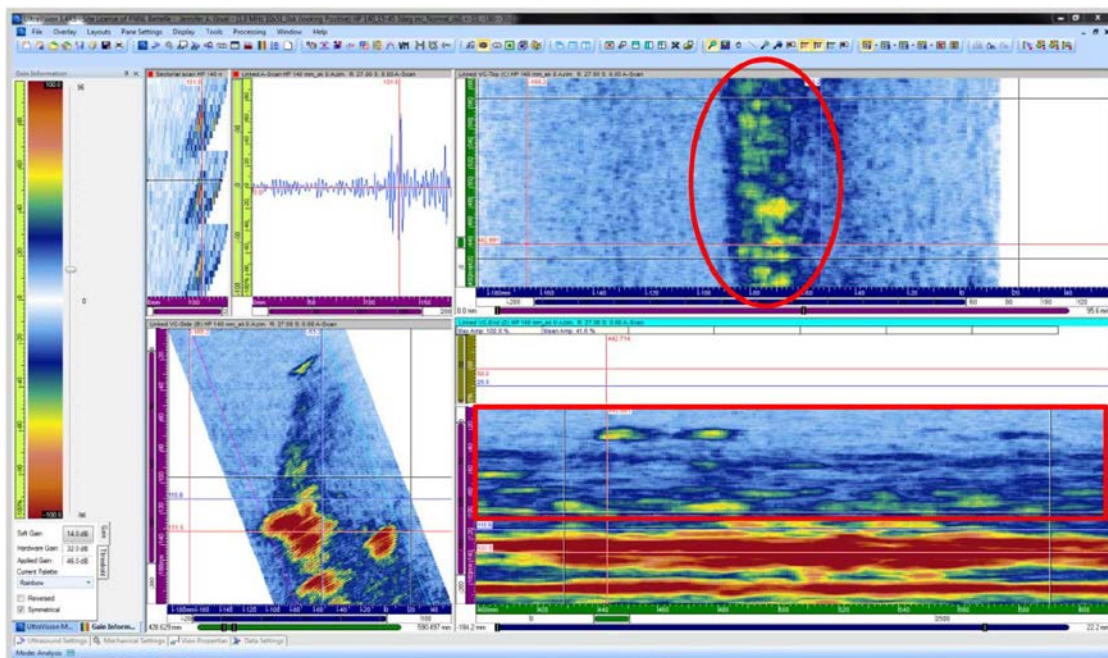
**Figure 6.31.** Skew 0 View of DM-05 Weld Region Indications Adjacent to Circumferential Flaw 4 (all circled/boxed in red)

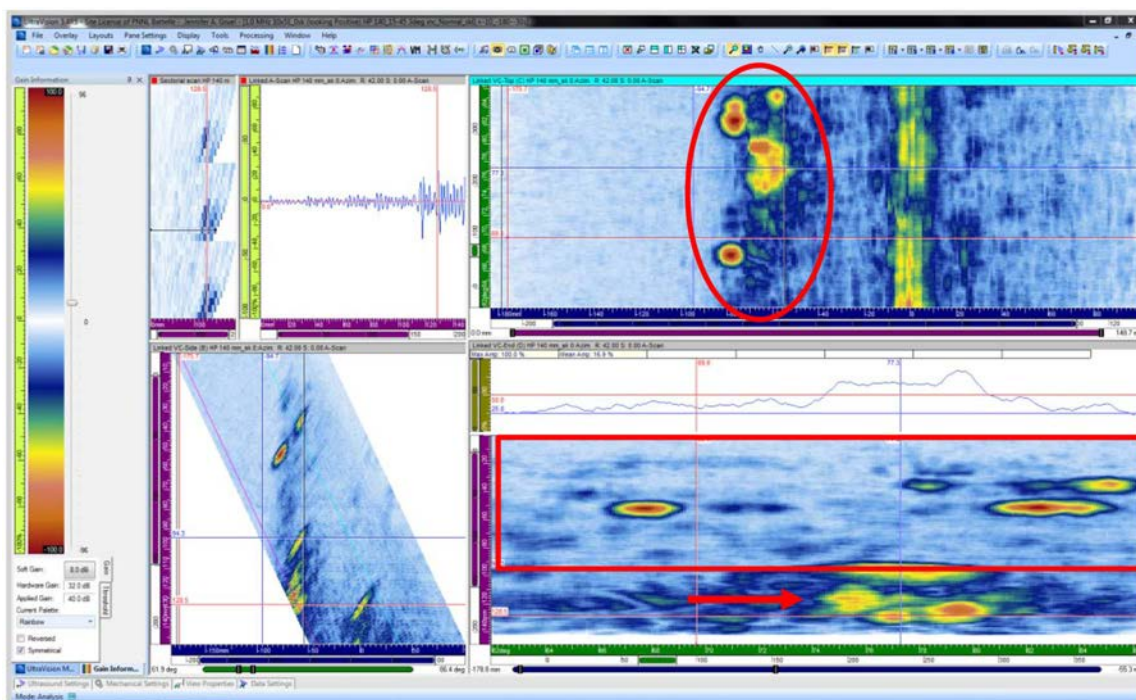
**Figure 6.32.** Skew 0 View of Axial Flaw 4 DM-10 (red arrow) with Weld Region Indications Circled/Boxed in Red

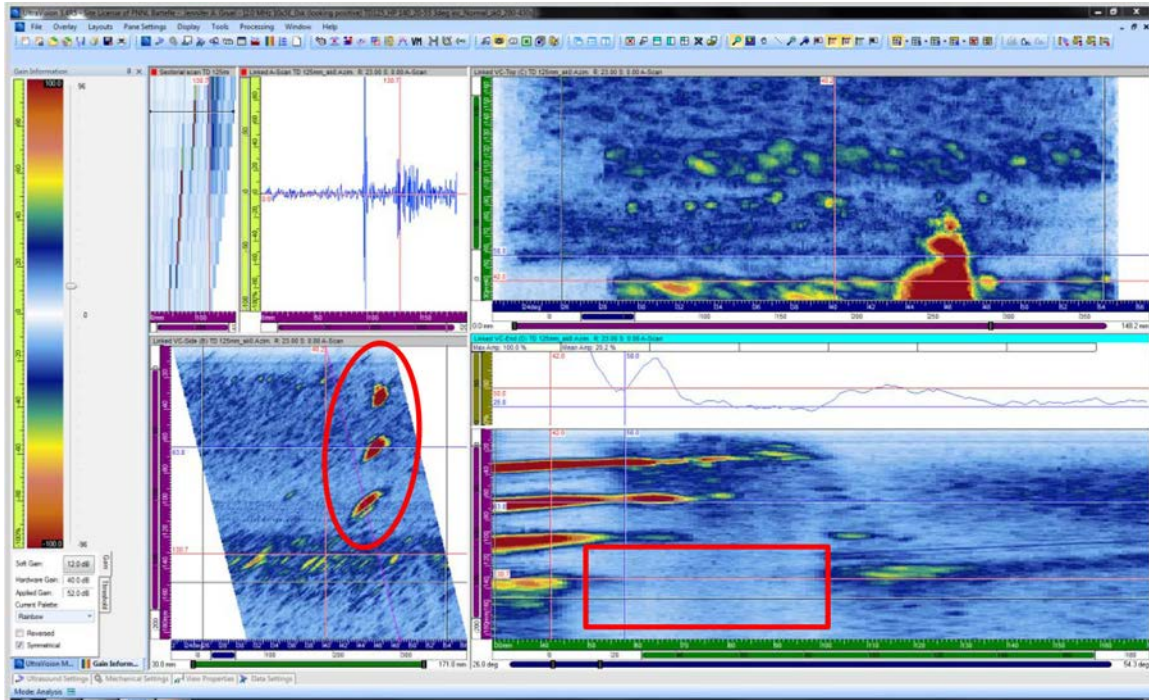
**Figure 6.34.** Mock-up DM-05 Axial Flaw 1 Region (flaw not detected) and Three SDHs Circled in Red with a TD Focus at 125 mm (4.92 in.). The scan is in the CW direction with a 0-degree skew. ID weld region is boxed in red.

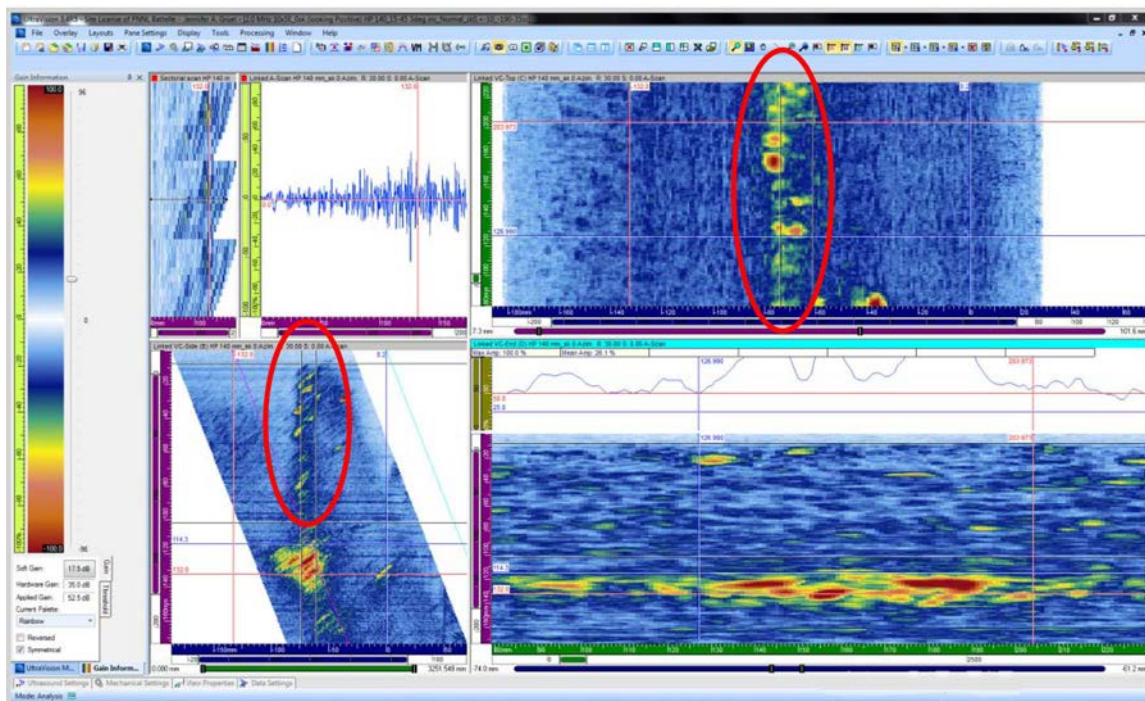
**Figure 6.37.** Looking Positive Skew 0 View of Circumferential Flaw 3 DM-05 (indicated by red arrow) with Weld Fabrication Flaws Circled in Red

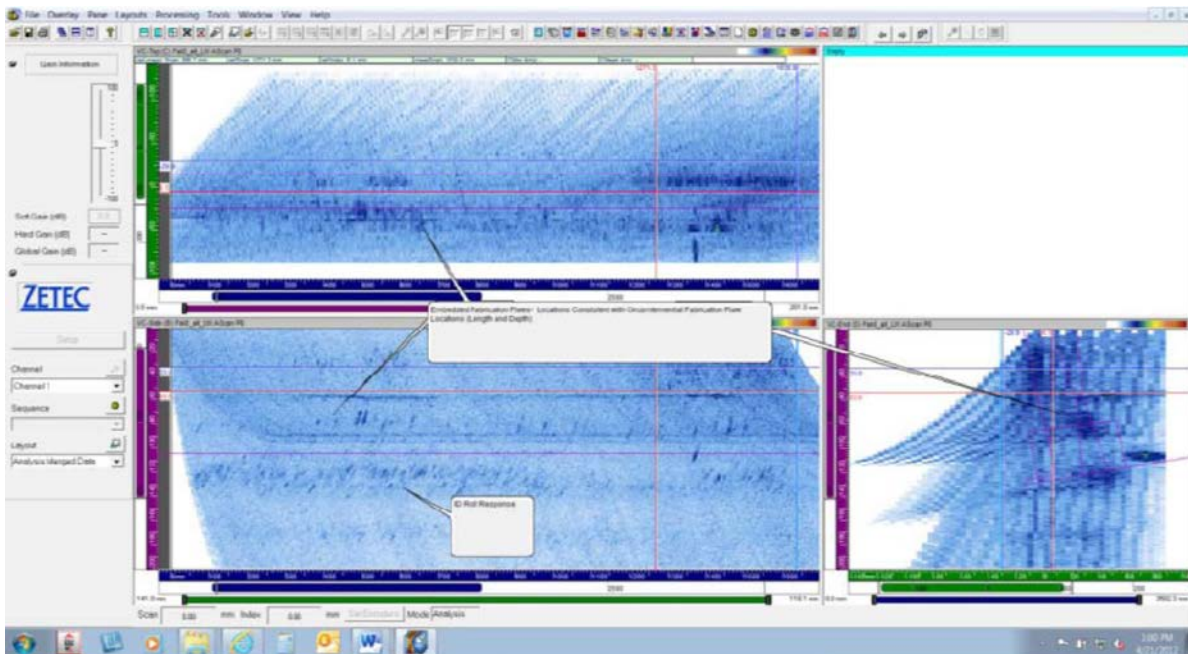
**Figure 6.43.** Circumferential Scan Data from a Field Weld – “Weld Noise” Noted

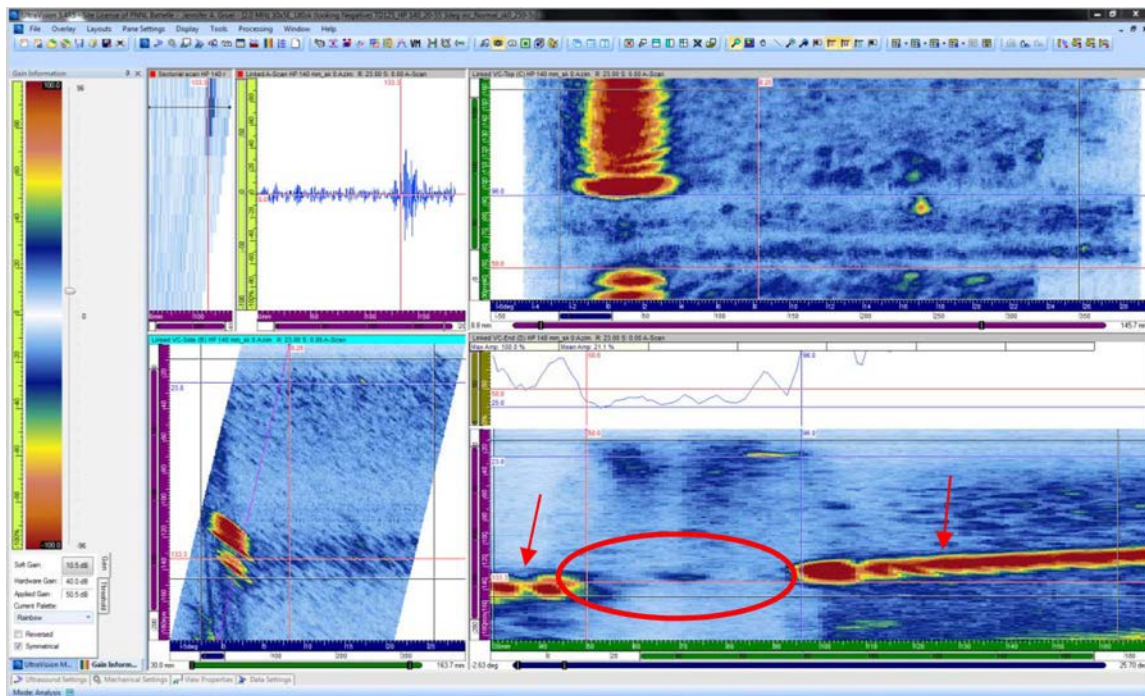
**Figure 7.1.** DM-10 CCW, Skew 0, Half-path Focus. End-of-specimen is visible in the axial Flaw 3 region and is noted by red arrows. Lack of specimen corner response in the weld is circled in red.
