**UNITED STATES  
NUCLEAR REGULATORY COMMISSION**

March 24, 2014

SUBJECT: ARKANSAS NUCLEAR ONE – NRC AUGMENTED INSPECTION TEAM  
FOLLOW-UP INSPECTION REPORT 05000313/2013012 AND  
05000368/2013012; PRELIMINARY RED AND YELLOW FINDINGS

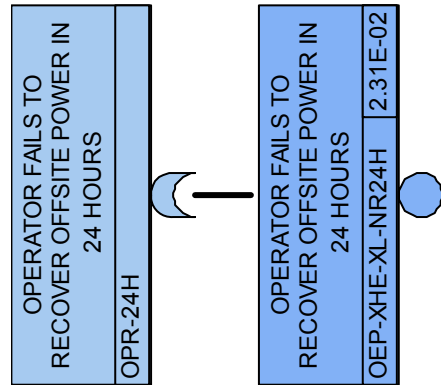
Figure A-3: Offsite Power Recovery Fault Tree

Note that the non-recovery probability was set to one in a change set

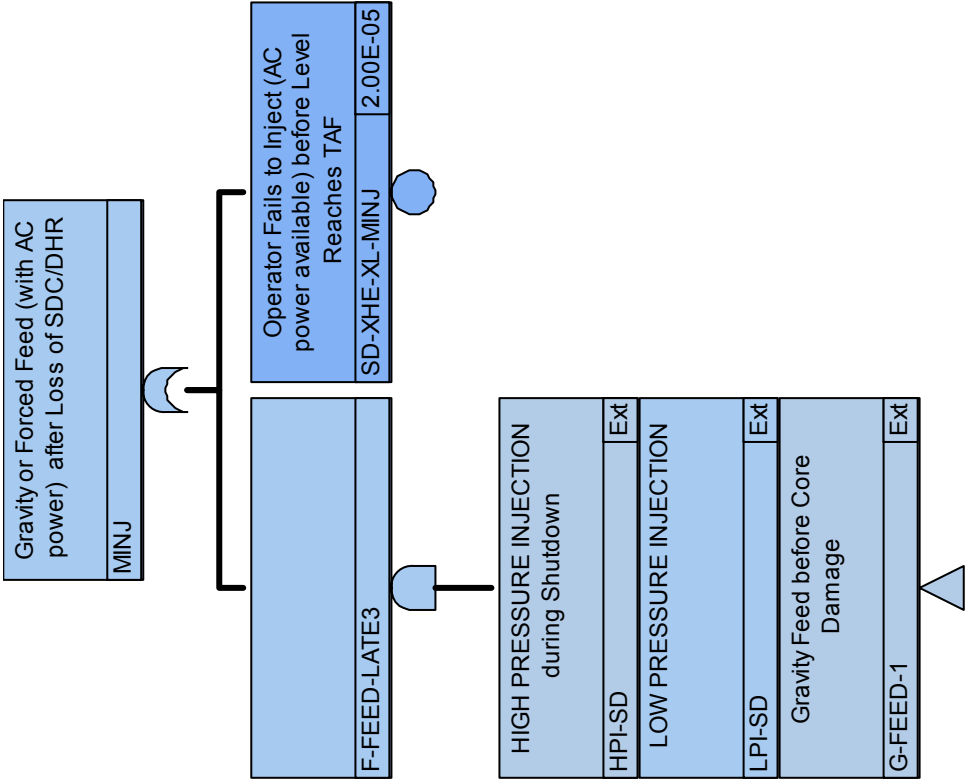
Figure A-6: Gravity and Forced Feed Fault Tree

Note the gravity feed portion of this FT is set to fail as gravity feed will not work because the physical level of the BWST is lower than the refueling canal

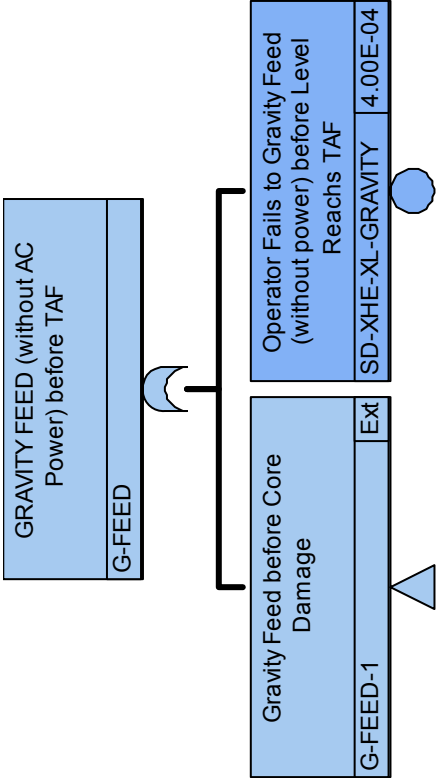
Figure A-7: Gravity Feed (without AC Power) Fault Tree

Note this FT is set to fail as gravity feed will not work because the physical level of the BWST is lower than the refueling canal

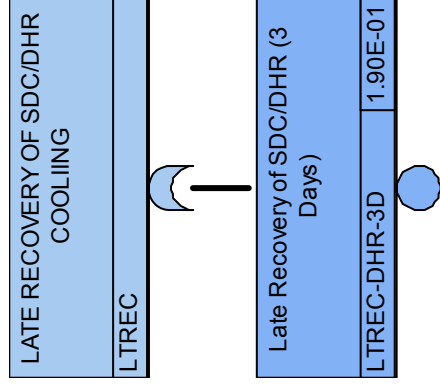
Figure A-11: SDC/DHR Late Recovery Fault Tree

Note the value of the late recovery basic event varies with the time available
