Calc. Pkg No. VSC-04.3101
File No.: VSC-04.3101
Revision: 3

VSC-04 / VSC-24 General Licensees

VSC-24 CoC Renewal Aging Management Review

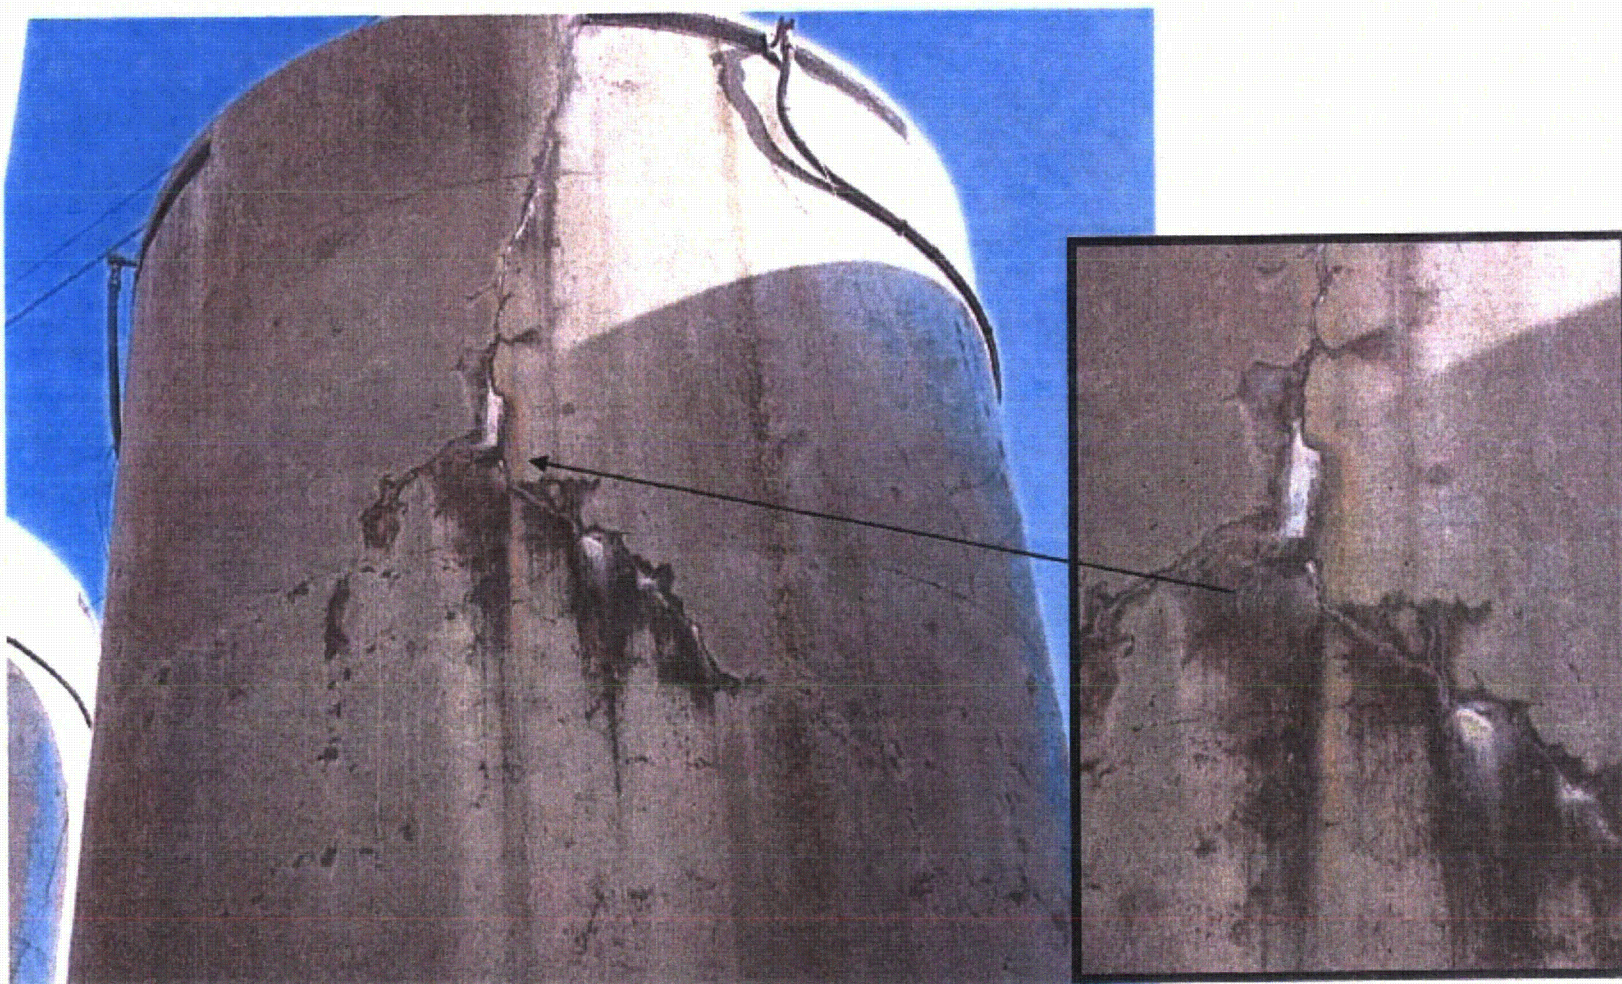
Figure 1 - VCC Surface Cracks and Mineral Deposits

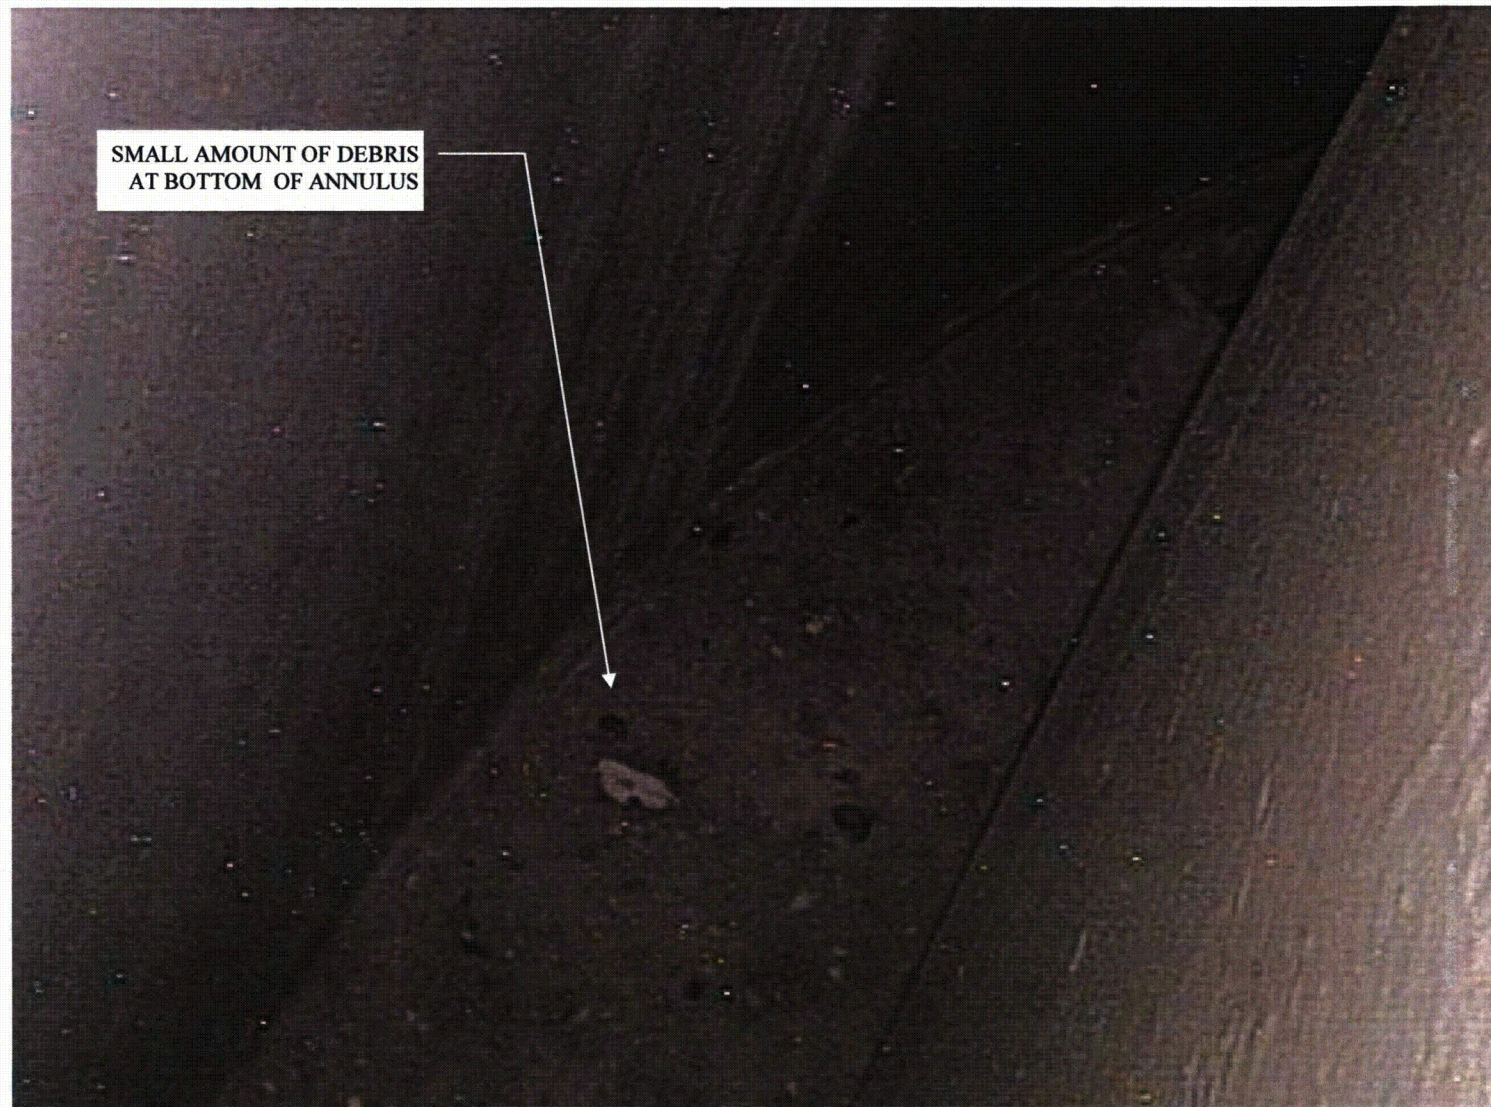
Figure 2 - Debris at Bottom of VCC Annulus

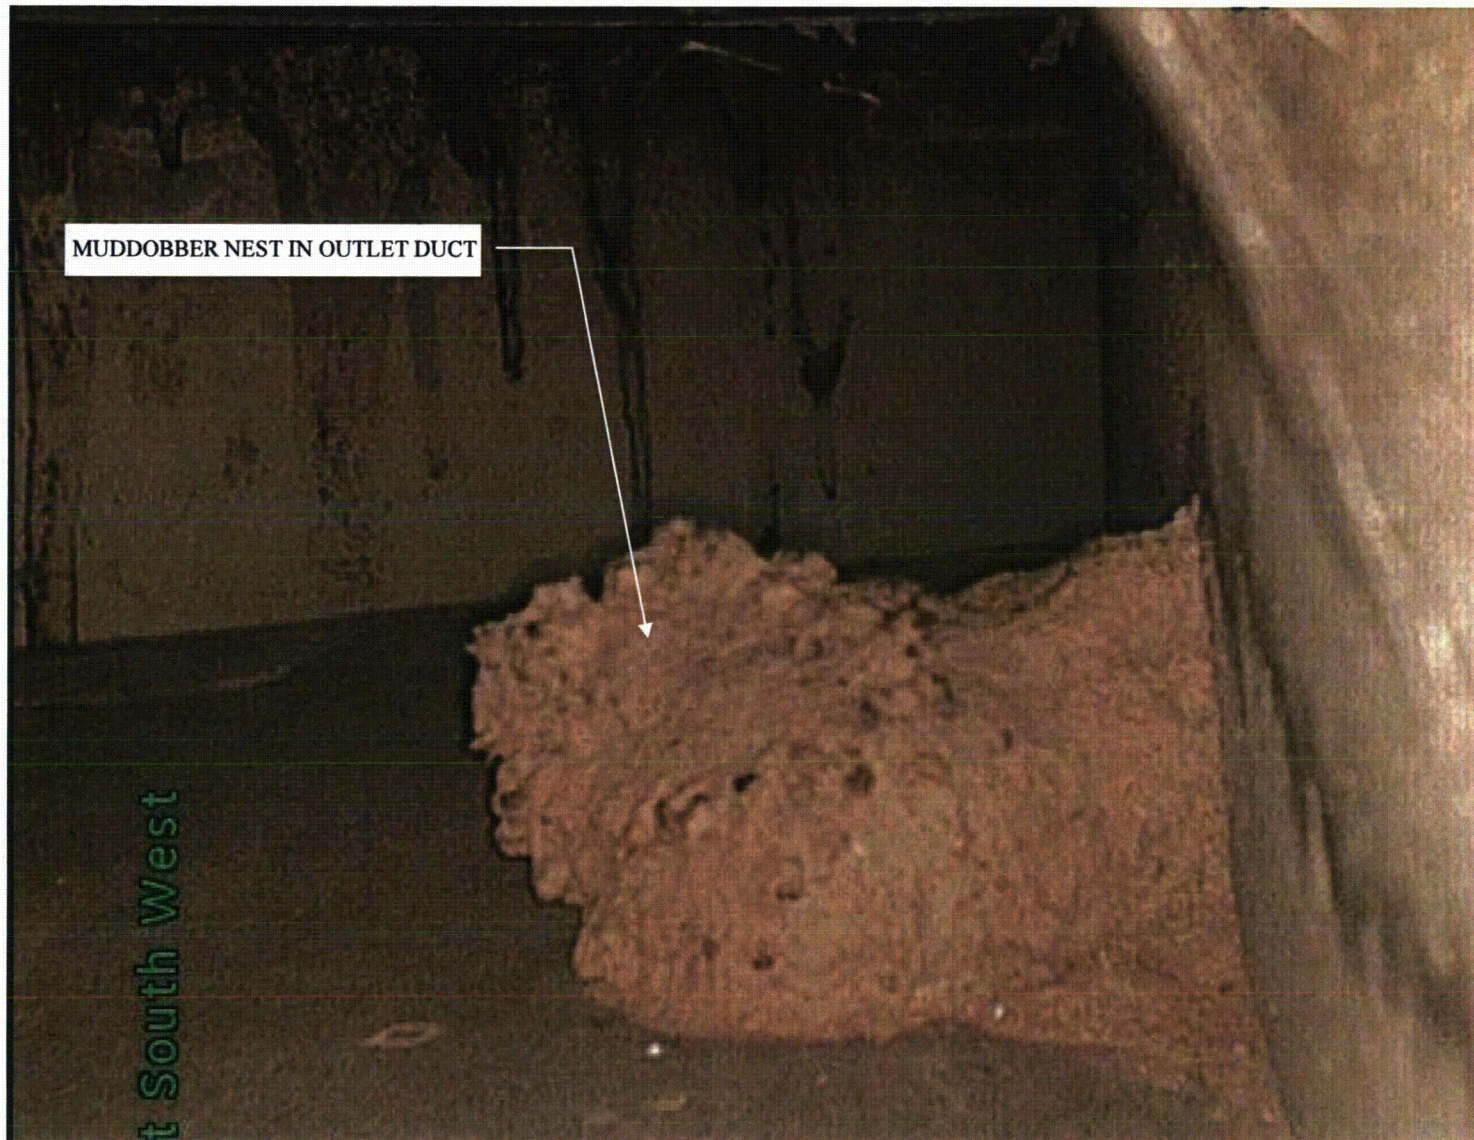
Figure 3 - Muddobber Nest in VCC Outlet Duct

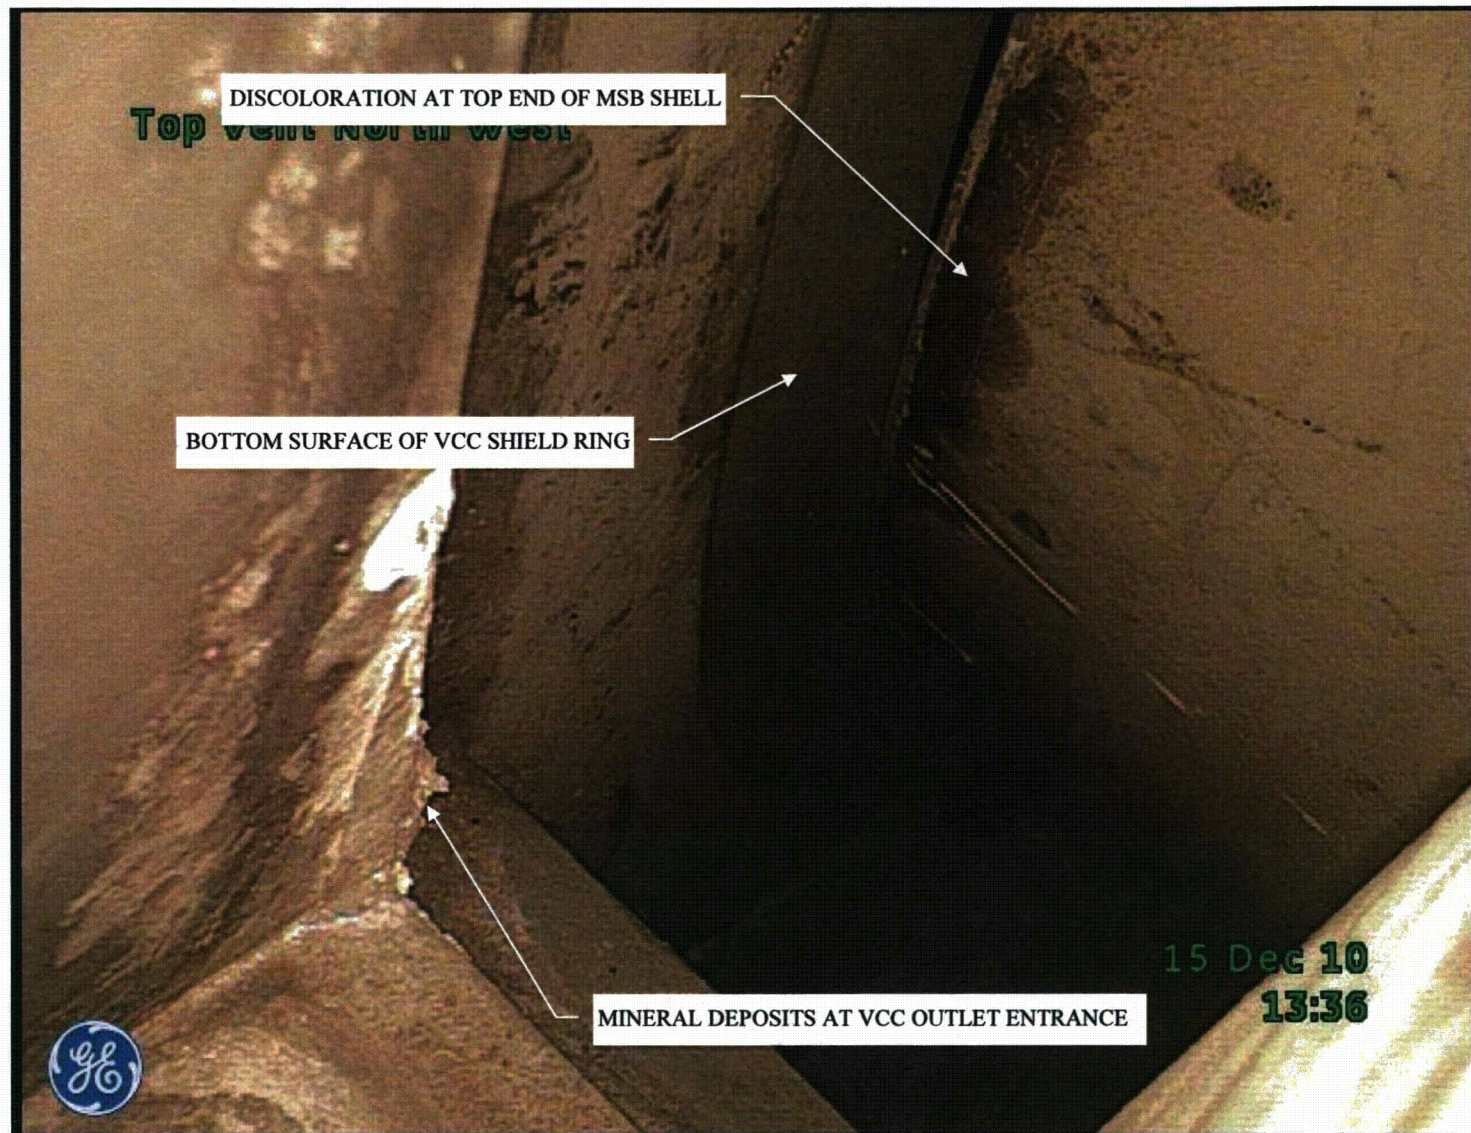
Figure 4 - Top End of VCC Annulus and MSB Assembly

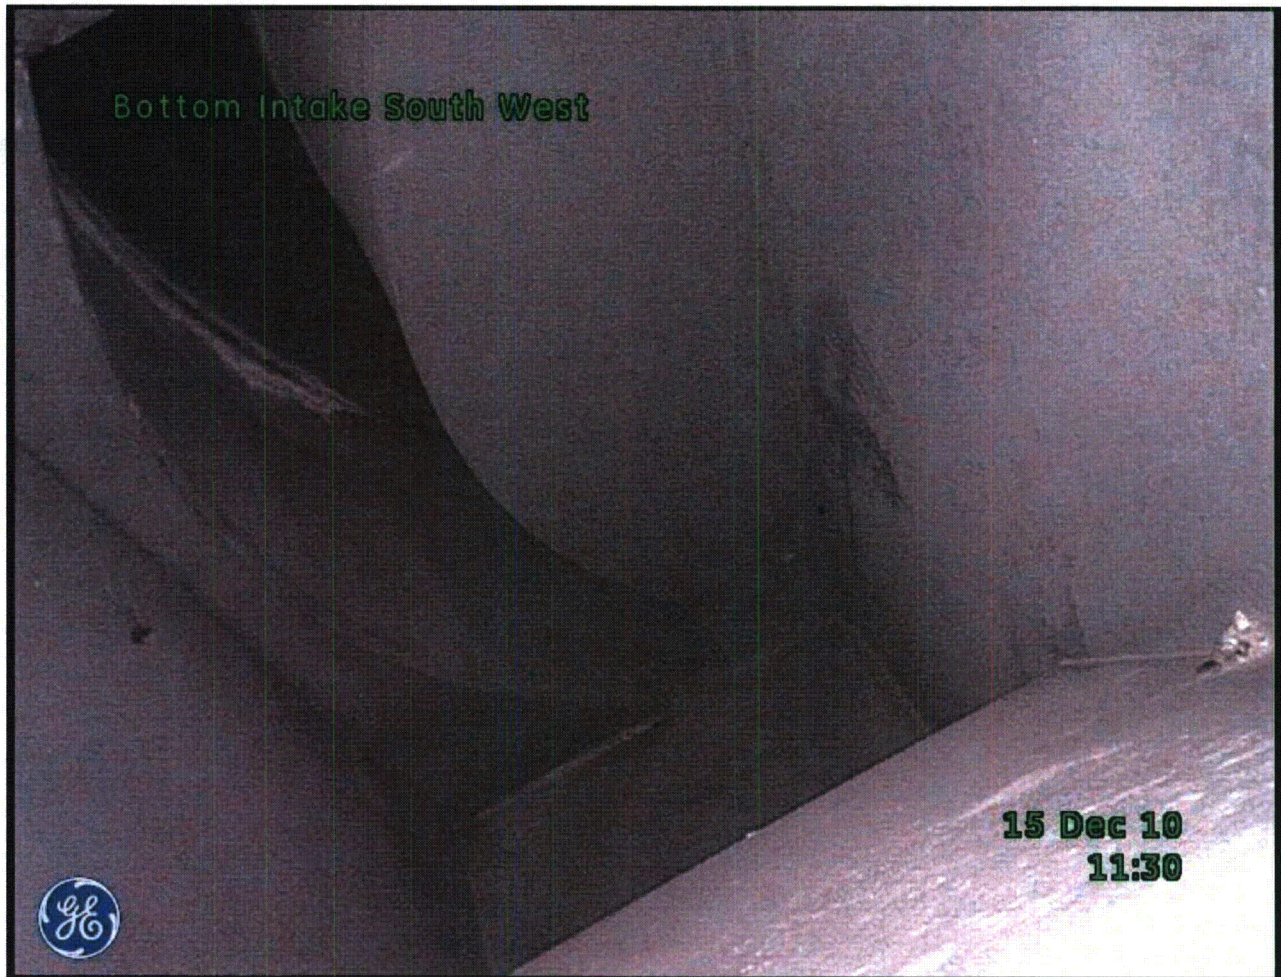
Figure 5 - VCC Air Inlet Duct (looking up into VCC annulus)

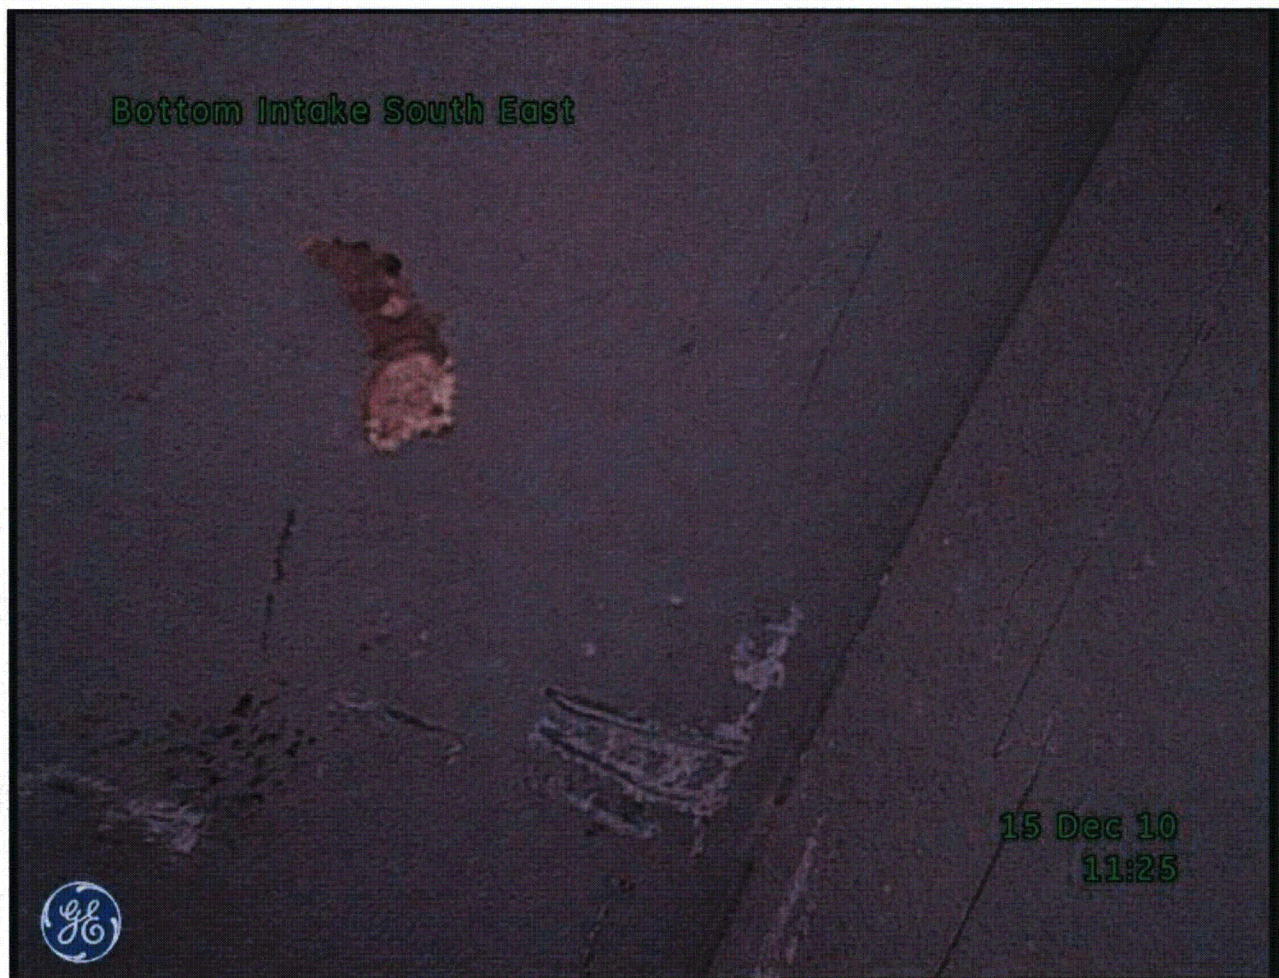
Figure 6 - Local Coating Failure and Metal Corrosion

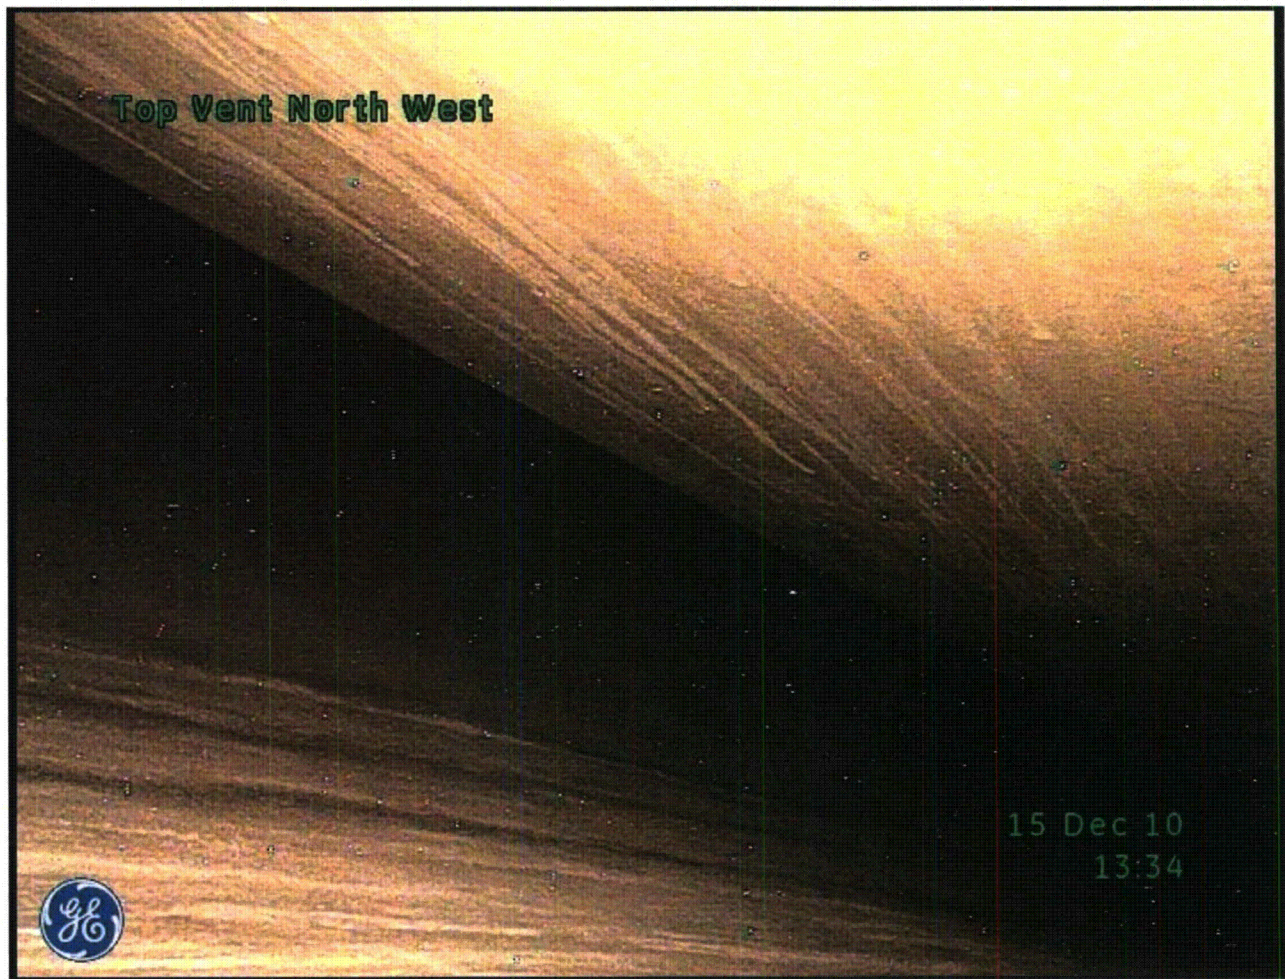
Figure 7 - Deposits on MSB Radial Surface

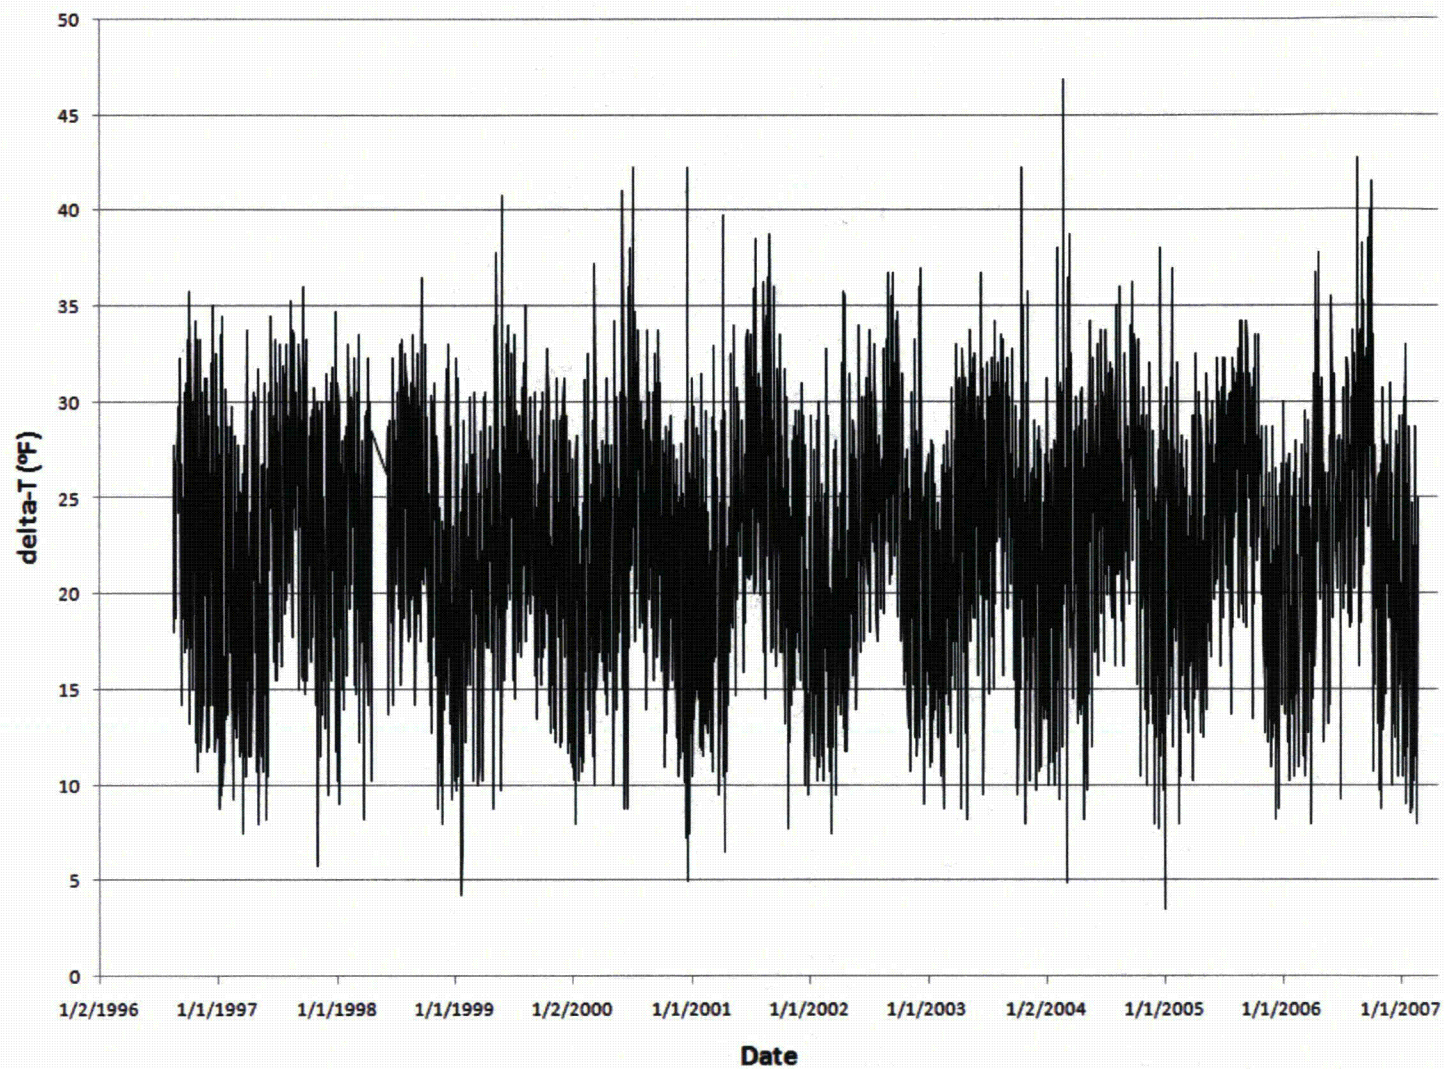
Figure 8 - Ventilation Air Temperature Rise for a Typical Cask

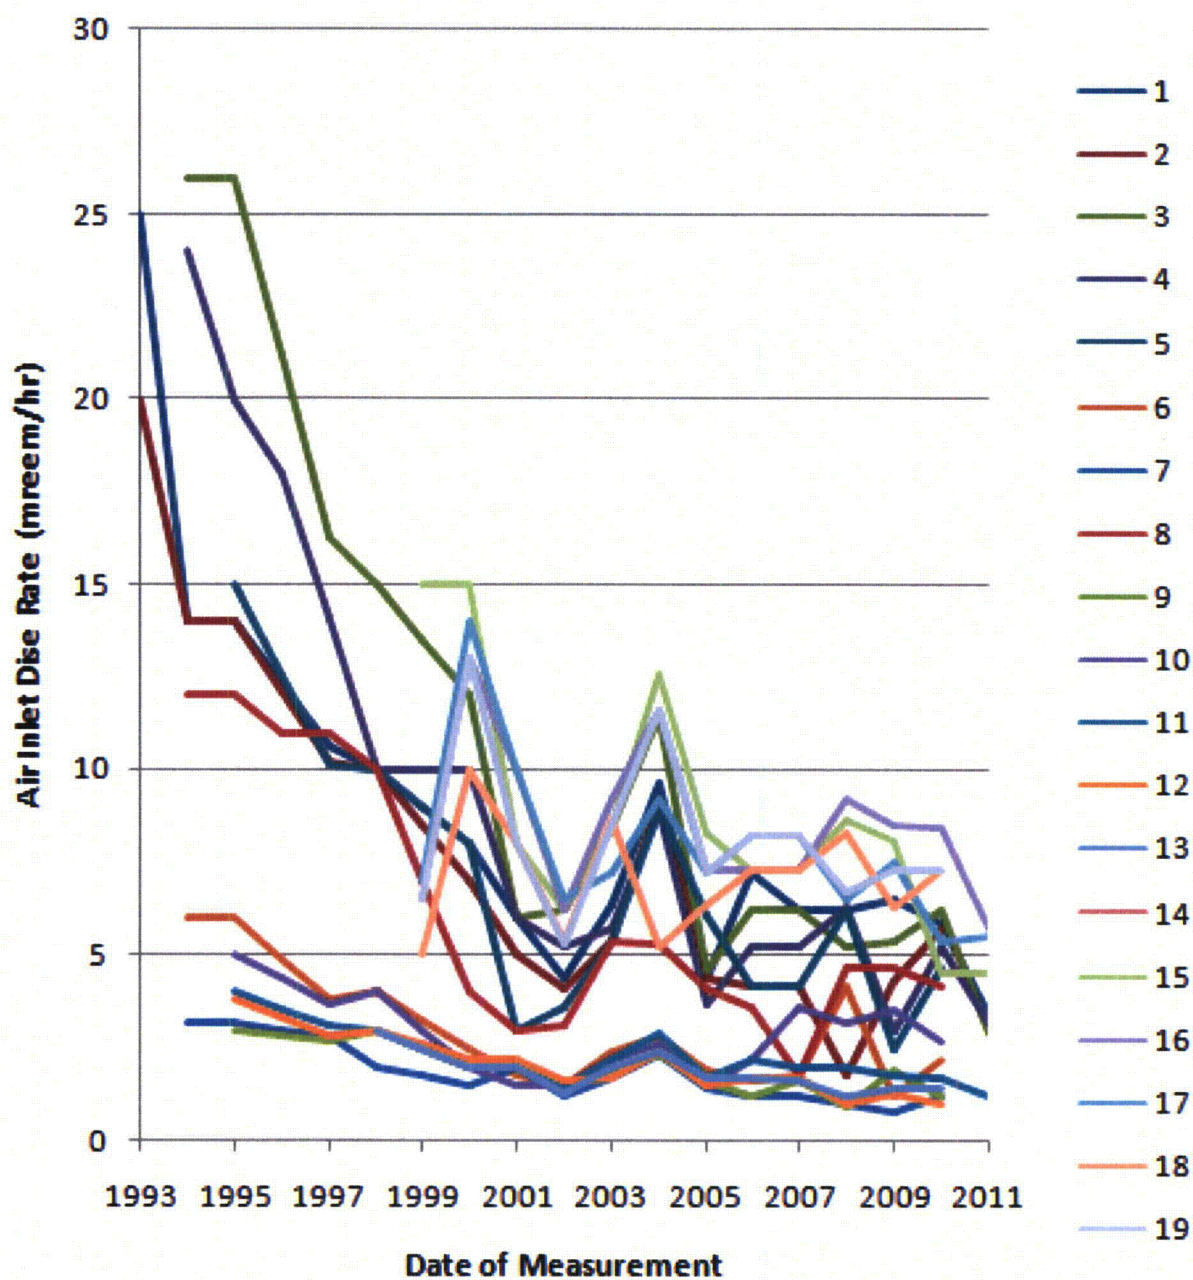
Figure 9 - Palisades Air Inlet Duct Dose Rate Trends

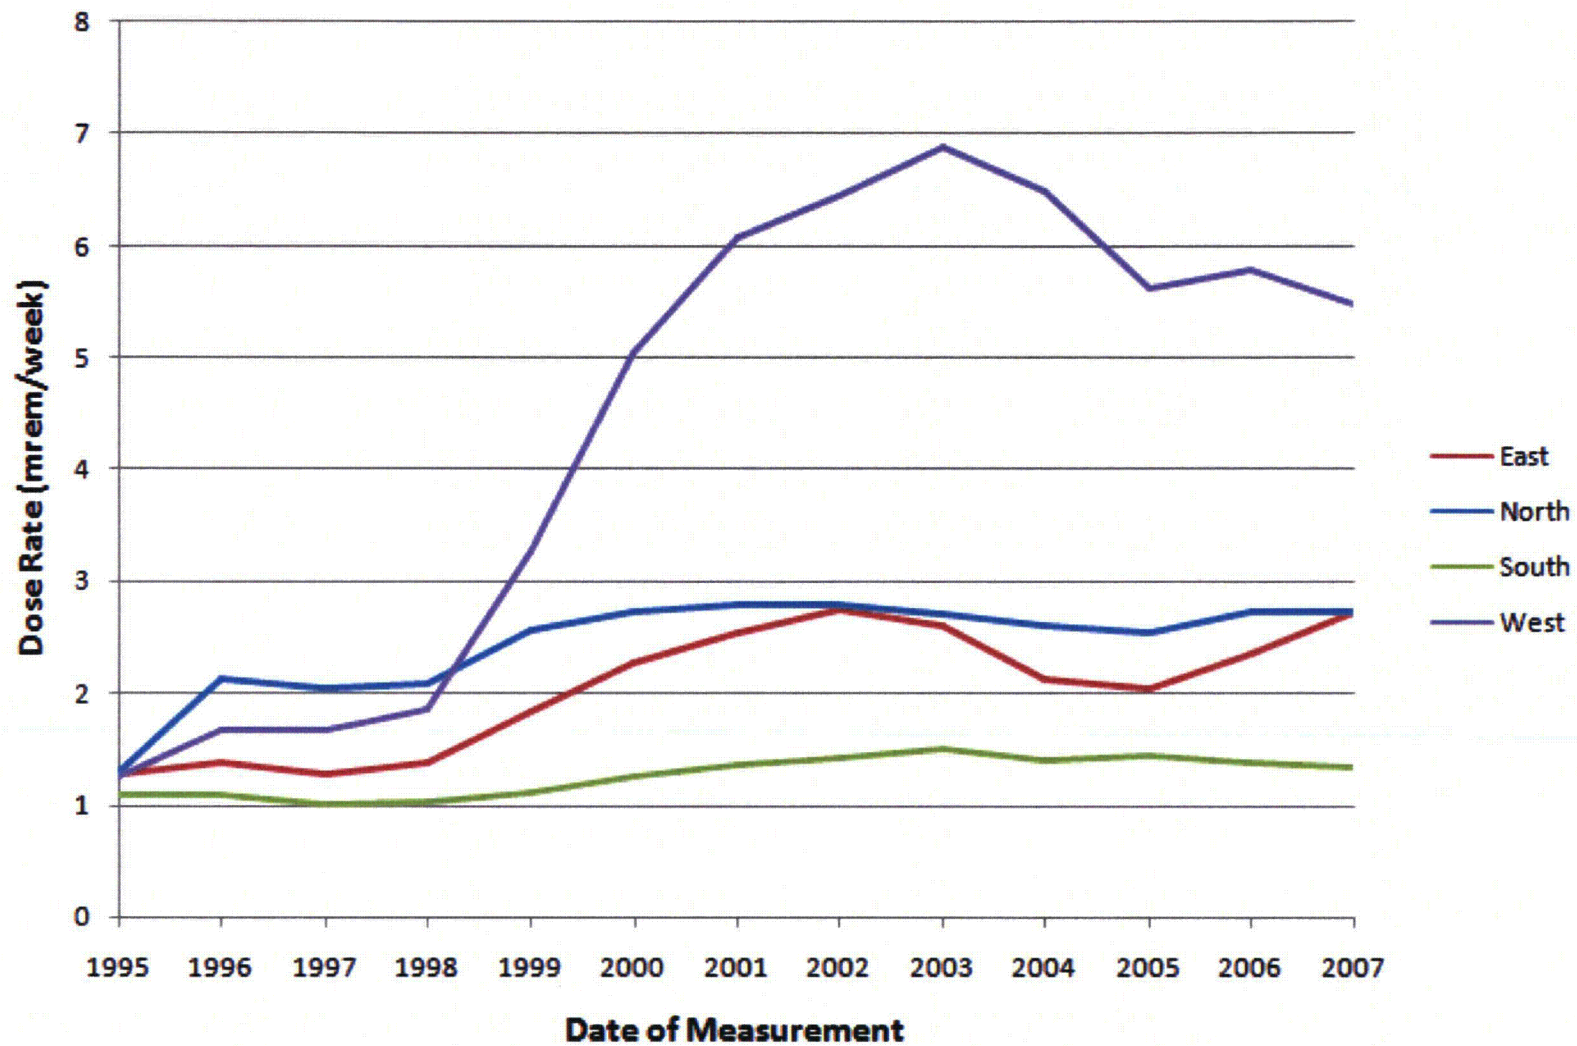
Figure 10 - Point Beach ISFSI Fence Dose Rate Trends
