April 4, 2014  
ES/NRC 14-006  
Docket No. 72-1007

**Subject: Response to Request for Additional Information for the VSC-24 CoC  
Renewal Application (TAC No. L24694)**

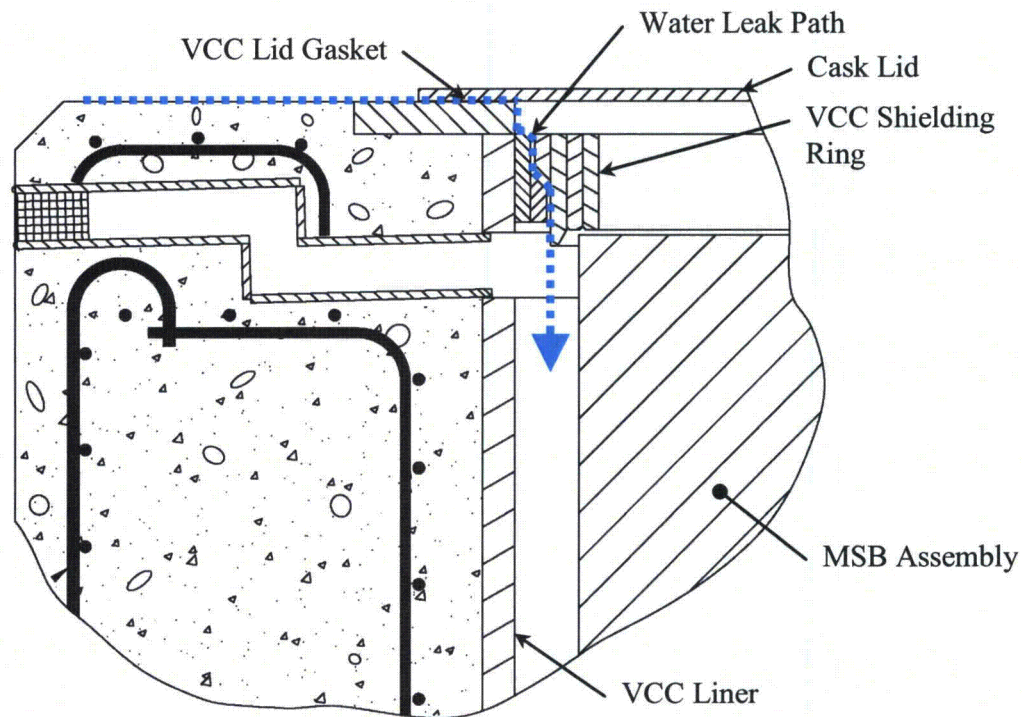
#### Potential Leak Path through VCC Lid Gasket

The VCC lid gasket lies in a sheltered environment with very low radiation levels. Only the inside and outside edges of the VCC lid gasket are directly exposed to an oxidizing atmosphere. Therefore, minimal degradation of the VCC lid gasket is expected to occur during the extended storage period. Unless the VCC lid gasket is disturbed, it is not expected that the lid gasket will allow any water to leak into the VCC cavity. The most likely disturbance of the cask lid is if the bolts and lid are removed, but as discussed in the response to RAI-20, the old lid gasket is required to be replaced with a new lid gasket the prior to re-installation of the cask lid, regardless of condition of the old lid gasket. Therefore it is highly unlikely for the lid gasket to degrade and leak. Nonetheless, in the unlikely event that degradation of the VCC lid gasket material results in a water leak, the design of the VCC shielding ring plates will direct water flow down the VCC annulus and prevent water from accumulating on the top of the MSB assembly, thereby preventing the possibility of accelerated corrosion of the MSB structural lid and closure weld.

The VCC shielding ring is placed on the top of the cask liner assembly after the MSB assembly is lowered into the VCC cavity. It fits loosely inside the cask support rings at the top of the cask liner and extends over the top corner of the MSB assembly. As shown in the figure below, any water that leaks through the VCC lid gasket will be directed down the annular gap between the cask liner and VCC shielding ring, where it will drip to the bottom of the VCC annulus, and will not collect on the MSB structural lid, thereby preventing accelerated corrosion of the MSB lid or welds. Any significant amount of water that drips to the bottom of the VCC annulus will drain out the VCC inlet channels. The carbon steel surfaces of the VCC liner and MSB assembly that form the VCC annulus are coated for corrosion protection. Moisture that accumulates on the coated surfaces of the VCC liner and MSB shell will evaporate or drain out of the VCC assembly. Therefore, failure of the VCC lid gasket is not expected to lead to accelerated corrosion of the VCC liner and MSB shell.

in the unlikely event that degradation of the VCC lid gasket material results in water leakage into the VCC assembly, accelerated corrosion, although not expected, will be managed through AMP inspections.

- Sections 3.4.2.4 and 3.4.4: Revised discussion of consequences of water leakage through the lid gasket.
- Table 17, "Scope": Add replacement of VCC Lid Gasket.

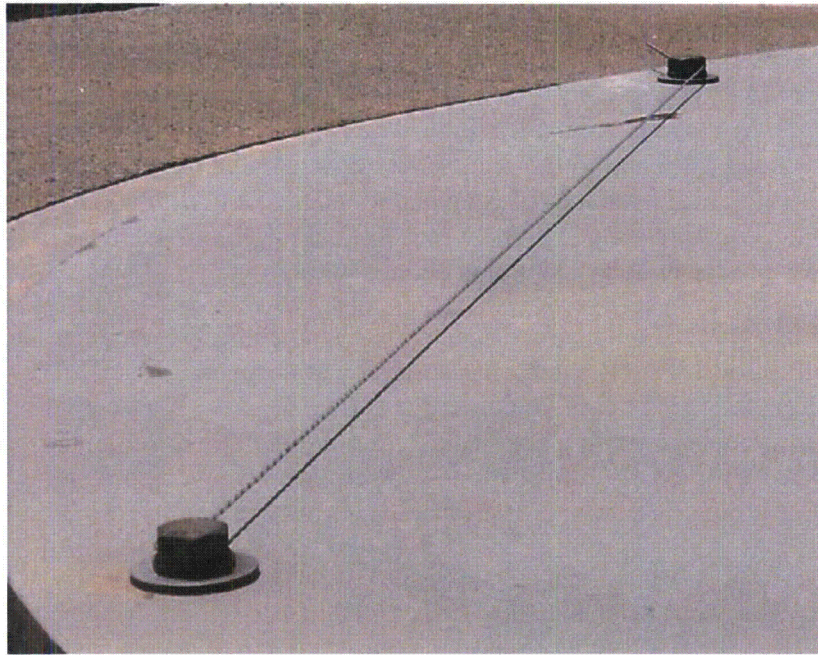
**Condition of Palisades Lead Cask VCC Lid Bolts**

The VCC lid bolts are made from A307 carbon steel with a zinc coating or other protective finish. The protective finish on the VCC lid bolts is intended to inhibit corrosion. However, the VCC lid bolts may experience some corrosion during the extended storage period, as operating experience shows. As noted in the Palisades Lead Cask Inspection Report, when the VCC lid bolts were removed, some corrosion was identified on the bolts. However, as shown in the picture below, the amount of corrosion on the VCC lid bolts of the Palisades lead cask was limited to local discoloration of the surface finish, and as such, they were determined to be acceptable for continued use.

- Sections 3.2.2.4: Revised to clarify that the corrosion on the VCC lid bolts was limited to discoloration of the surface finish (i.e., rust bloom) and that the bolts were determined to be acceptable for continued use.

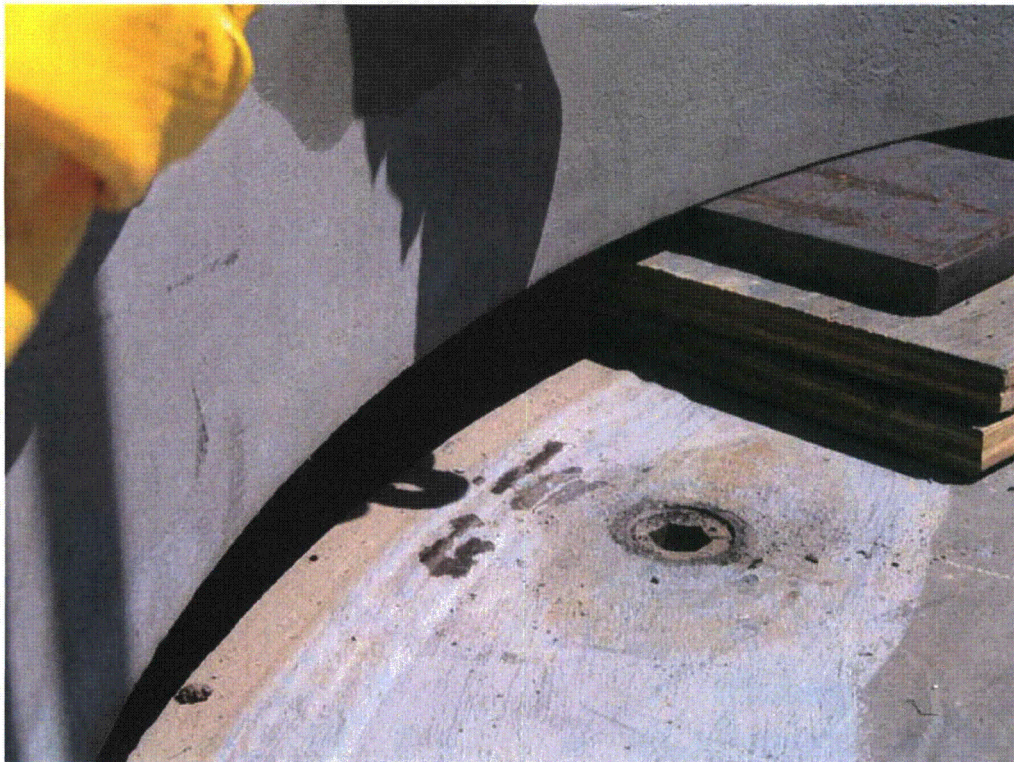
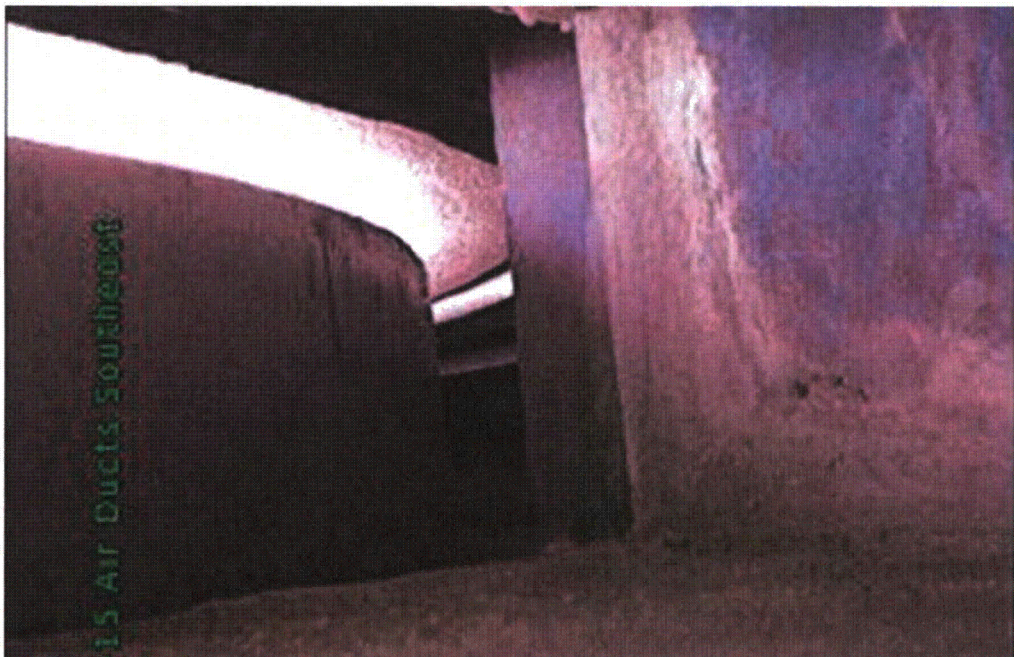
**Photographic Evidence of No Crevice Corrosion at MSB Top Corner**

As discussed in Section 3.2.2.4, the VCC shield ring was lifted by a small amount (approximately 3-inches) to allow visual inspection of the MSB top corner region (i.e., the MSB closure weld), as shown in the first figure below. The visual examination did not identify any evidence of crevice corrosion occurring between the top end of the MSB assembly and the VCC shield ring. Further evidence of the lack of crevice corrosion at the top end of the MSB assembly is shown in the photographs provided below, which are included in the Palisades Lead Cask Inspection Report. The first photograph shows the top edge of the MSB shell exposed after lifting the shield ring. There are no visible signs of corrosion on the top corner of the MSB shell, although some coating was inadvertently scraped off, as discussed in Section 3.4.4 of the renewal application. The second photograph, which is taken from inside one of the VCC air outlet assemblies looking at the top corner of the MSB assembly, shows some discoloration of the coating at the top end of the MSB shell due to high temperatures experienced during the closure welding process, but no signs of corrosion.
