**Subject: October 2013 Inspection Report
Cameco Resources Permit 603**

OCTOBER 2013 INSPECTION REPORT

PERMIT 603

COMPANY:	Cameco Resources (CR)
LOCATION:	North of Glenrock, Converse County (Highland)
DATE OF INSPECTION:	October 23, 2013
DATE OF REPORT :	February 6, 2014
INSPECTOR:	Pam Rothwell, Permit Coordinator
CO. STAFF PRESENT:	Ken Garoutte, CR SHEQ Manager

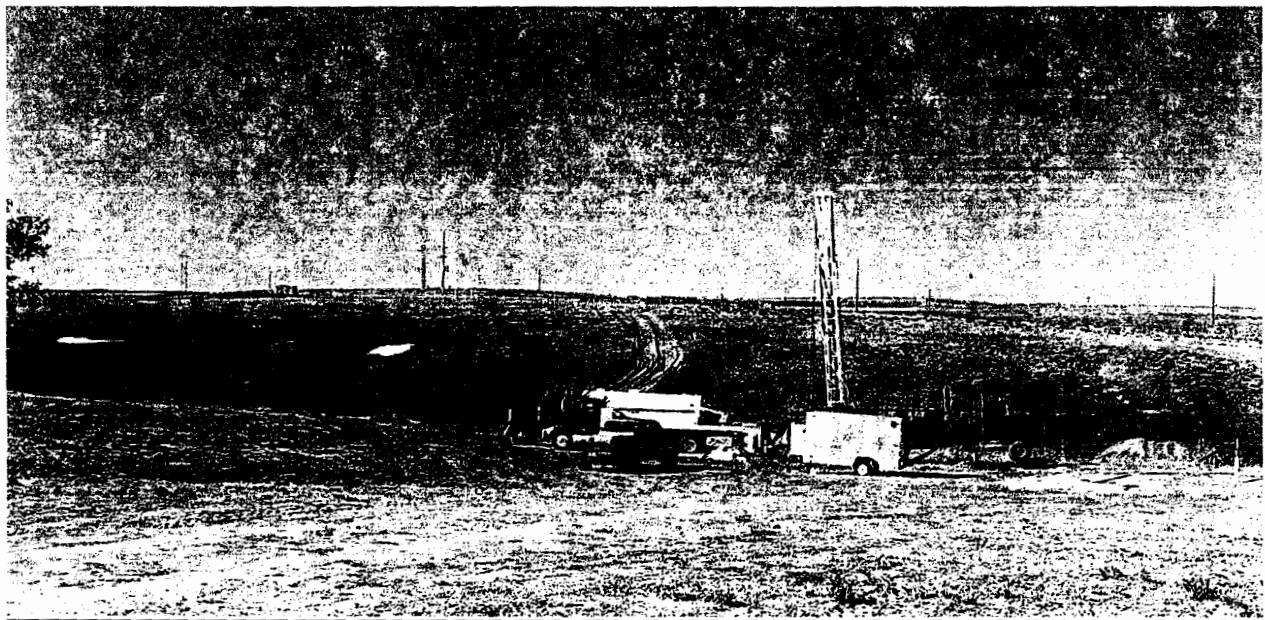
- New shallow investigation well (i.e., NOV Docket No. 5131-13) were being drilled at the time of the inspection (**Figure 1**)
- MU-E (South)
 - Inspected HH 13, Five wells turned on for RO injection

Figure 1 drill rig installing new shallow aquifer investigation wells

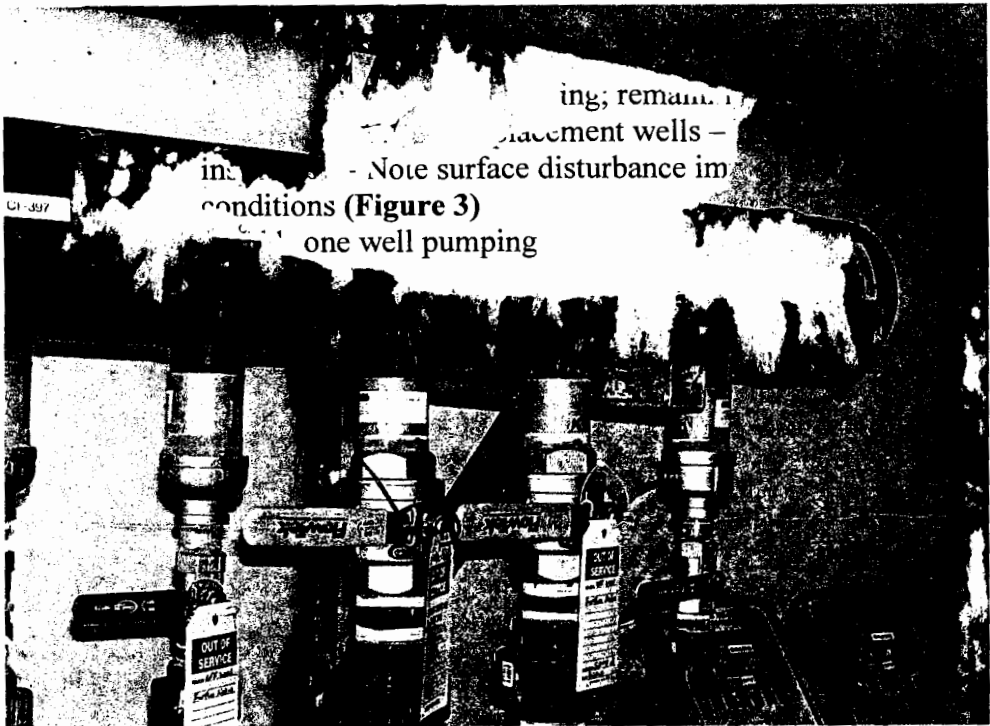
- Inspected HH 12, GWS
 - Inspected HH E12 also used for HHD2-3, DP-22 operating
- MU-C
 - Six wells along the haulageway @ approx. 600' piped to HH C-19 (**Figures 2, 3 & 4**) Request to turn on the wells but need approval for converting the wells (will discuss at meeting with LQD Supervisor on 10-25-14)

Figure 2 New piping for underground haulageway restoration wells CIMW-1 and CRMW-3

1. The wells used for the underground haulageway restoration (CIMW-1, CRMW-2, CRMW-3 and CRMW-4) were noted to be piped into HH -C19 during the inspection. To date, Cameco does not have an approved restoration plan for the haulageway. LQD sent review comments addressing the proposed plan on January 3, 2013. No response has been received. LQD agreed to allow Cameco to pursue restoration of some mine units while restoration plans and reviews are in progress. However, delays in the reviews to approve the restoration plans are not acceptable. Please submit the responses to comments within 30 days.

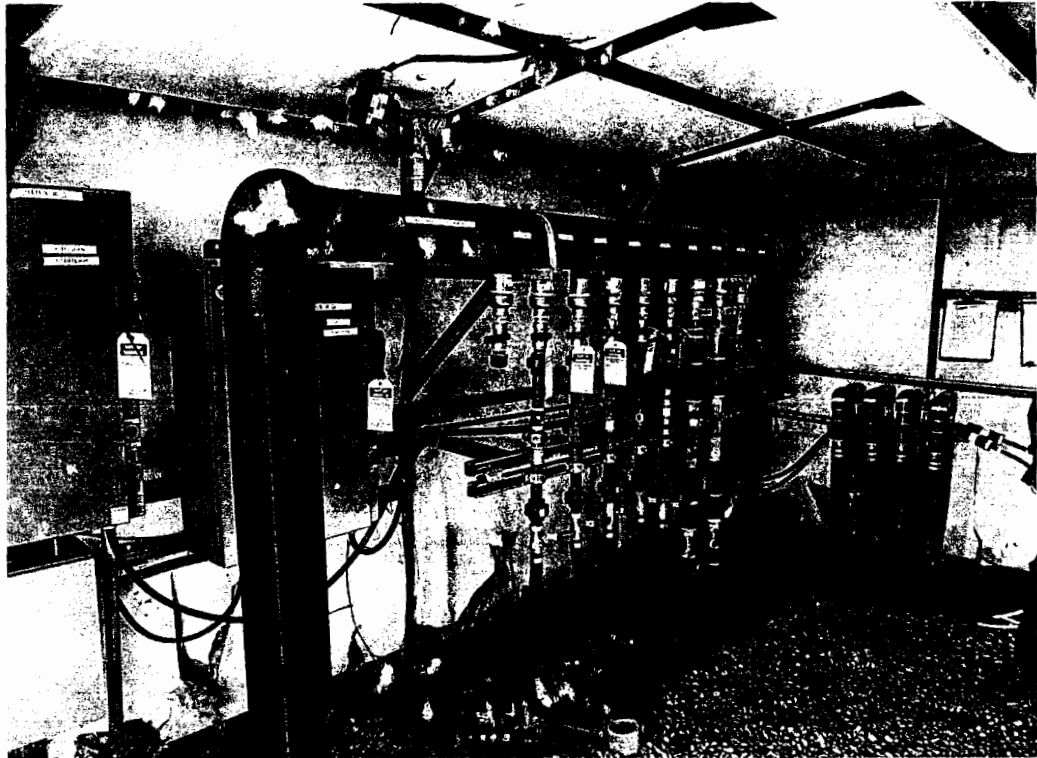
Figure 3 New piping for underground haulageway restoration wells CIMW-1 and CRMW-3

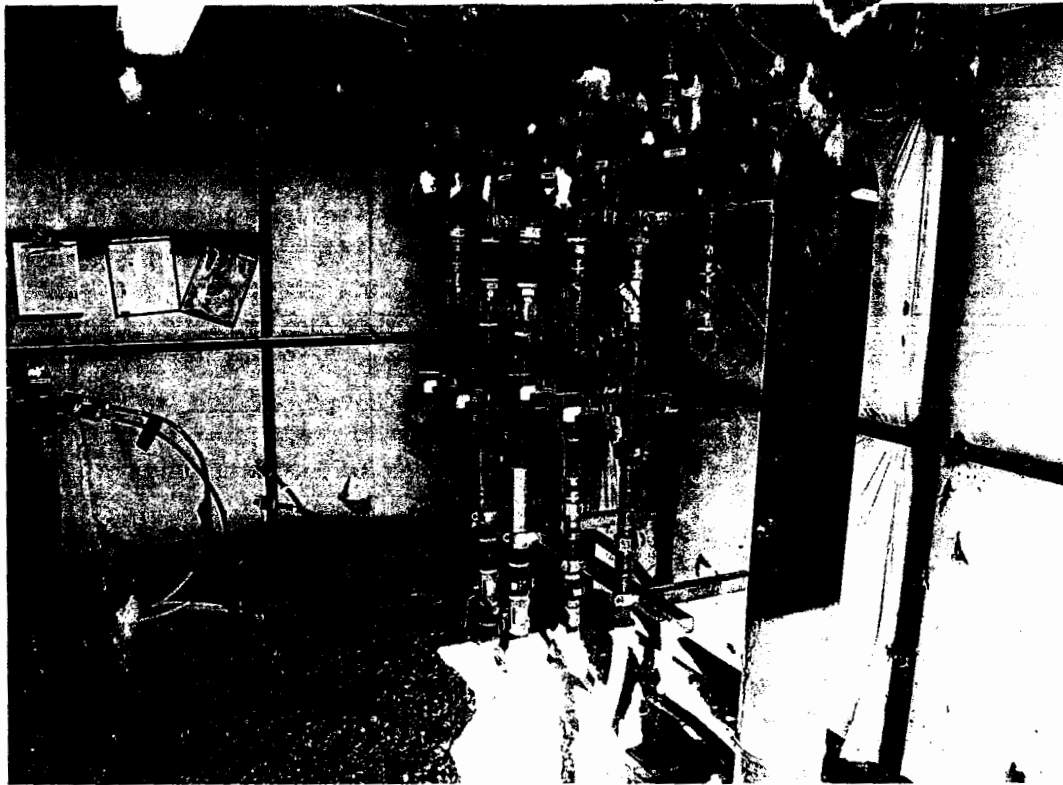
Figure 5 New piping for underground haulageway restoration wells CRMW-2 and CRMW-4

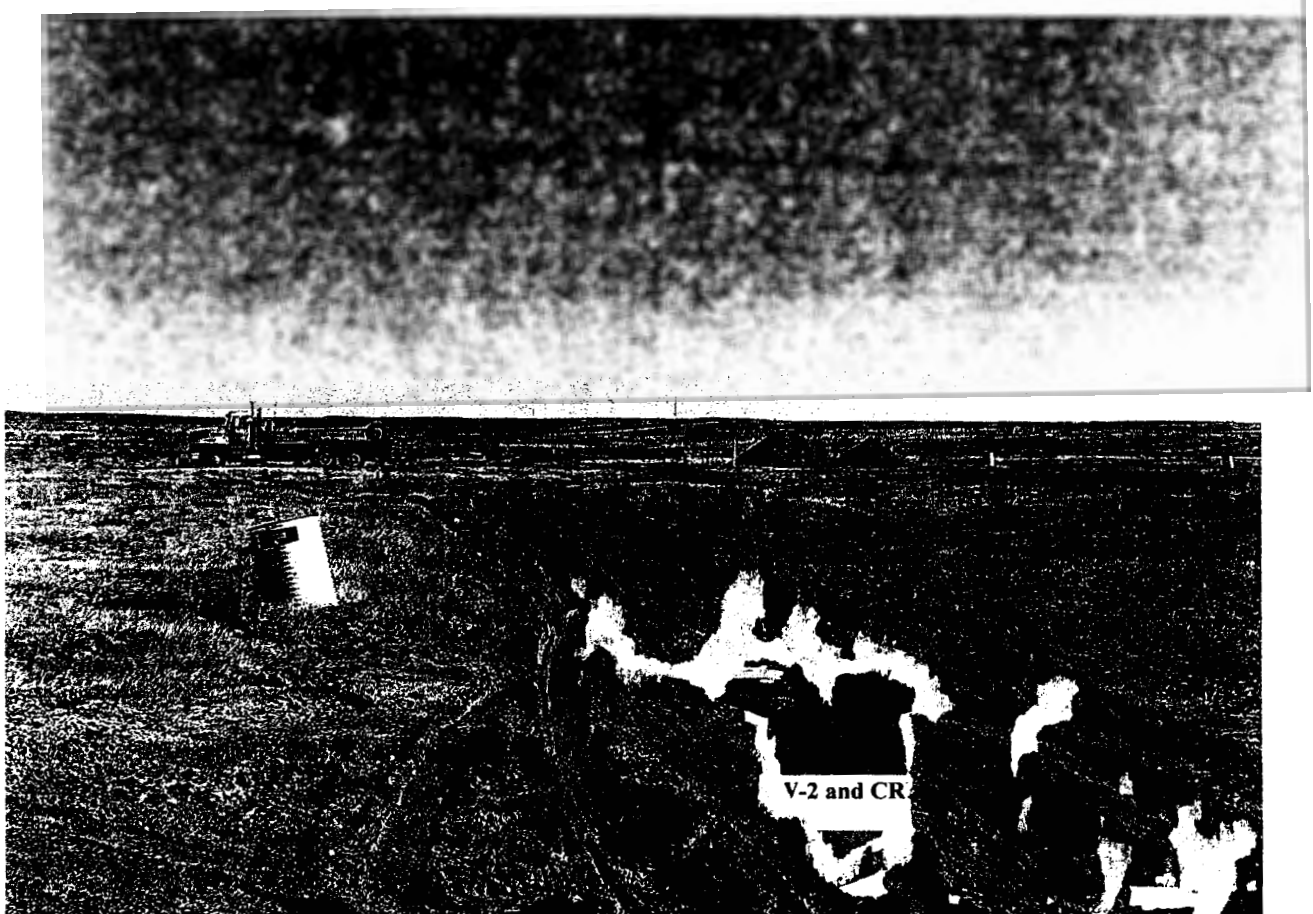
- MU-H
 - Inspected HH 1, Four wells in operation to remove residual uranium
 - HH 4 and HH 14 not operating; remaining HHs are operating
 - Proposal for sixteen replacement wells – Mud pit construction ongoing during inspection – Note surface disturbance impacts due to heavy equipment on wet conditions (**Figure 3**)
 - HH 11, one well pumping
- MU-I
 - Inspected HH 6, twelve wells producing and twelve wells injecting

Figure 6 Road disturbances to topsoil for construction of mud pits in MU-H (replacement wells)

2. The surface disturbance in MU-H due to mud pit construction was noted. Cameco is reminded as stated in the permit, *Areas where topsoil has not been removed, such as temporary non-routine access to individual well drilling sites, is not intended for routine vehicular access. Regular access across such areas is restricted to foot traffic or low bearing pressure vehicles to prevent topsoil compaction.* Please continue to encourage the field operators to use designated pathways as much as possible to access the construction sites. Please ensure the appropriate reclamation work including chisel plowing or ripping of the soil is completed followed by reseeding the soil.
