Inservice Inspection Program Relief Request SWOL-REP-1 U2 for Approval of an
Alternative to the ASME Code, Section XI, for Preemptive Full Structural Weld
Overlays

**Proposed Alternative
In Accordance with 10 CFR 50.55a(a)(3)(ii)**

SWOL-REP-1 U2 Use of Alternate Repair Criteria

**Summary of Root Cause Evaluation Report
U2 Pressurizer Structural Weld Overlays
Missed Fabrication Flaws**

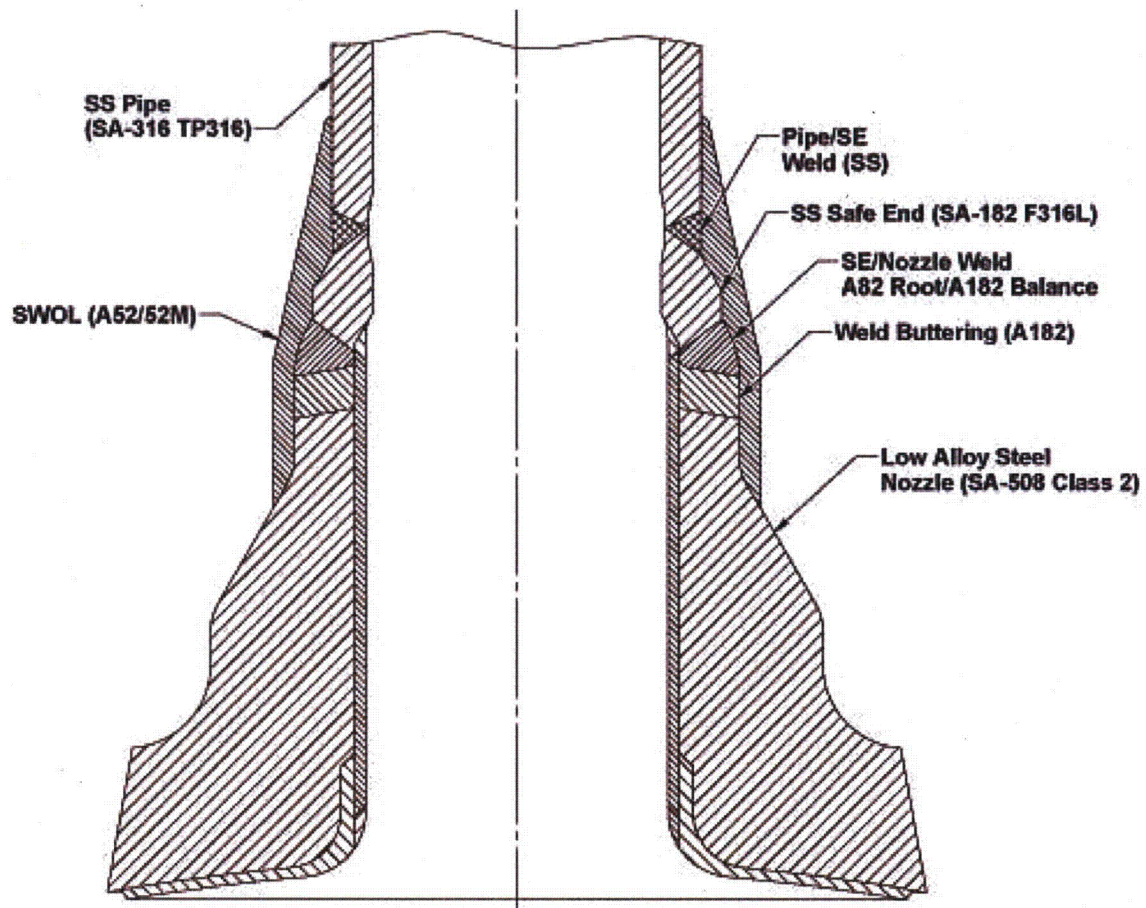
Figure 1 - Typical SWOL Configuration

The materials listed above apply to all pressurizer nozzles. A typical SWOL configuration is depicted in Figure 1.

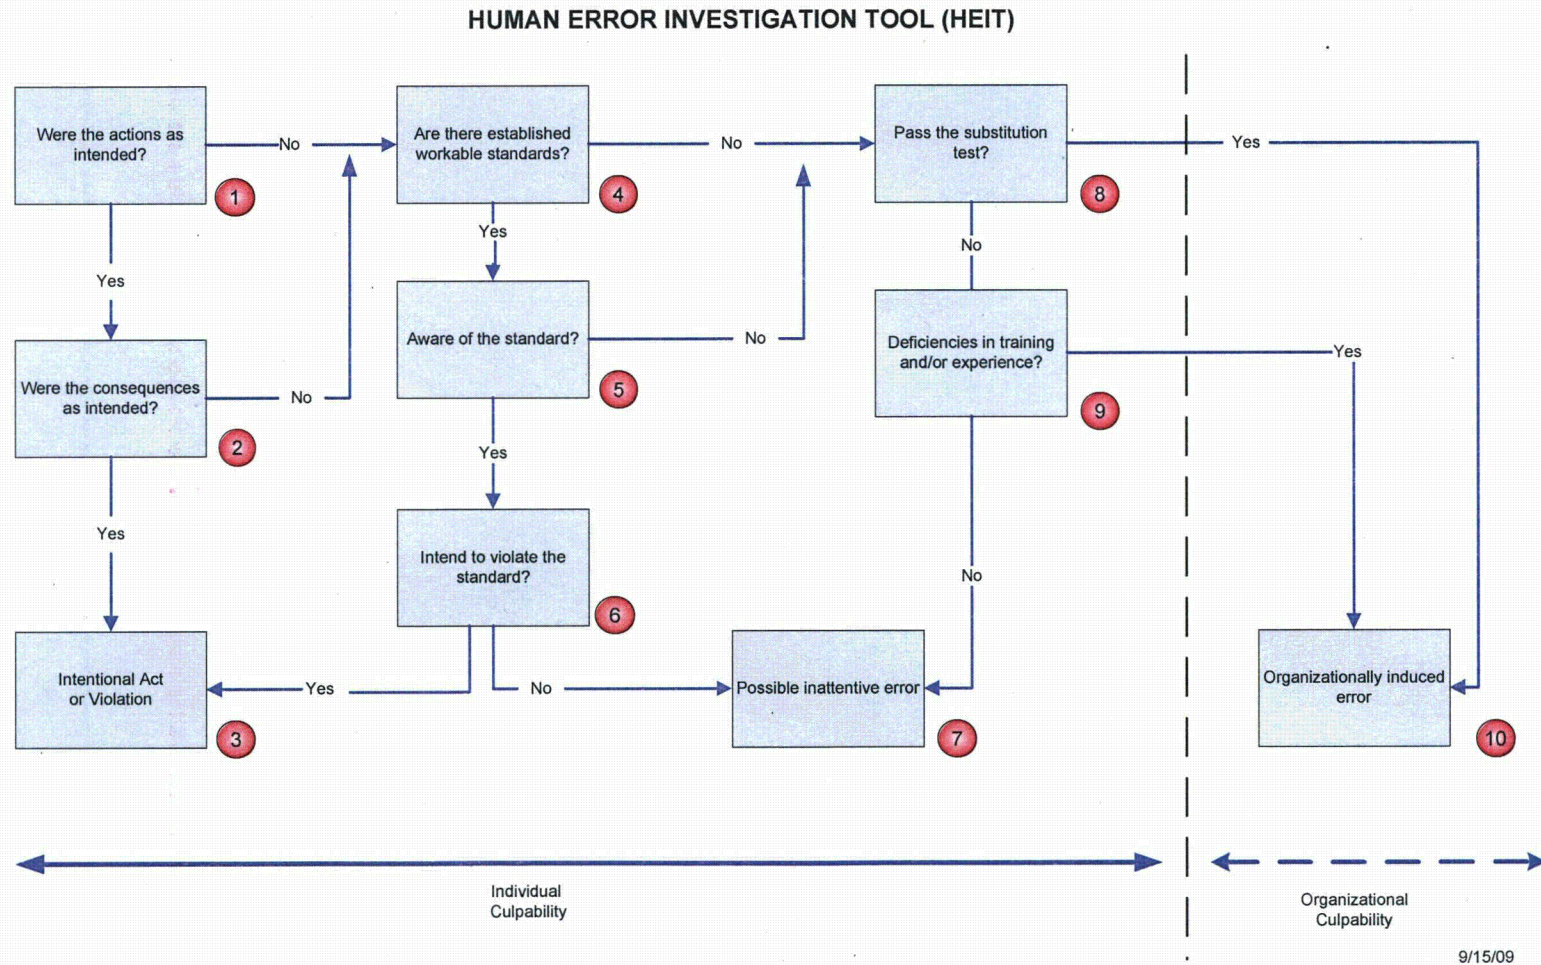
Figure -1 Human Error Investigation Tool (HEIT) Flowchart

The cause for the high scan speed appears to be organizationally induced in that the PDI procedure left reductions in scan speed up to the judgment of the inspector. The procedure provided direction to reduce scan speed for irregular weld-surface conditions, but it leaves the definition of irregular surface conditions up to the judgment of the inspector (note that the interviews indicated that the inspectors did not think the surface condition was irregular). Also, an industry expert cited that scan speed should be reduced when an underlying complex geometry exists; however, this requirement is not described in the PDI procedure.
