## PART 21 - BEARING DEFECT

# **FINAL REPORT 10CFR PART 21 REPORT OF A POTENTIAL SAFETY HAZARD**

**Report No. 47**  
**Page 1 of 3**

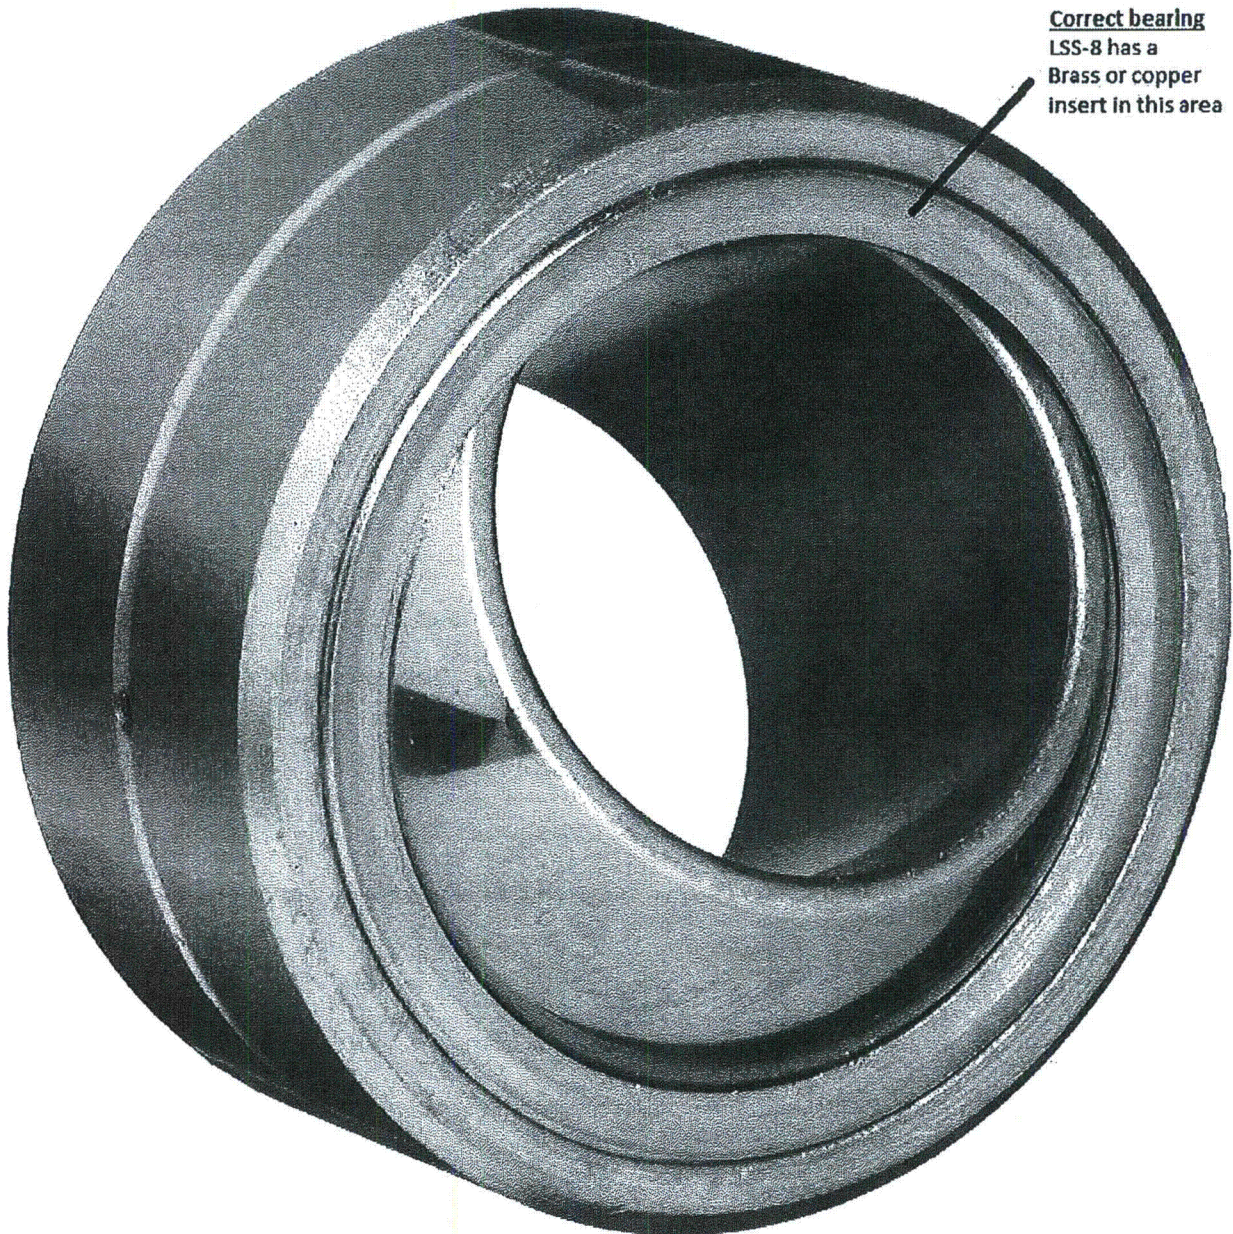
<b>PREPARED BY:</b> <u>Ed Grandusky</u>  <b>TITLE:</b> <u>Manager Gov't Aftermarket Engineering</u>  <b>PART NAME:</b> <u>Heim LSS-8 bearing</u>	<b>File No:</b> <u>Various</u> <b>Serial No:</b> <u>See page 2</u>  <b>Type:</b> <u>GS-2</u> <b>Ref:</b> <u>NA</u> <b>DR Part No:</b> <u>75439A07</u> <b>DR Dwg No:</b> <u>75439A</u> <b>Rev. Level:</b> <u>B</u>				
<b>1. DESCRIPTION OF DEFECT OR NON-COMPLIANCE</b> <p>On Dresser-Rand Drawing 75439A part number 07 is identified as a Heim LSS-8 bearing that has an Aluminum Bronze insert to accommodate a non-lubricated application. Dresser-Rand shipped 10 bearings part number 75439A07 to Dominion Nuclear in 2006 that were Seal Master Com 8 bearings that do not have an Aluminum Bronze insert.</p>					
<b>2. POTENTIAL SAFETY HAZARD OR NON-COMPLIANCE</b> <p>Extended operation without lubrication will result in the Seal Master Com 8 bearing dragging or seizing resulting in poor turbine control and turbine overspeed.</p>					
<b>3. NUMBER AND LOCATION OF ALL COMPONENTS</b> <p>There are 18 turbines tabulated on page 2 that use this bearing, all have PG type mechanical governors.</p>					
<table border="1"> <tr> <td><b>4. CORRECTIVE ACTION BY:</b></td> <td><u>Staff</u></td> <td><b>COMPLETED BY</b></td> <td><u>4/16/14</u></td> </tr> </table> <p>The Part Design record was updated to emphasize copper alloy insert and the Inspection record was changed to require the vendor part number be recorded on the inspection form.</p>		<b>4. CORRECTIVE ACTION BY:</b>	<u>Staff</u>	<b>COMPLETED BY</b>	<u>4/16/14</u>
<b>4. CORRECTIVE ACTION BY:</b>	<u>Staff</u>	<b>COMPLETED BY</b>	<u>4/16/14</u>		
<b>5. ADVICE TO AFFECTED CLIENT RELATED TO THIS REPORT</b> <p>The customer should visually inspect this bearing for the bronze insert. See picture on page 3. If no insert is visible then the bearing should be replaced at the first opportunity.</p>

Correct bearing  
LSS-8 has a  
Brass or copper  
insert in this area

"This bearing is used on turbines that have a PG type mechanical governor with the cam plate linkage. Extended operation without lubrication will result in the Seal Master Com 8 bearing seizing. The customer should visually inspect this bearing for the bronze insert. If no insert is visible then the bearing should be replaced at the first opportunity."
