Wyoming Department of Environmental Quality (WDEQ)- Land Quality Division (LQD)
Inspection Memorandum

File: Lost Creek ISR, LLC – Permit 788

Date of Inspection: February 28, 2014

Subject: Monthly Inspection

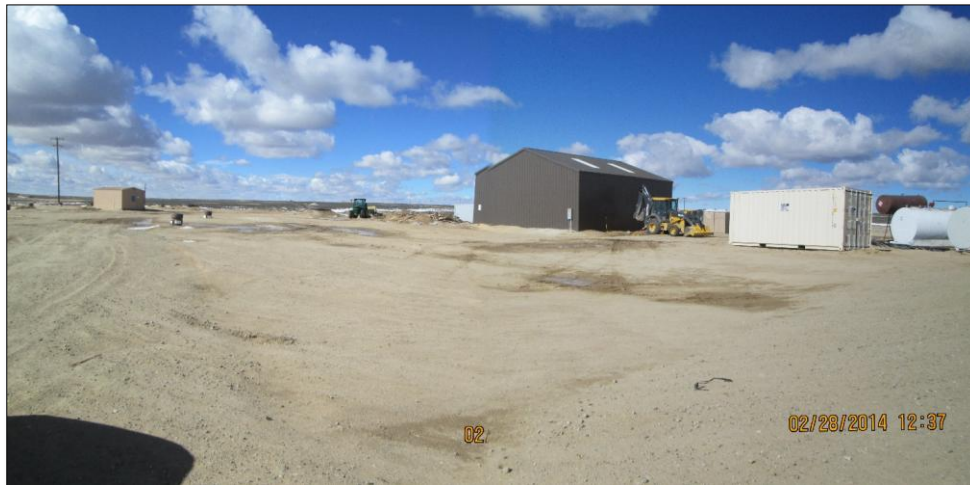
Photo Number 1: This is view of the laydown yard north of MU1 looking generally west by northwest. This panoramic view depicts this area as being cleared of the laydown yard “creep” documented at this location in the previous (Jan 2014) Inspection Report. This clean-up adequately addresses the laydown yard “creep” that occurred here. LCI should consider the installation of a fence to prevent the “creep” from occurring again.

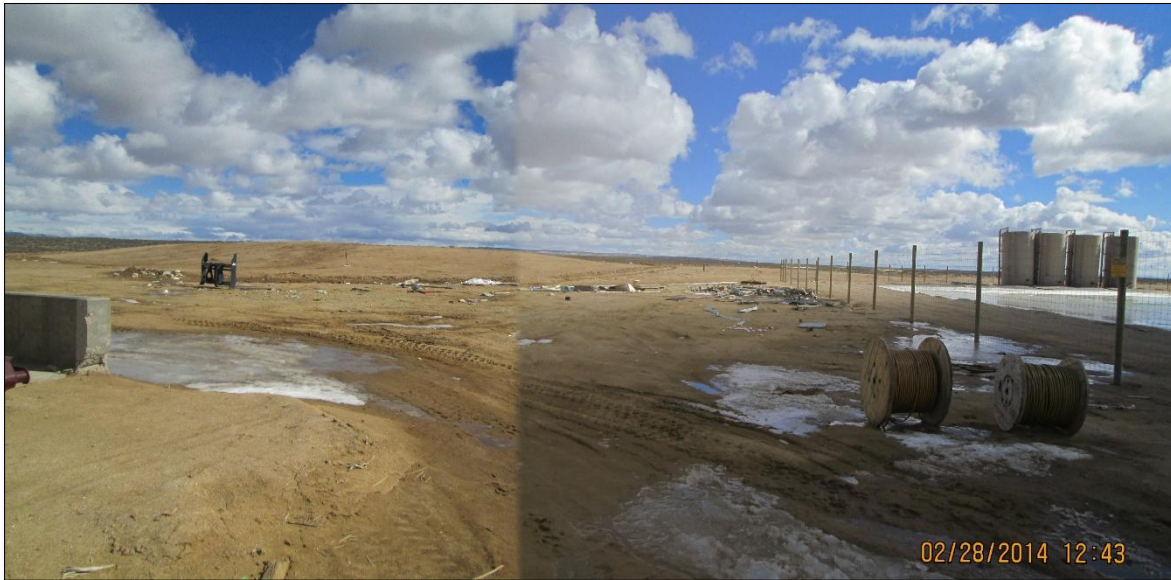
Photo Number 2: This depicts the informal laydown area north of the ponds at the Plant Site looking generally east by northeast. There is still a large amount of small items that must be removed from this area before it can be considered cleaned up. It is imperative that this area be cleared because it is situated atop the Plant Site diversion channel.

- 6) Removal of equipment stored in Plant Site diversion channel
The large pieces of equipment stored in this area had been removed as of the January 2014 Inspection (see report dated January 23, 2014); however, the smaller items were noted at that time as being frozen into the ground. Because of that, it was acknowledged that the smaller items would not be picked up until the ground conditions allowed it. During this Inspection, the ground was slushy at the surface (not frozen). **All of the smaller items in the informal laydown area north of the ponds must be picked up by the March 26, 2014 Inspection.** The installation of delineation posts around that area (to prevent its use as a laydown area in the future) may be deferred until warmer months.

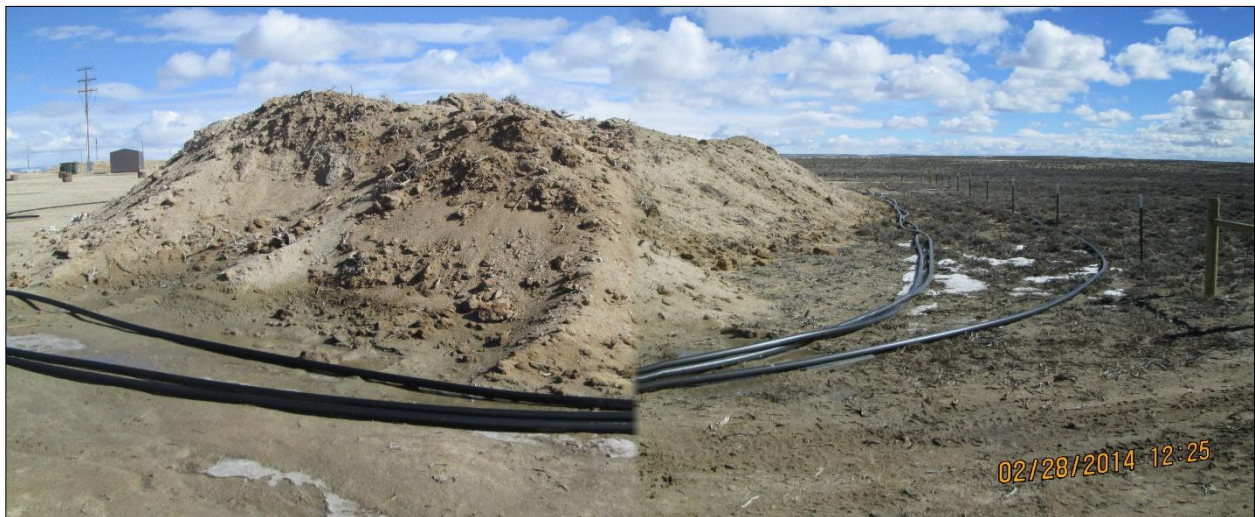
The short-term **topsoil stockpile at the southern edge of HH 1-4 needs to be protected with a v-ditch or berm** (see Photo Number 3 in the attached Photo Addendum).

Photo Number 3: This is a view of the western edge of the temporary topsoil stockpile at the south edge of HH 1-4. Even though this is a temporary stockpile, it needs to be protected from erosion with a berm, at least on the down gradient side. The down gradient side is the south side of the stockpile which is the right side in this photo.

- 1) Trash around the site needs to be picked up in the wake of the late-February early-March storm front that moved through the area **(deadline March 26, 2014),**
- 2) The temporary topsoil stockpile at the south edge of HH 1-4 needs a berm or v-ditch constructed around its base **(deadline April 30, 2014),**

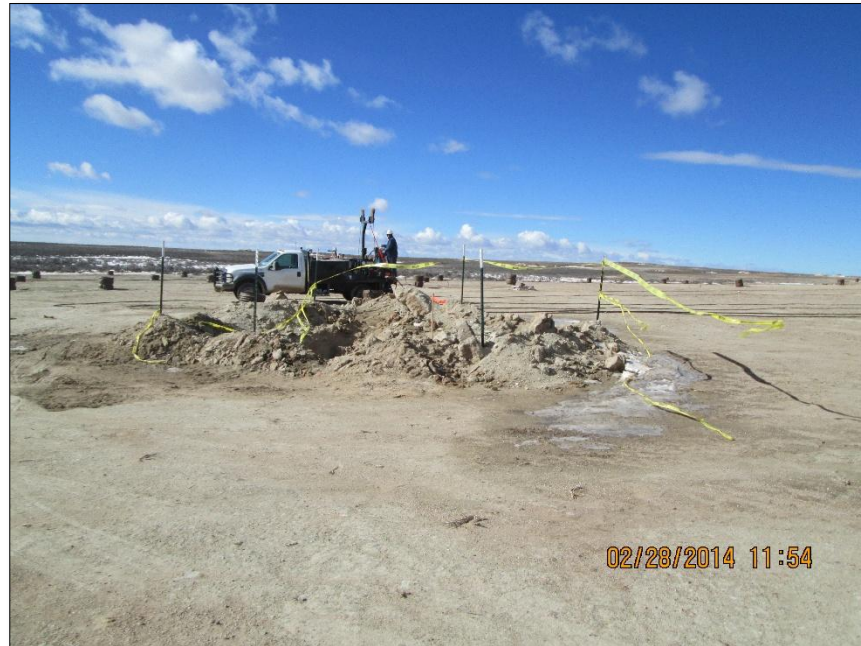
Photo Number 4: This depicts the excavation at LC-254 in MU1 Header House 4. The MIT truck can be seen in the background in this photo. It is situated upon HH 1-4 injection well 1I212, which is one of the eight injection wells within a 100 foot radius of LC-254.

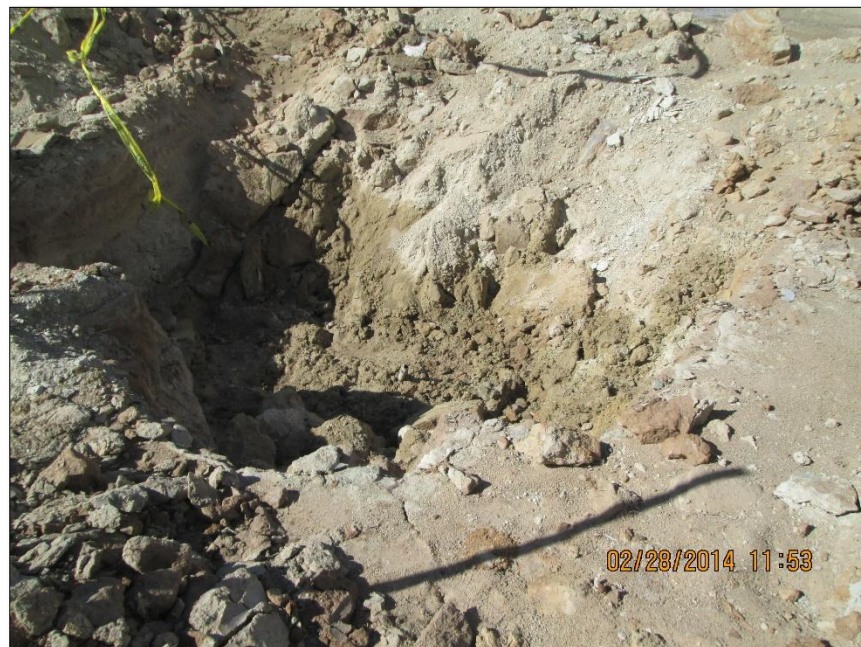
The crux of today's Inspection was to investigate the presence of mining fluids at the ground surface at LC-254. On the morning of February 24, 2014 a LCI well field worker discovered considerable "moisture" in the ground around an older (circa 2008) delineation drill hole in MU1. The delineation hole was LC-254. LC-254 is located in Header House 4, about 20 feet south of the Lost Creek Fault which trends generally east-west. At the time of the discovery of the "moisture" (or water) around LC-254, Header House 4 in MU1 (HH 4-1) had been operational for about two weeks.

Photo Number 5: This is a view inside the excavation at LC-254. LCI staff indicated that a large chunk of ice was removed from this excavation and place in one of the ponds at the Plant Site.

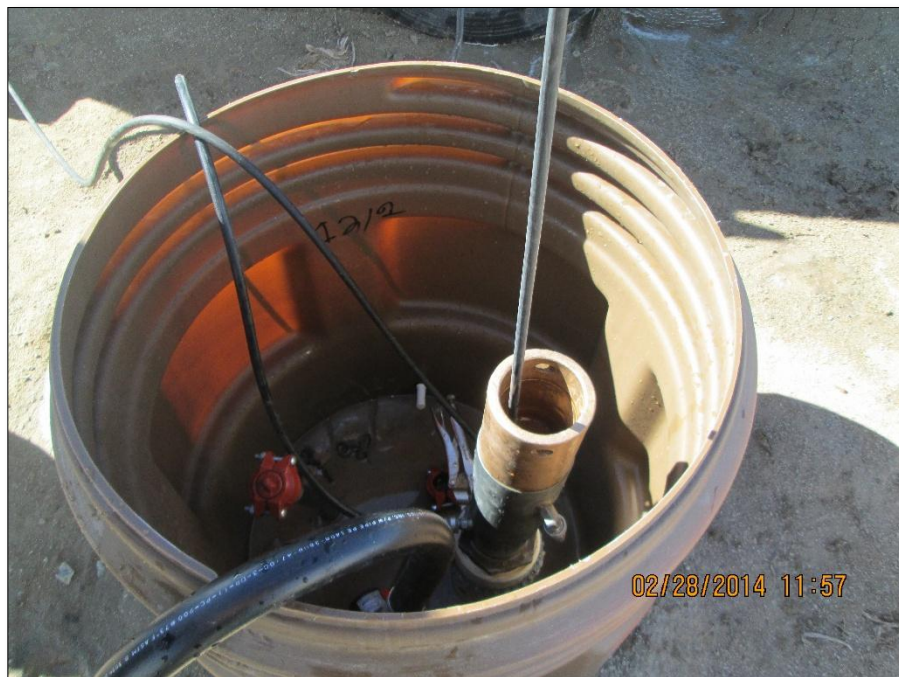
Photo Number 6: This depicts the well head at 11212 (which is depicted from afar with an MIT truck in Photo Number 3 above).

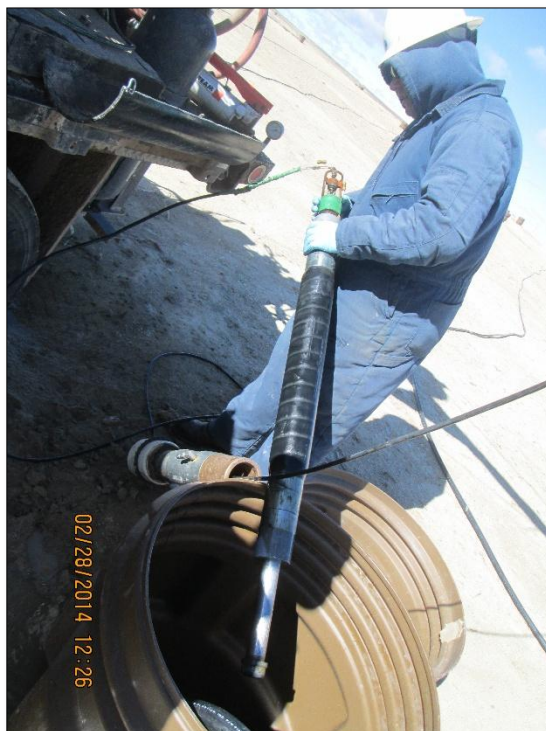
Photo Number 7: This depicts the down-casing packer assembly used during MIT in injection well 11212.
