SUBJECT: PALISADES NUCLEAR PLANT INTEGRATED INSPECTION REPORT  
05000255/2014002

Inspection Report (IR) 05000255/2014002, 01/01/2014 – 03/31/2014; Palisades Nuclear Plant; Equipment Alignment; Inservice Inspection Activities; Refueling and Other Outage Activities; Radiological Hazard Assessment and Exposure Controls.

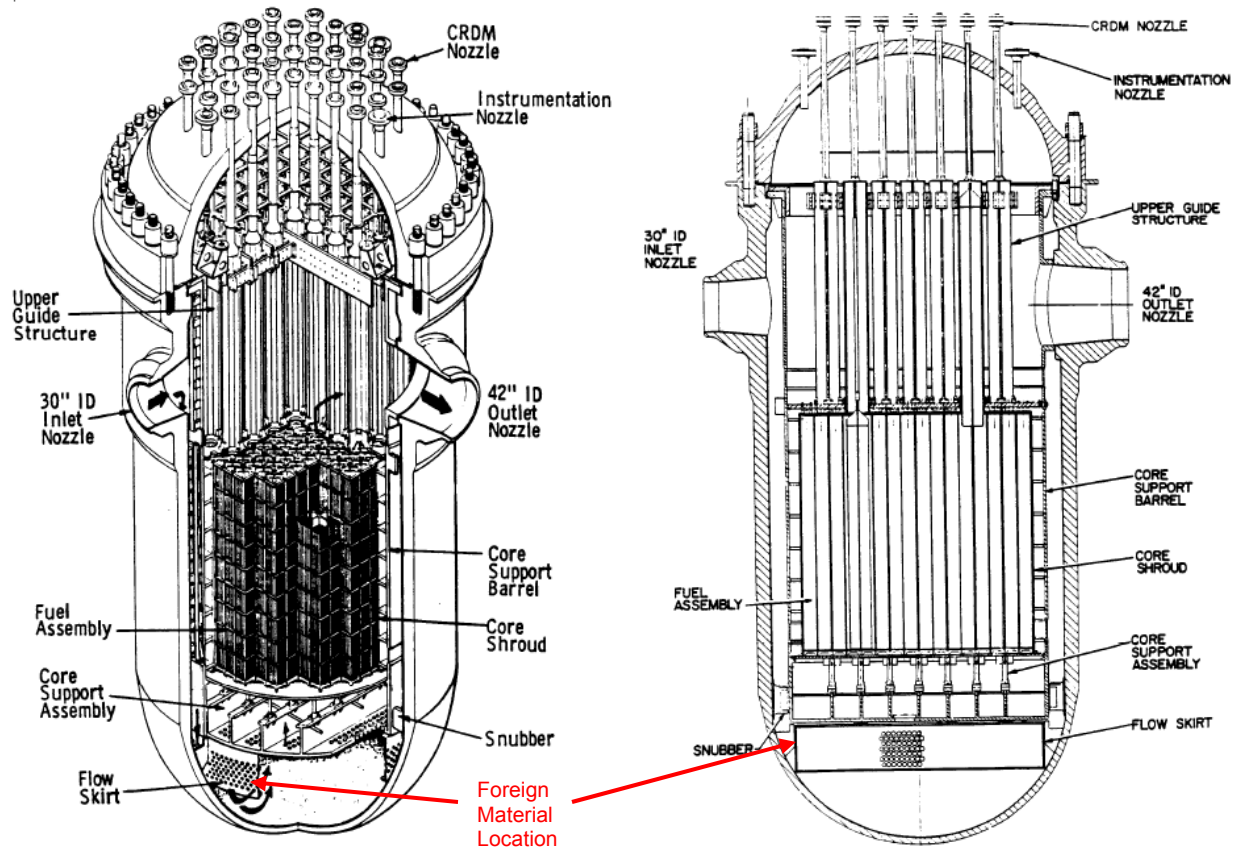
The reactor vessel is shown in the figures below. Four PCPs circulate water through the PCS. After the water has passed through the steam generators and transferred heat to the secondary system, the water is pumped by the PCPs through the PCS cold legs and into the reactor vessel. In the included figures that depict the Palisades PCS, one cold leg (inlet nozzle) and one hot leg (outlet nozzle) are shown for the purpose of simplicity. In actuality, there are four cold legs and two hot legs. Water enters the reactor vessel via the cold legs and flows down between the reactor vessel wall and the core support barrel. Near the bottom of the vessel is a flow skirt that contains many small holes that most of the water flows through. Some water also passes below the flow skirt into the bottom of the vessel. After flowing through or under the flow skirt, the water then flows up into the active fuel region to remove heat from the nuclear fuel. After flowing through the fuel region, the water exits the vessel through the hot legs and into the steam generators.

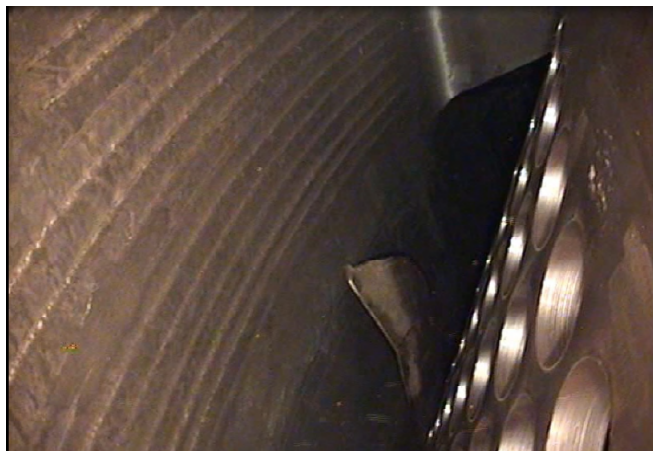
The 2014 refueling outage included the removal of the core barrel to support more comprehensive reactor vessel inspections than can typically be conducted. This activity was pre-planned for reasons not related to the pump impeller concern, but coincidentally allowed for a more thorough inspection for foreign material in the reactor vessel. The licensee anticipated finding the suspected broken piece from the PCP-C vibration event in October 2011 in the vessel. The reactor vessel FOSAR activities identified two pieces of broken impeller; one piece was removed from the vessel and the other piece was lodged between the reactor vessel and the bottom corner of the flow skirt. The licensee attempted to remove the lodged piece using several methodologies, including pulling using vice grips and pushing using hydraulic tools. Despite the application of approximately 3,000 pounds per square inch (psi) of force, the piece did not move.

View of the impeller piece looking down from above the flow skirt

Since the licensee could not remove the impeller piece from the vessel, Operability Evaluation CR-PLP-2014-01510 was developed to evaluate the operability of the reactor vessel. The piece was tapered in thickness from  $\frac{3}{16}$  inches to roughly one inch wide,

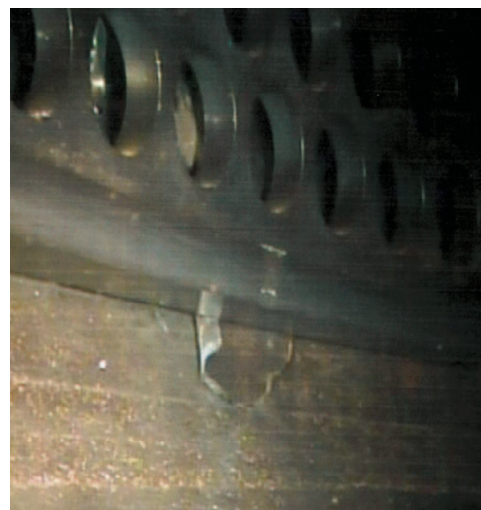
View of the impeller piece looking up from below the flow skirt.
