CENSEE EVENT REPORT

SERIAL: RSEP/79-1133

SUPPLEMENTAL INFORMATION  
FOR  
LICENSEE EVENT REPORT 79-26 REV. 1

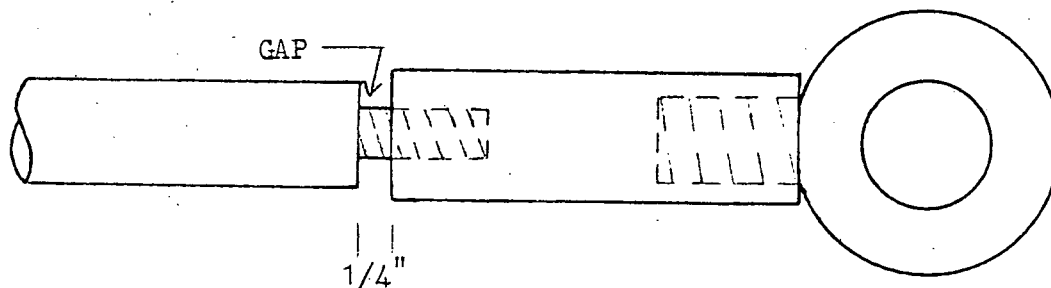
POSITION PRIOR TO FAILURE

Following the failure, it was noticed that the snubber's front mounting piece had not been threaded fully onto the front end of the shaft (see attached drawing). This resulted in the threaded end being subjected to loads much higher than normal. Angular loads are generated at the time of compression lockup due to the inherent flexibility of the 5/8 inch diameter, 6 inch stroke shaft. If the front mounting bracket had been seated against the shaft step, the threaded end would not have been exposed to these loads. Thus, the rigidity and strength of the shaft as a whole would have been enhanced to the extent that the failure probably would not have occurred.

Since the threaded end is exposed, it must act as a load supporting part of the shaft. Due to its smaller diameter it is much more vulnerable to failure than the shaft when exposed to angular loading.

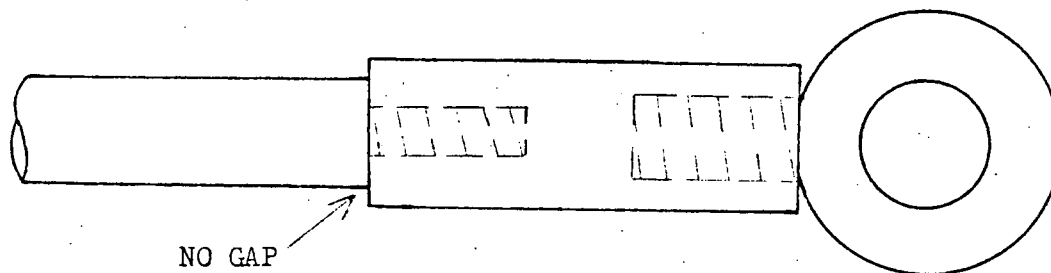
CORRECT POSITION

The threaded end is no longer exposed since the front mounting bracket is seated against the shaft step. Therefore the joint between the front mounting bracket and the shaft is more rigid and able to withstand the angular loads experienced by the snubber during the functional test.

Precautionary instructions will be added to both the functional test procedure and the reinstallation instructions to ensure that the front mounting bracket is seated against the shaft step. This action should eliminate further occurrences during either testing or while the snubber is in service.
