Subject of this Document: Failure Analysis of a Bolt from "B" Reactor
Coolant Pump at the H. B. Robinson Unit 2
Nuclear Power Station

Author(s): C. Czajkowski

**Failure Analysis of a Bolt from "B" Reactor Coolant Pump
at the H. B. Robinson Unit 2 Nuclear Power Station**

July 1982

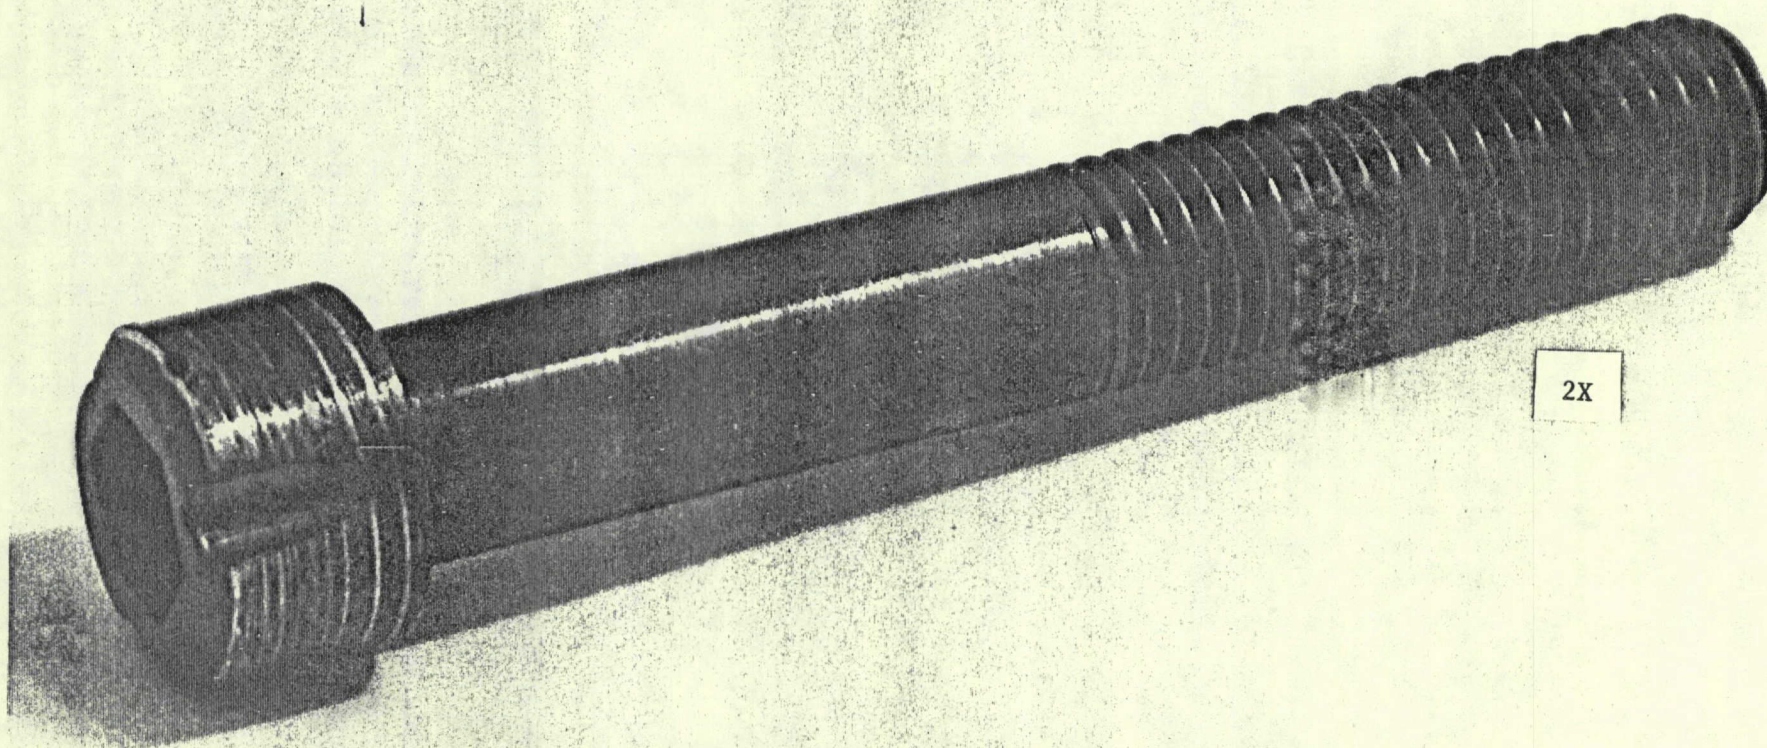
The bolt received at BNL was 0.625 inch diameter and 4 inches long (Figure 1), it was non-magnetic and was surveyed by BNL Health Physics to have a 300 mR/hr- γ and a 3R/hr- β count indicating the presence of Co-60 isotope. The bolt had a hex head configuration which had three machined slots used for staking the bolt in place after torquing. Visual examination of the bolt did not reveal any cracks so a dye penetrant examination was performed using Spotcheck Brand (all Formula B) Penetrant Type SKL-HF/SKL-S, Developer Type SKD-NF and Cleaner/Remover Type SKC-NF. Figures 2-5 represent the results of the dye penetrant examination. The pictures were taken approximately 90° apart in relation to the bolt's outside surface. It can be clearly seen on the photographs that the indications encompass approximately three threads and are approximately 1/2 inch from the bolt's end.

Figure 1. Macro photograph of "as received" bolt from "B" Reactor Coolant Pump from the H. B. Robinson Unit 2 nuclear power plant.

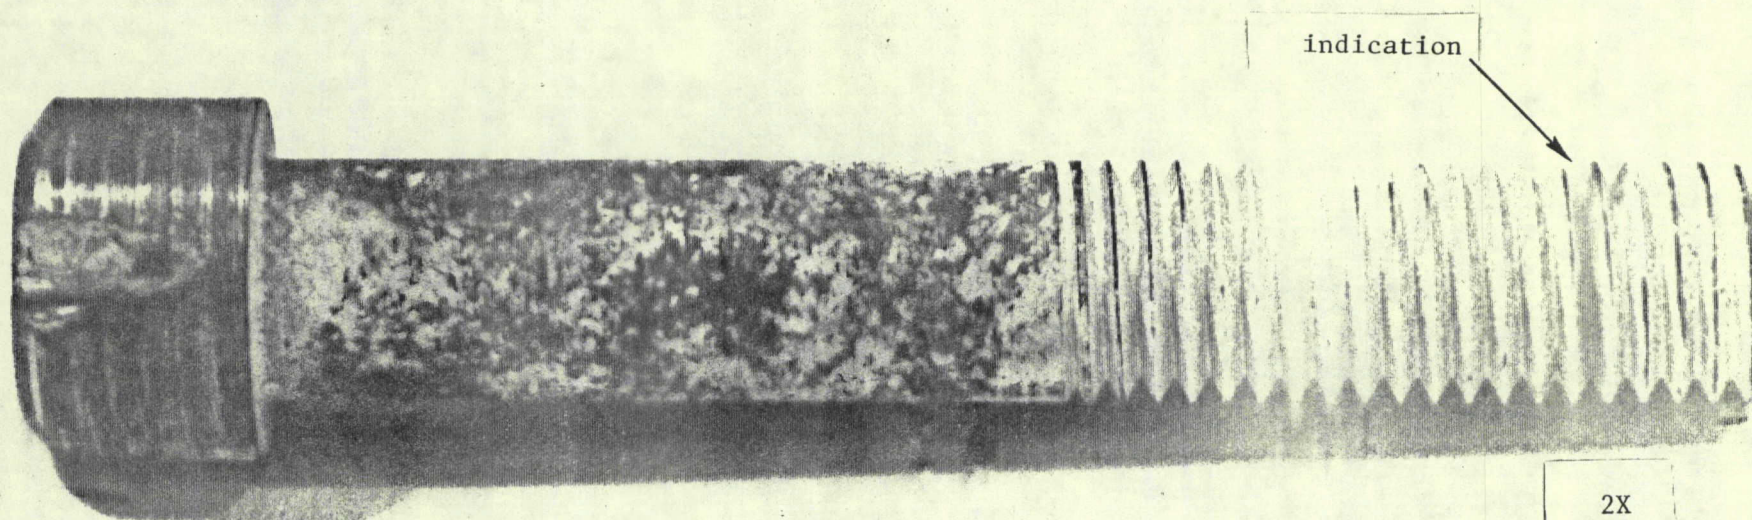
Figure 2. Optical photograph of bolt after dye penetrant examination.

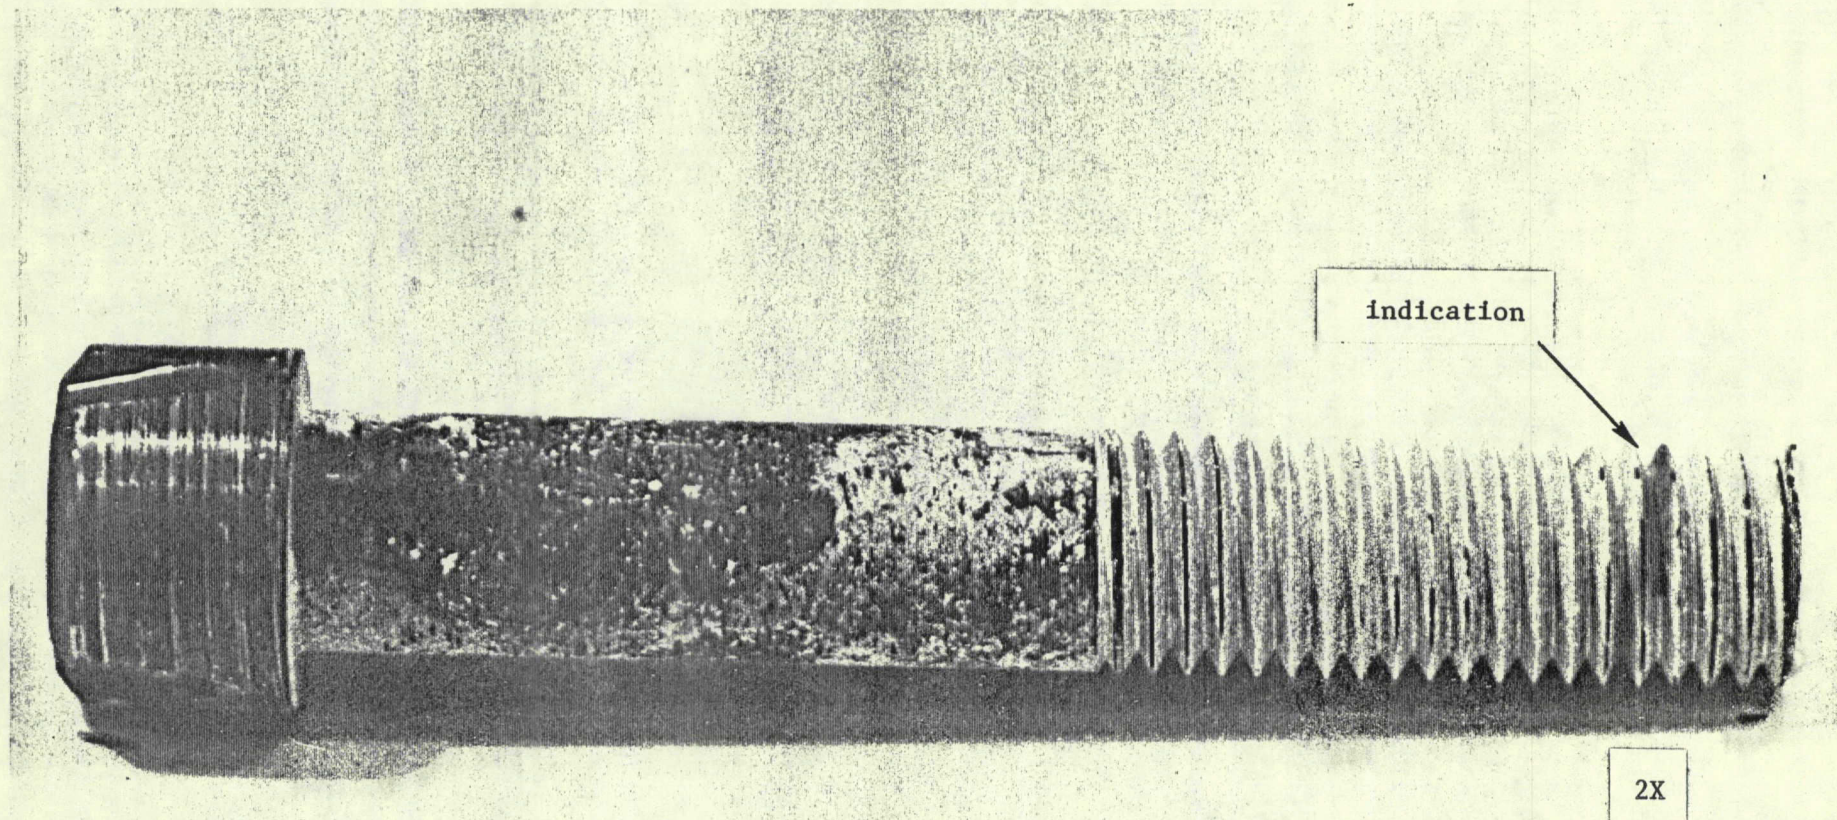
Figure 3. Optical photograph of bolt after dye penetrant examination.
($\sim 90^\circ$ counterclockwise rotation from figure 2.)

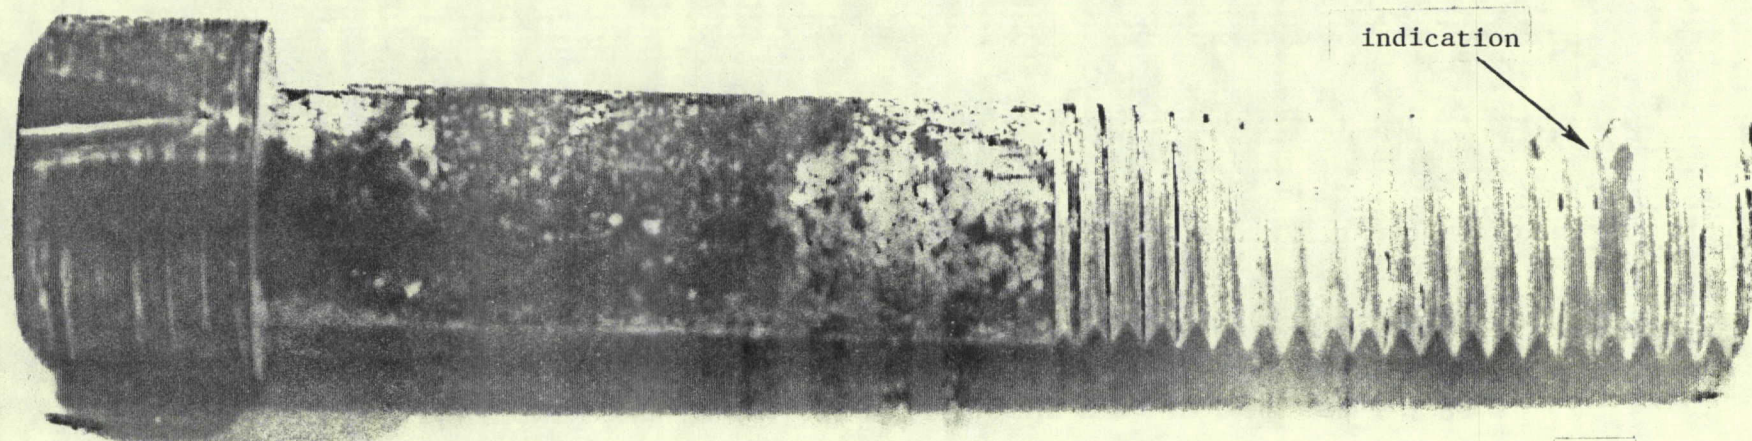
indication

Figure 4. Optical photograph of bolt after dye penetrant examination.
(~90° counterclockwise rotation from figure 3.)

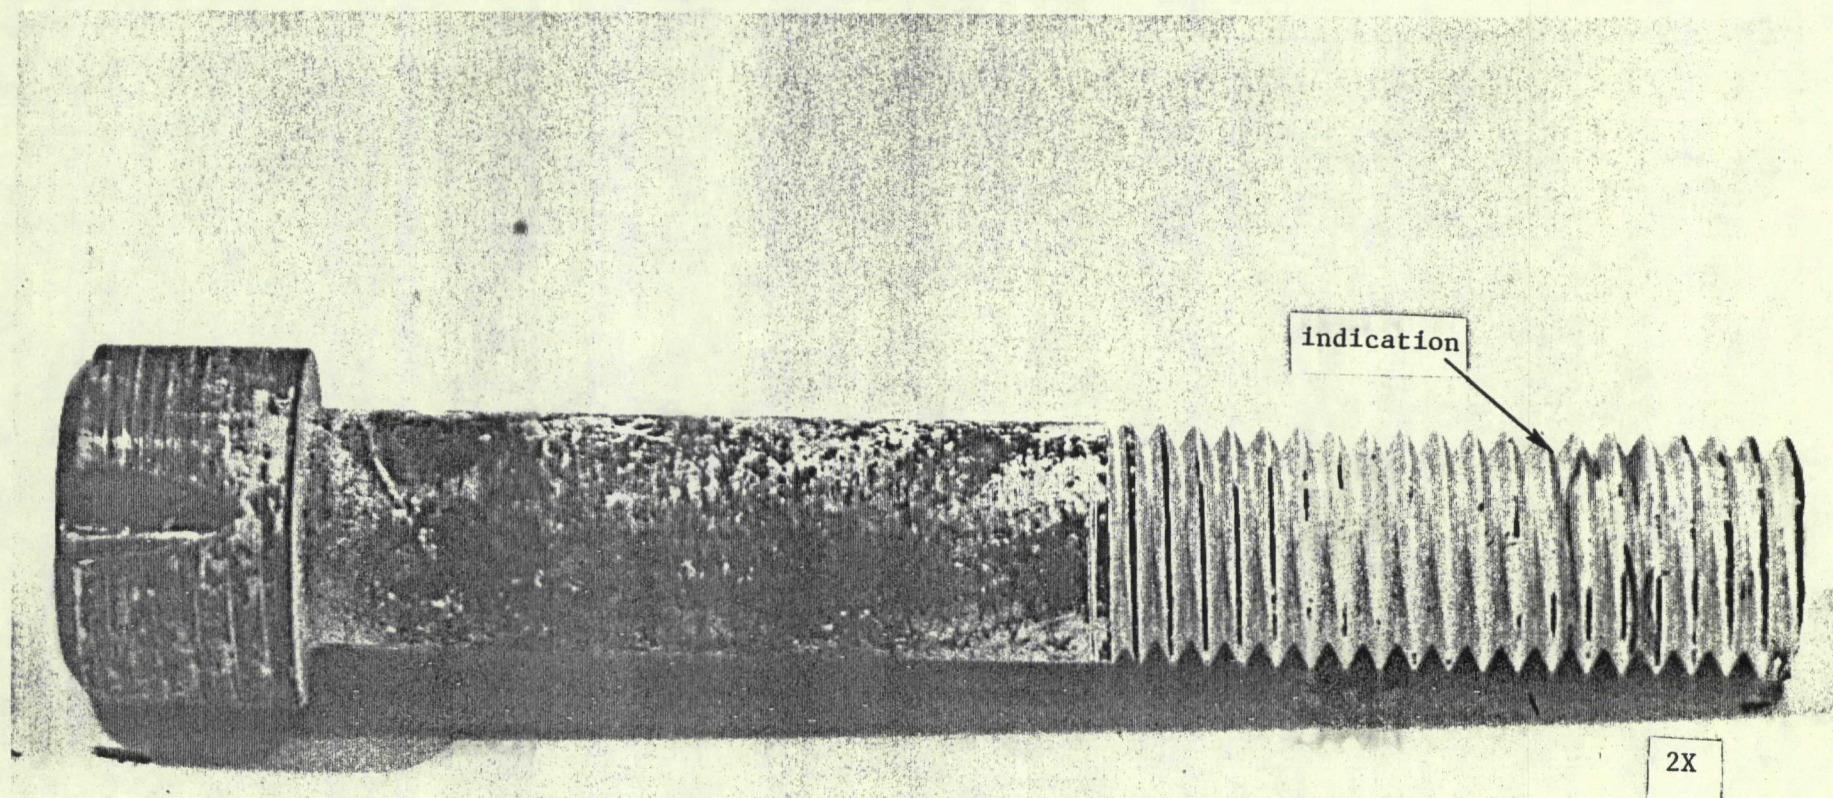
Figure 5. Optical photograph of bolt after dye penetrant examination.
(~90° counterclockwise rotation from figure 4.)

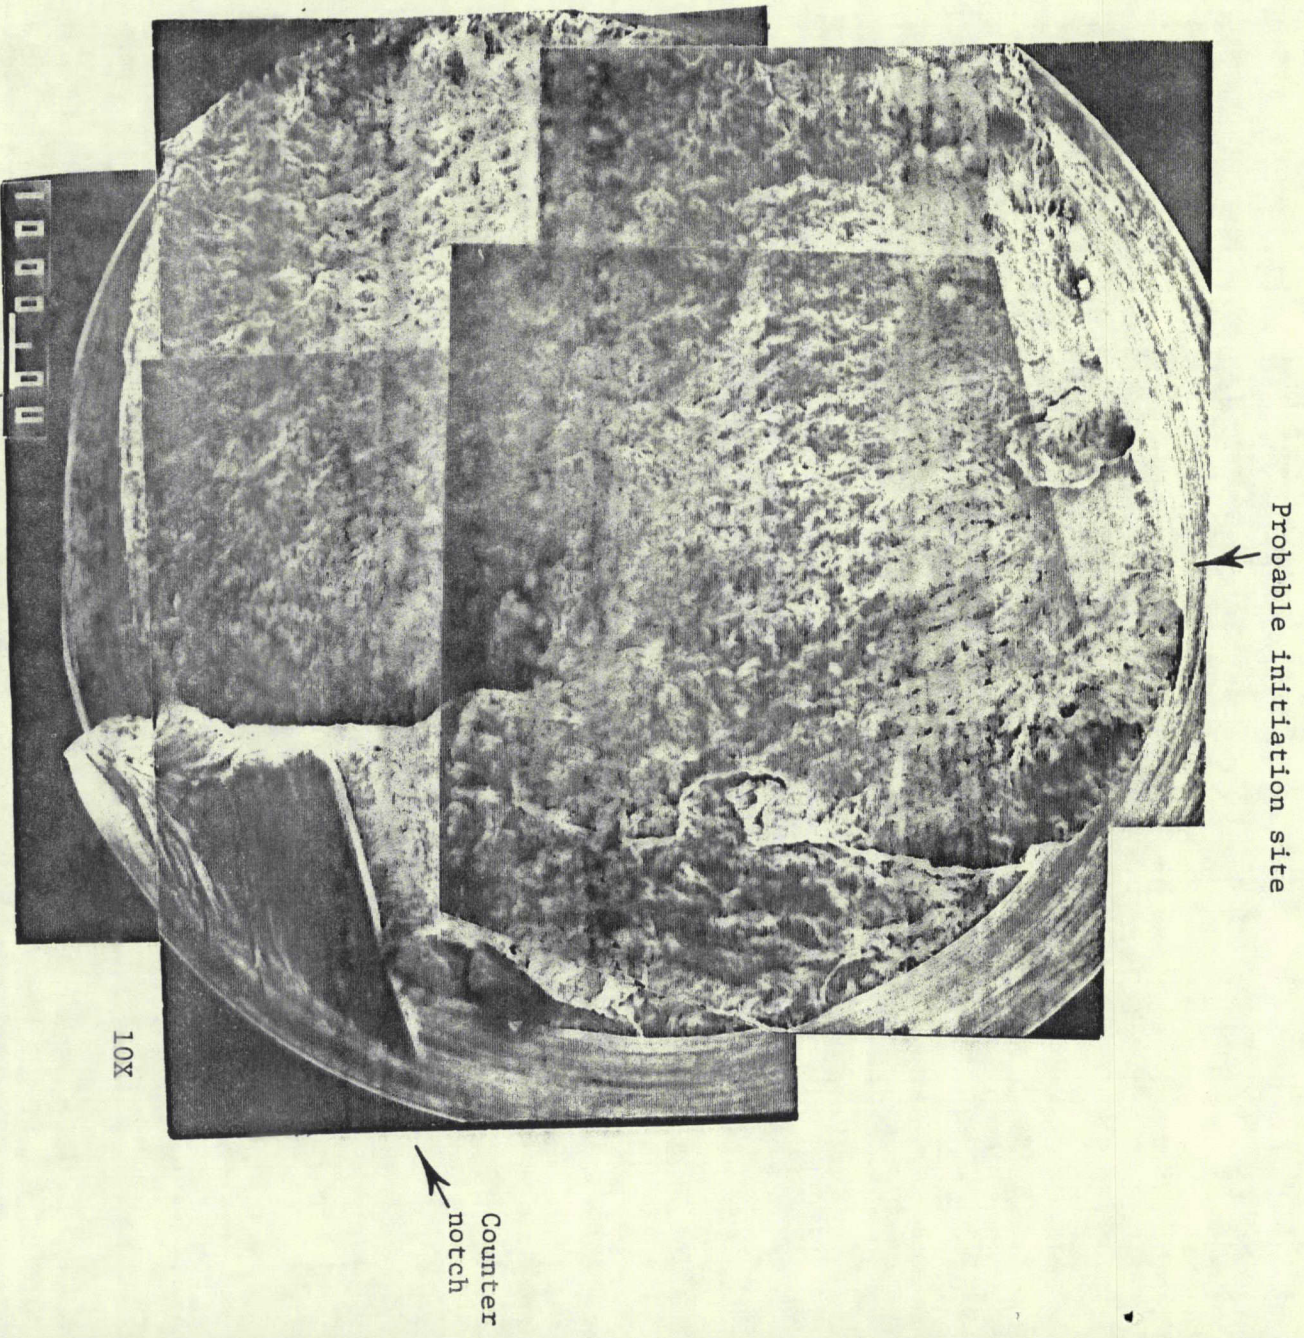
The crack was opened for evaluation by cutting a small counter notch in a thread and then by applying a bending moment. The fracture face (Figures 6 and 7) was essentially transgranular with a somewhat stepped appearance. There was no definitive evidence of fatigue striations or river markings.

Figure 6. SEM photograph of the fracture surface of the bolt after opening up of the crack

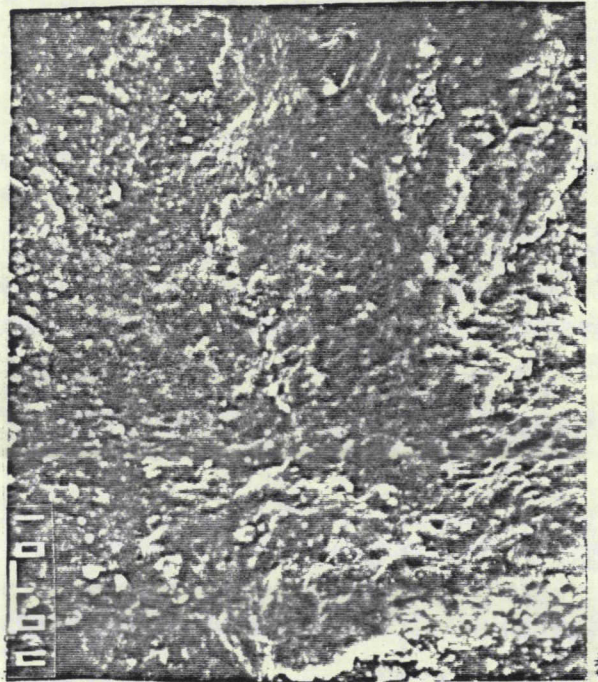
Figure 7. Higher magnification SEM photograph of typical area on specimen's fracture surface

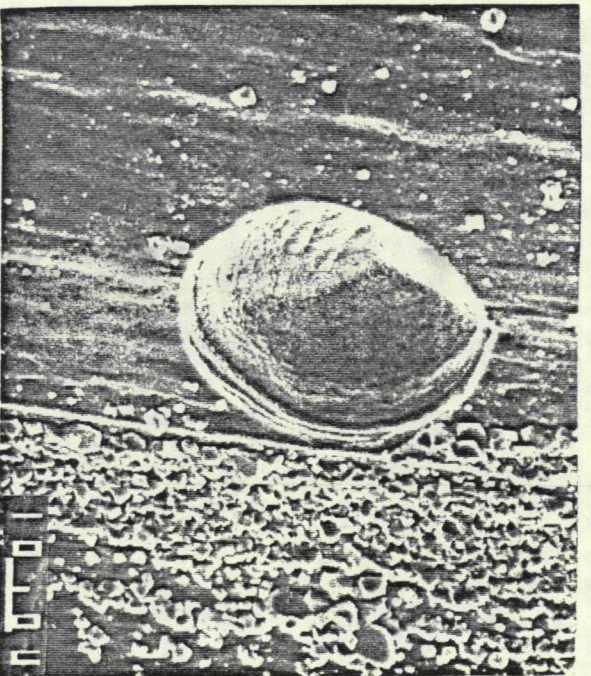
During the examination of the fracture face various indications of pitting were observed on the machined portion of the threads (Figures 8 and 9). Additionally one pit was noted to be at the root of the notch in the approximate plane of the fracture face (Figure 10). Another area (Figure 11) appeared to be a possible site for pit initiation.

Figure 8. Pit found on machined thread portion of bolt

Machined
portion
of thread
→

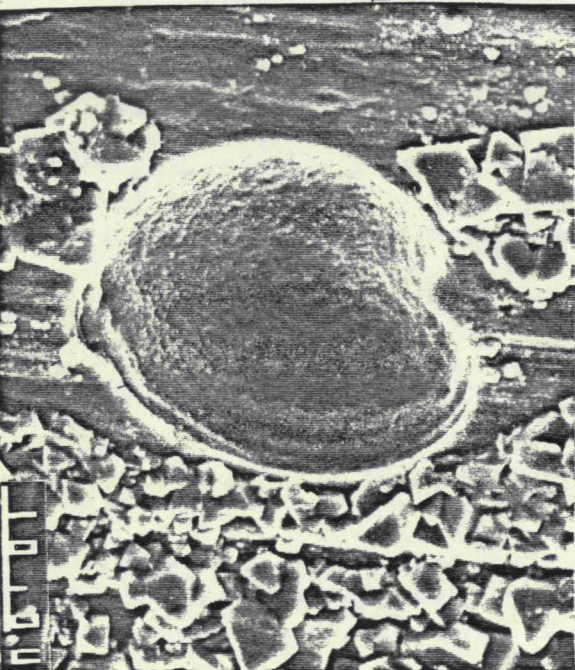
Figure 9. Another pit found on machined portion of bolt

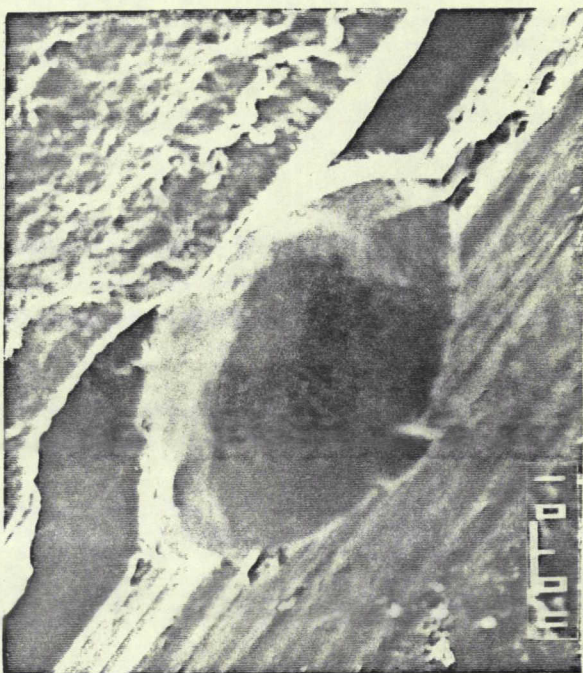
Figure 10. SEM photograph of pit found in the root of the thread adjacent to the fracture surface

Root of thread
Fracture surface
1000X

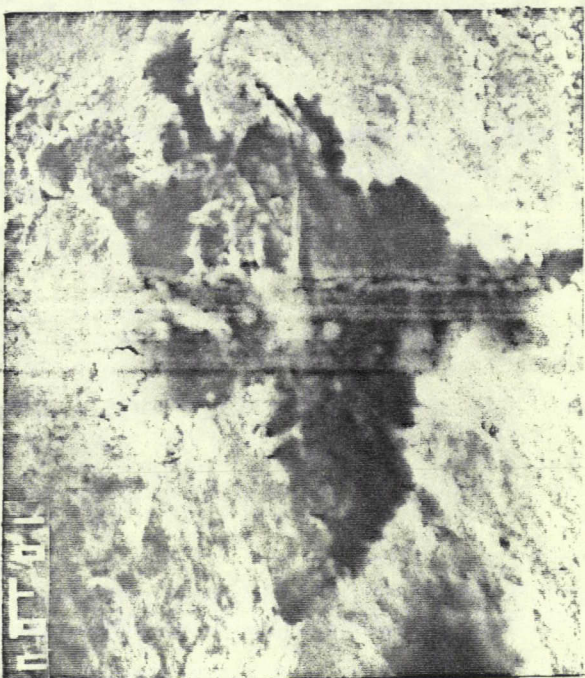
Figure 11. Probable pit initiation site found on machined area of thread

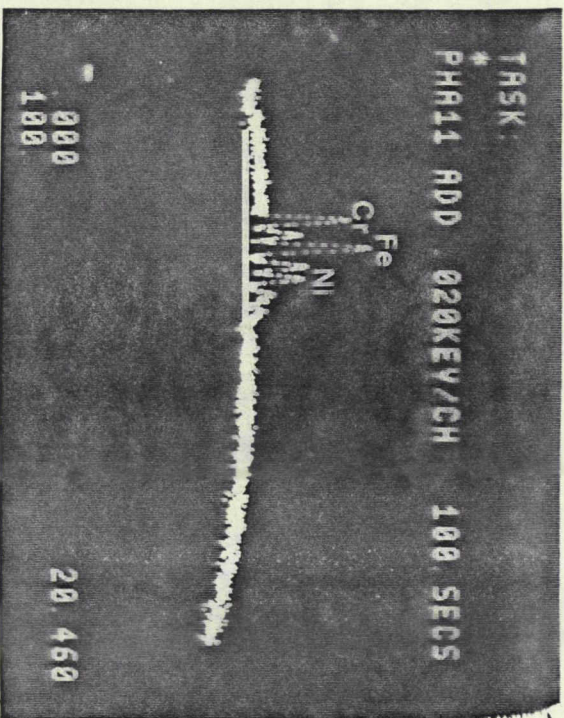
EDS examination of the base metal for constituents was accomplished (Figure 12) and revealed the alloy to be similar to type 304 stainless steel. Additionally, EDS examination of the darker area near the bolt tip displayed a

Figure 12. EDS scan of base material for constituents (Cr/Fe .84) (Accelerating Voltage 35 Kv)

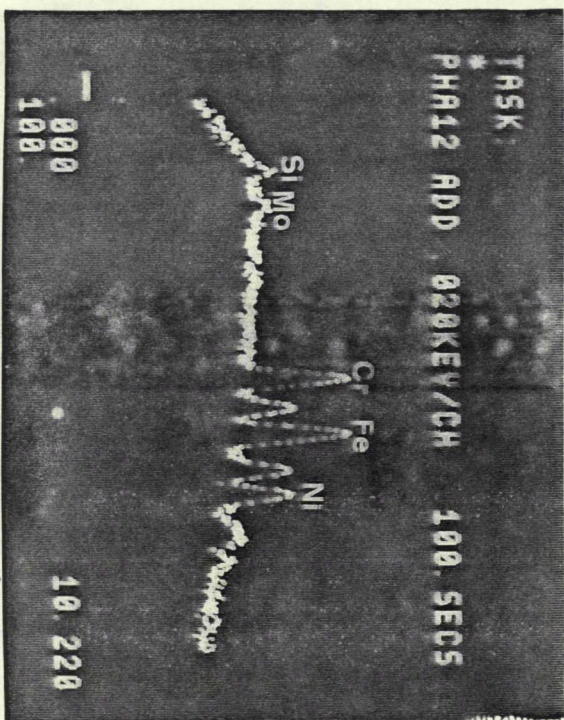
Molybdenum peak (Figure 13). This scan was repeated at a higher accelerating voltage (Figure 12) and the Molybdenum peak disappeared. This is indicative that the Mo was a surface phenomenon only and was possibly related to the use of a Molybdenum-type lubricant on the bolt's threads.

Figure 13. EDS scan of dark area near bolt tip (Accel. Voltage 17 Kv)

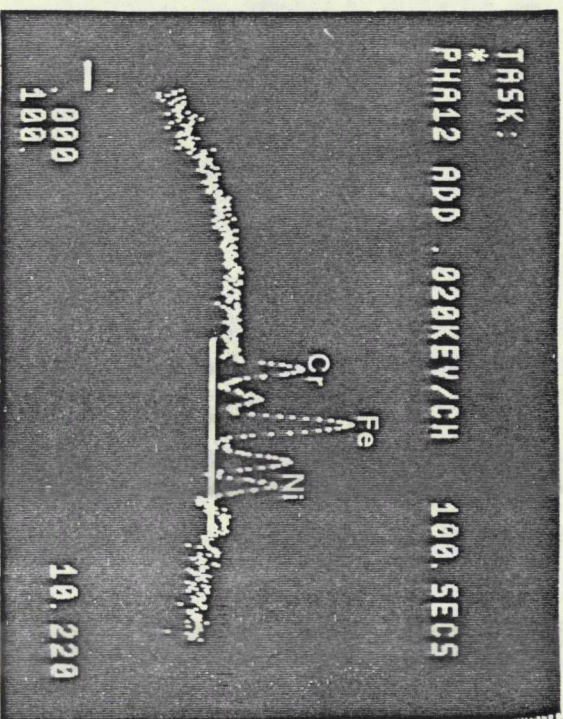
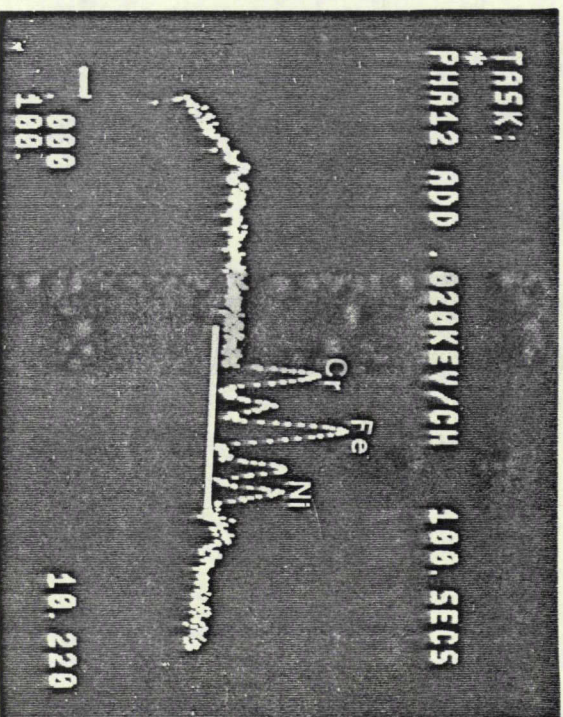
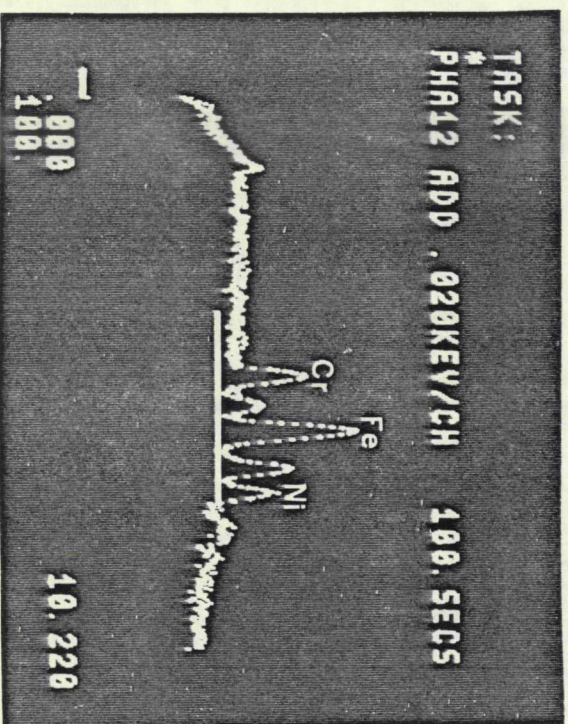
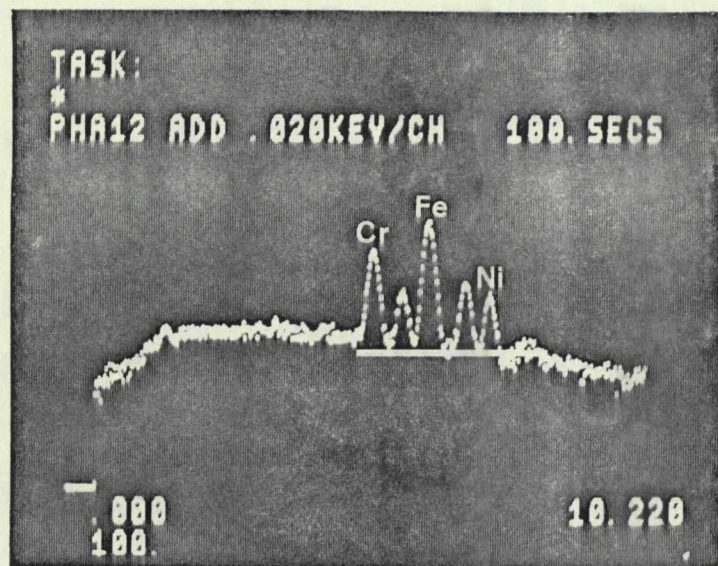
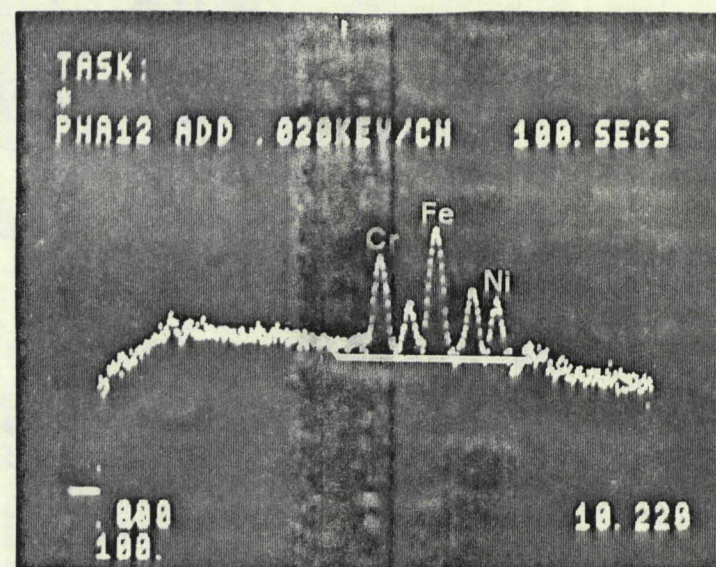
Due to the decontamination treatments performed on the bolt prior to SEM evaluation, EDS analysis of the fracture surface for contaminants and possible corrosive species was considered fruitless and was omitted from the evaluation. It was felt worthwhile however, to attempt an analytical SEM technique for determining the environment responsible for stress corrosion cracking of austenitic stainless steels (4). This technique produced data on Type 316 stainless steels in both hydroxide and chloride environments. It is based on the observations that in chloride solutions, the corrosion product is chromium rich while in hydroxide solutions the corrosion product is iron rich. The determination of the environment responsible for the cracking is based upon the Cr/Fe ratio as measured by EDS peak heights. The data produced in Reference 4 showed consistently higher Cr/Fe ratios for chloride cracking (0.6-0.9) while lower ratios were evident for hydroxide cracking (0.4-0.6). This technique was performed on the fracture face of the bolt in 5 scans traversing the fracture face and is depicted in Figures 14-18. The ratio values ranged from a low of 0.632 to a high of 0.778. Although not conclusive in nature these results do indicate the possibility of a chloride-type stress corrosion cracking phenomenon.

Figure 14. EDS scan of fracture face for Cr/Fe ratio. (Cr/Fe-.632)

Figure 15. EDS scan of fracture face for Cr/Fe ratio. (Cr/Fe-.778)

Figure 16. EDS scan of fracture face for Cr/Fe ratio. (Cr/Fe-.667)

Figure 17. EDS scan of fracture face for Cr/Fe ratio. (Cr/Fe-.765)

Figure 18. EDS scan of fracture face for Cr/Fe ratio. (Cr/Fe-.765)

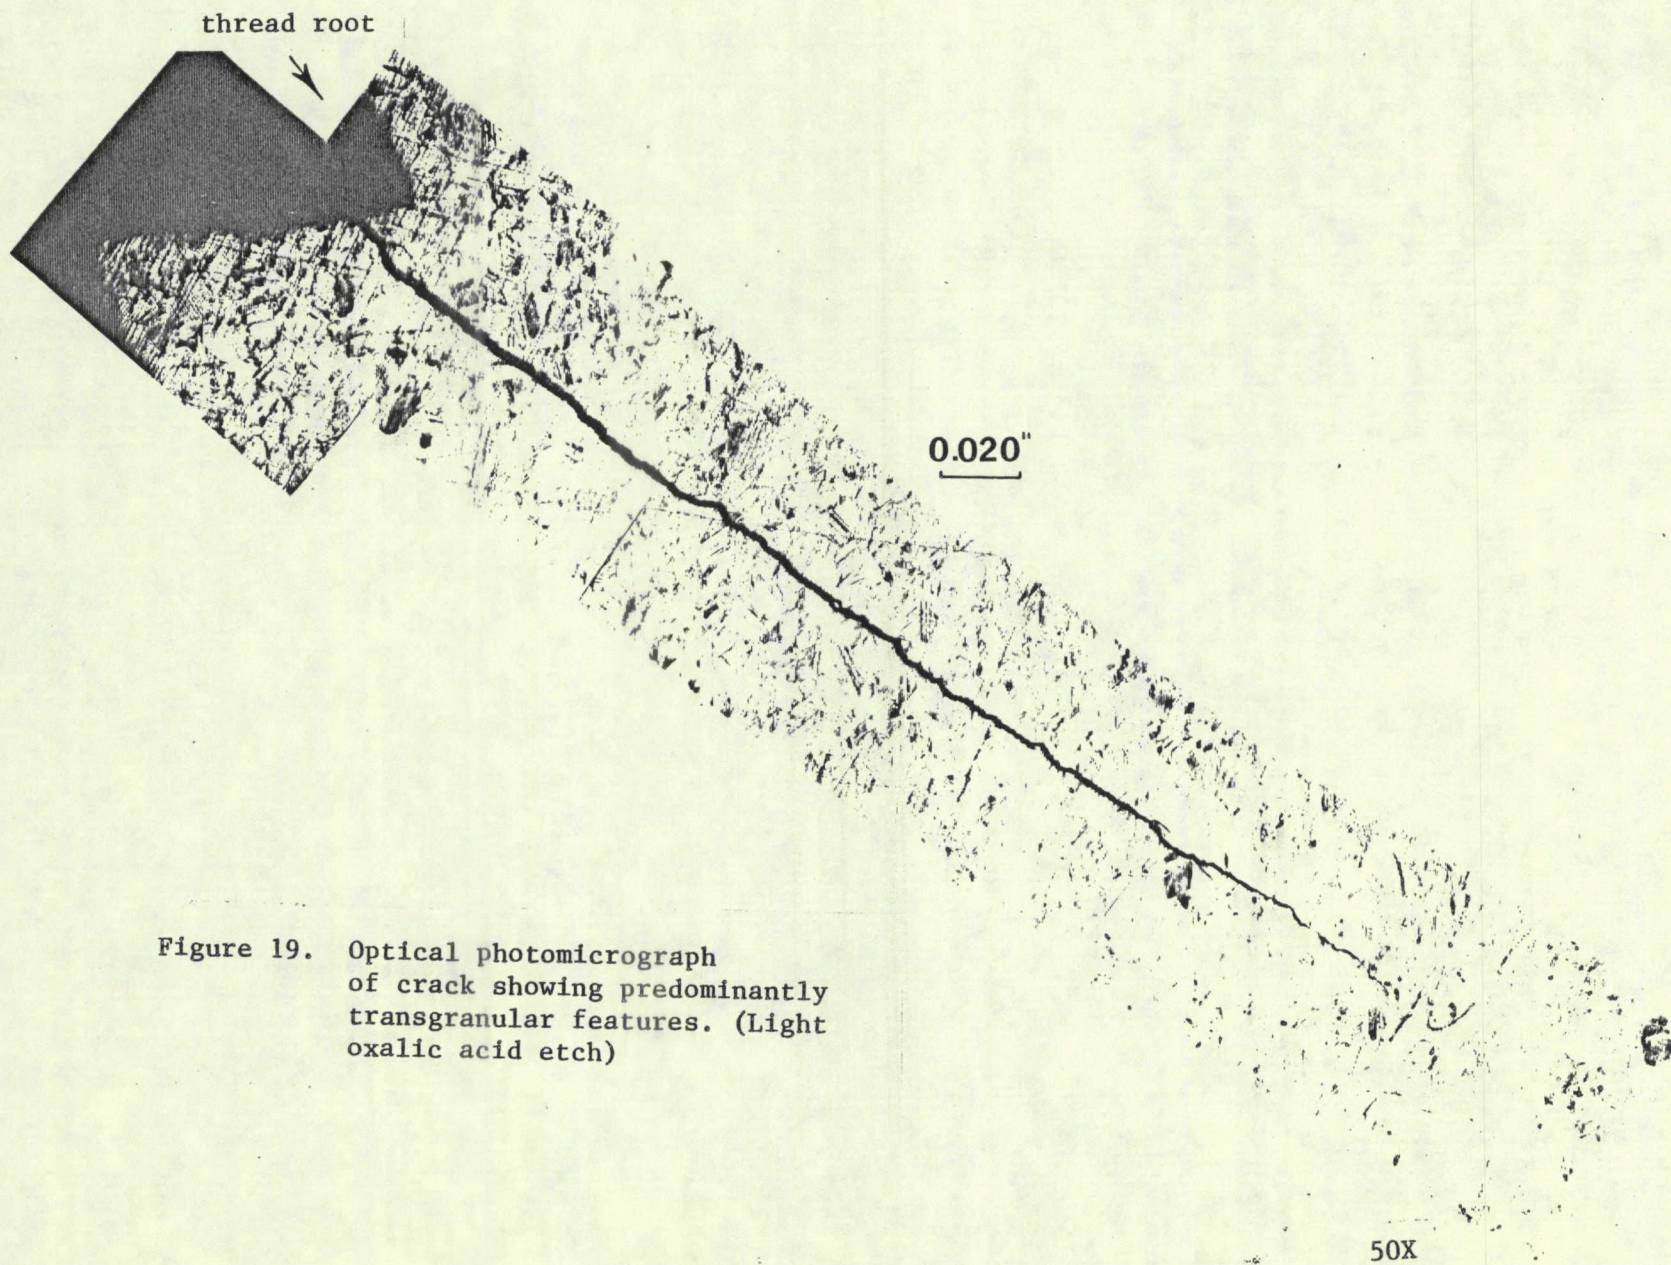
cracking is predominantly transgranular with some fern-like branching. The second sample was subjected to the ASTM A-262 Practice A test for detection of sensitization. The microscopic examination of this sample disclosed a severely cold worked structure in the area of the threads (Figure 20). This structure had the acicular characteristics of martensite. Additionally, a small crack was noted, which under higher magnification (Figure 21) appeared to be transgranular in nature and originating at the thread root.

Figure 19. Optical photomicrograph of crack showing predominantly transgranular features. (Light oxalic acid etch)

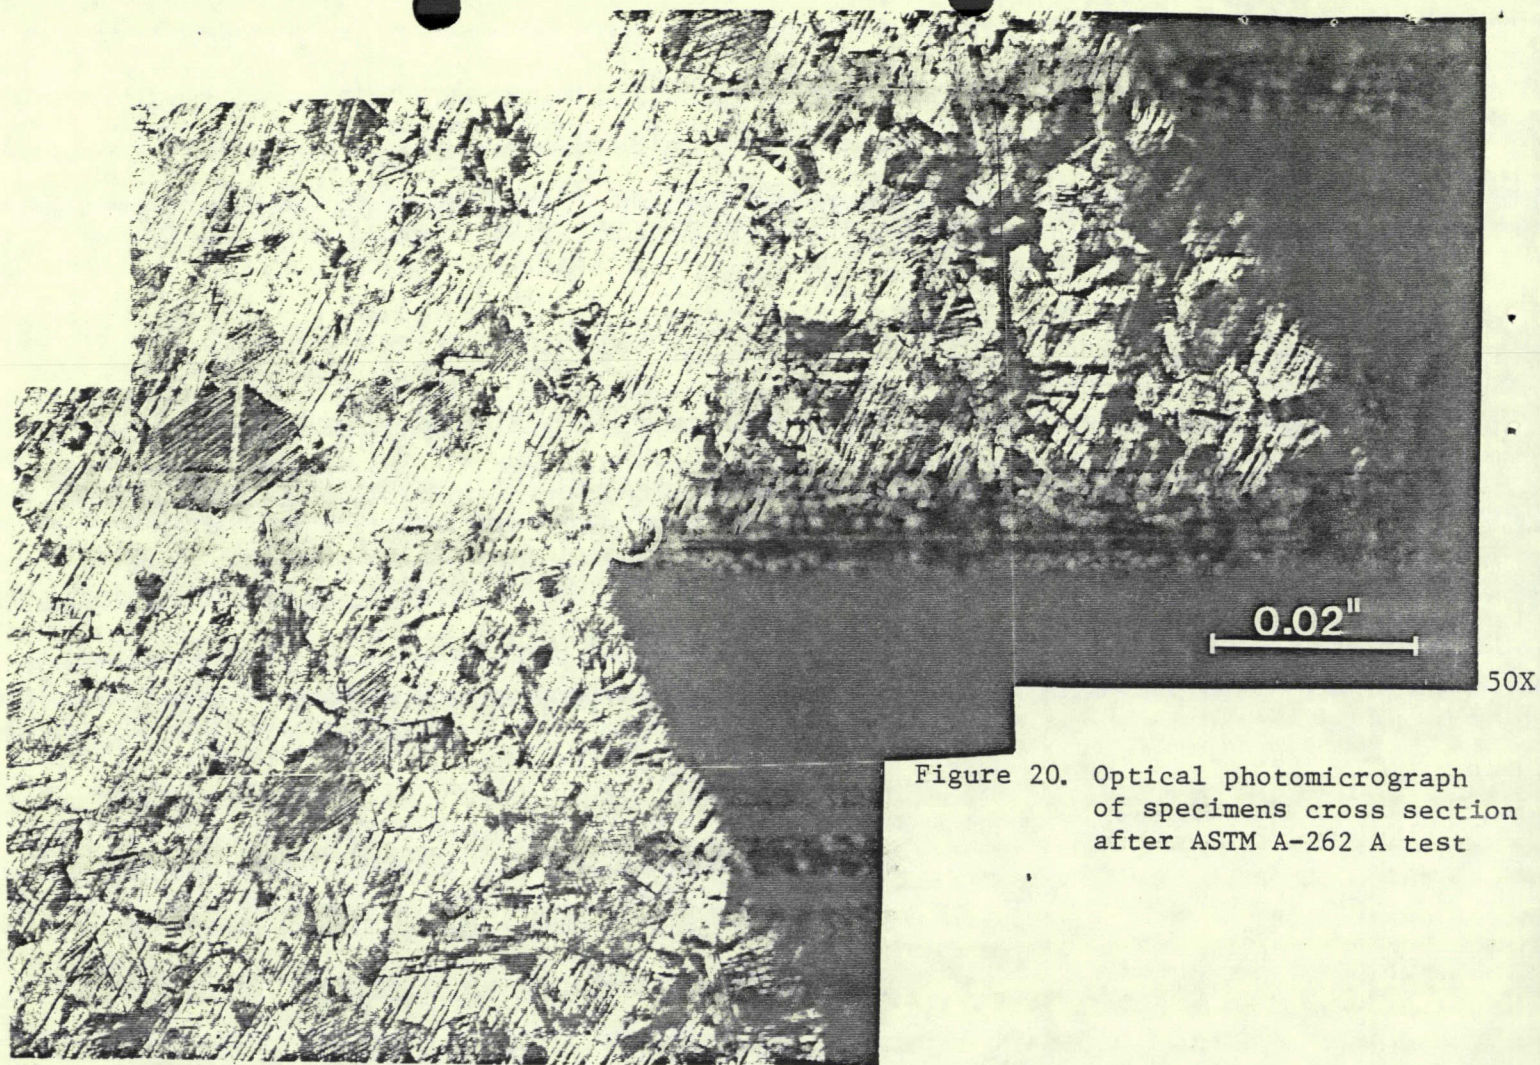
Figure 20. Optical photomicrograph of specimens cross section after ASTM A-262 A test

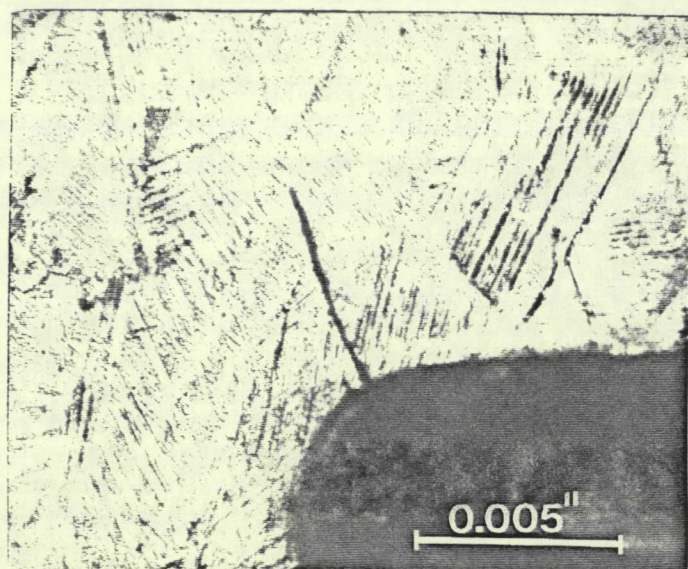
Figure 21. Higher magnification photo of circled area (above)

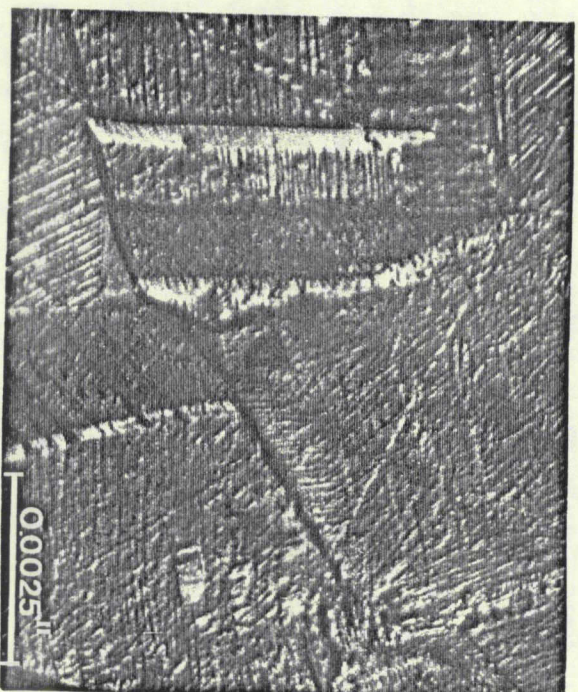
The bolt material showed no evidence of material sensitization as clearly seen in Figure 22.

Figure 22. Optical photomicrograph of bolt base material after ASTM A262 - Practice A showing no evidence of material sensitization
