Letter to N. C. Moseley from Carolina Power and Light Company dated June 13, 1975.

H. B. ROBINSON UNIT NO. 2
LICENSE NO. DPR-23
INSULATION AND PIPING AFFECTED BY FAILURE OF "C"
REACTOR COOLANT PUMP SEAL, MAY 2, 1975

Subject: Analysis of Submerged Stainless Piping and Potential for
Halide Stress Corrosion Cracking at H. B. Robinson Unit No. 2

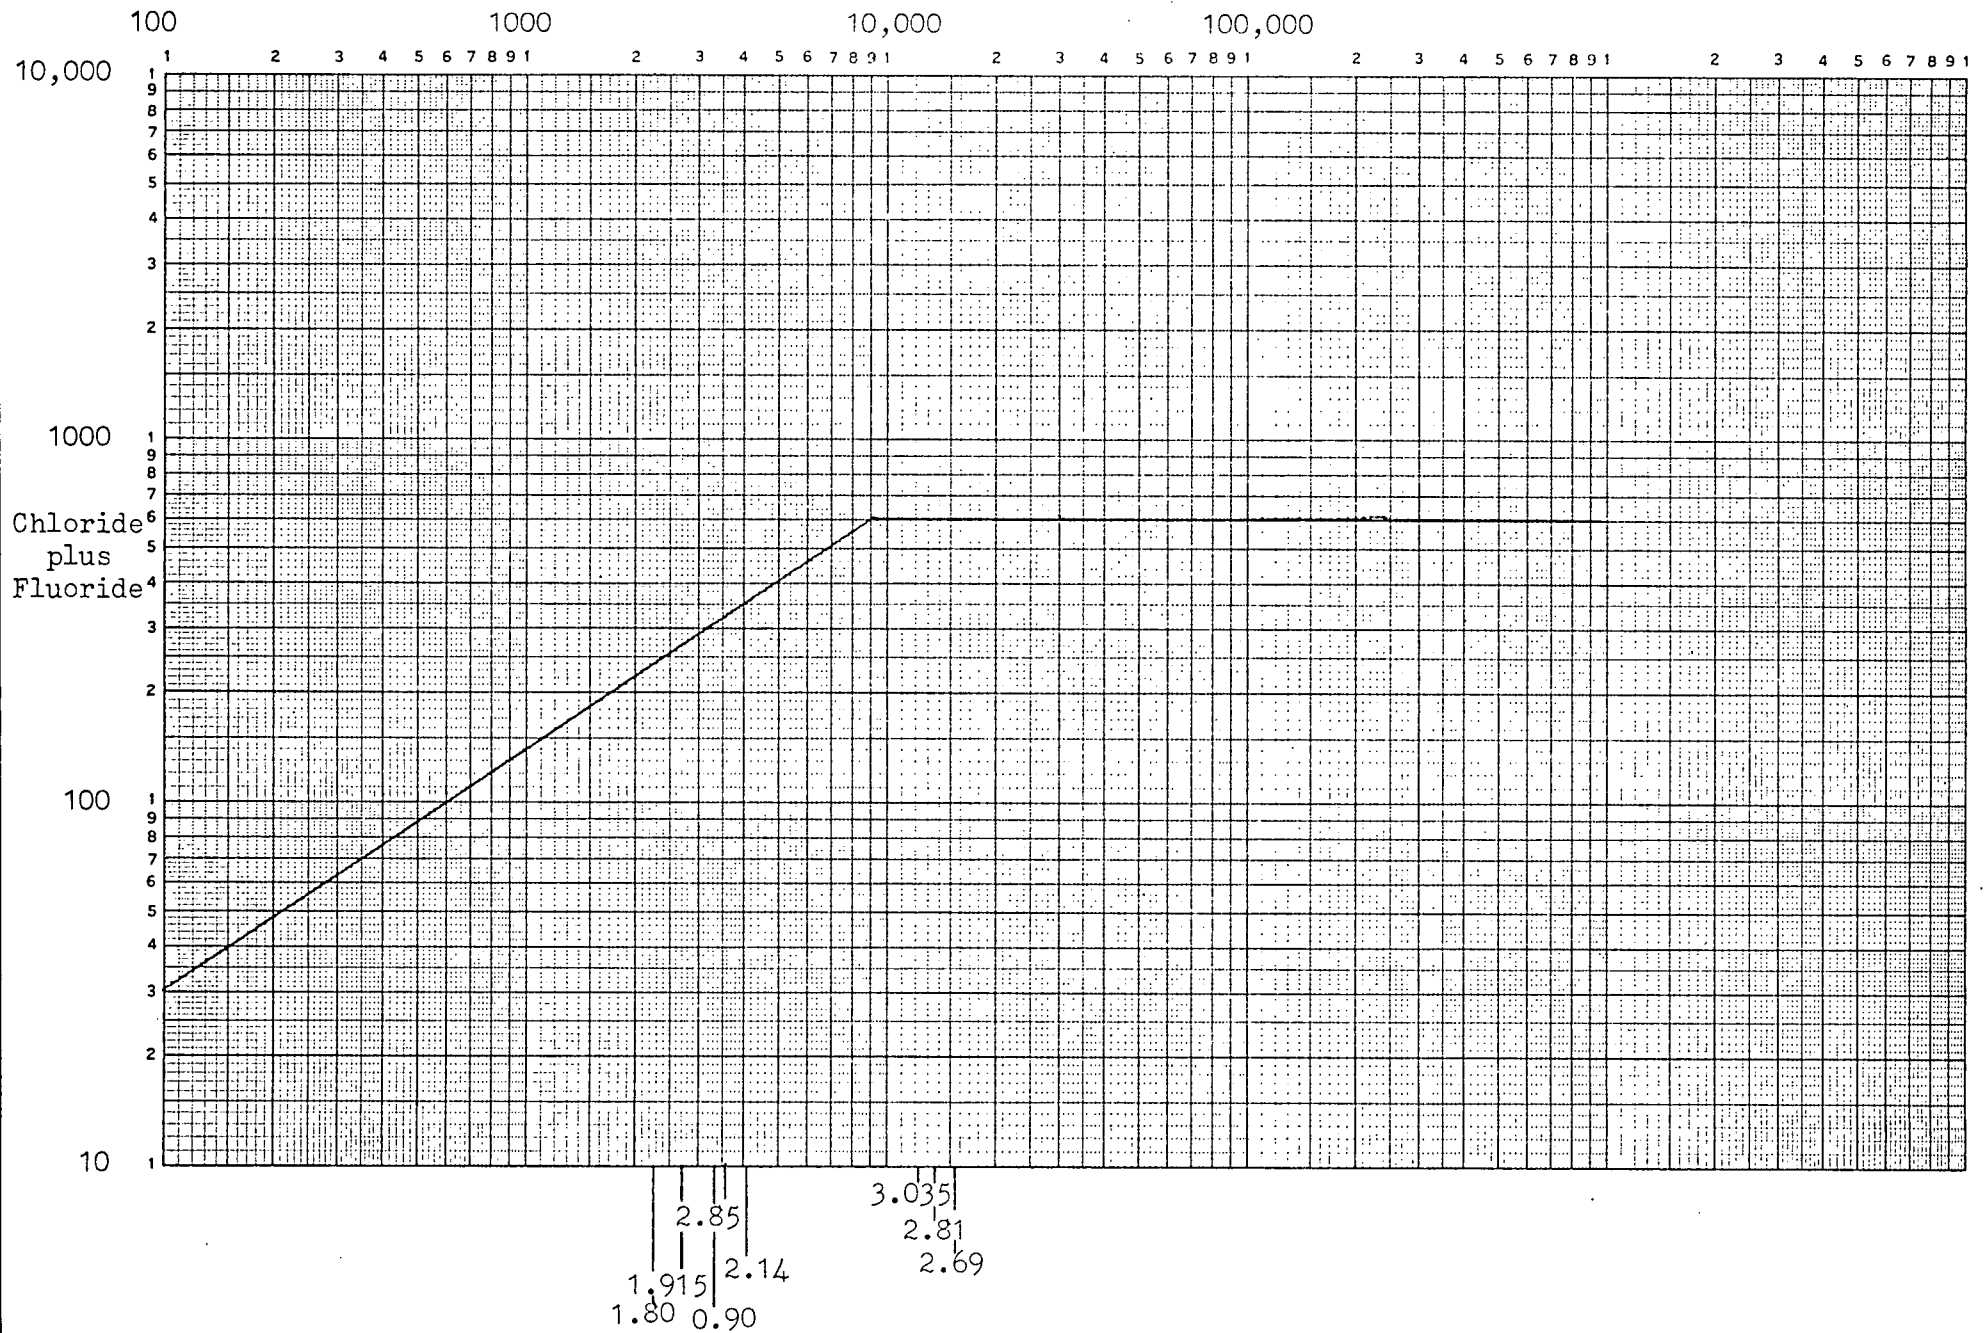
GRAPH 1

A plot of the chemical analysis data for each line and its corresponding insulation is enclosed as Graph 1. This acceptance curve is per the subject Westinghouse Specification PS 83336 KA which corresponds to Figure 1 of Regulatory Guide 1.36, "Non-Metallic Thermal Insulation for Austenitic Stainless Steel". This indicates that sufficient leachable sodium and silicate ions are present to assist in minimizing the effects of the chloride and fluoride.

To account for all chlorides present, the plot consists of sodium and silicate ions versus chloride and fluoride ions in the insulation plus chloride and fluoride ions on the pipe. On this basis, even though the lines were in contact with the contaminated water for some time, no adverse chemical effects attributed to halogens and stress corrosion have resulted.

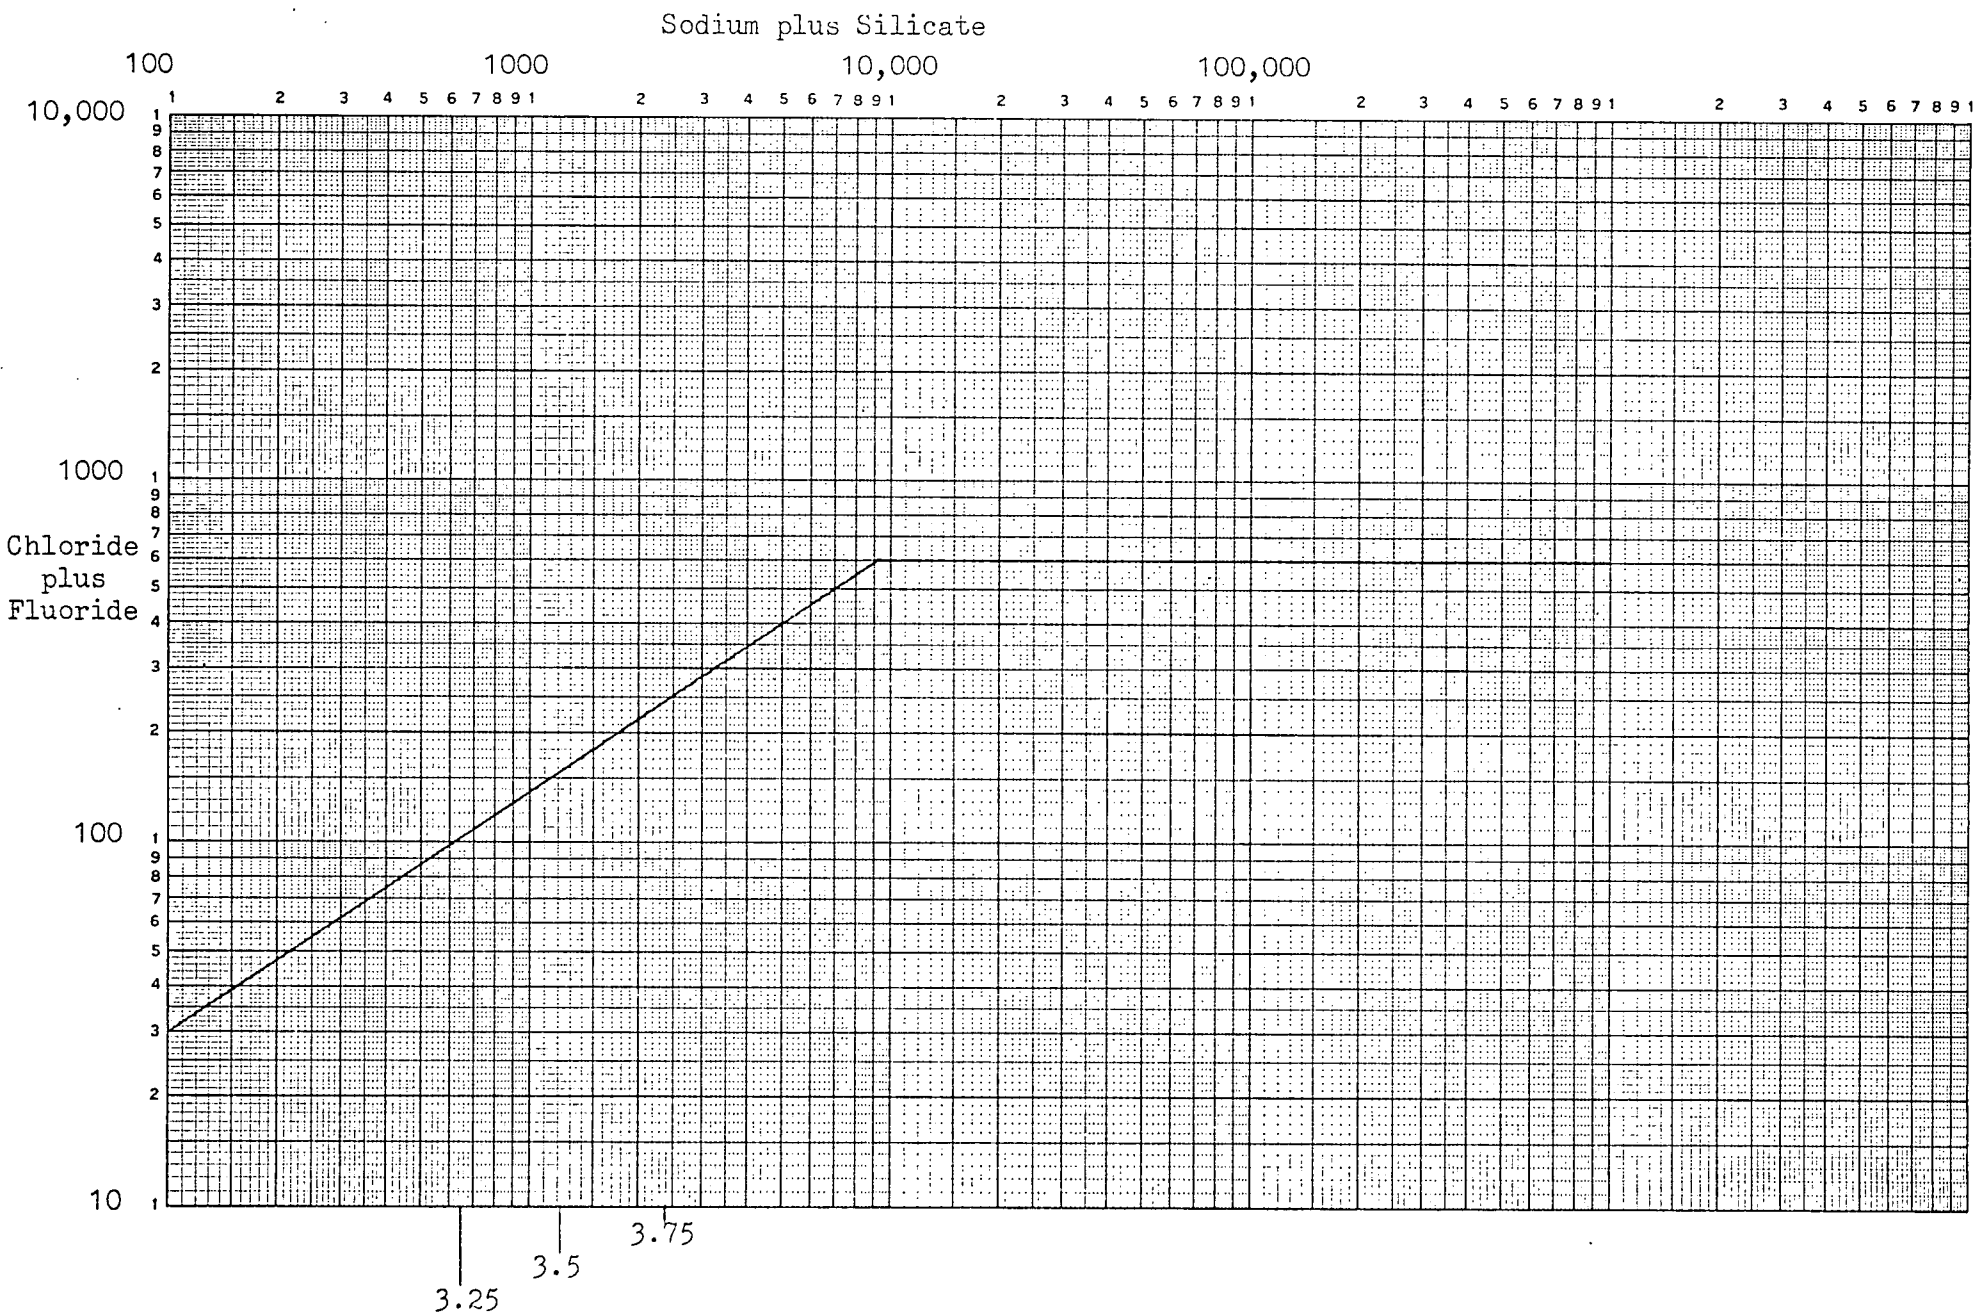
GRAPH 2

The piping systems within "C" Reactor Coolant Pump Bay experienced significant wetting of the insulation due to spray from the failed pump seal, but none were submerged due to water accumulation on the containment floor. The inlet and outlet "C" loop piping, "C" Reactor Coolant Pump casing, and "C" loop insulation were examined for possible chloride and fluoride ion problems. Also in order that a comparison between dry and wetted main coolant piping insulation could be made, samples were also analyzed from "A" and "B" main coolant loops. These results are given in Table 3 and are plotted on Graph 2. The same basis for acceptance of this insulation as was used above was applied in this case.

4. Insure that no main loop piping was submerged.
Corrective Action: No main loop piping was submerged.
5. All insulation in "C" Pump Bay that was wetted should be removed, the pipe cleaned, and the insulation replaced.
Corrective Action: A chemical analysis was made of insulation in "C" Bay and compared with insulation for the other pump bays that had not been wetted (Table 3 and Graph 2). Acceptance was based on the same criteria as referenced in Item 3 above.

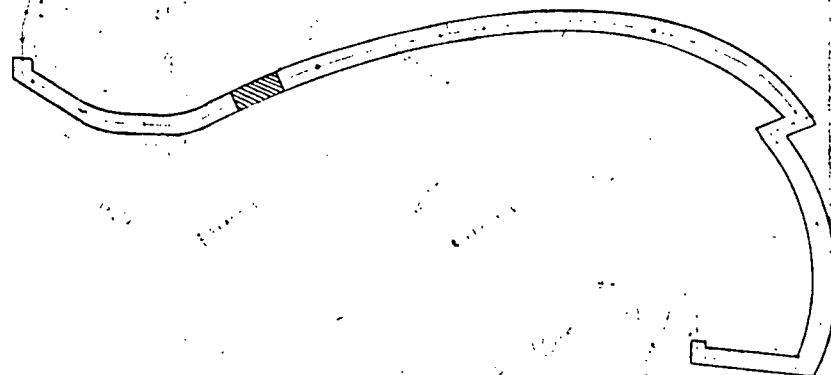
LINE DIAGRAM 2

So that the sections of pipe that were submerged can be better visualized, Line Diagrams 1 through 7 are provided to show these pipe locations and elevations. The diagrams also show that all of these lines include at least one isolation valve between the reactor coolant loop piping and the section of submerged pipe. Thus, in the event that a problem might inconceivably occur with pipe cracking and leakage, the line can be isolated.
