Carolina Power & Light Company

H. B. ROBINSON STEAM ELECTRIC PLANT
Post Office Box 790
Hartsville, South Carolina 29550

Serial: RSEP/78-106

In accordance with Section 6.9.2.a.9 of the Technical Specifications,
the following Reportable Occurrence is submitted:

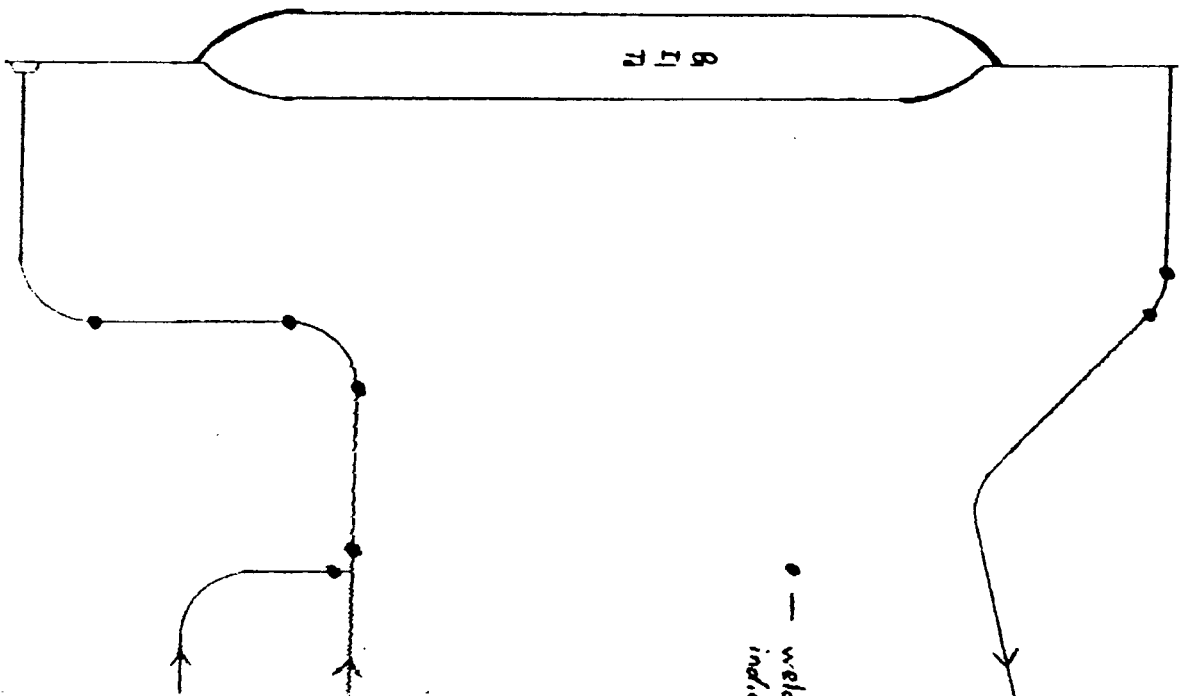
On March 5, 1978, sections of safety injection piping near the boron injection tank were being ultrasonically examined as a followup to metallurgical analysis of portions of the failed boron injection tank (LER 77-25). Indications were noted in the heat affected zone on the pipe side of eight pipe to fitting welds (see attached sketch). Additional NDE inspections will be performed to determine if such indications exist in areas other than in the safety injection piping adjacent to the boron injection tank. At present, it is planned to replace all affected piping prior to startup following refueling.

• — welds with indications
