Table of Contents

PREFACE:

The eighth Semi-Annual Operating Report is submitted in accordance with Section 6.6.1 of the H. B. Robinson Unit No. 2 Technical Specifications. The report relates plant operating experiences and pertinent information regarding operations during the period of January 1, 1974, to June 30, 1974.

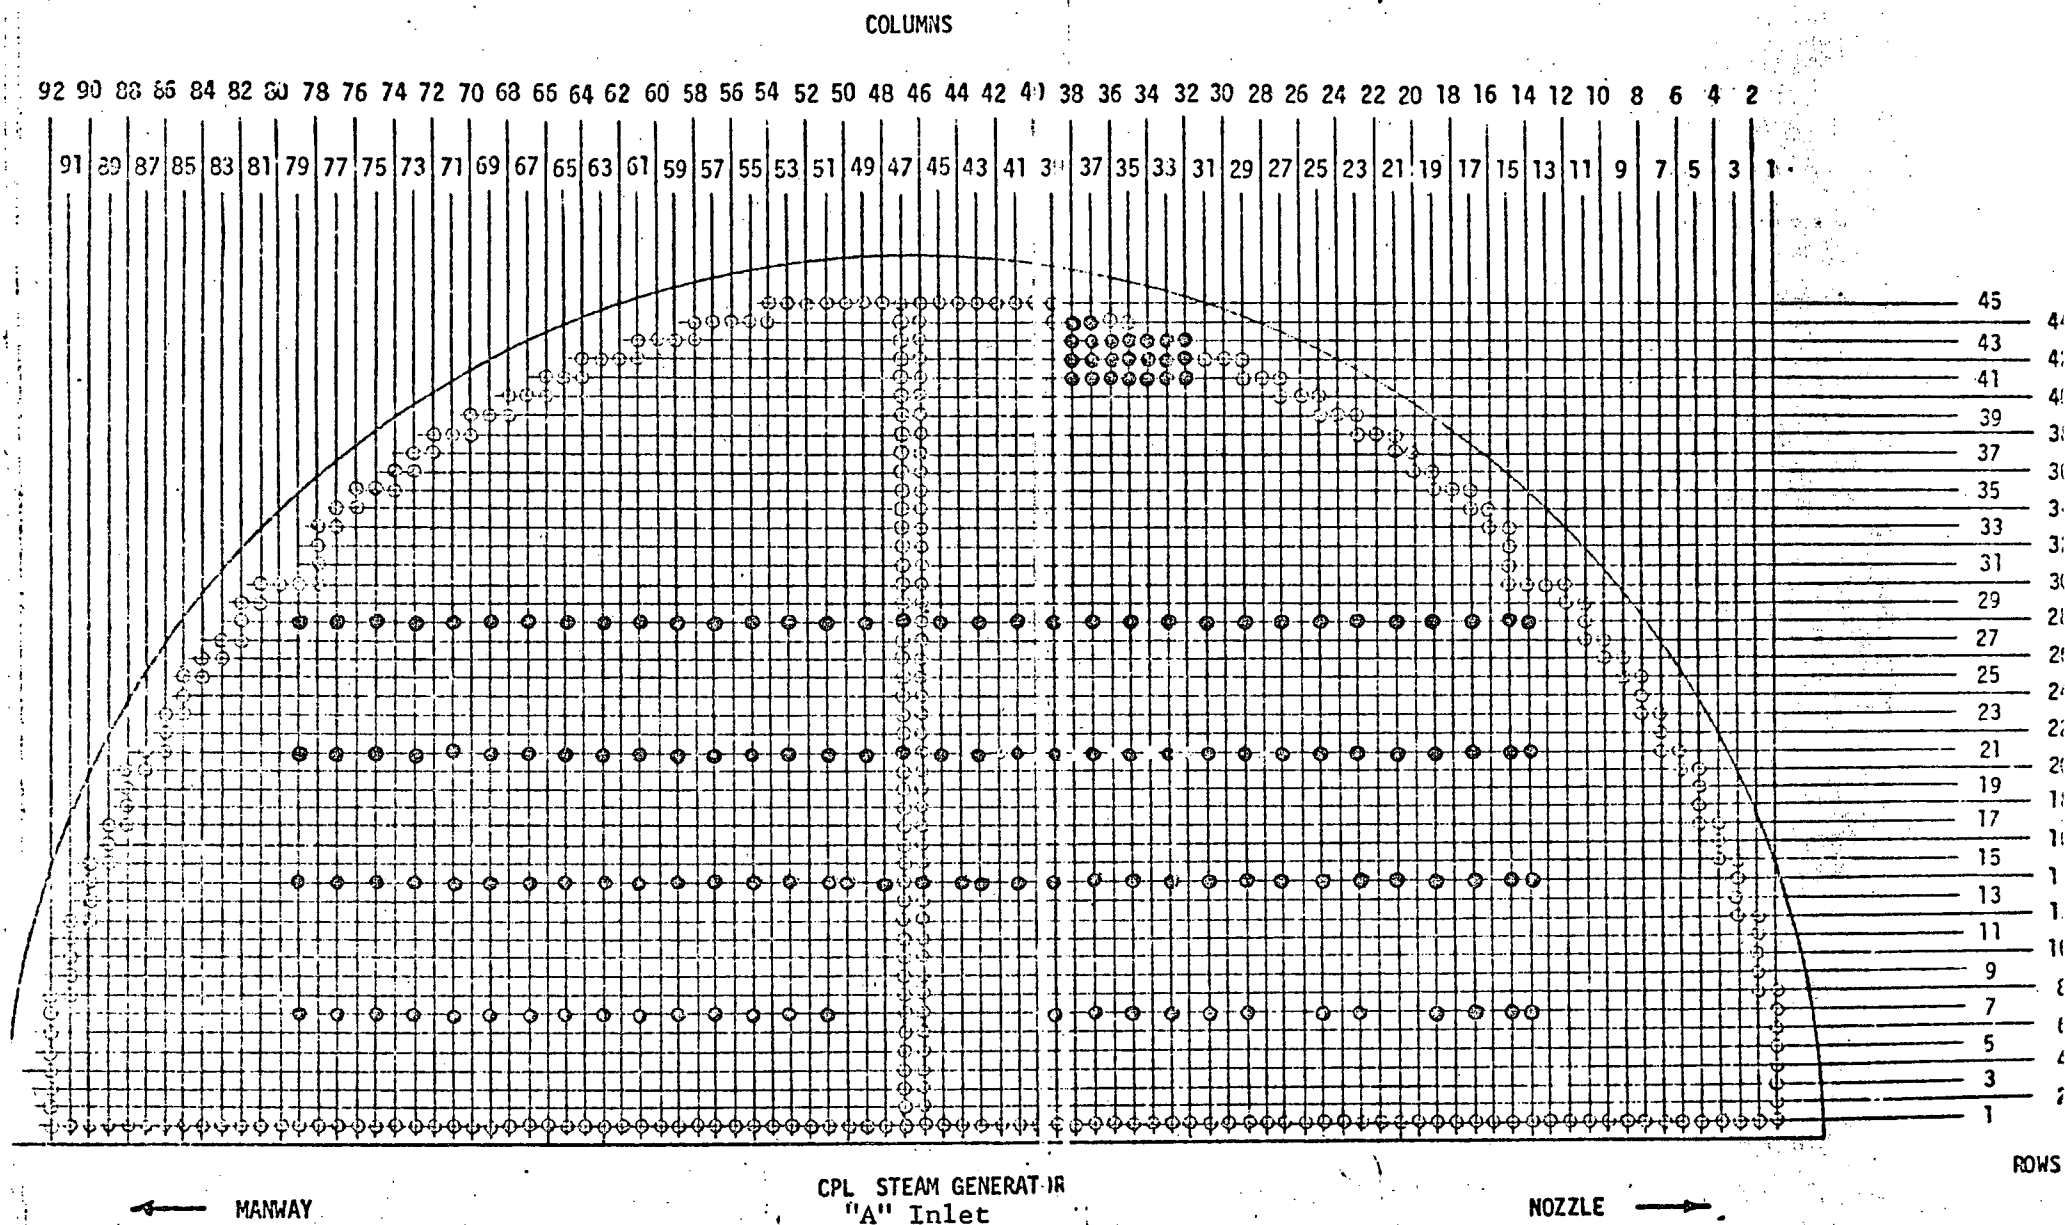
Figure 5

• Tubes Inspected at Test Frequency of 25 KHZ

View of Tubes at 25 KHZ

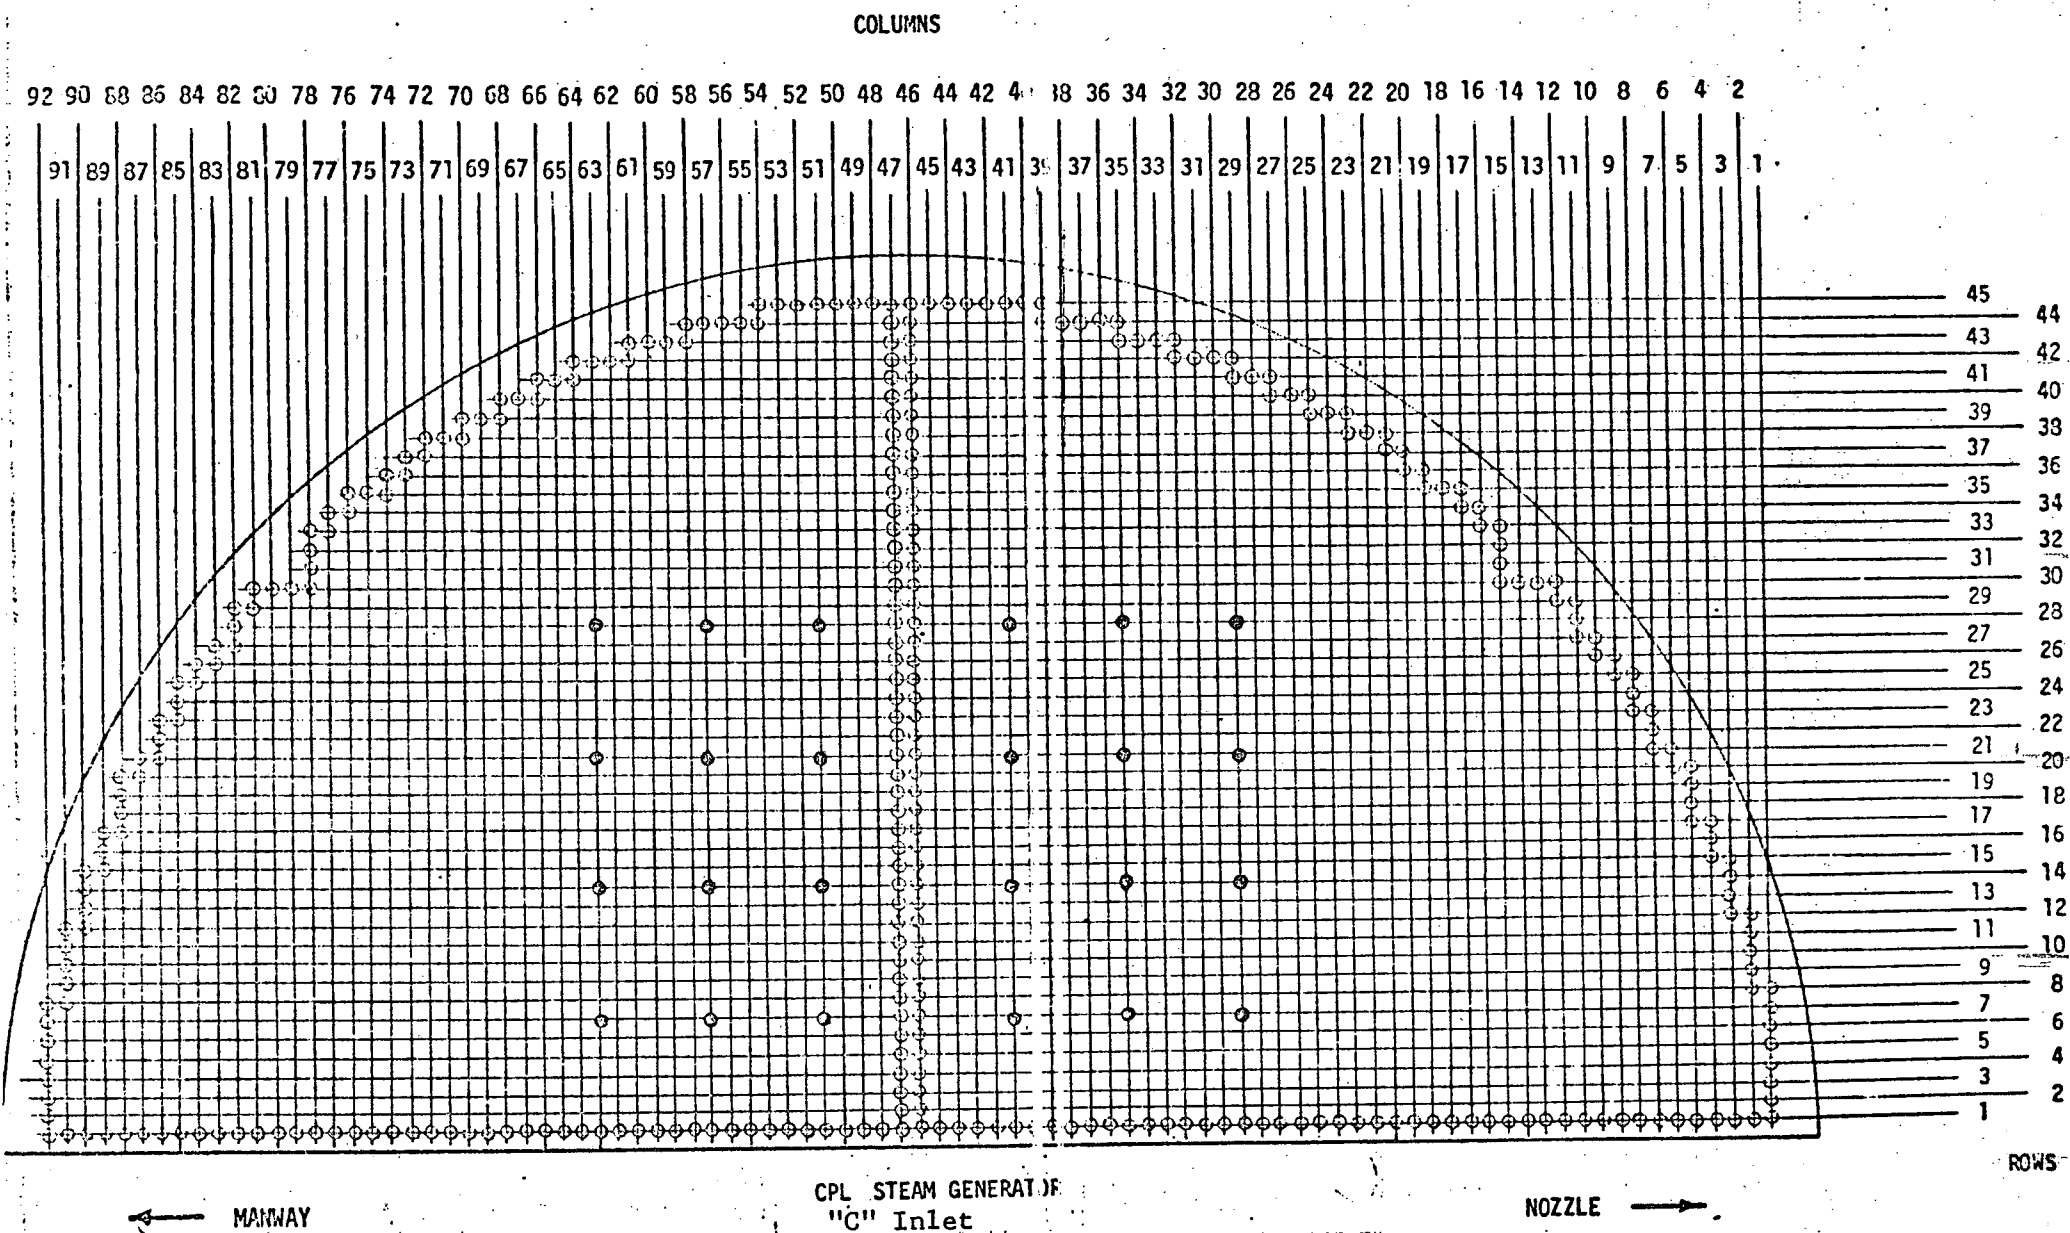
Figure 7

• Tubes Inspected at Test Frequency of 25 KHZ

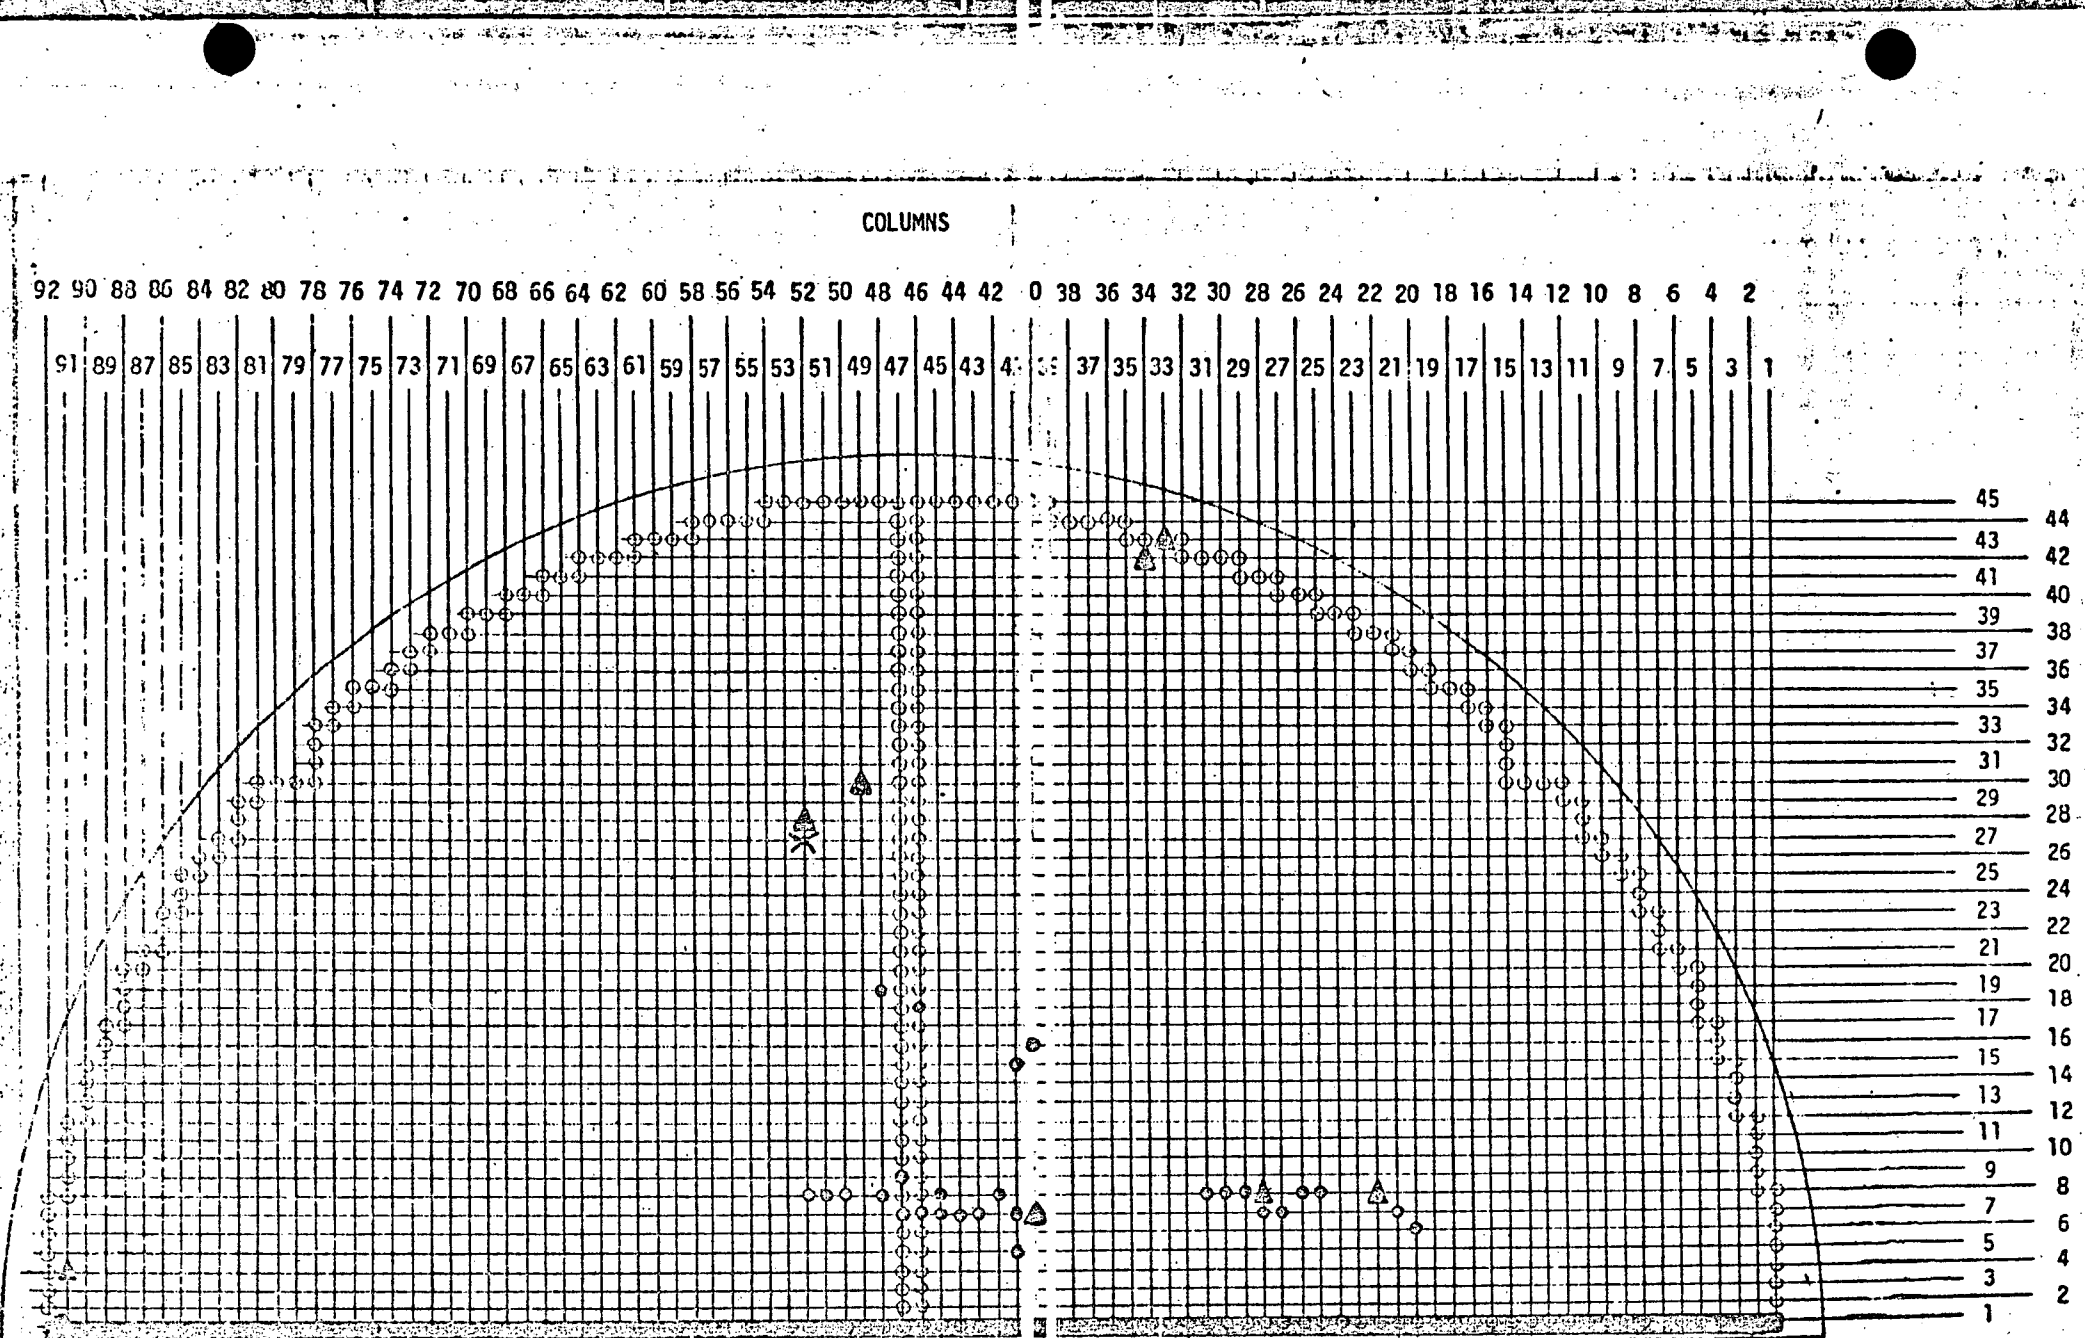
Figure 9

CPL STEAM GENERATOR
"A" Plugged Tubes

- Plugged, 1971
- Plugged, 1972
- ✕ Plugged, 1973
- ▲ Plugged, 1974

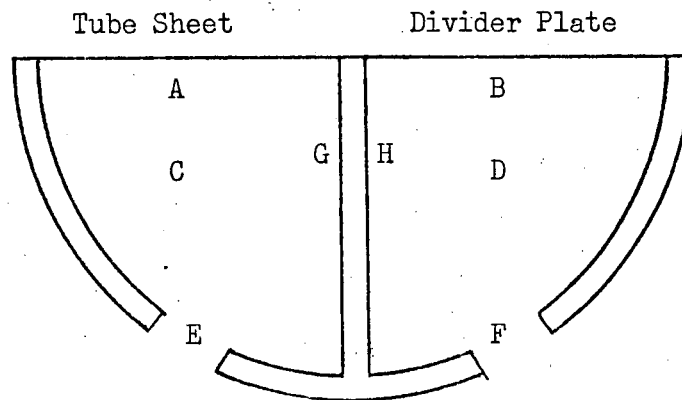
Figure 15

Readings	Mr/hr	
SURVEY	INLET	OUTLET
A Tube Sheet	15000	
B Tube Sheet		12000
C Interior	10000	
D Interior		10000
E Manway	3000	
F Manway		3000
G Divider Plate	10000	
H Divider Plate		10000
J General Field	10000	10000

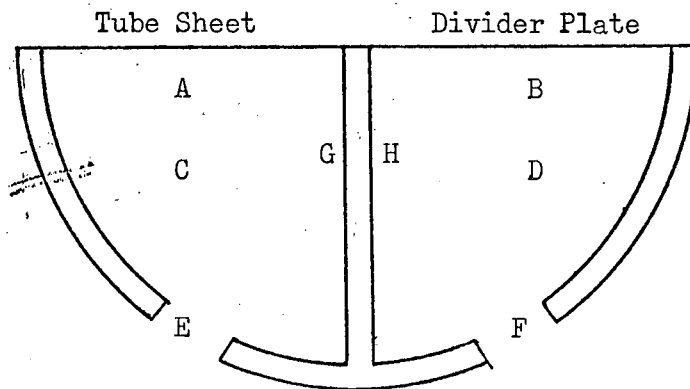
Figure 16

STEAM GENERATOR "B"

Readings	Mr/hr	
SURVEY	INLET	OUTLET
A Tube Sheet	15000	
B Tube Sheet		15000
C Interior	16000	
D Interior		16000
E Manway	5000	
F Manway		5000
G Divider Plate	16000	
H Divider Plate		18000
J General Field	16000	16000

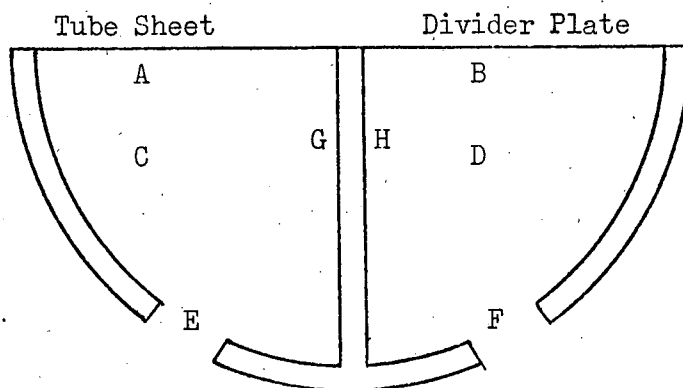
STEAM GENERATOR "C"

Readings	Mr/hr	
SURVEY	INLET	OUTLET
A Tube Sheet	15000	
B Tube Sheet		15000
C Interior	12000	
D Interior		14000
E Manway	10000	
F Manway		7000
G Divider Plant	13000	
H Divider Plant		13000
J General Field	12000	14000
