H. B. ROBINSON UNIT NO. 2

SEMI-ANNUAL OPERATING REPORT NO. 6

JANUARY 1, 1973 THROUGH JUNE 30, 1973

EQUIPMENT	NATURE OF MAINTENANCE	EFFECT ON SAFE OPERATION	MALFUNCTION		CORRECTIVE/PREVENTIVE ACTION	TIME OUT OF SERVICE
			CAUSE	RESULT		
Audio count rate channel selector switch	Corrective	None	Switch was dirty and needed lubricating	Channel selector switch was frozen	The switch was cleaned and lubricated	1 hr.
"B" boric acid evaporator	Corrective	None	PS-8 switch out of calibration	Feed valve opens at too high tank level	The PS-8 switch was recalibrated	2 hrs.
"A" feedwater pump discharge drain valve	Corrective	None	Defective valve	Excessive leakage	New 1500 lb. valve was installed	2 hrs.
"A" steam generator level transmitter LT-475	Corrective	None	Transmitter out of calibration	Improper indication	The transmitter was calibrated	5 hrs.
R-14 radiation monitor	Corrective	None	The check source, operate alarm had a broken wafer	Defective check source	The wafer was replaced	2 hrs.
Gland steam condenser	Corrective	None	Defective gasket	Excessive leakage	A new gasket was installed	4 hrs.

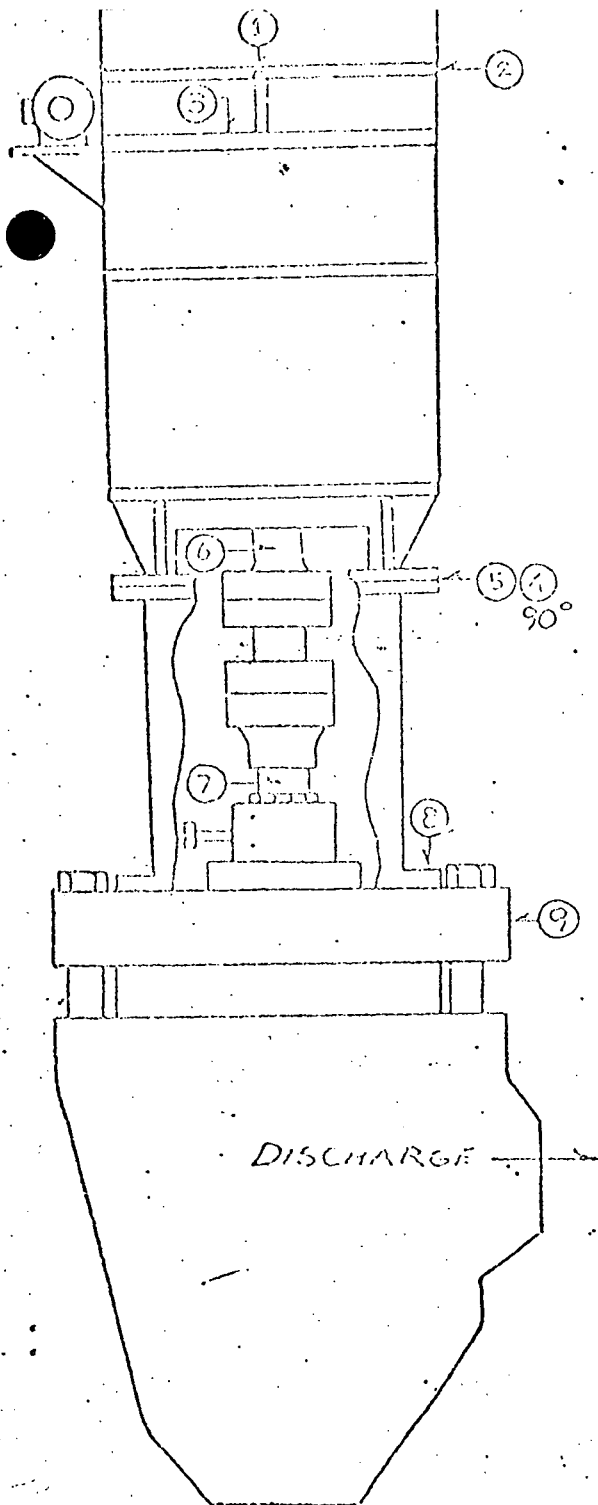
Reactor Coolant Pump "A"  
 Loop Pressure - 2200 psi  
 Loop Temperature - 550°F

Point	TIME	
	0545	0630
1		.75
2		.85
3		.7
4		.5
5	.7	.35
6		
7	11	8
8		.2
9		1.4

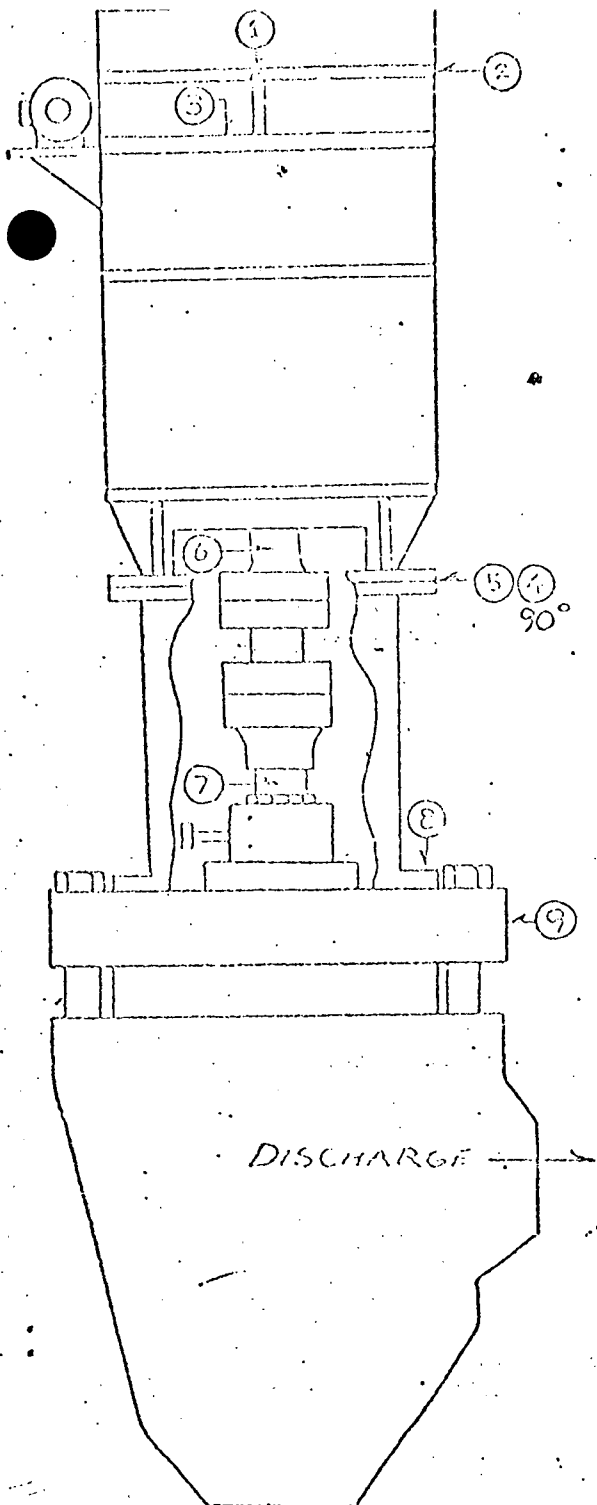
Reactor Coolant Pump "B"  
Loop Pressure - 2200 psi  
Loop Temperature - 550°F

Point	TIME	
	0435	
1	.6	
2	1.1	
3	1.0	
4	.8	
5	1.0	
6	-	
7	11	
8	.8	
9	1.5

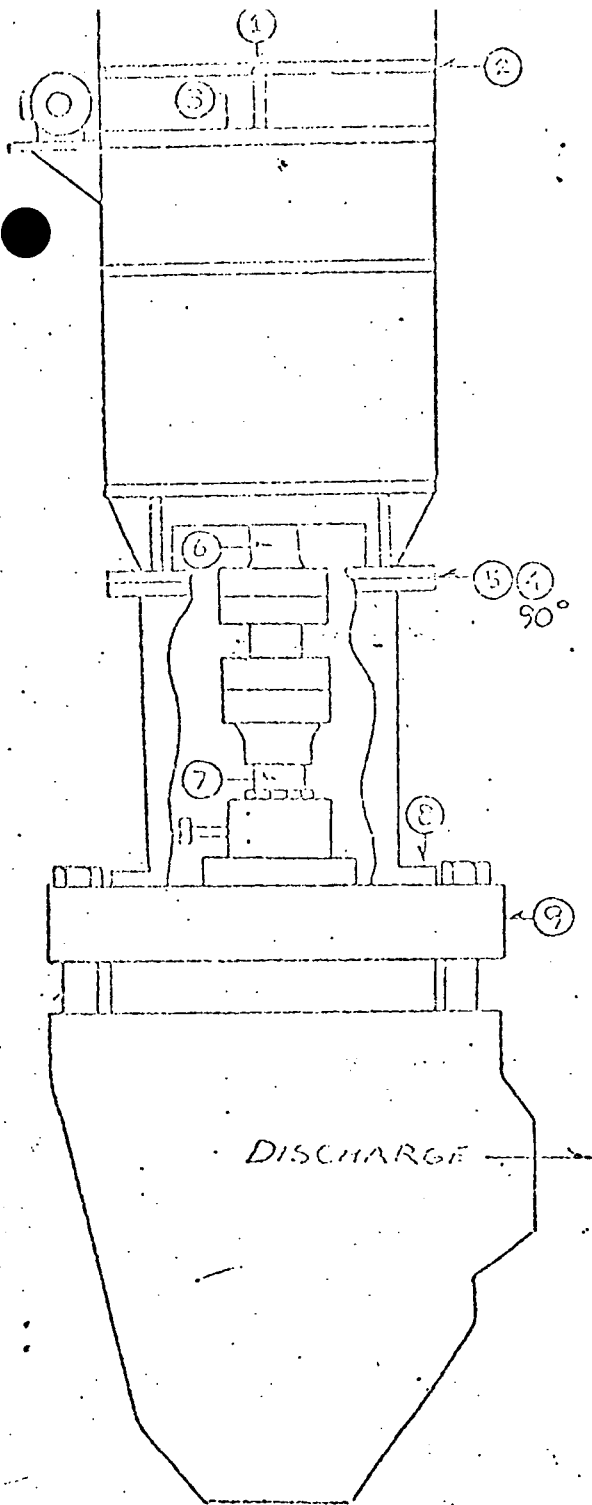
Table No. 3

Reactor Coolant Pump "C"  
Loop Pressure - 2200 psi  
Loop Temperature - 550°F

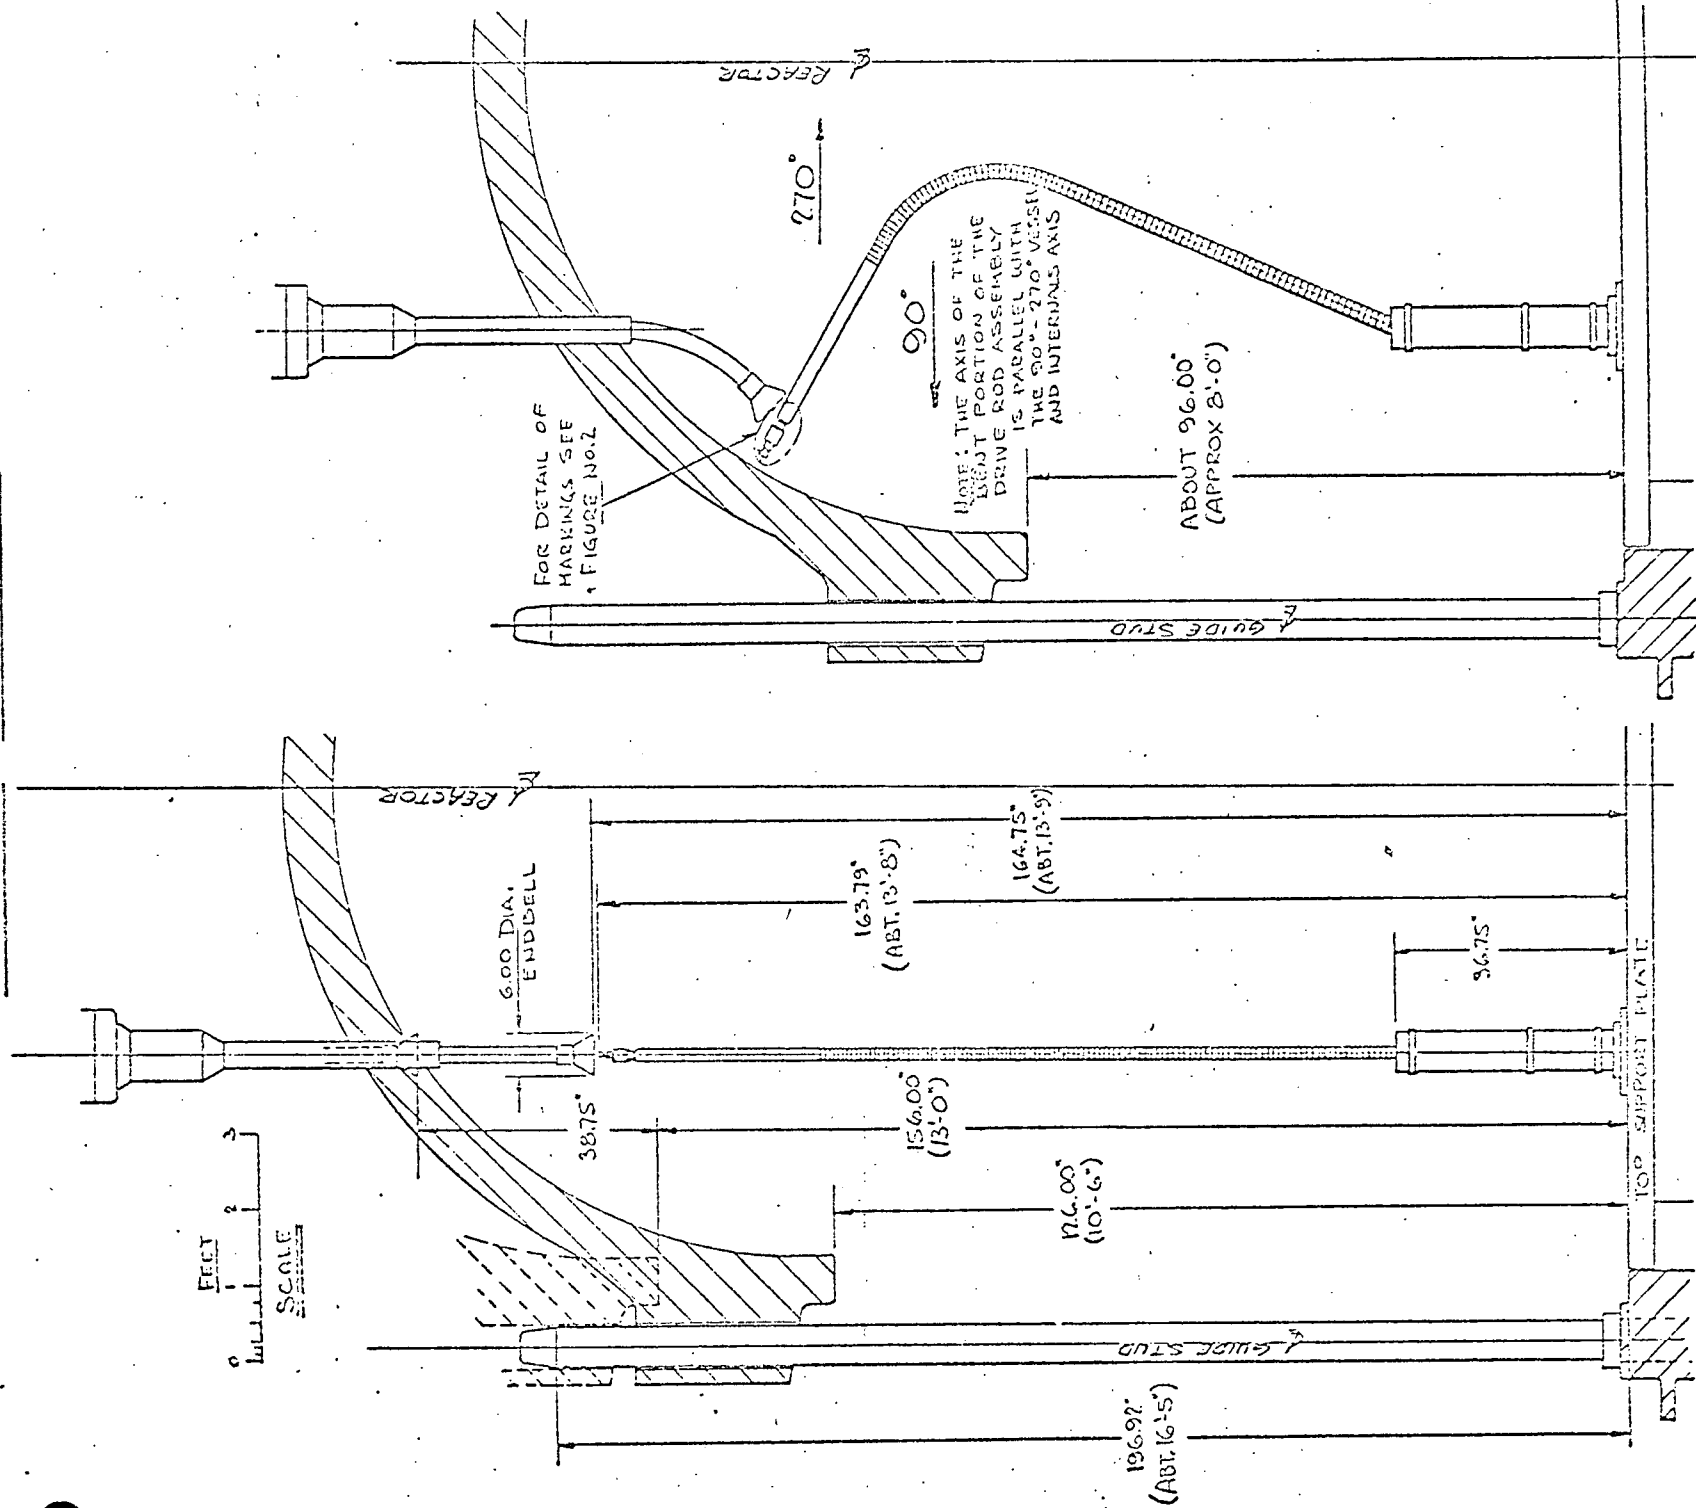
FIGURE NO. 1

# DAMAGED DRIVESHAFT

THEORITICAL RECONSTRUCTION OF THE N-7 DRIVE LINE INCIDENT, ILLUSTRATING THE DAMAGED COMPONENTS AS MEASURED BY BEST VISUAL ESTIMATE

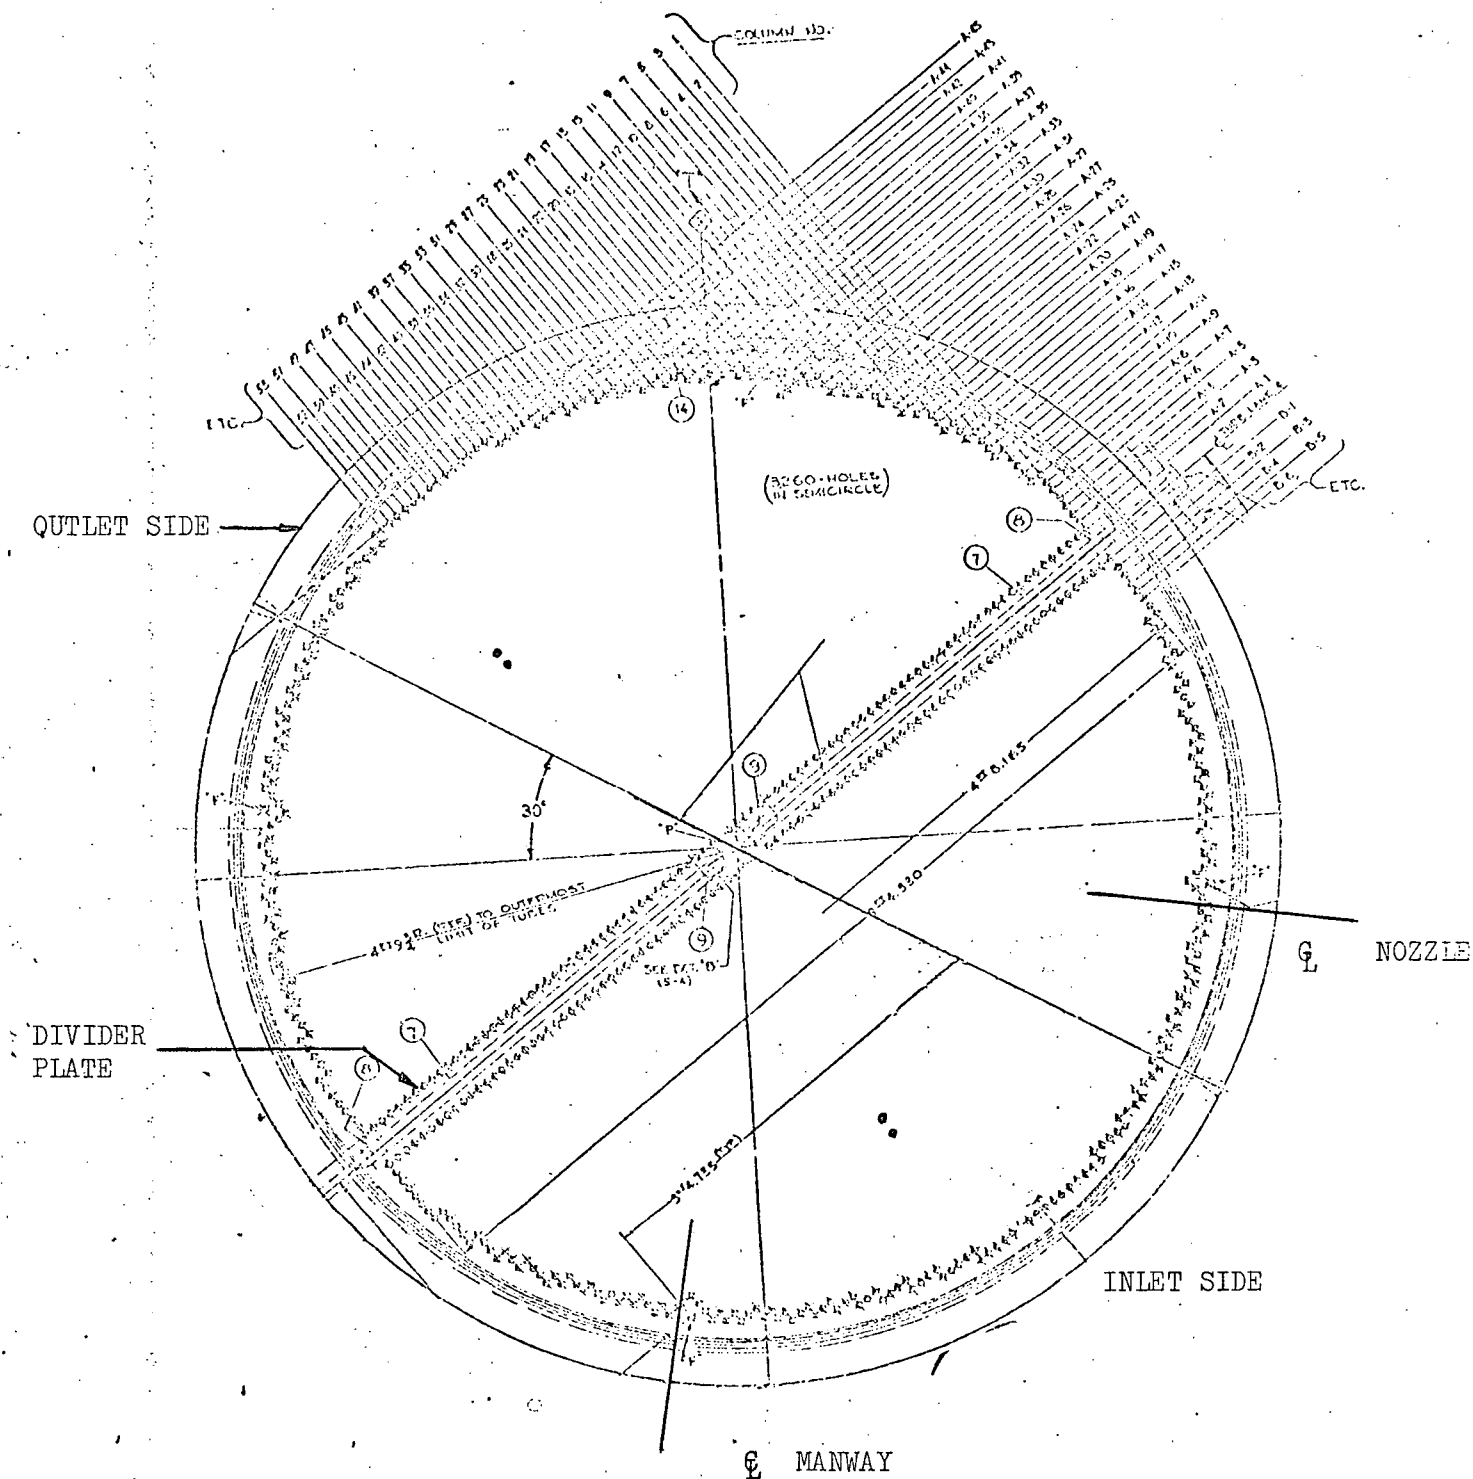
FIGURE 1

ROW	COLUMN	PENETRATION %	LOCATION
28	52	92	2" Above Tube Sheet
27	52	75	2" Above Tube Sheet

LOCATION OF PLUGGED TUBES IN S. G. "A"  
VIEW IS LOOKING UPWARD AT TUBE SHEET  
FROM CHANNEL HEAD
