ACCESSION NBR: 8108250441 DOC. DATE: 81/08/21 NOTARIZED: YES DOCKET #  
 FACIL: 50-261 H. B. Robinson Plant, Unit 2, Carolina Power and Light 05000261  
 AUTH. NAME: AUTHORITY AFFILIATION  
 UTLEY, E.E. Carolina Power & Light Co.  
 RECIP. NAME: RECIPIENT AFFILIATION  
 VARGA, S.A. Operating Reactors Branch 1

H. B. ROBINSON STEAM ELECTRIC PLANT, UNIT NO. 2  
DOCKET NO. 50-261  
LICENSE NO. DPR-23  
STEAM GENERATOR RECOVERY PROGRAM

STEAM GENERATOR REPAIR AND PREVENTATIVE  
MEASURES REPORT

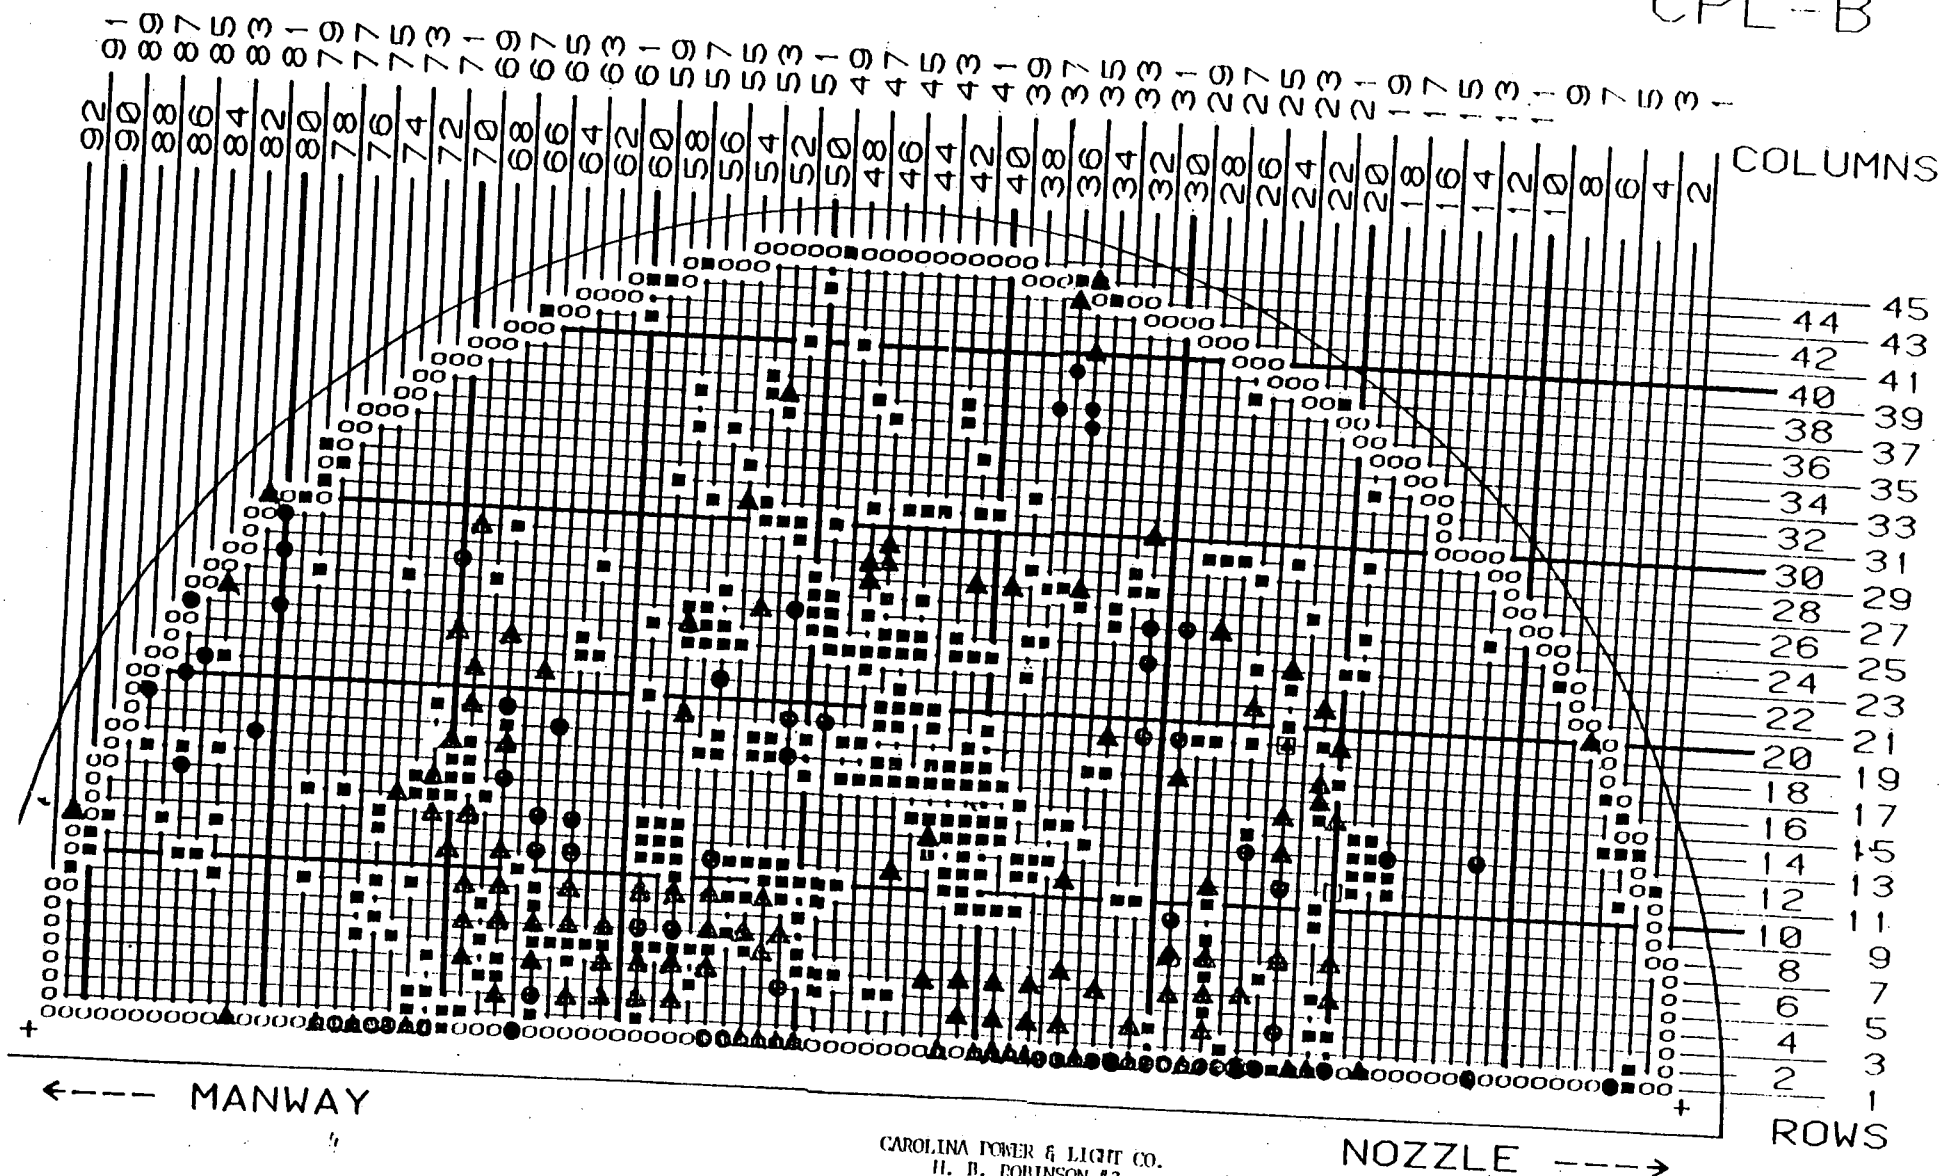
Figure 3.1.13  
SERIES 44

CAROLINA POWER & LIGHT CO.  
H. B. ROBINSON #2  
S/G R OUTLET 8/81

(END): ○ = <20% or Distorted  
 △ = 20-47%  
 □ = ≥48%

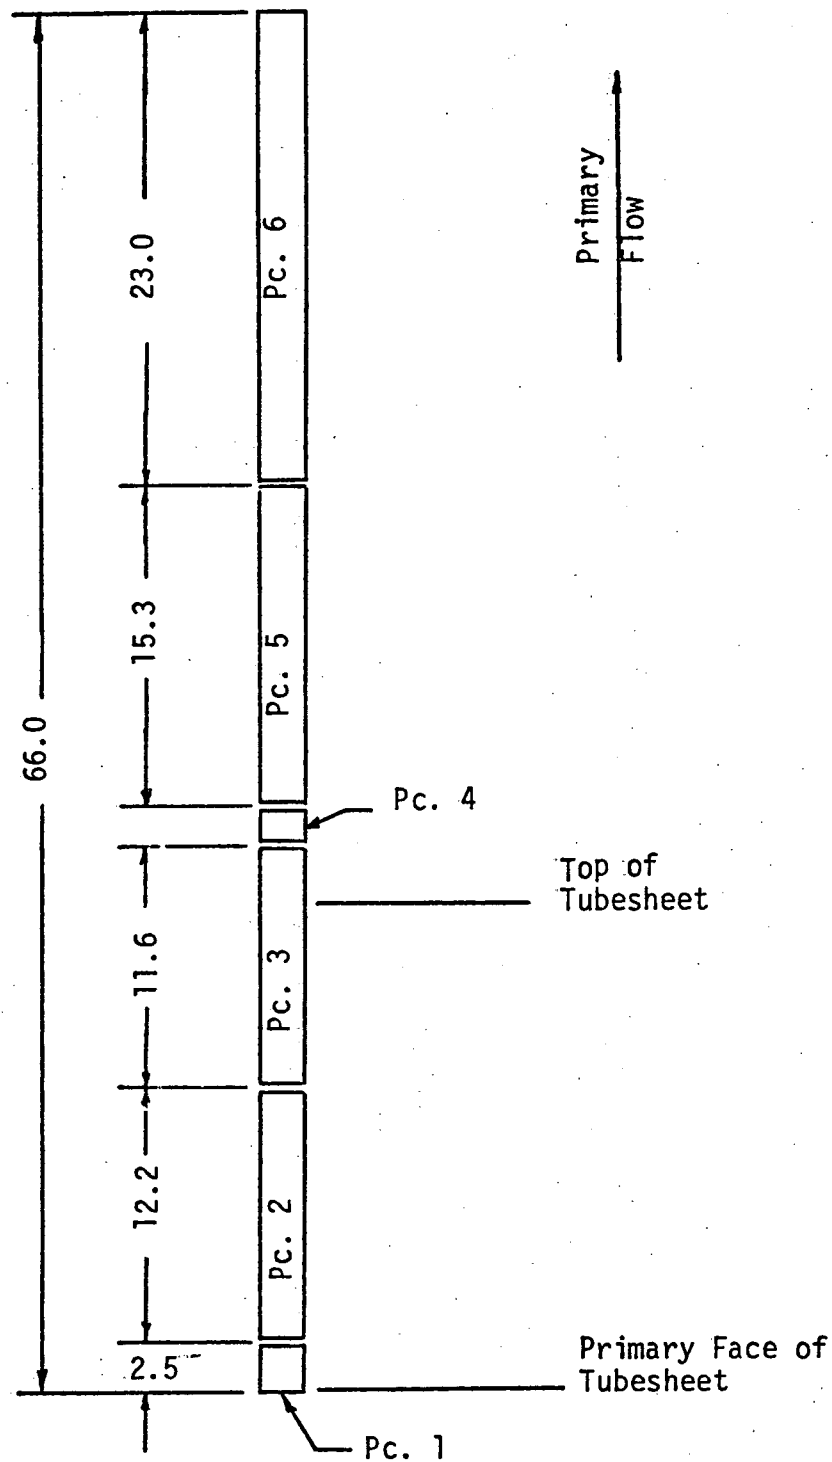
FIGURE 3.2.1

4. Piece #4 contained the crack which presumably caused the primary to secondary leakage in this tube. As received, the crack was approximately 13/16" long, through-wall, and obviously deformed due to flaring of the tube end (believed to be caused by the in-situ ID cutting operation). SEM (Scanning Electron Microscopy) of the fracture faces revealed essentially total intergranular facets except at the offset, approximately at the mid-length of the crack, where a small local zone of dimple rupture was noted. This indicates that initially two shorter stress corrosion cracks existed, in tandem but offset and separated by about a 0.050" wide ligament. Subsequently, the ligament experienced continued intergranular stress corrosion cracking until the remaining sound metal over loaded, parted mechanically and permitted the two cracks to link up and form the single crack observed upon tube removal. It is not possible from the metallographic examination to unambiguously define when the link up occurred.

The cause of the leakage and reported through-wall eddy current signals in tube R36C37 were clearly due to the axial stress corrosion crack(s) above the tube sheet surface. The intergranular nature of these cracks as well as the general IGA observed in the tube sheet crevice are consistent with previously observed metallographic evidence of caustic related attack. Although not rigorously quantifiable, laboratory tests suggest that caustic stress corrosion cracking (SCC) of Inconel 600 in the 600°F range is favored by higher stresses and higher temperature. Test data from experiments with 10% and 50% caustic concentrations show that 10% is the more aggressive environment.

Axial, throughwall crack,  
13/16-inch long

Axial, partial penetration crack  
(assumed to be aligned as shown)

SUMMARY OF EXAMINATION OF H. B. ROBINSON TUBE --  
R36 C37 HOT LEG, STEAM GENERATOR B

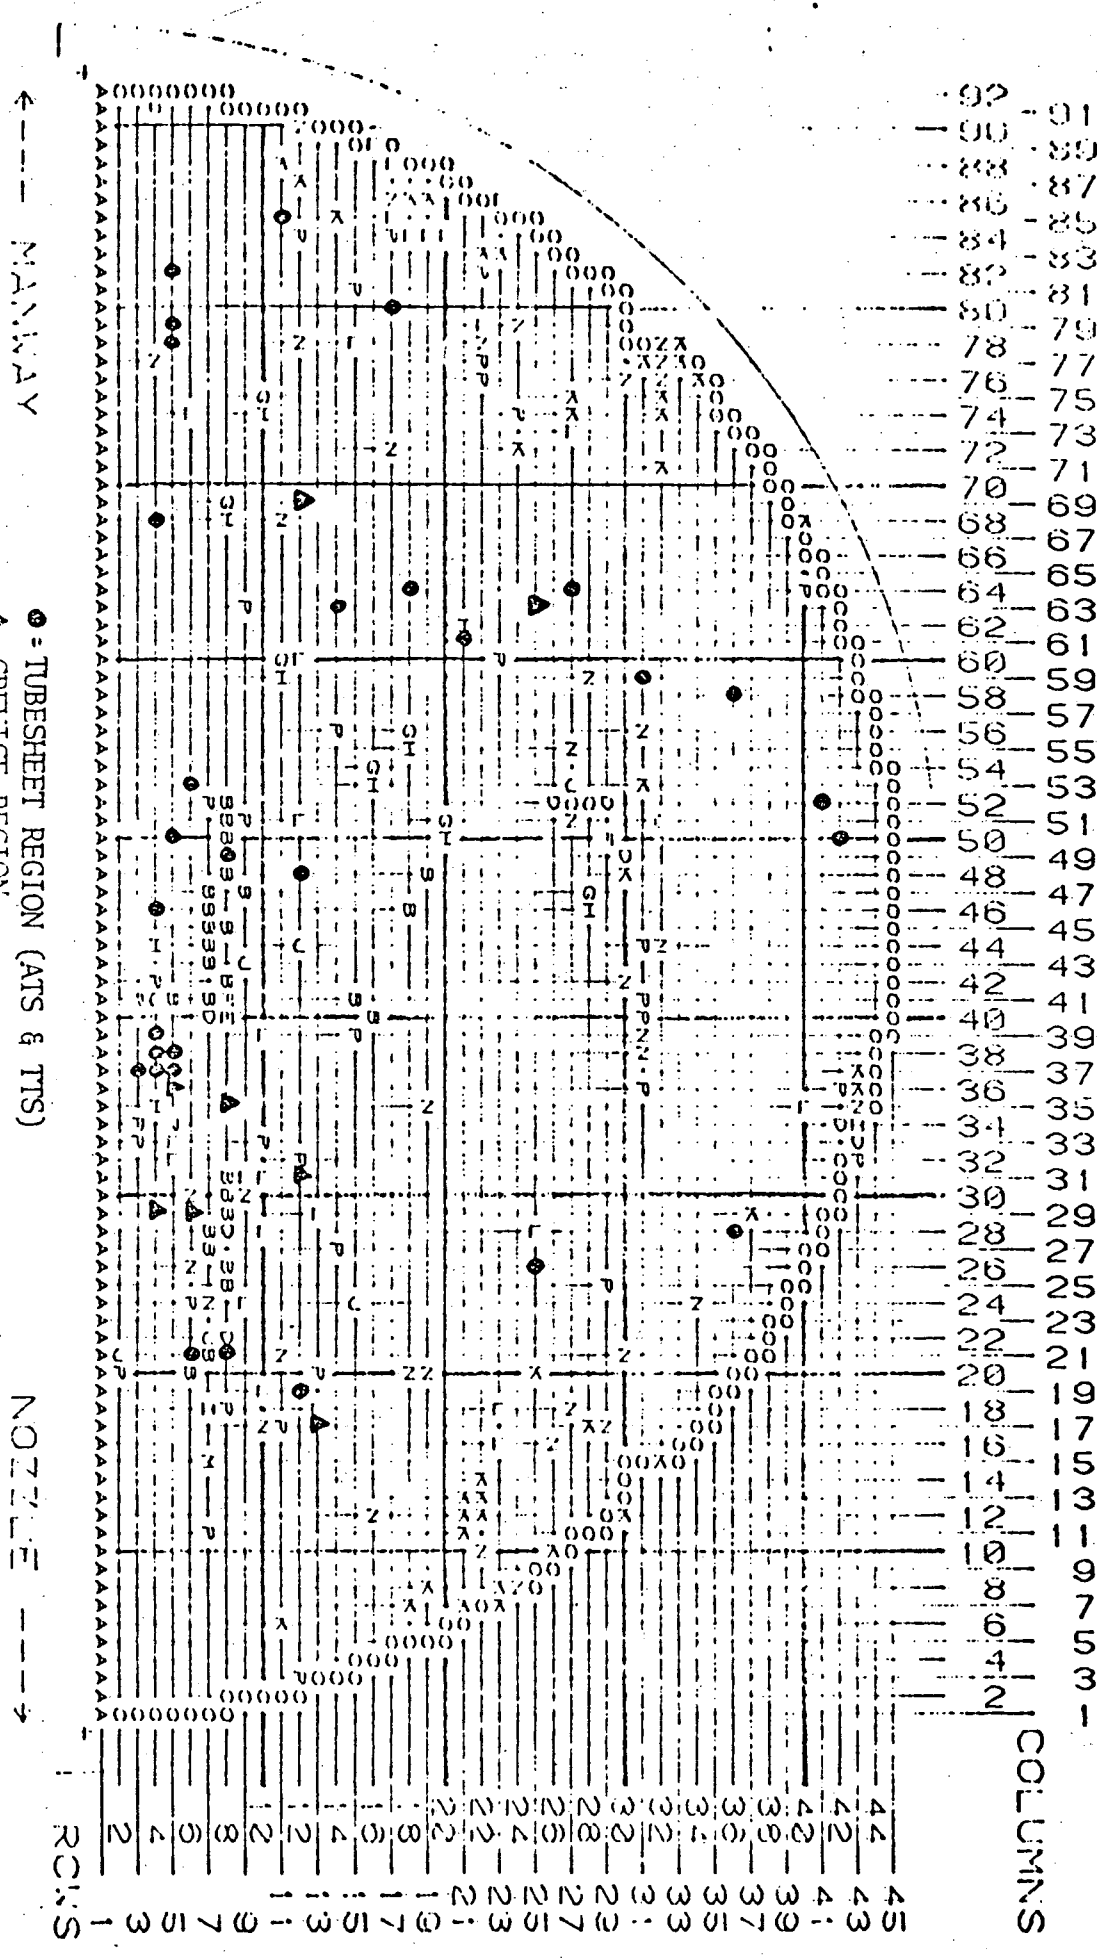
The numbers of the plugged tubes in each of the elevations (regions) within the steam generator where the pluggable indications or distorted signals were observed are tabulated in Table 4.1.1. The distributions of the tubes plugged for crevice region and tubesheet (combined above the tube sheet and top of the tube sheet) indications are plotted on tube sheet maps for each steam generator in Figures 4.1.1 to 4.1.3.

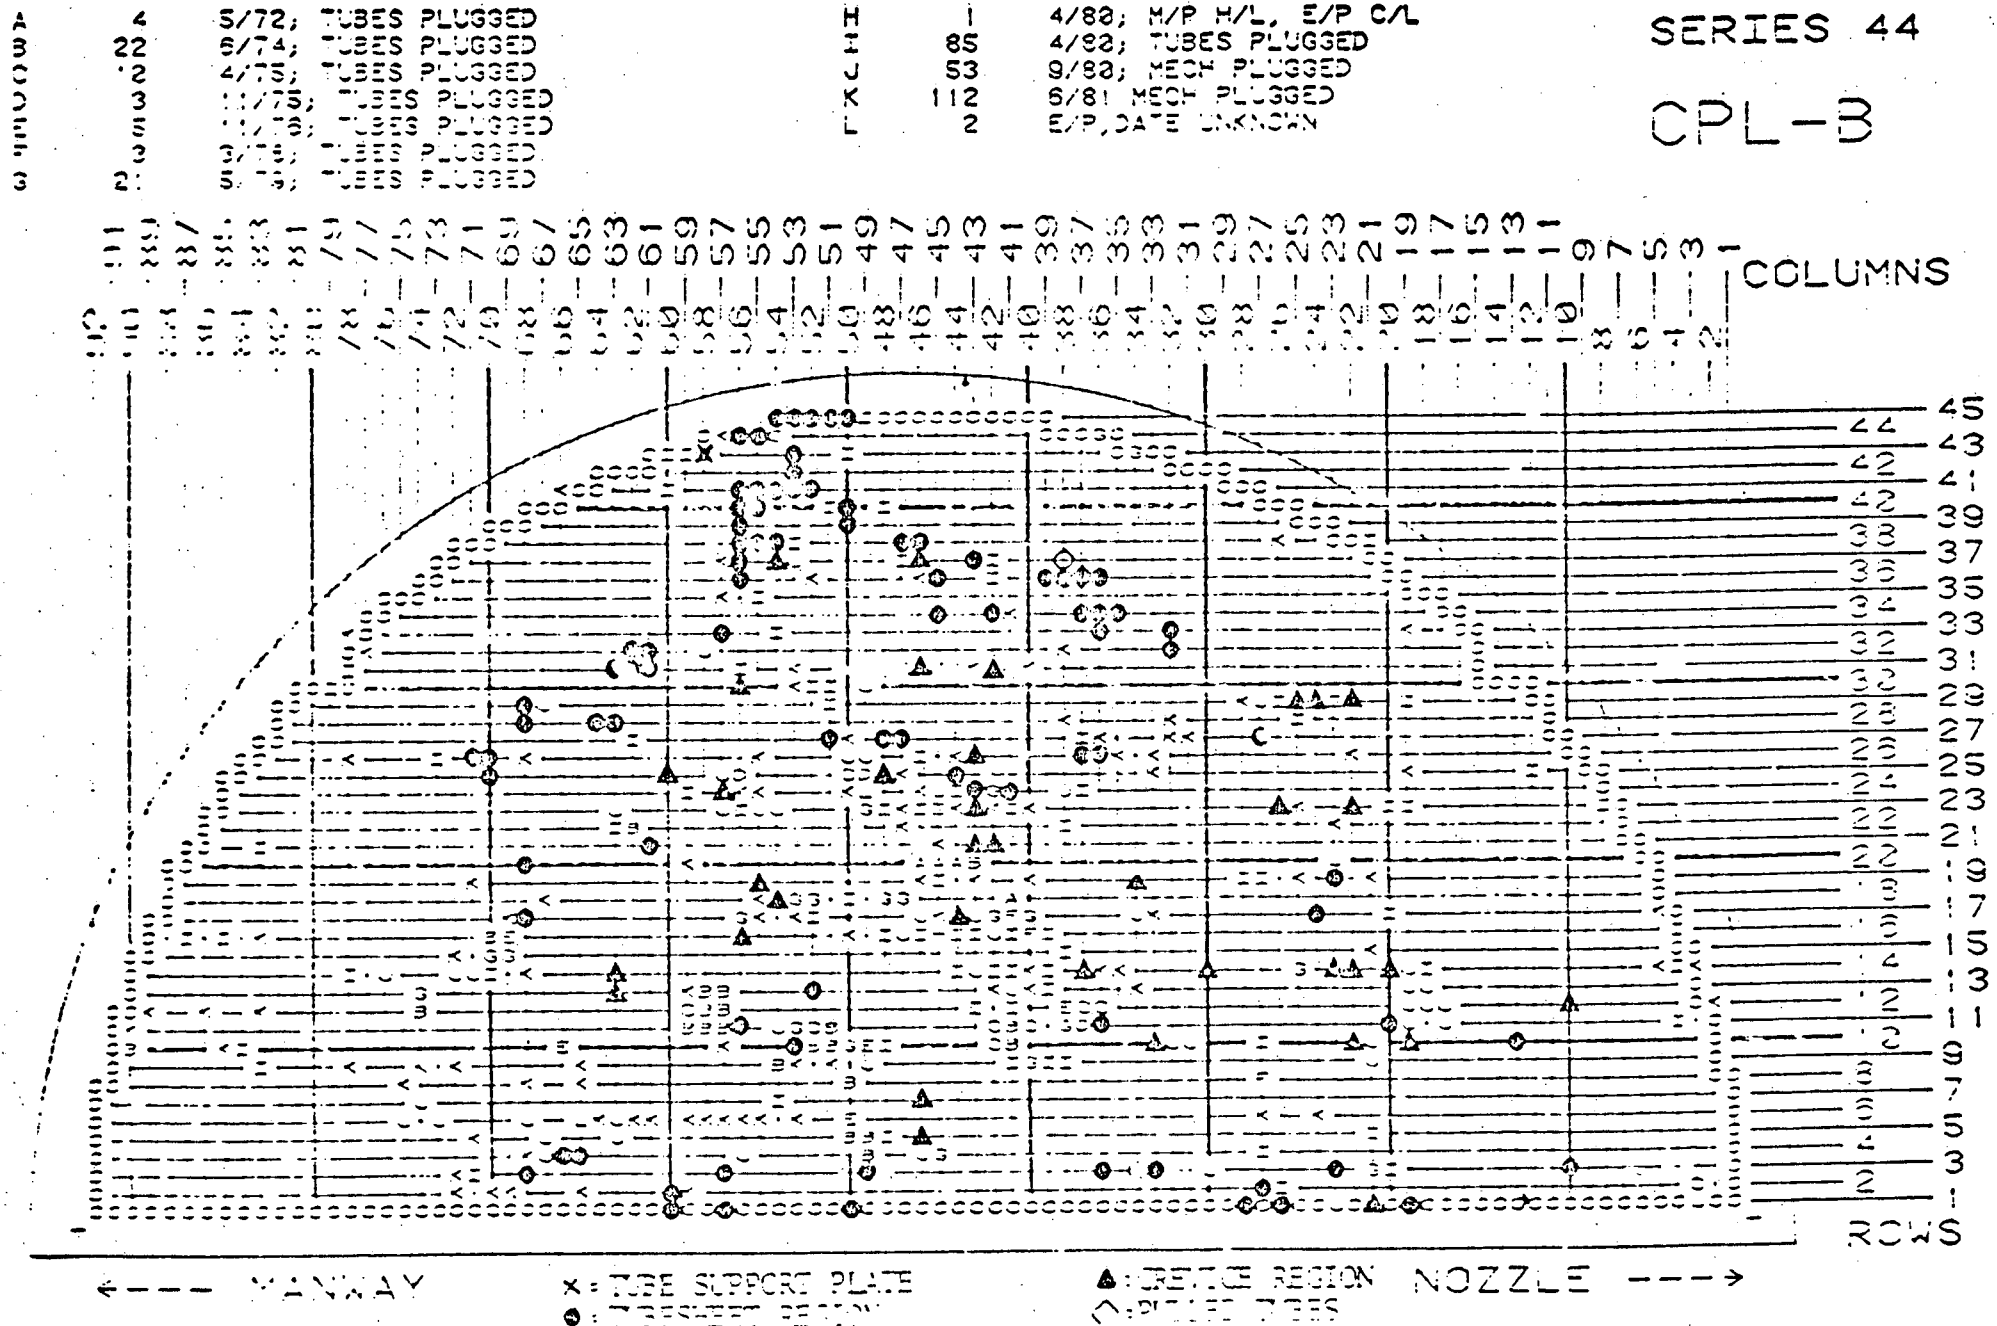
**FIGURE 4.1.2**

TUBES PLUGGED  
H. B. ROBINSON = 2  
Steam Generator B  
8/31 INSPECTION

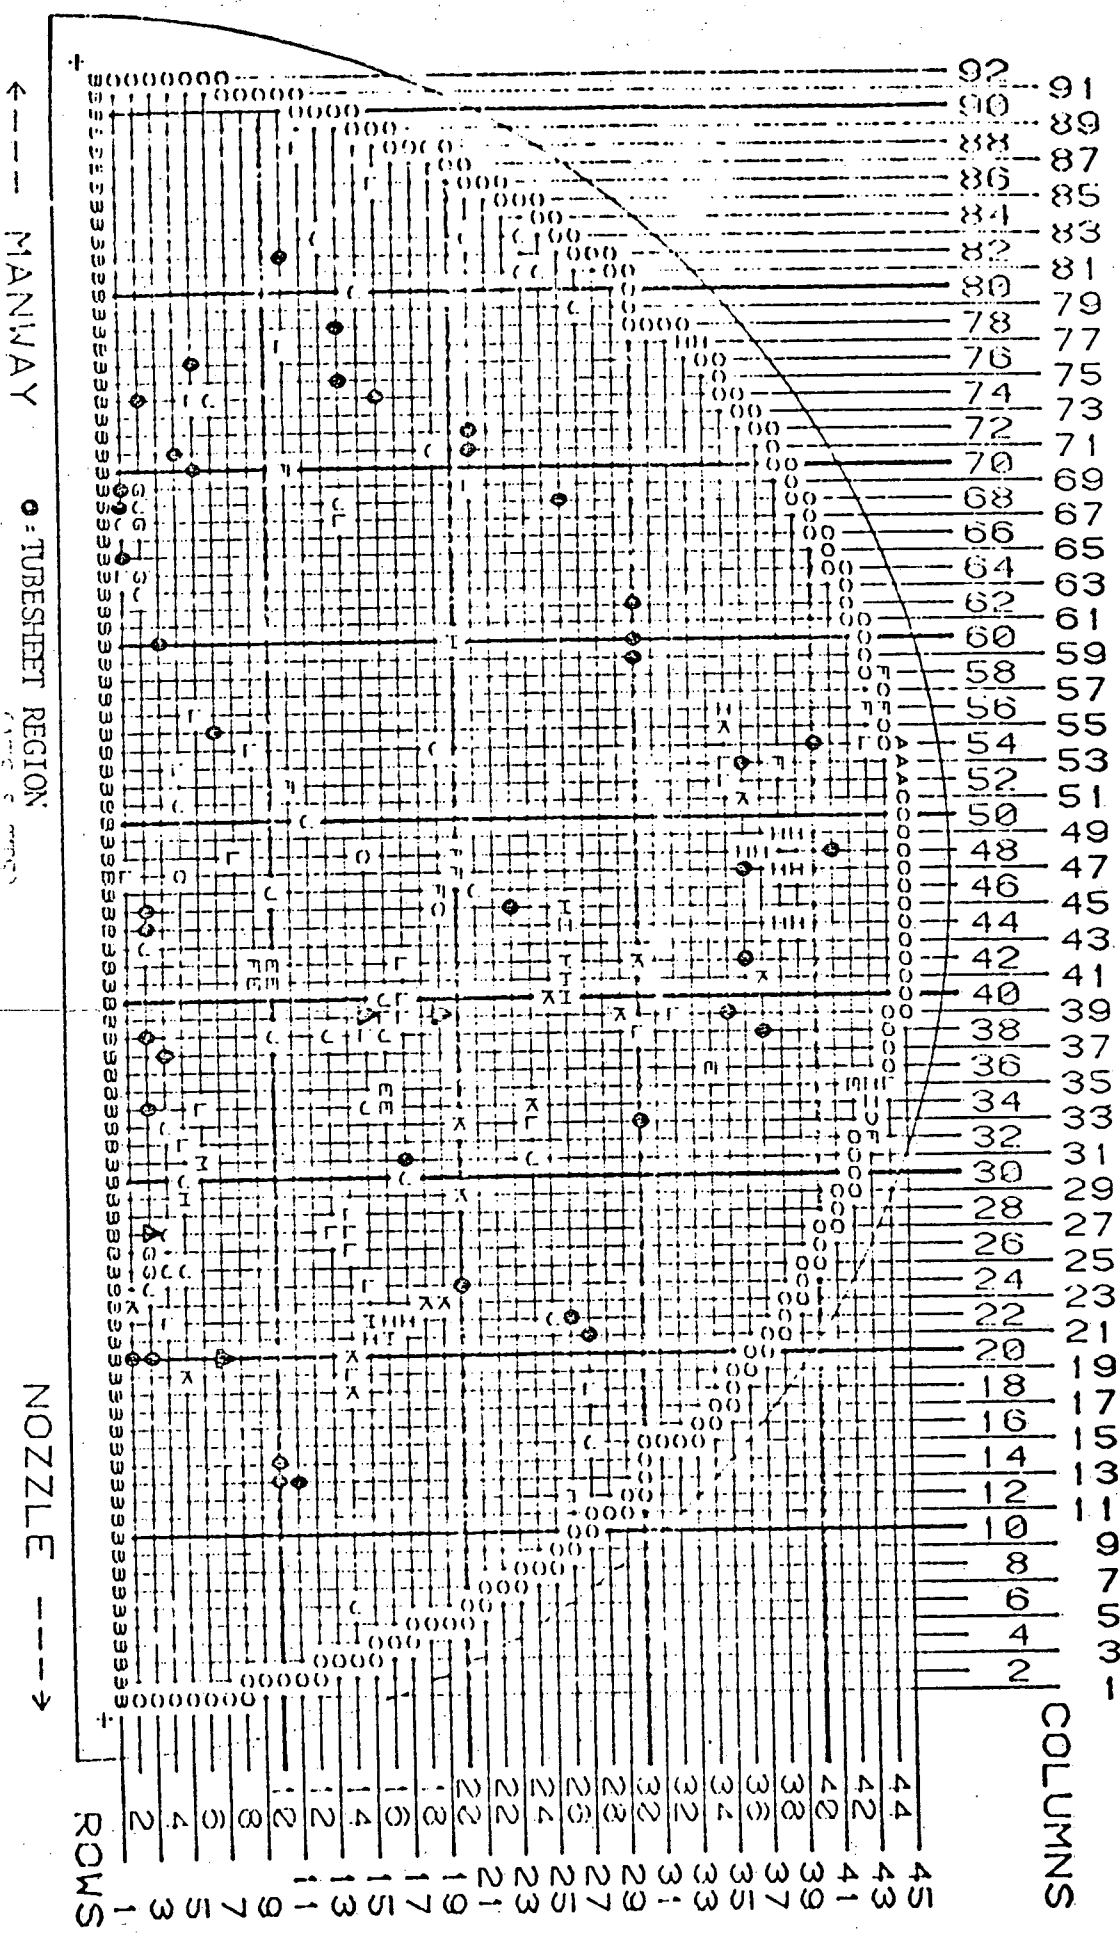
TUBES PLUGGED  
H. B. ROBINSON #2  
STEAM GENERATOR C

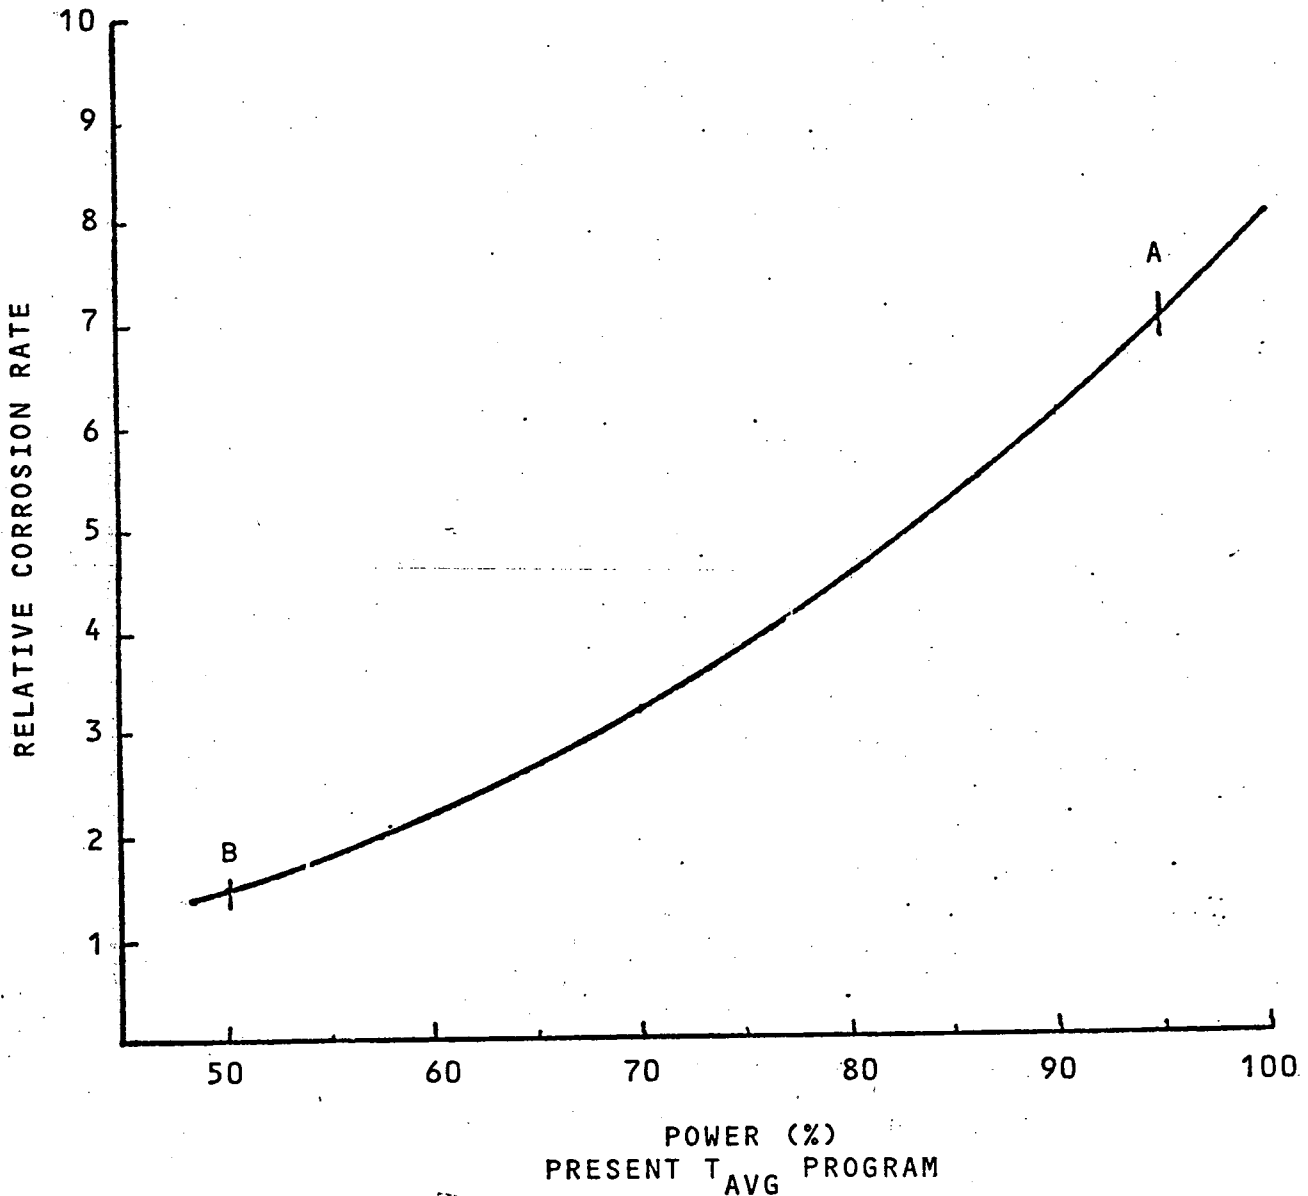
FIGURE 4.3.1

Figure 4.3.1 represents the approximate relative corrosion rate of mill annealed I-600 in a 10% NaOH environment as a function of power level under the present operational  $T_{AVG}$  program at H. B. Robinson Unit 2. (The original corrosion rate data were developed as a function of temperature and this has been related to power levels by equating values for  $T_{HOT}$  to the original corrosion rate vs temperature curve). The points A&B indicated on the curve for the example of 95% and 50% power represent a reduction of approximately a factor of 5 in the corrosion rate. A reduction in rate, coupled with the anticipated benefits of the sludge lancing and flushing, should reduce the rate of tube degradation occurring in the sludge pile region. Therefore CP&L intends to operate Robinson-2 at an approximate power level equivalent to 50% or 576°F ( $T_{HOT}$ ) for the remainder of this operating cycle.

2. The corrosion rate data of Figure 4.3.1 illustrates that a reduction to 50% power should gain an approximate 4.7 fold benefit in reduced corrosion rate to give an effective 112 days ( $4.7 \times 24$  days from 1. above) at 50% power.

RELATIVE TUBE CORROSION RATE AS A FUNCTION OF  
POWER LEVEL WITH AN ASSUMED ENVIRONMENT OF 10% NaOH
