H. B. ROBINSON STEAM ELECTRIC PLANT, UNIT NO. 2
DOCKET NO. 50-261/LICENSE NO. DPR-23

SUBMITTAL OF CONTAINMENT SURVEILLANCE TENDON TEST RESULTS

TITLE: Inspection and Evaluation of Containment Prestressed Tendon
25-Year Surveillance Block

Document No. 96236-TR-01
Revision 0
Volume 1 of 1

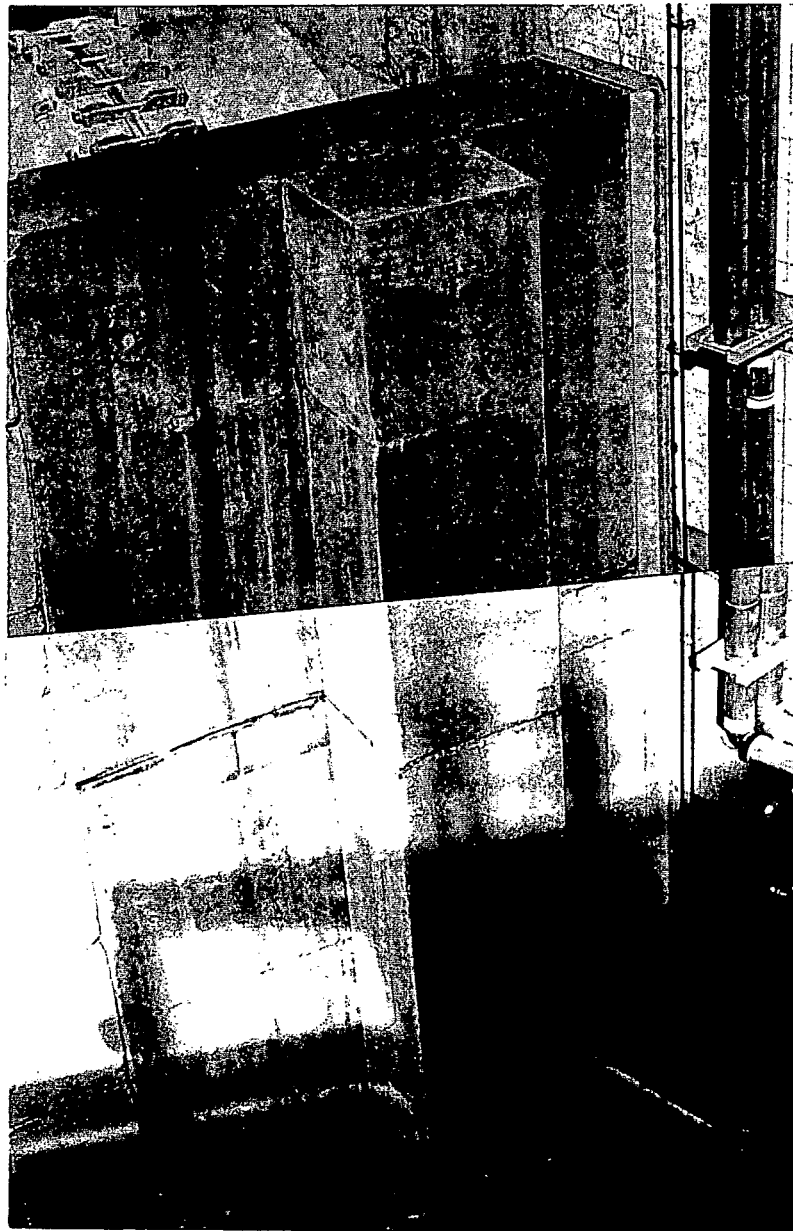
FIGURE A1.

During a site visit to the Robinson Nuclear Power Plant, the surveillance tendon block was visually inspected. The block was standing up-right, adjacent to the containment building (Figure A1). No evidence of damage or deterioration was detected on the exposed surfaces of the block.

Surveillance Tendon Block at Robinson Nuclear Power Plant

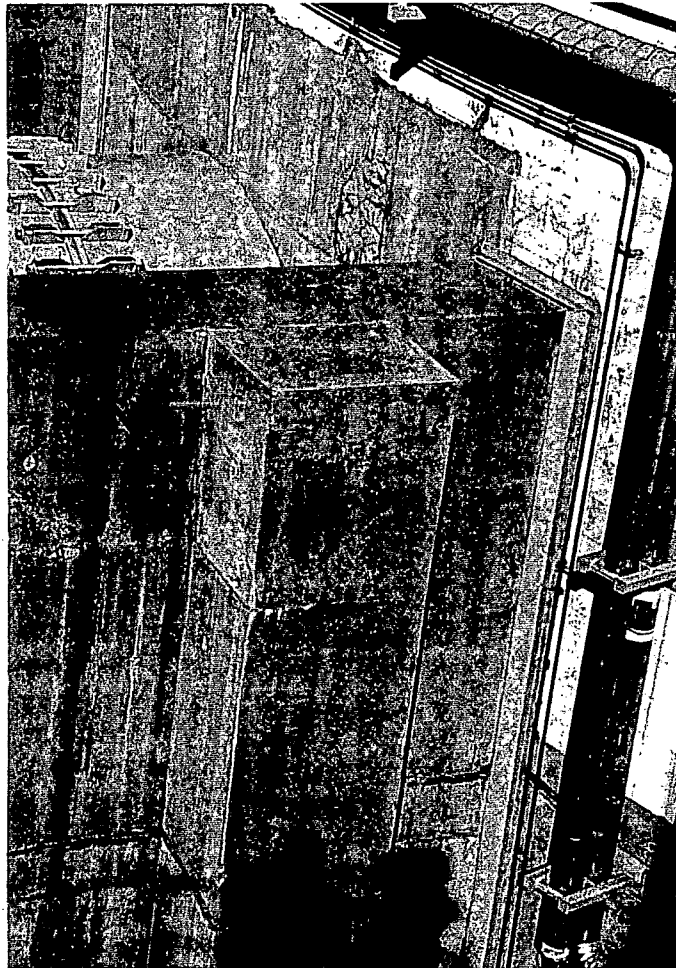
FIGURE A3.

pattern can be categorized as map cracking (Figures A3 and A4). Later coring of this section revealed that this was only a mortar-type repair material measuring approximately 0.75" thick. It was applied to the upper section of the block after construction was complete. Concrete under this outer layer was similar in composition to the rest of the block (Figure A5).

Surface Cracks On The Top Portion Of The Block

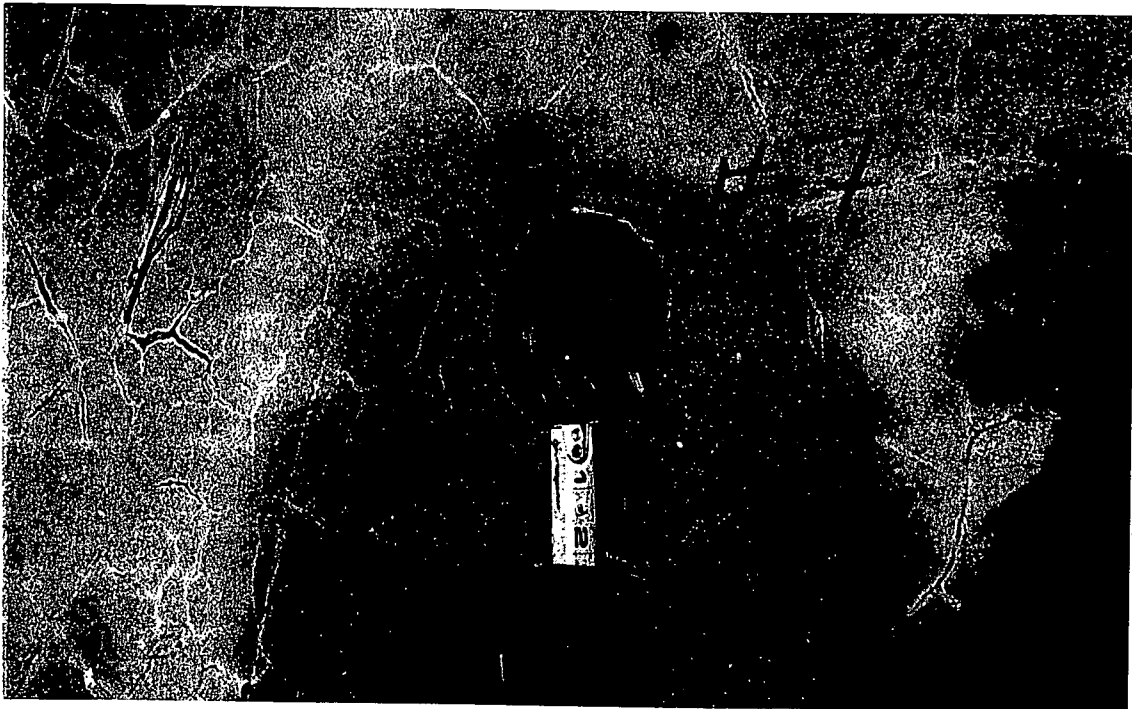
Depth of Repair Material Applied to the Surface
FIGURE A5.

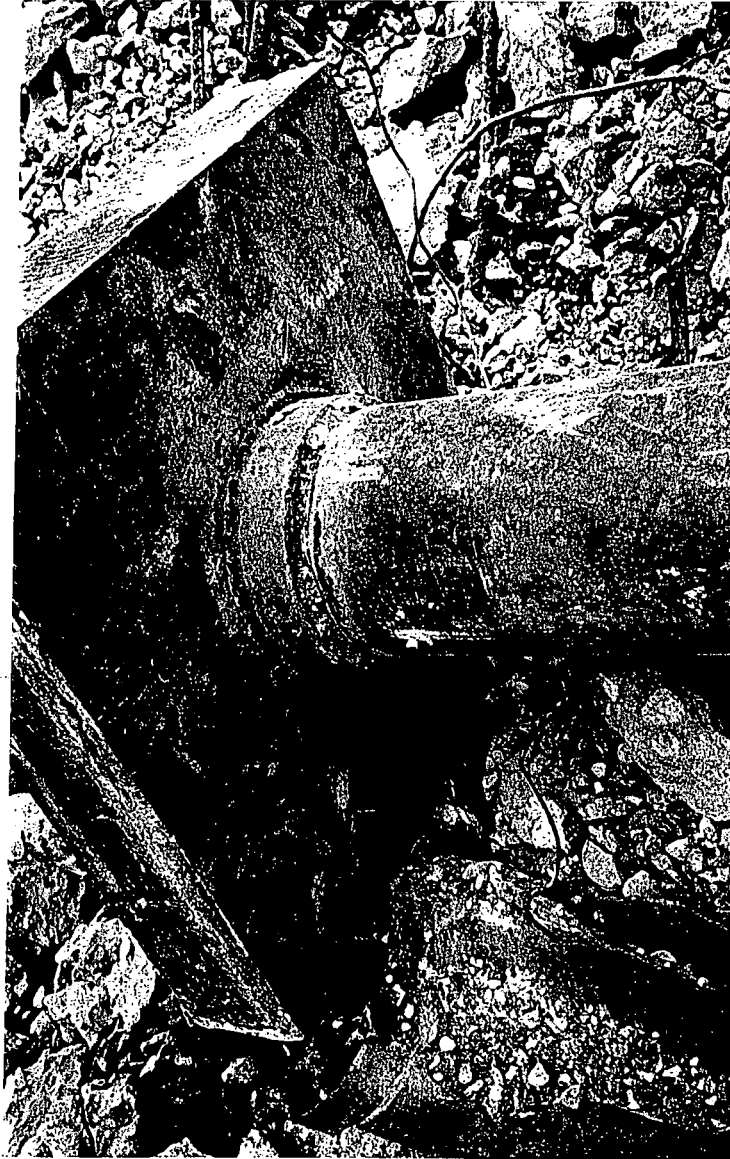
Figures A11 to A19 show the different parts of the tendon assembly immediately after exposure. Figure A11 and A12 show the base plate and a detail view of its bottom side. The superficial corrosion products (stains) on this surface were slightly covered with oil, and corrosion was limited to only the metal surface. The surrounding concrete did not contain any corrosion products. This oily surface indicates that the corrosion had not been active after construction and most likely was present at the time of construction. Figure A13 shows a close-up of the grouting pipe attached to the bottom of the base plate.

The Bottom Base Plate
FIGURE A11.

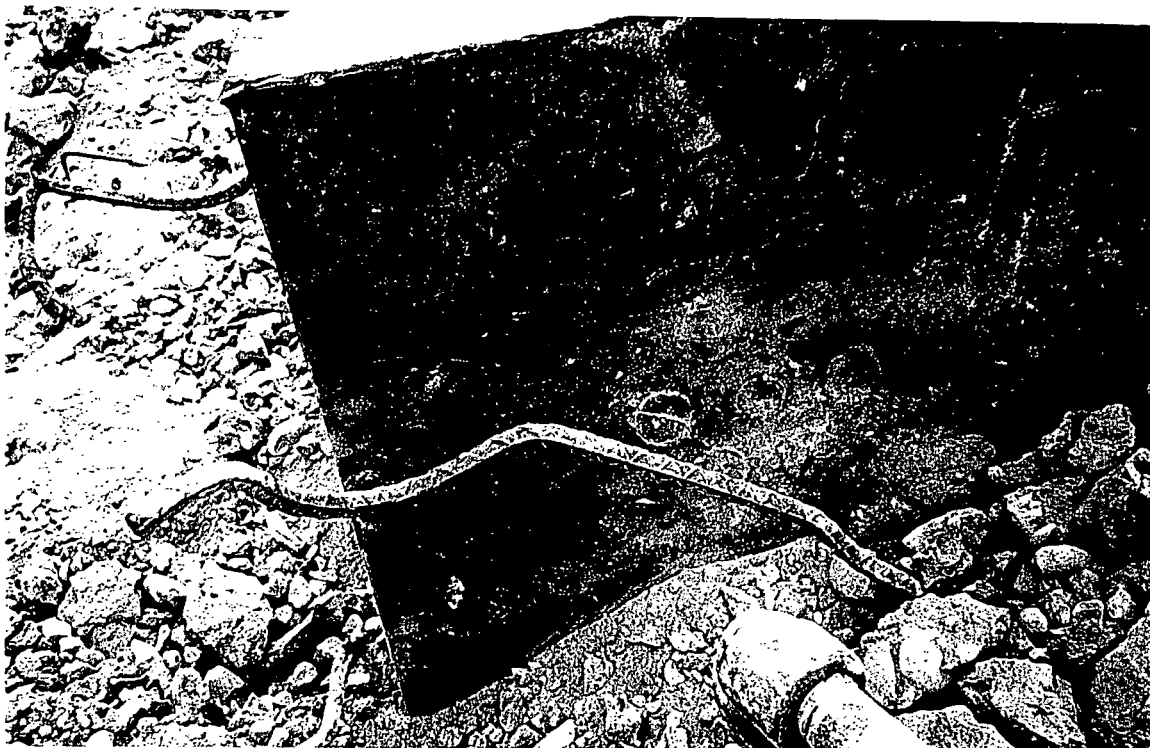
View of the Bottom Face of the Bottom Base Plate
FIGURE A12.

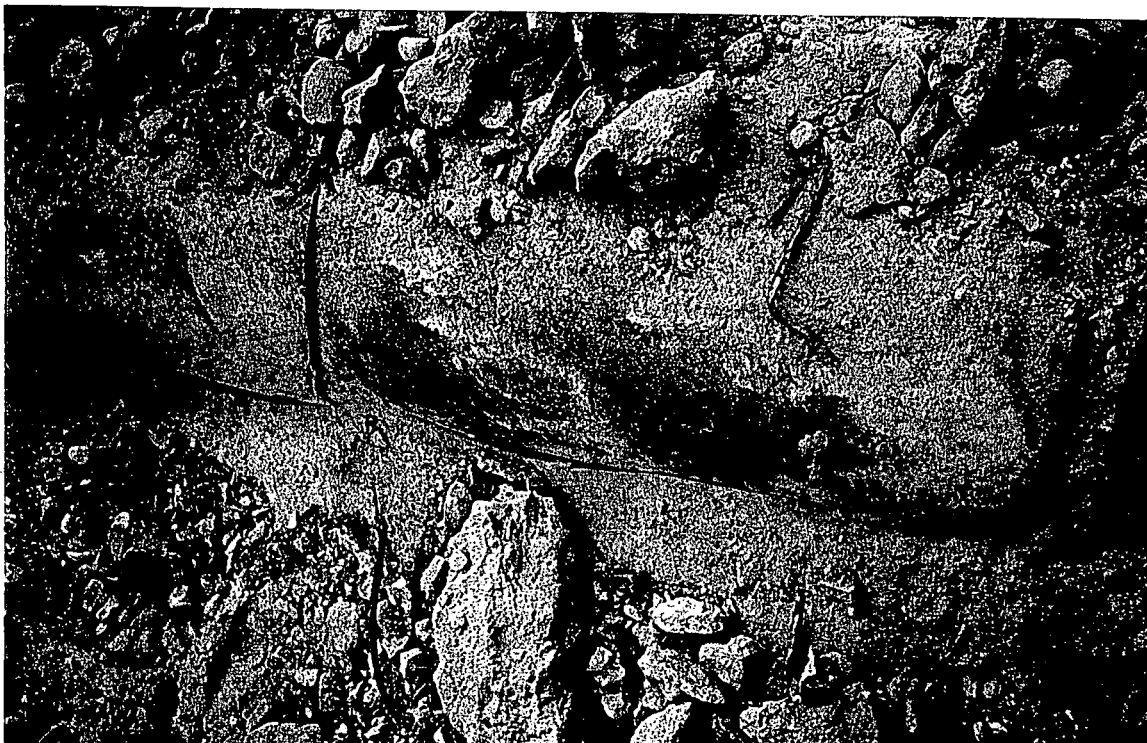
Figures A14 to A16 show the outside surface of the galvanized steel pipe housing the tendon rods and the pipe-concrete interface. The entire surface was clean with no sign of corrosion. A pocket of loose, brown, moist powder, approximately 5 cubic inches in volume, was discovered directly beneath the top plate. A small sample was collected and sealed in a plastic bag for further analysis (Figure A17). The powder material was surrounded by cement grout rather than concrete. It appears that this grout had seeped out of the pipe during grout injection and filled a void beneath the top anchoring plate. The chemical constituents of this powder was determined by Energy Dispersive X-ray Analysis (EDX) (Table 1) and was found to be consistent with the normal constituents found in Portland cement. The material is most probably unhydrated cement grout which did not harden due to the partial contamination with foreign materials such as a lubricant or sealing agent used in other components of the tendon assembly. The quantity was insignificant and was not related to any corrosion or aging mechanism. Figures A18 to A20 show the anchoring plate located at the top of the tendon assembly. Figure A18 shows the bottom surface of this plate while Figures A19 and A20 show the exposed galvanized steel cap on the top of this plate.

Surface of the Pipe Encasing the Tendon Bars
FIGURE A14.

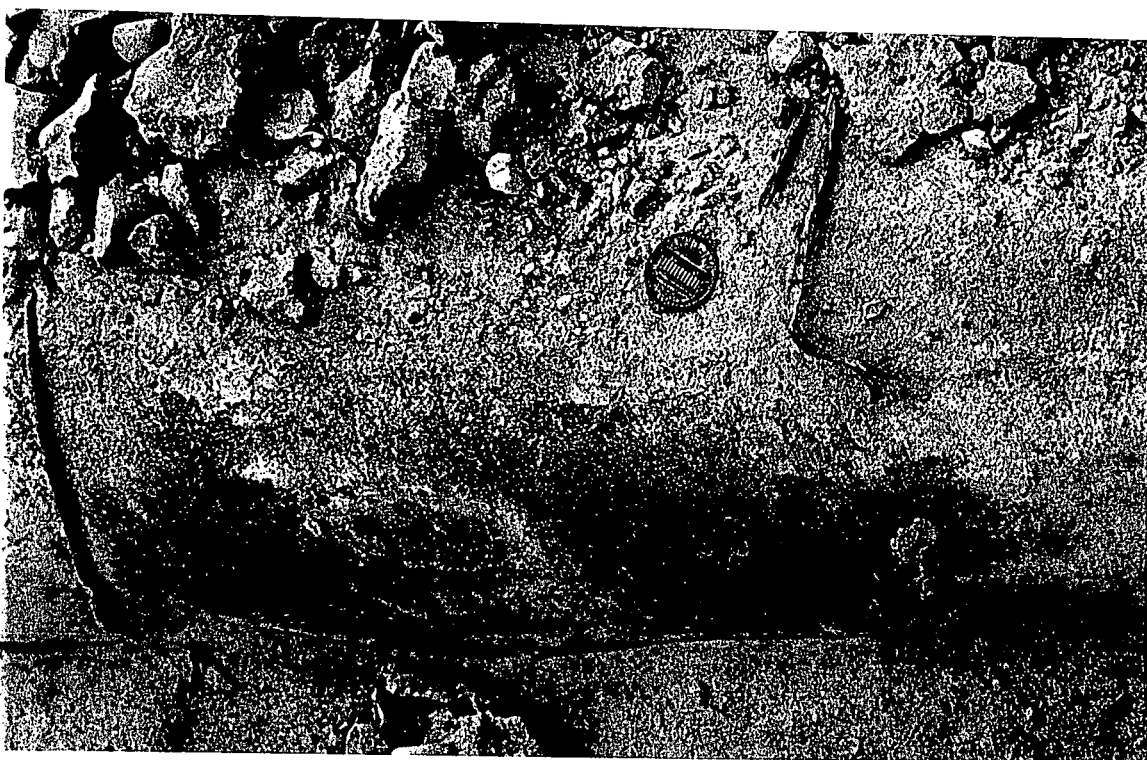
Close-up of Pipe Surface Encasing the Tendon Bars
FIGURE A15.

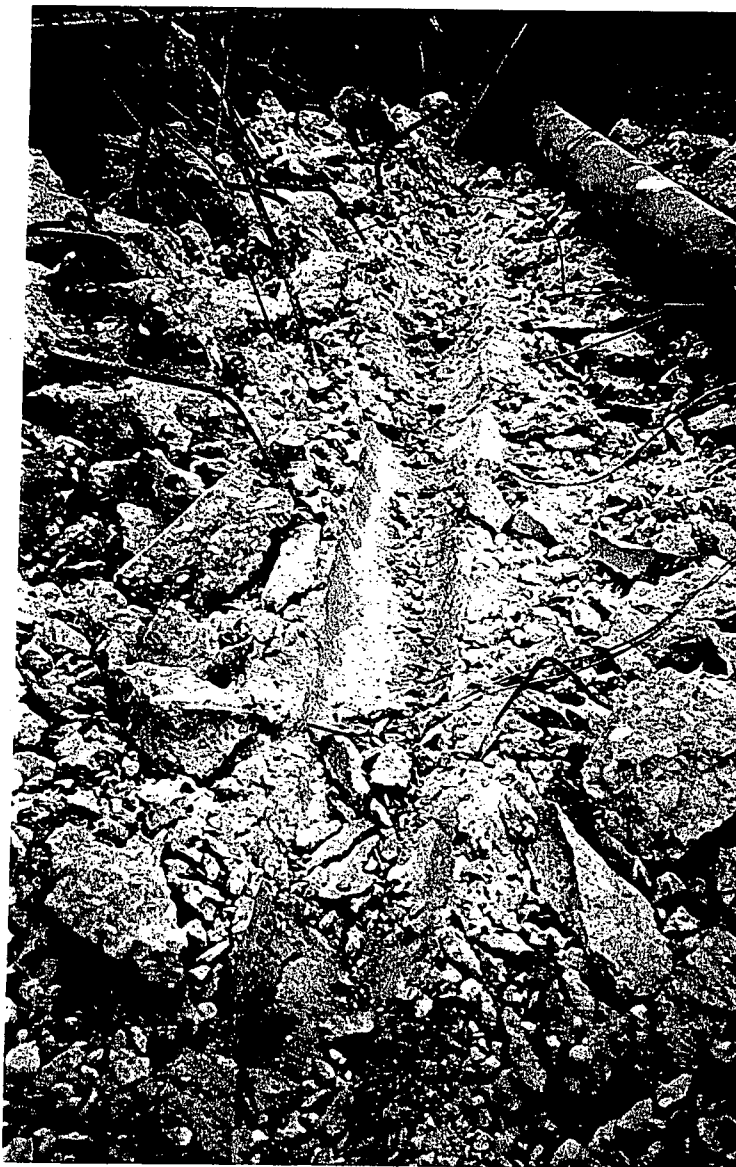
Concrete to Pipe Interface Region
FIGURE A16.

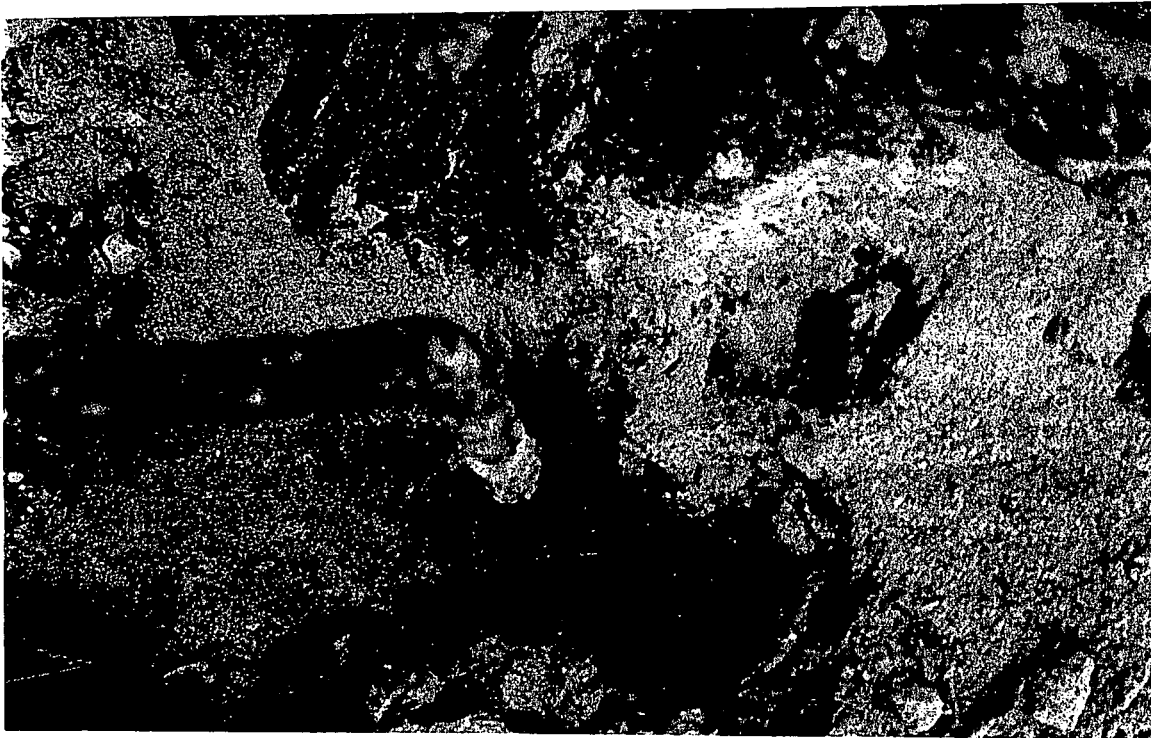
Unhydrated Grout Pocket Under Top Plate
FIGURE A17.

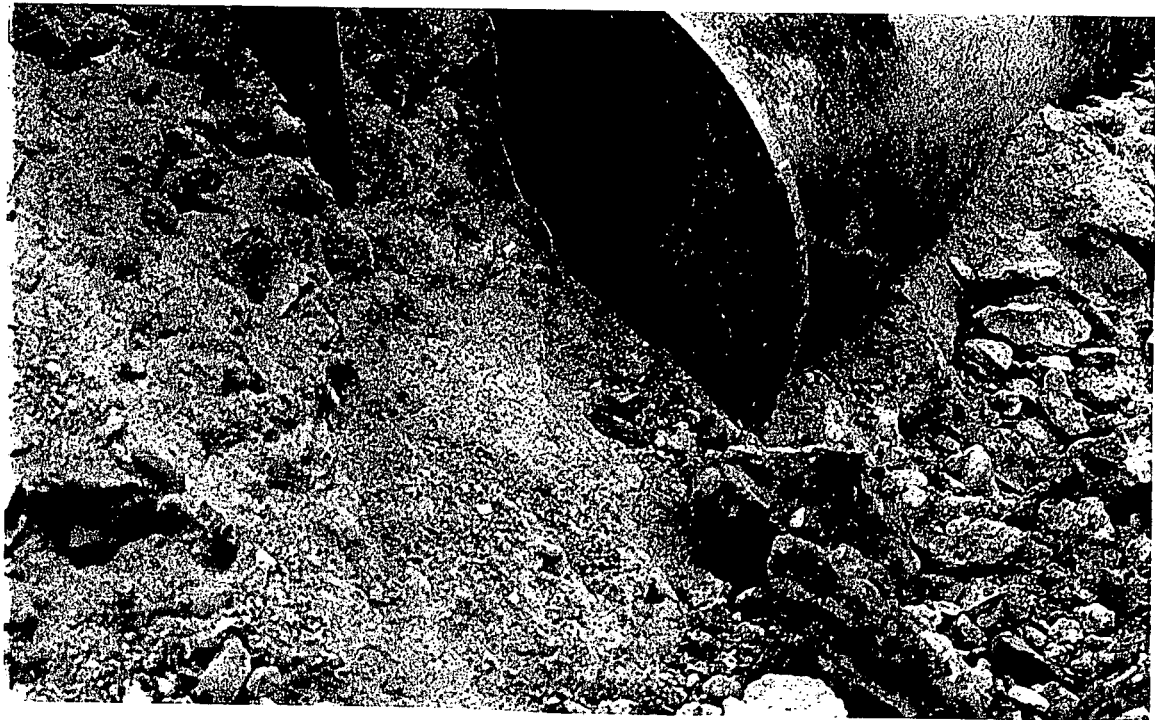
The outside surface of the galvanized steel cap had no signs of corrosion, but the bottom surface of the plate exhibited superficial corrosion which probably occurred during construction, based upon its uniform appearance. The spiral steel around both portions of the pipe exhibited no sign of corrosion.

End Surface of Top Plate Cap Immediately After Exposure
FIGURE A20.

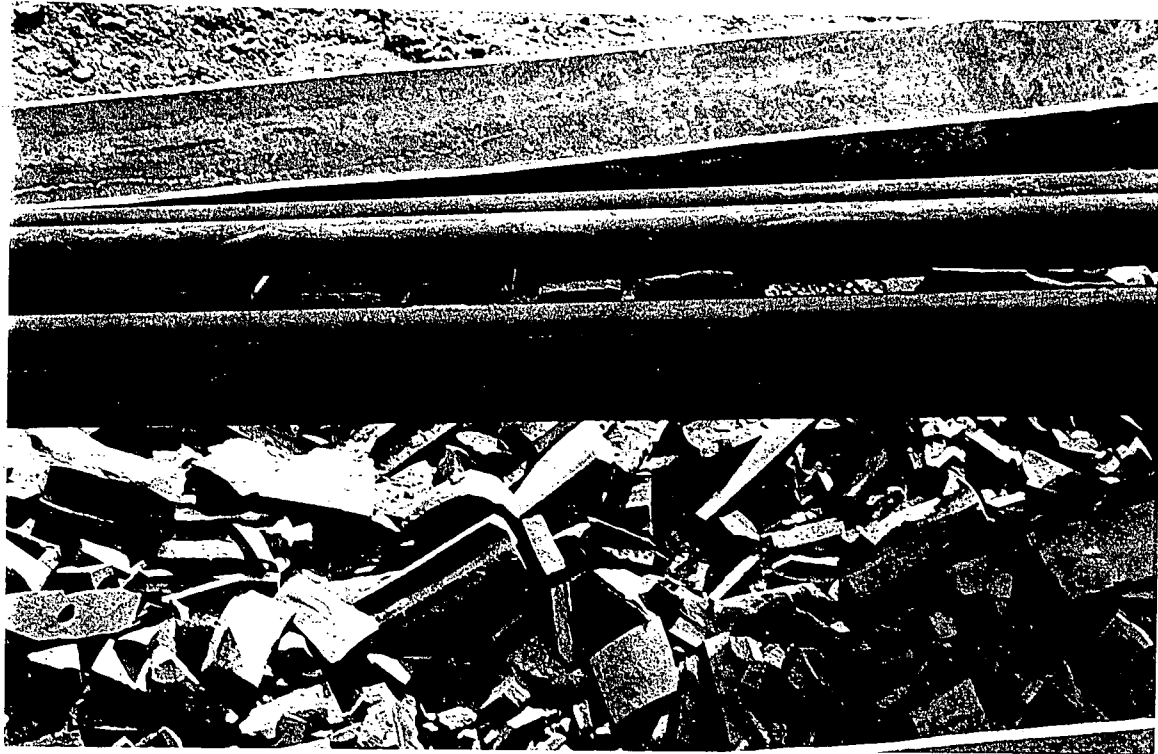
In some areas separated grout had a reddish-brown stain at the contact surface with the bars (Figure A34) that is suspected to be an oxide which occurred during construction.

View Depicting Reddish Stains on the Grout
FIGURE A34.

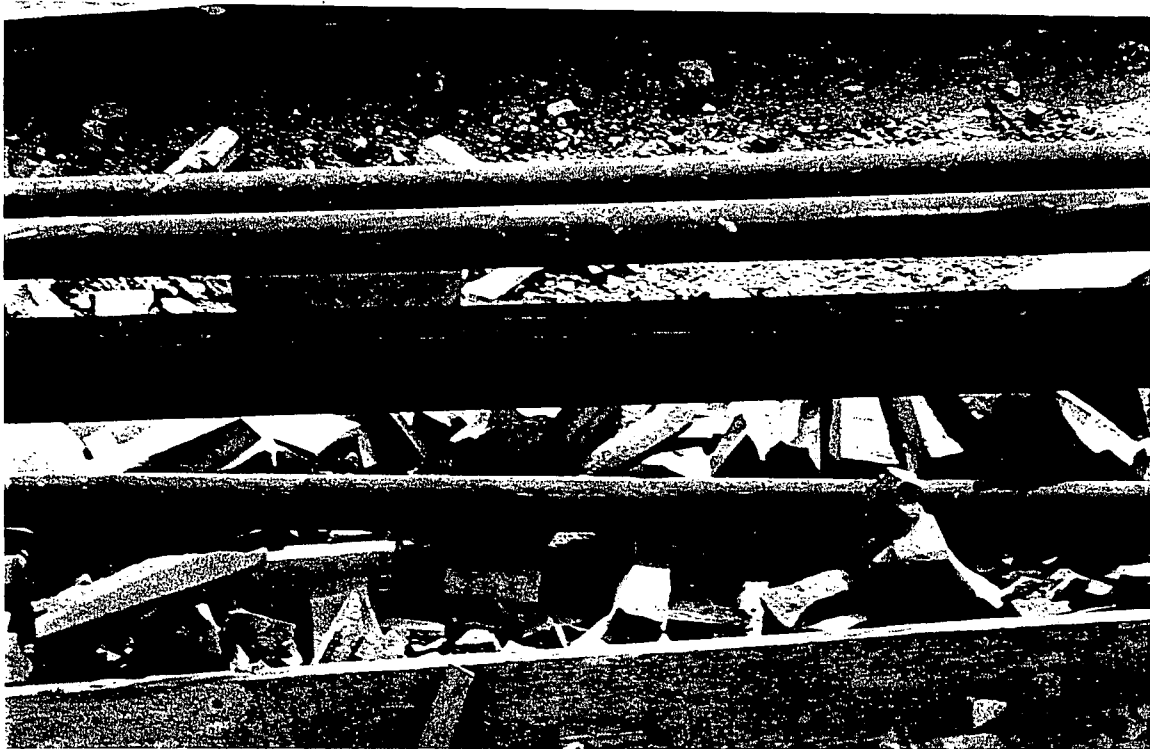
The surface of the bars were covered with a reddish-brown oxide that could be removed simply by wiping the surface clean by hand (Figures A35 - A37). No measurable metal loss or etching could be detected once the dust was removed. The couplings on three out of six tendons had clear marks which indicate that they had been touching the casing (Figures A38 and A39). There were no apparent signs of active corrosion or deterioration because of this. After proper marking to show the number and orientation of each bar, the bars were cut about 2' from each end plate (Figure A40) and all the components were transferred to the Altran materials laboratory facility in Cambridge, MA. Once in the lab, each individual specimen was logged and tagged as received. The components transferred to the lab are:

Corresponding Reddish Stain on the Bars
FIGURE A35.

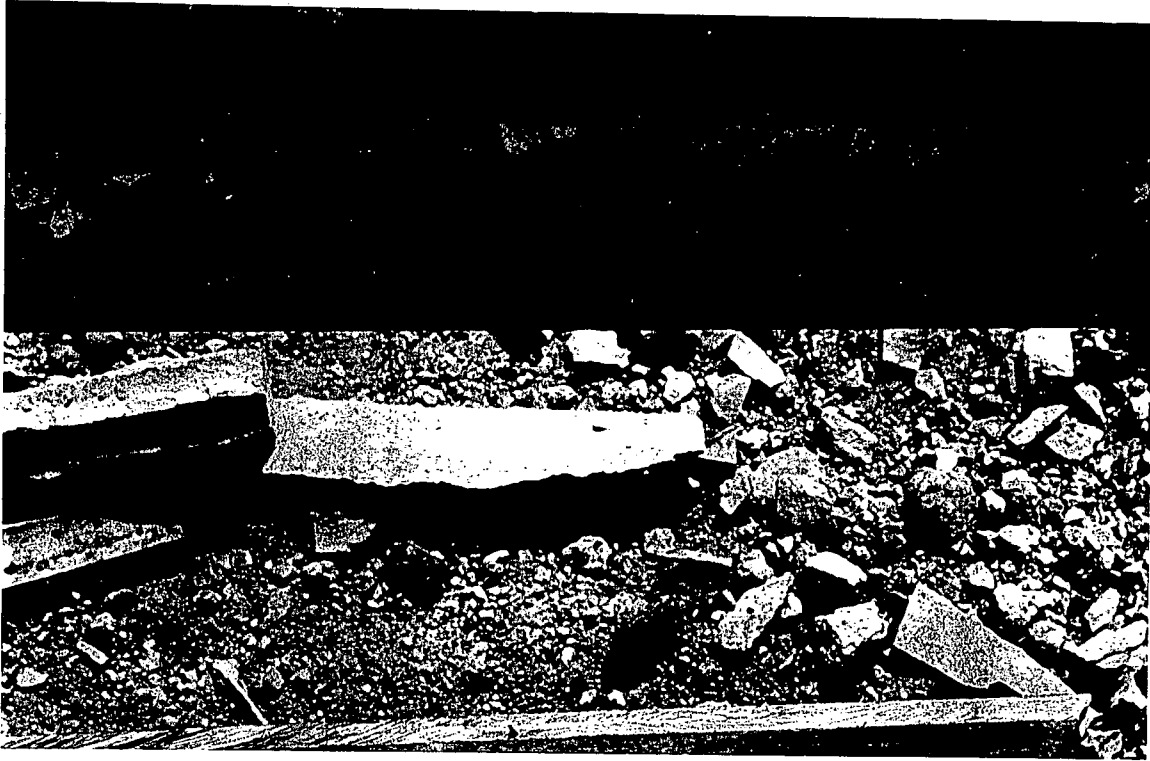
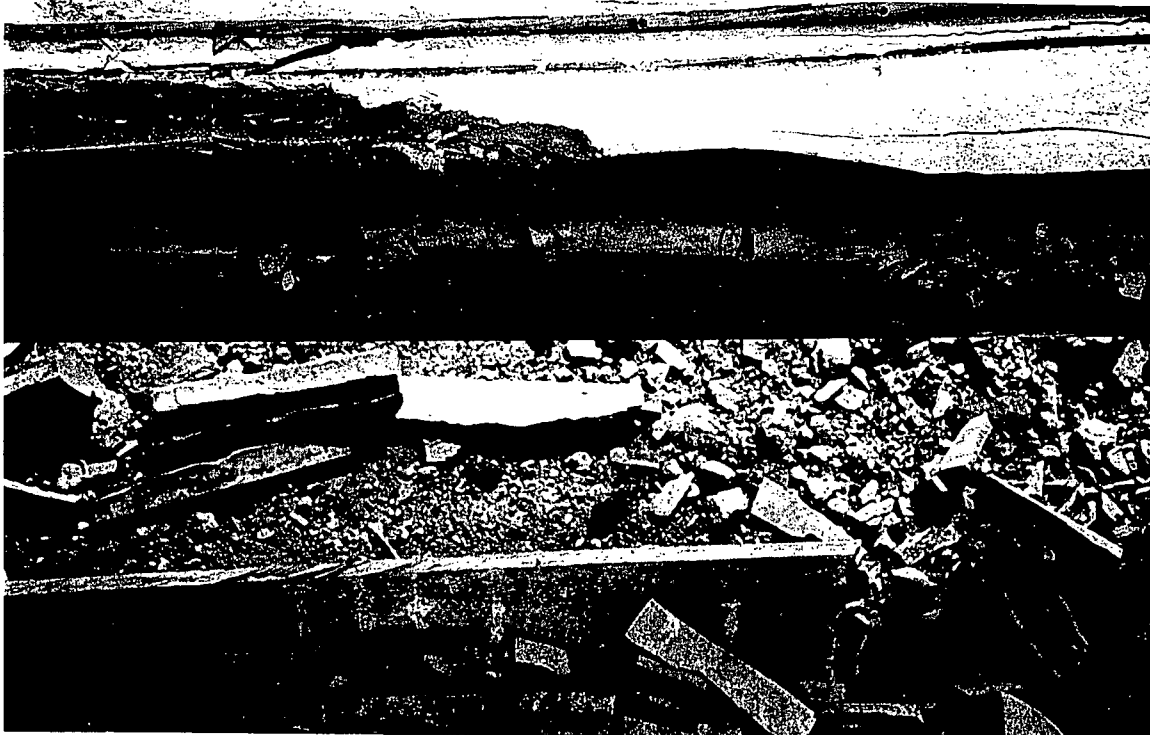
View Showing the Reddish Stain on the Bars
FIGURE A36.

View Showing the Reddish Stain on the Bars
FIGURE A37.

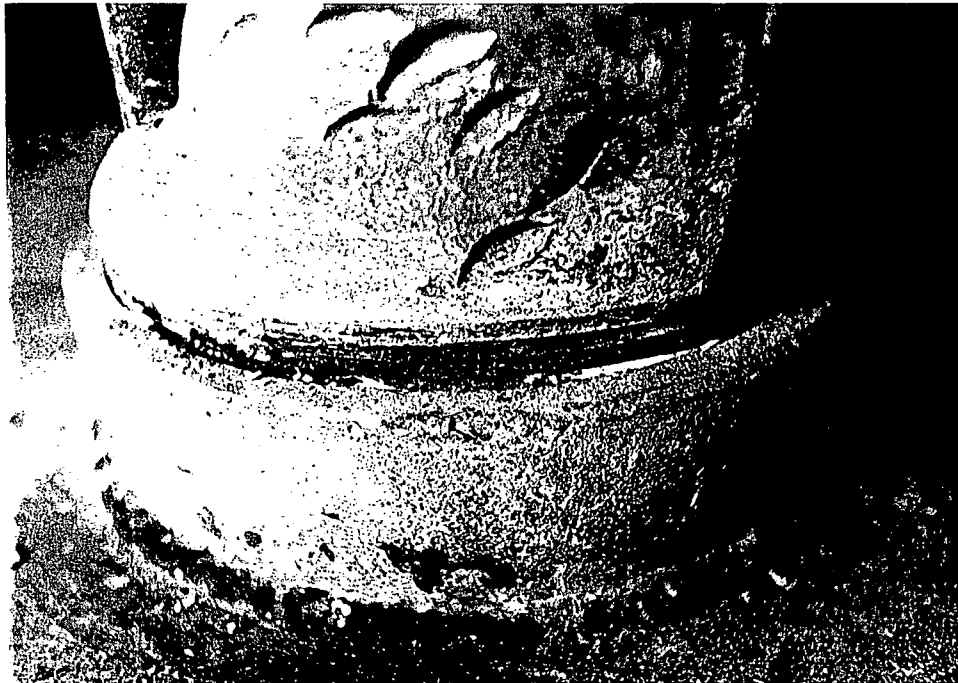
Detail View Depicting Corrosion at the Casing Threads
FIGURE A45.

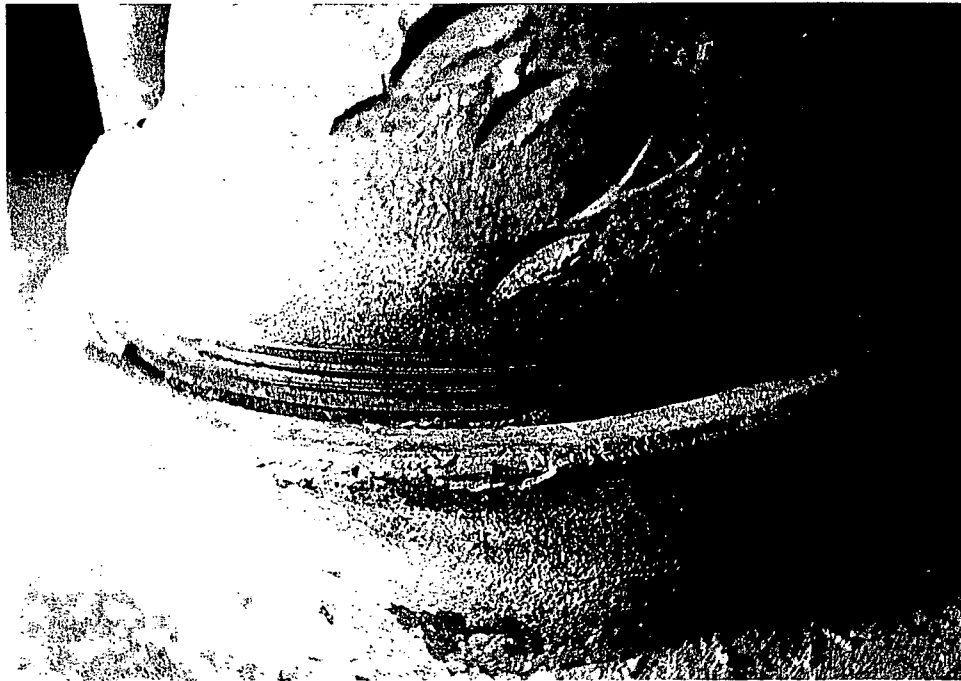
Same Corroded Section After Cleaning with a Wire Brush
FIGURE A46.

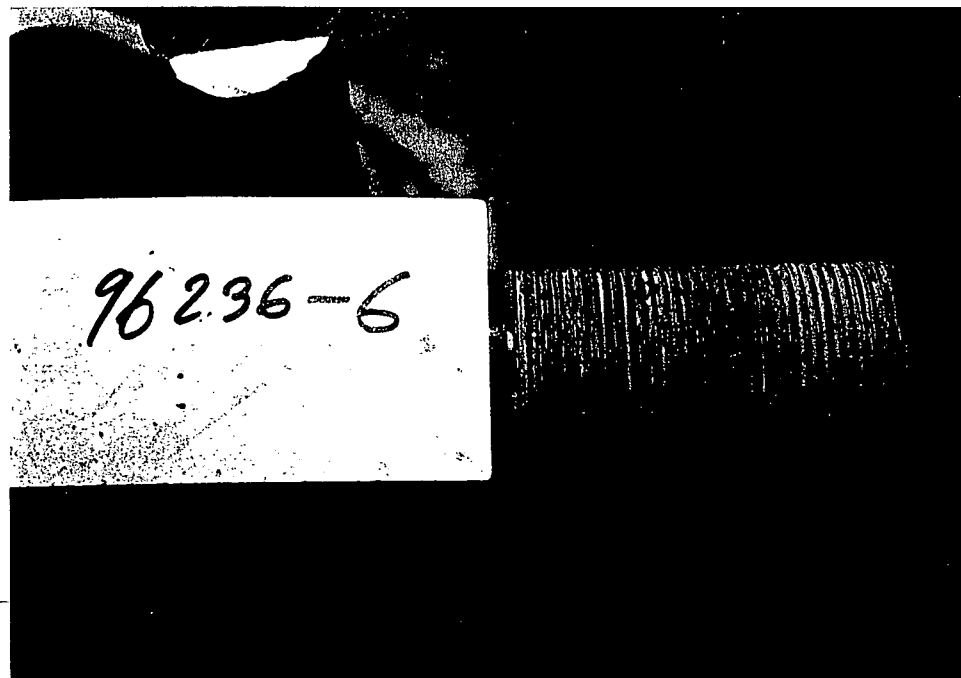
No sign of corrosion was detected around the bars. Bar number three was removed and the threaded sections inspected. There were no signs of corrosion either in the plate or on the threaded part of the bar (Figures A47 and A48).

The Threaded End of a Bar Removed from the Bottom Plate
FIGURE A47.

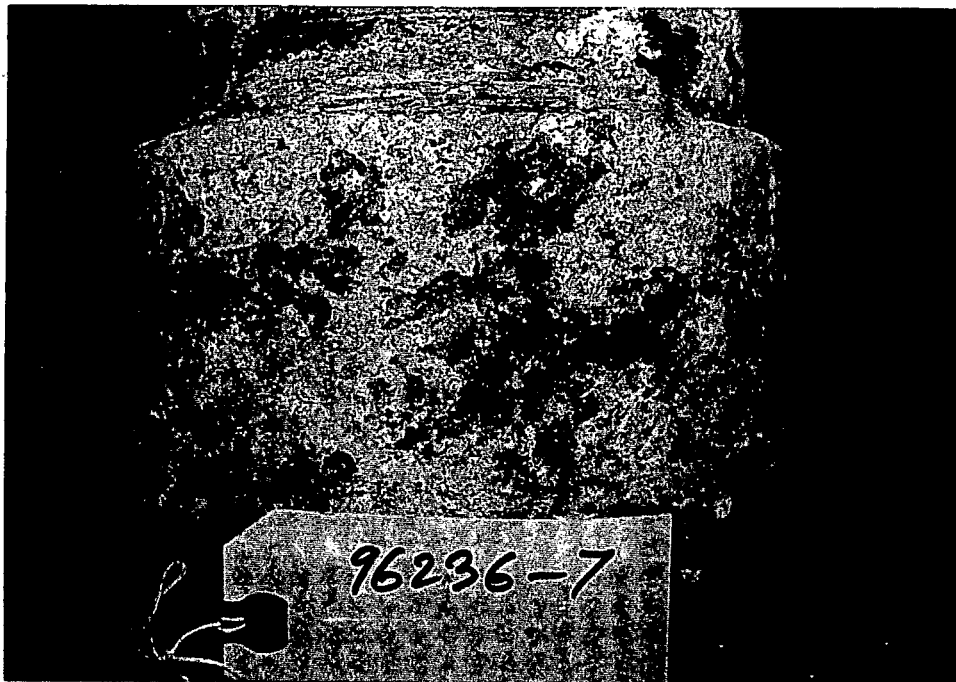
The only noticeable sign of corrosion was on the outside surface of the casing pipe coupling which spread over an estimated 15% of the surface (Figure A50). A spot which appeared to be the most severe, was cleaned and the depth of pitting was measured with a caliper (Figures A51 and A52). The depth of pitting was approximately 10 mils which was determined to be insignificant. This was very localized corrosion since no sign of propagation in the surrounding concrete or rebars could be detected when the block was cut. Owing to the high alkalinity and impermeability of the concrete surrounding the pipe coupled with the lack of moisture corrosion probably ceased shortly after construction.

Pipe Coupling Exhibiting Some Corrosion
FIGURE A50.

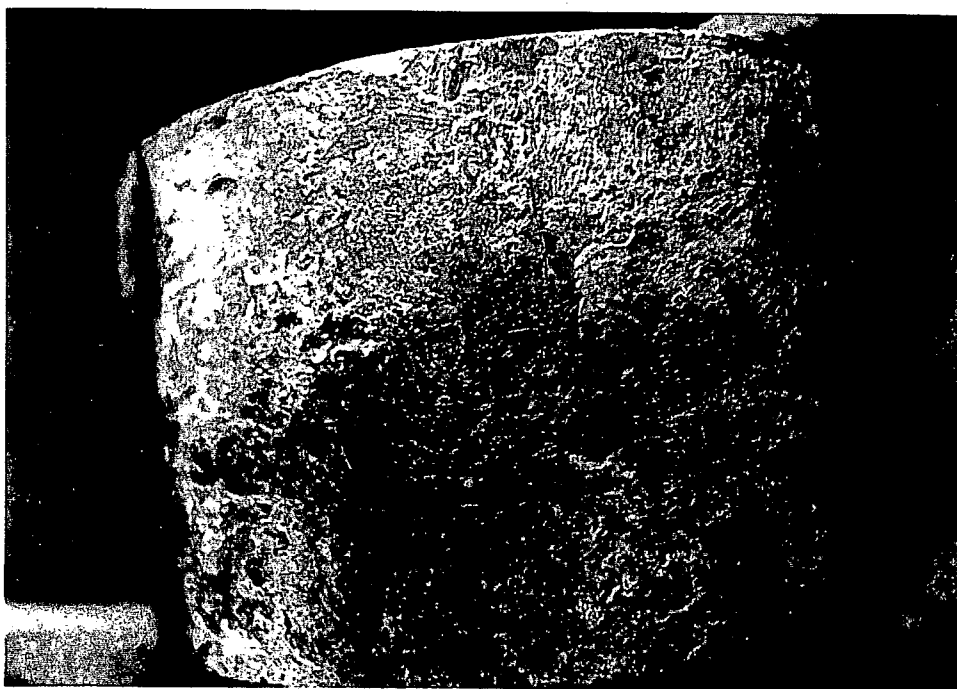
The Corroded Spot on the Pipe Coupling After Cleaning
FIGURE A52.

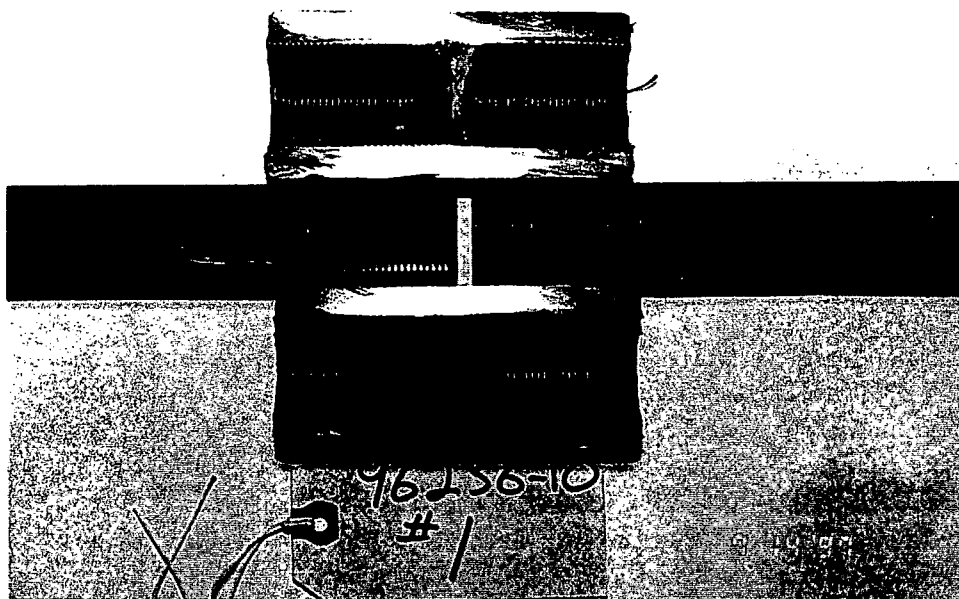
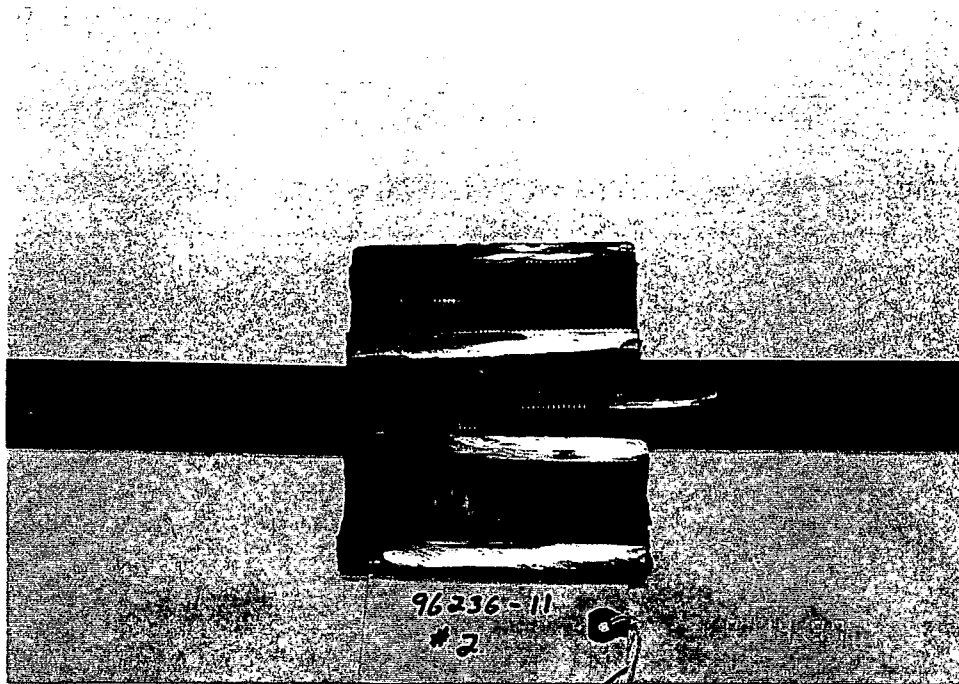
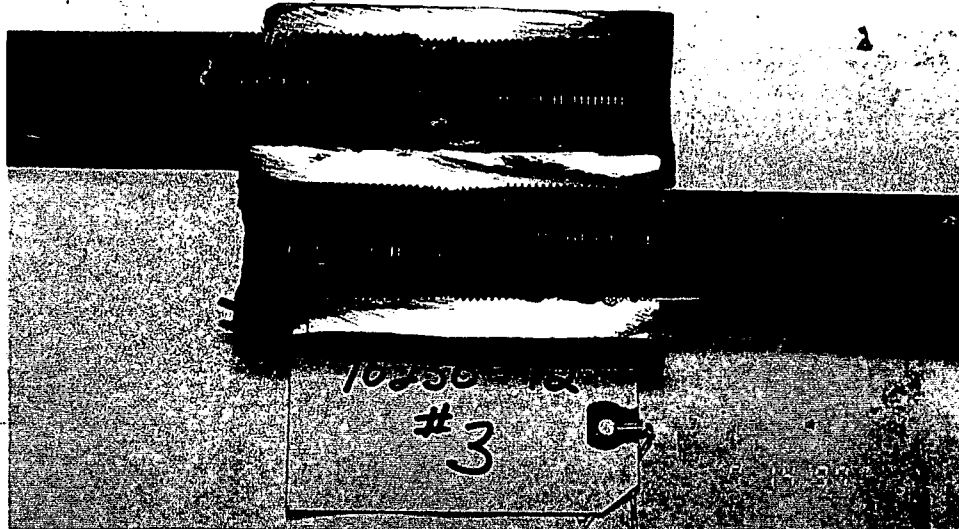
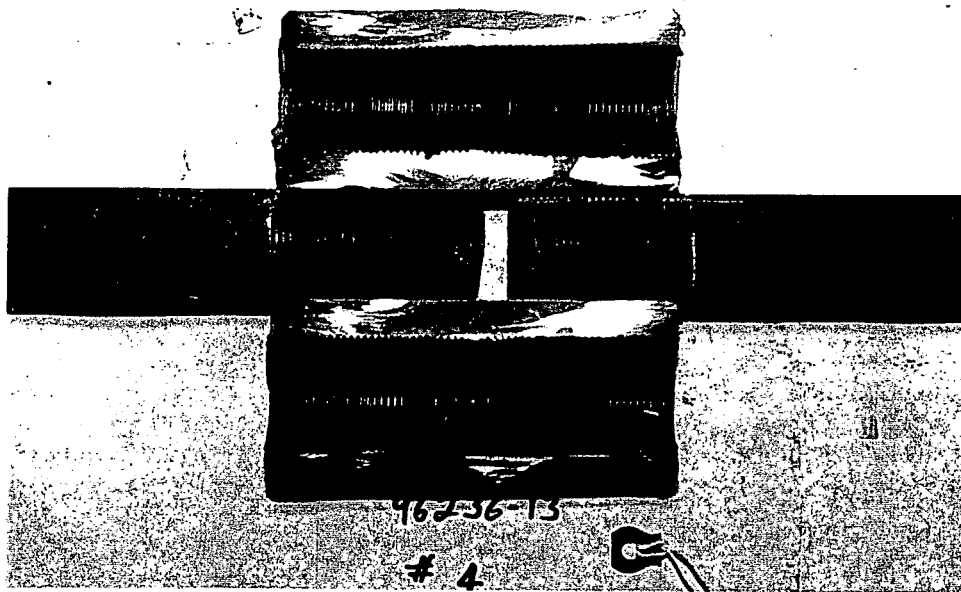
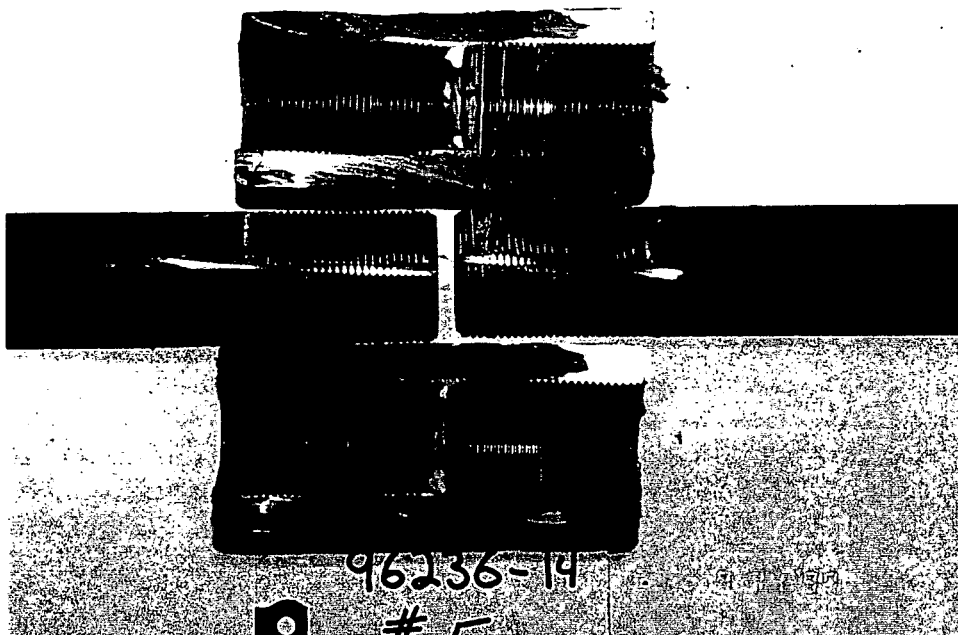
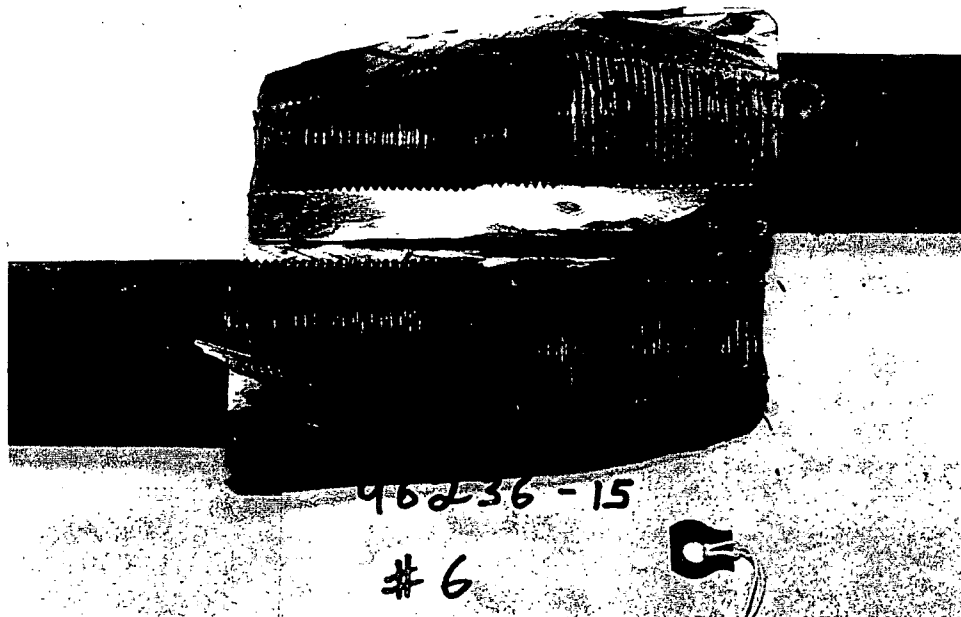
No visible sign of corrosion was found on the surface of the tendons or the couplings. The couplings were cut open lengthwise, and their internal surfaces were visually examined.
