SUBJECT: LER 94-002-00:on 940425,all three MSIVs were declared inoperable due to failure to meet TS required closure time.Caused by inadequate testing procedures.Addl MSIV accumulator tanks installed.W/940525 ltr.

H. B. ROBINSON STEAM ELECTRIC PLANT, UNIT NO. 2
DOCKET NO. 50-261/LICENSE NO. DPR-23
LICENSEE EVENT REPORT NO. 94-002-00

PLANT CONDITION OUTSIDE DESIGN BASIS DUE TO MSIV INOPERABILITY

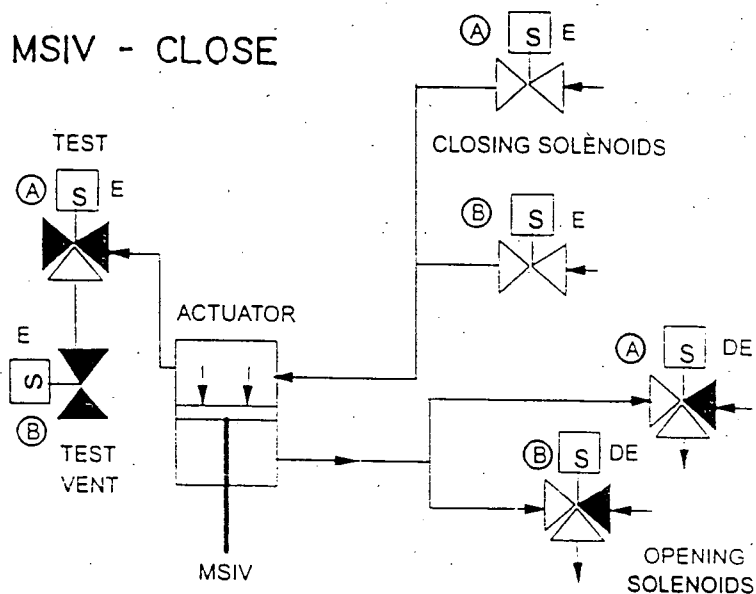
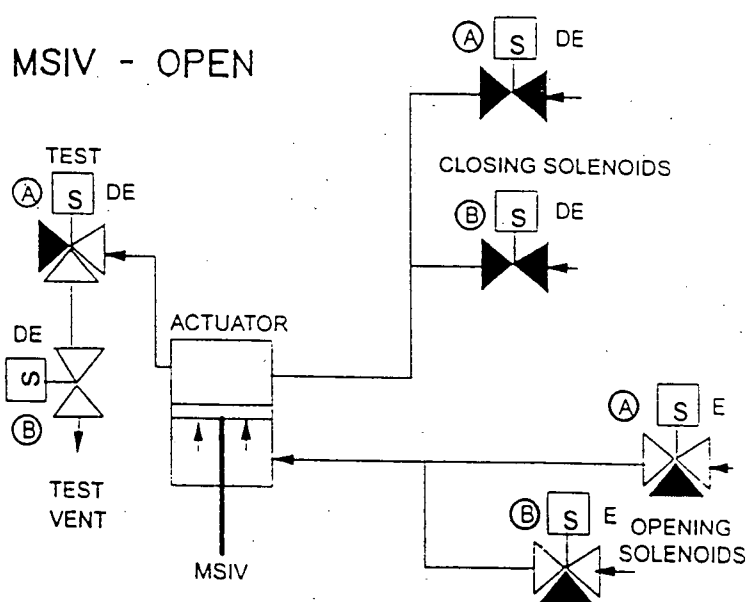
DIAGRAM: MSIV DUAL POSITION INDICATION

At approximately 2134 hours, control room operators noticed that the "B" MSIV position indicator was showing dual indication (i.e., dual indication means that the valve is between full open and full closed). The dual indication occurred because with instrument air isolated, an insufficient pressure differential existed across the actuator piston (see attached diagram) to keep the valve shut. As a result, the "B" MSIV drifted partially open for a period of approximately eight minutes. This condition placed the plant outside of the containment integrity requirements of TS 3.6.3. Instrument air was subsequently unisolated to the "B" MSIV, which resulted in the valve closing, and remaining closed.

On February 7, 1994, additional MSIV Accumulator tanks were installed and provide an increased volume of compressed air to assist MSIV closure within the required five second time period. Following completion of this modification and subsequent post-modification testing, all three valves were declared operable.
