Technical Report

STEAM GENERATOR WATER HAMMER EVALUATION  
H. B. ROBINSON STEAM ELECTRIC PLANT UNIT NO. 2

Report No. 6-2

March 13, 1980

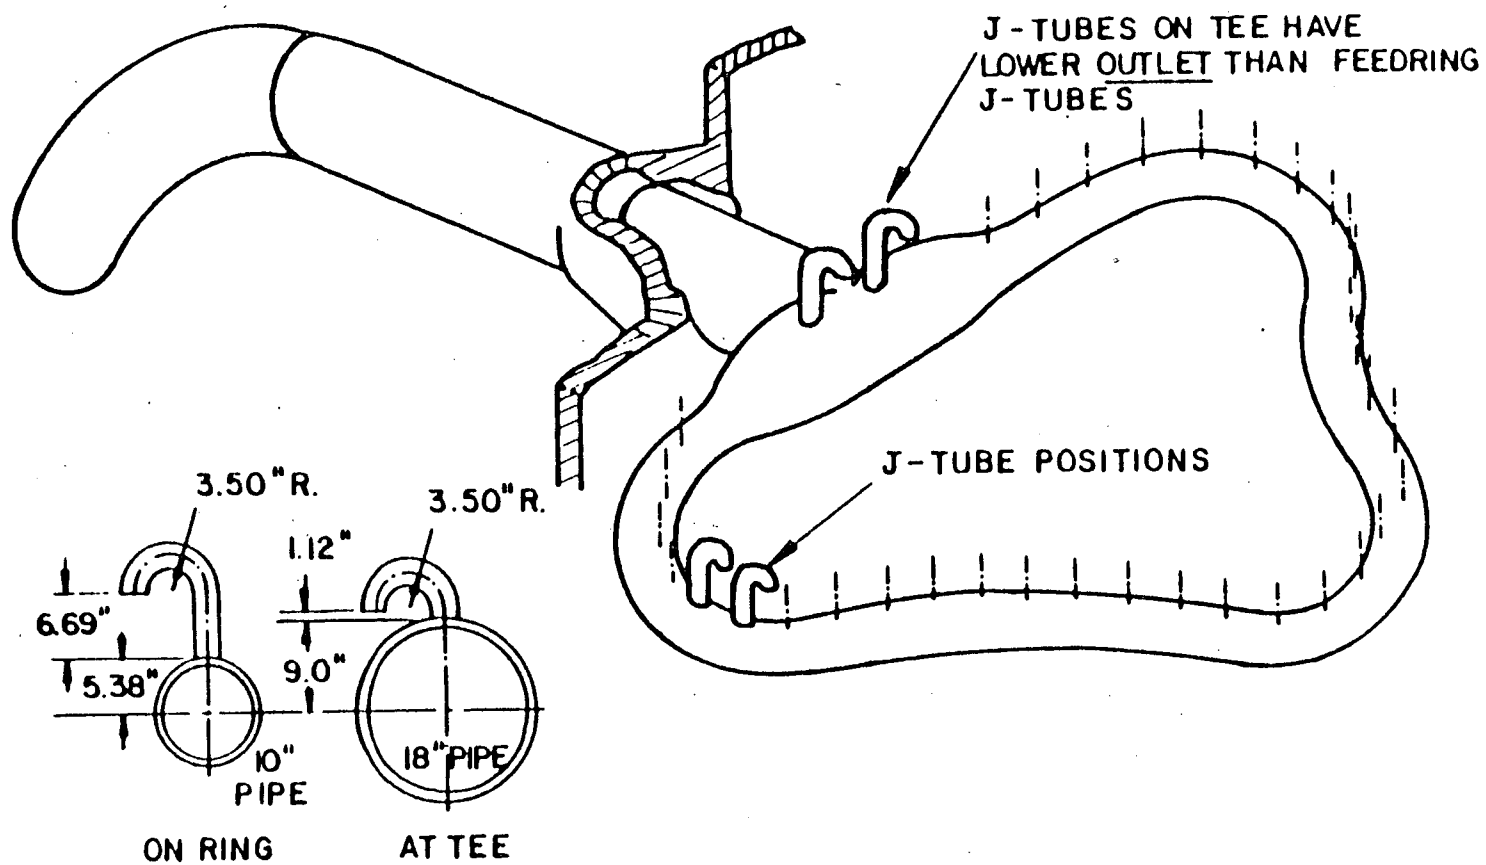
Figure 6. J-tubes Similar to those used at Indian Point Unit 2. [2]

In the interest of helping to keep the feedring from draining it has been recommended in the Creare Report [2] to install "J-tubes" similar to those shown in Figure 6. Currently, HBR does not plan to do this because of other mitigating features of the plant and the absence of any damaging hammer in the plant history [4].

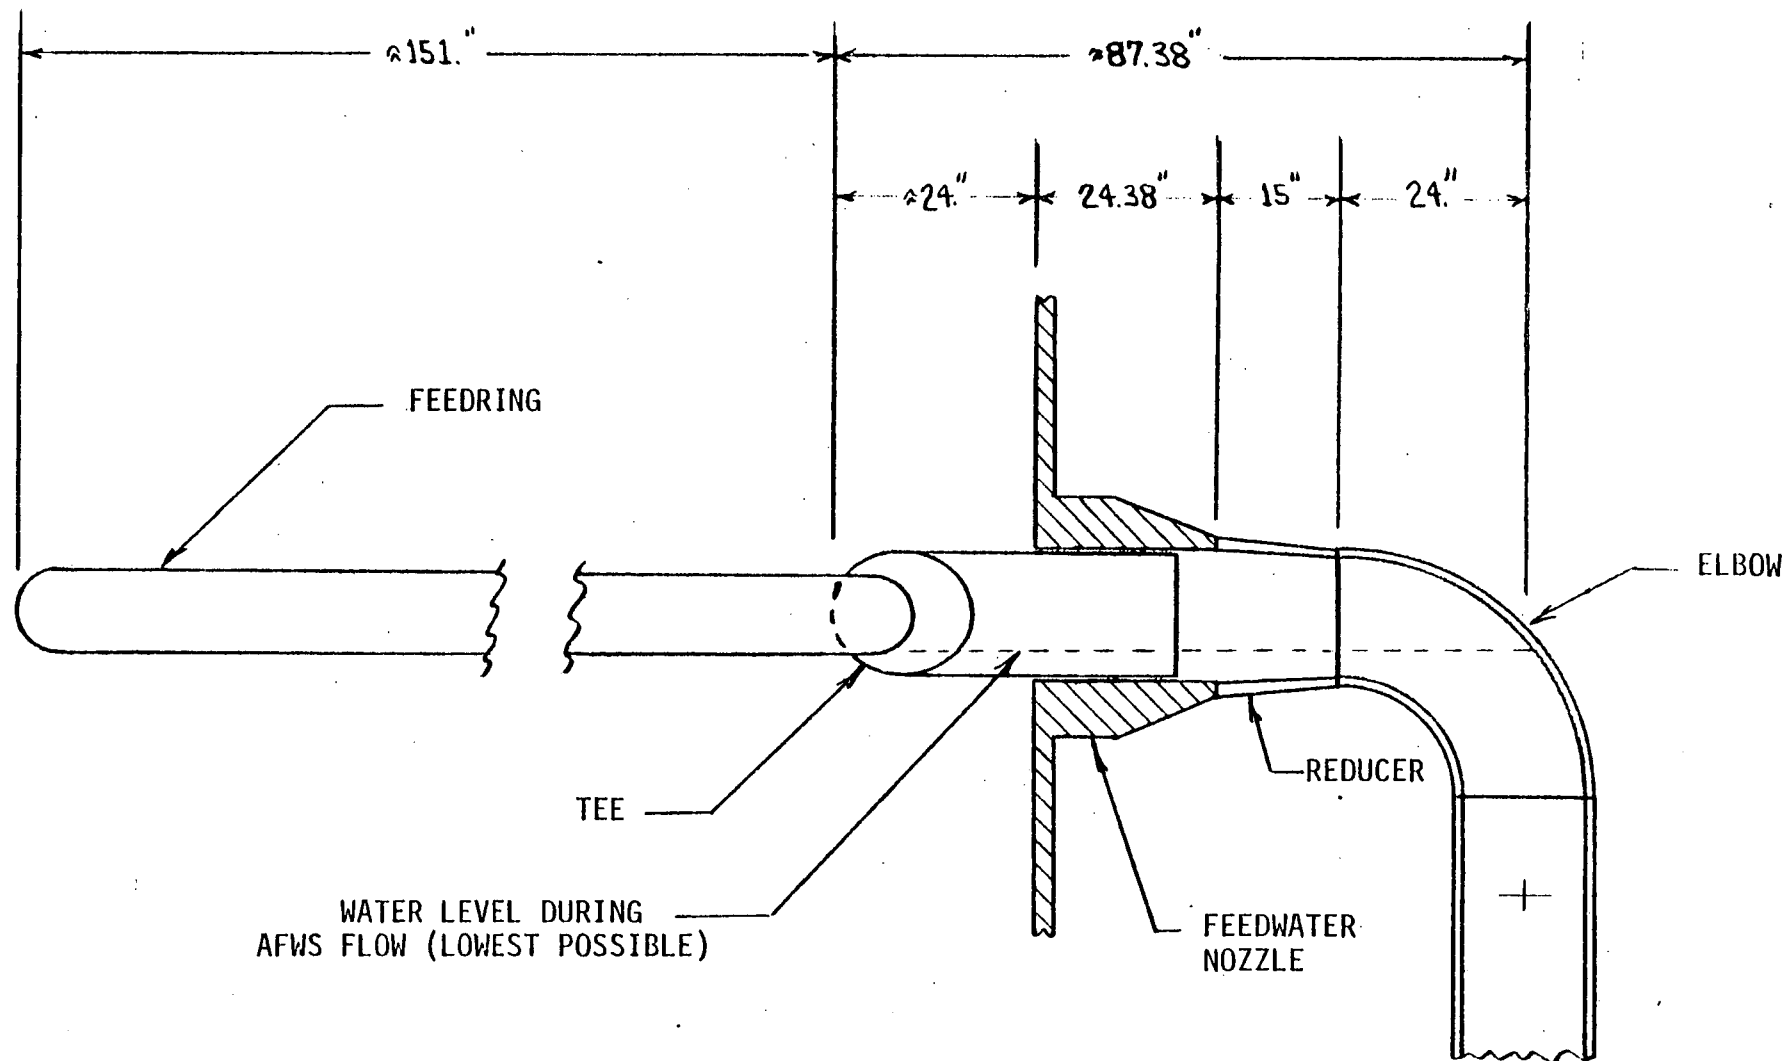
Figure 7. HBR Feeding and Piping Sketch

Westinghouse also notes [3] that another step may be taken which will lessen the likelihood of a water hammer and lessen its severity should one occur in the feedwater system. This involves modifying the feedwater piping to make the horizontal drainable lengths as short as possible. This was done in the original piping design for HBR producing for each of the three generators the configuration shown in Figure 7. (Taken from [4] and [5].) There is no horizontal run of pipe at all and the drainable volume is at a minimum. The horizontal length of reservoir in the tee, the nozzle and the reducer is only about 7.3 feet. This provides such a small steam condensing area during AFW flow that waves produced by counter-current flow are not likely to cause slug formation. Also, the short horizontal section provides a minimal volume in which a steam void could collapse and accelerate a slug. This is probably why the plant has never experienced a damaging water hammer. Conversations with the licensee indicate that one has never been heard.

In the Creare Report [2] mention is made of adding the length of the feedring itself to the total "horizontal" run of drainable pipe when considering the water hammer potential. We have concluded that this is not correct. Steam void collapse (should any occur in the feedring) would accelerate a slug of water to produce only internal momentum transfer. While external pressure pulses could occur they would be much less than those generated by a water hammer in an external feedwater pipe section. Also, no known damage has been traced to water hammers originating in the feedring sparger.

The model test results reported do not show a reduced likelihood of water hammer occurrence with decreasing external piping horizontal length. However, the over-pressure did decrease. Also, these model tests did not accurately simulate the feedring geometry. A simple straight pipe was used to model the feedring which allowed its total length to act as a direct extension of the external "horizontal" piping. Thus, it can be seen how in this case the simulated feedring length contributed to the mechanisms initiating water hammer and allowed a direct linear communication between feedring and external piping facilitating momentum transfer.
