CAROLINA POWER AND LIGHT COMPANY
H. B. ROBINSON SEG PLANT, UNIT NO. 2

1982 REFUELING OUTAGE
STEAM GENERATOR INSPECTION
REPORT

SEPTEMBER, 1982

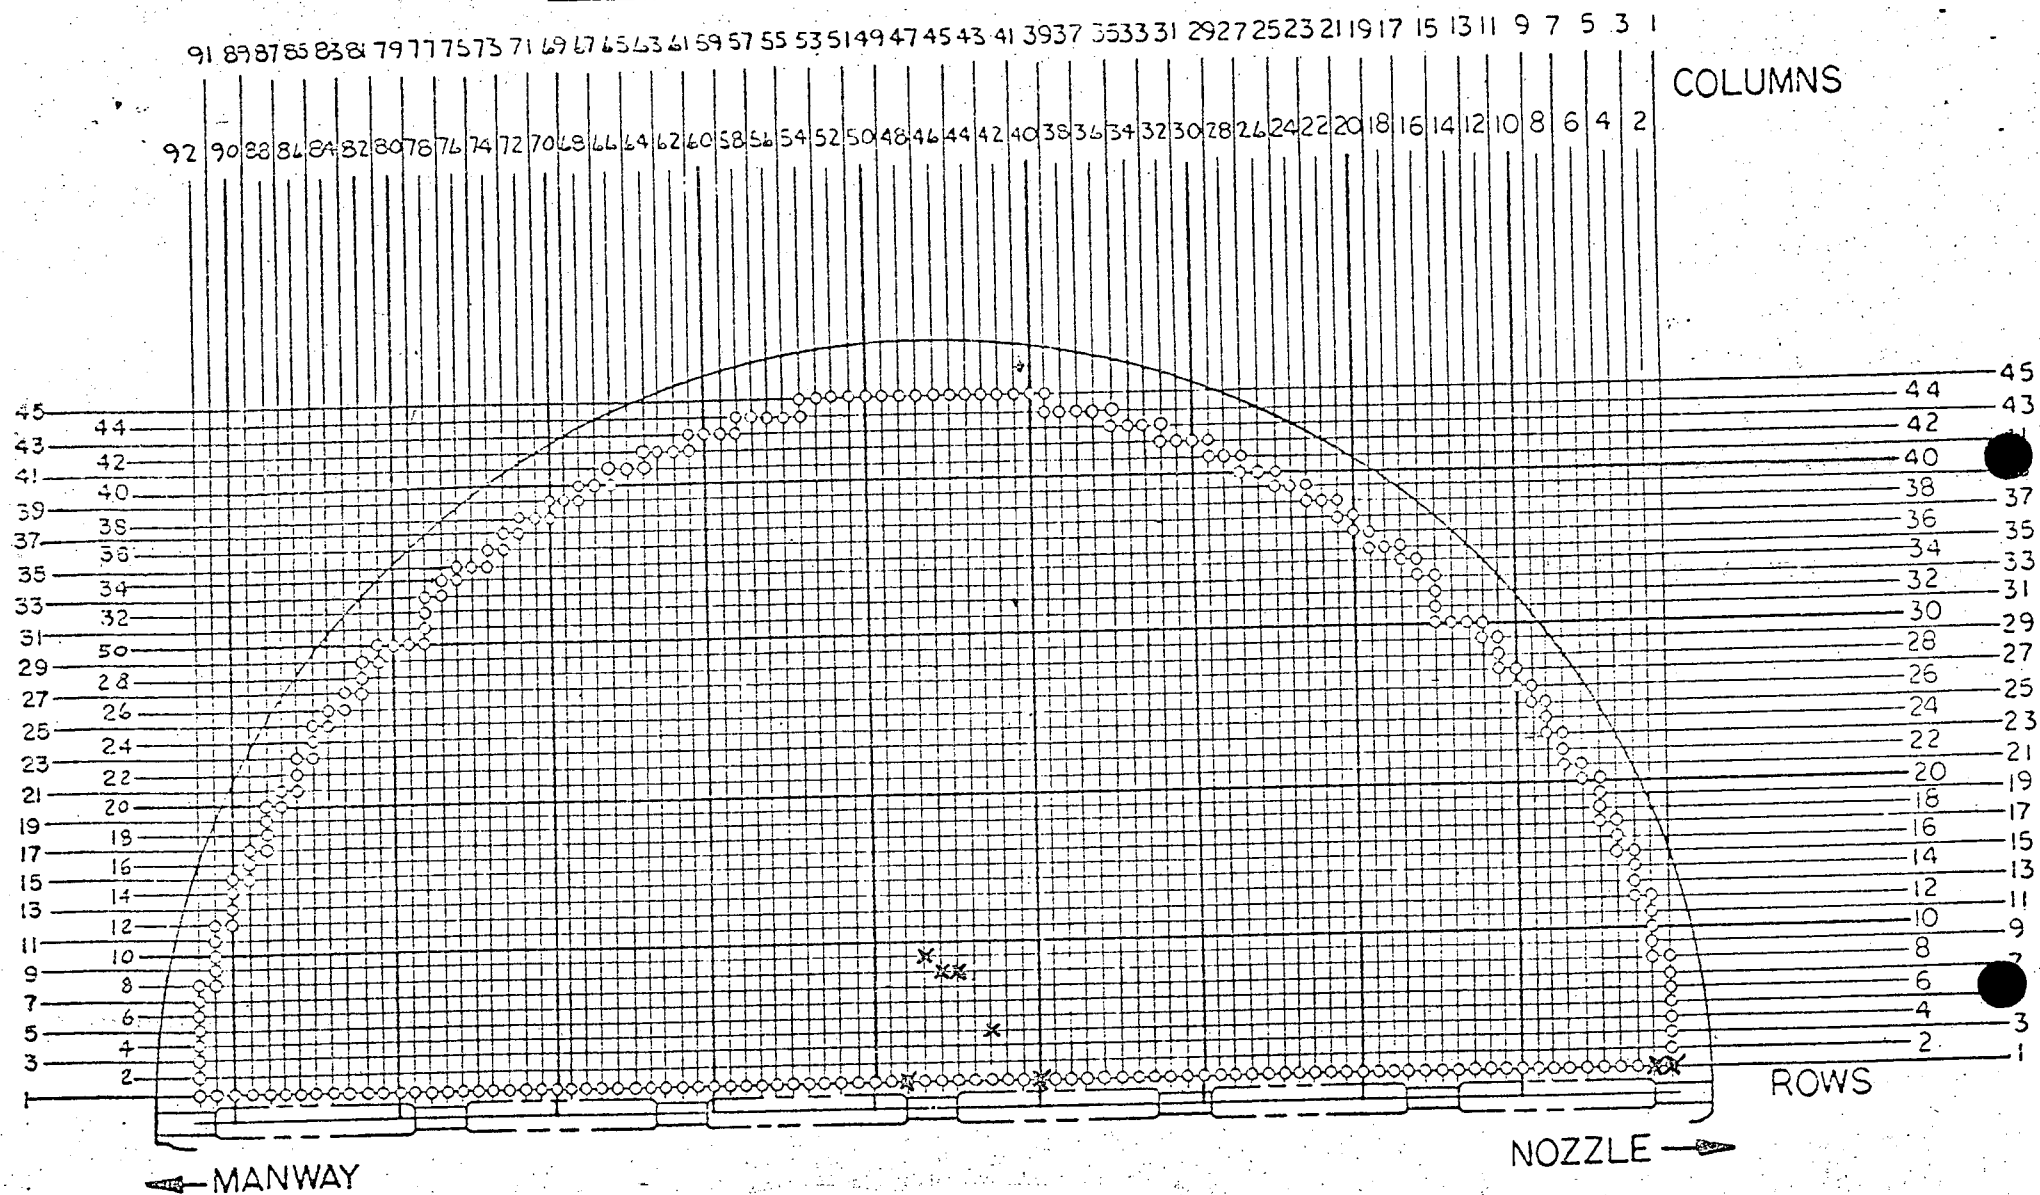
FIGURE I.1.1-1

The initial inspection sample selected consisted of all unplugged tubes in each S/G. Each tube was to be inspected full length (tube end to tube end). This was accomplished with the exception of eight tubes in "B" S/G which were inspected through the top support plate from each side but not through the U-bend region. These tubes, R1C1, R1C2, R1C40, R4C43, R8C45, R8C46, R9C47 and R1C48 are plotted on Figure I.1.1-1. These tubes were hand probed at the end of the inspection period, and the difficulty encountered due to probe friction did not warrant the radiation exposure required for the full length inspections. Also, these tubes are all located in a region which has never experienced U-bend degradation in any H. B. Robinson S/G. In addition, one tube in "C" S/G (R9C29) would not pass an eddy current probe thru the full tube length.

PLOT OF "B" S/G TUBES NOT INSPECTED THROUGH U-BEND

X = Denotes tubes not inspected through U-bend region.

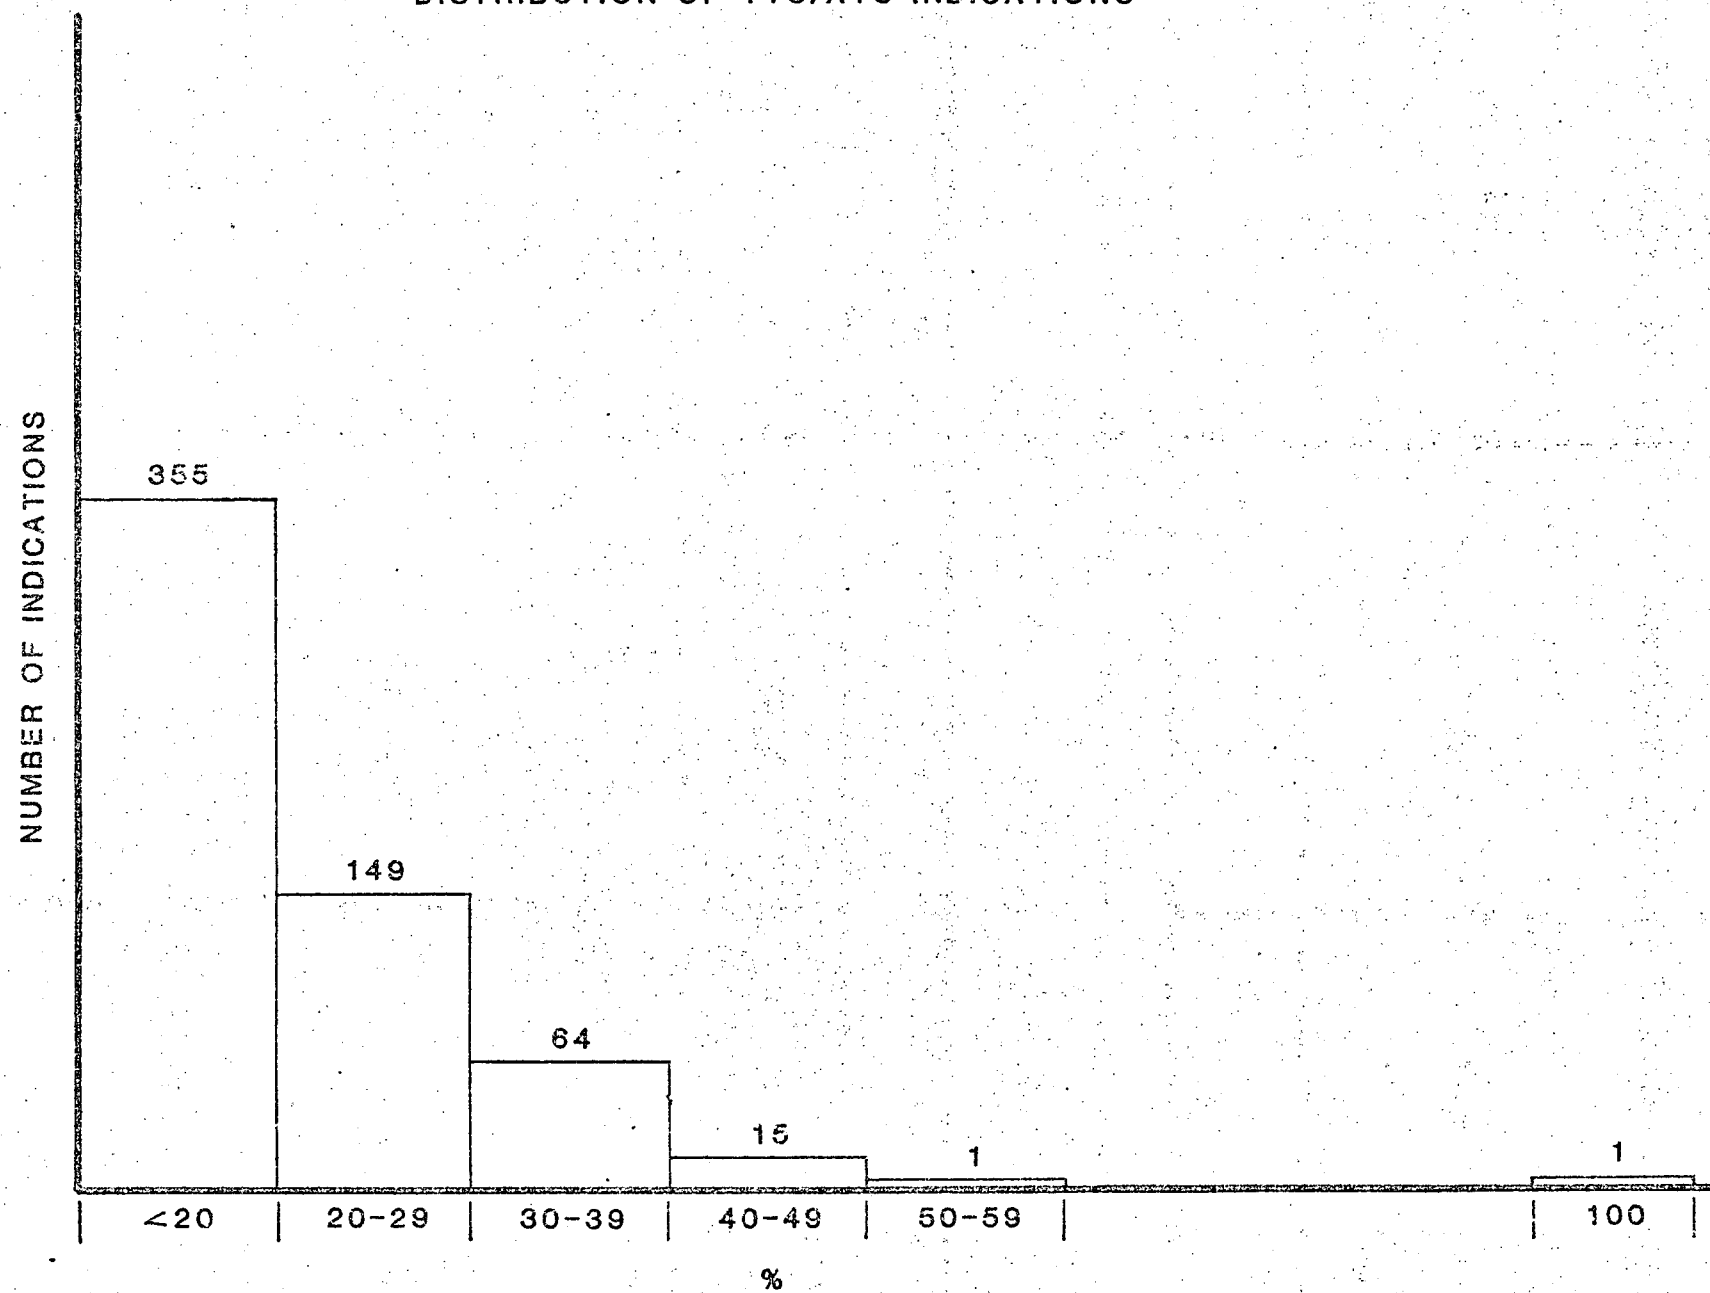
FIGURE I.1.4-1
A S/G INLET
DISTRIBUTION OF TTS/ATS INDICATIONS

The central area of the tube bundle on the inlet and outlet sides of the S/G's exhibited tube wall thinning believed to be due to phosphate corrosion in the length of tubing from the top of the tubesheet up to approximately 15 inches above the tubesheet. This corrosion is attributed to the presence of phosphate rich sludge in the S/G, and the region affected is consistent with the region where sludge accumulation is anticipated.

(as outlined in our submittal dated August 21, 1981). This conclusion is supported by the distribution of the eddy current indications with respect to number and size. This distribution is depicted in Figures I.1.4-1 through I.1.4-6.

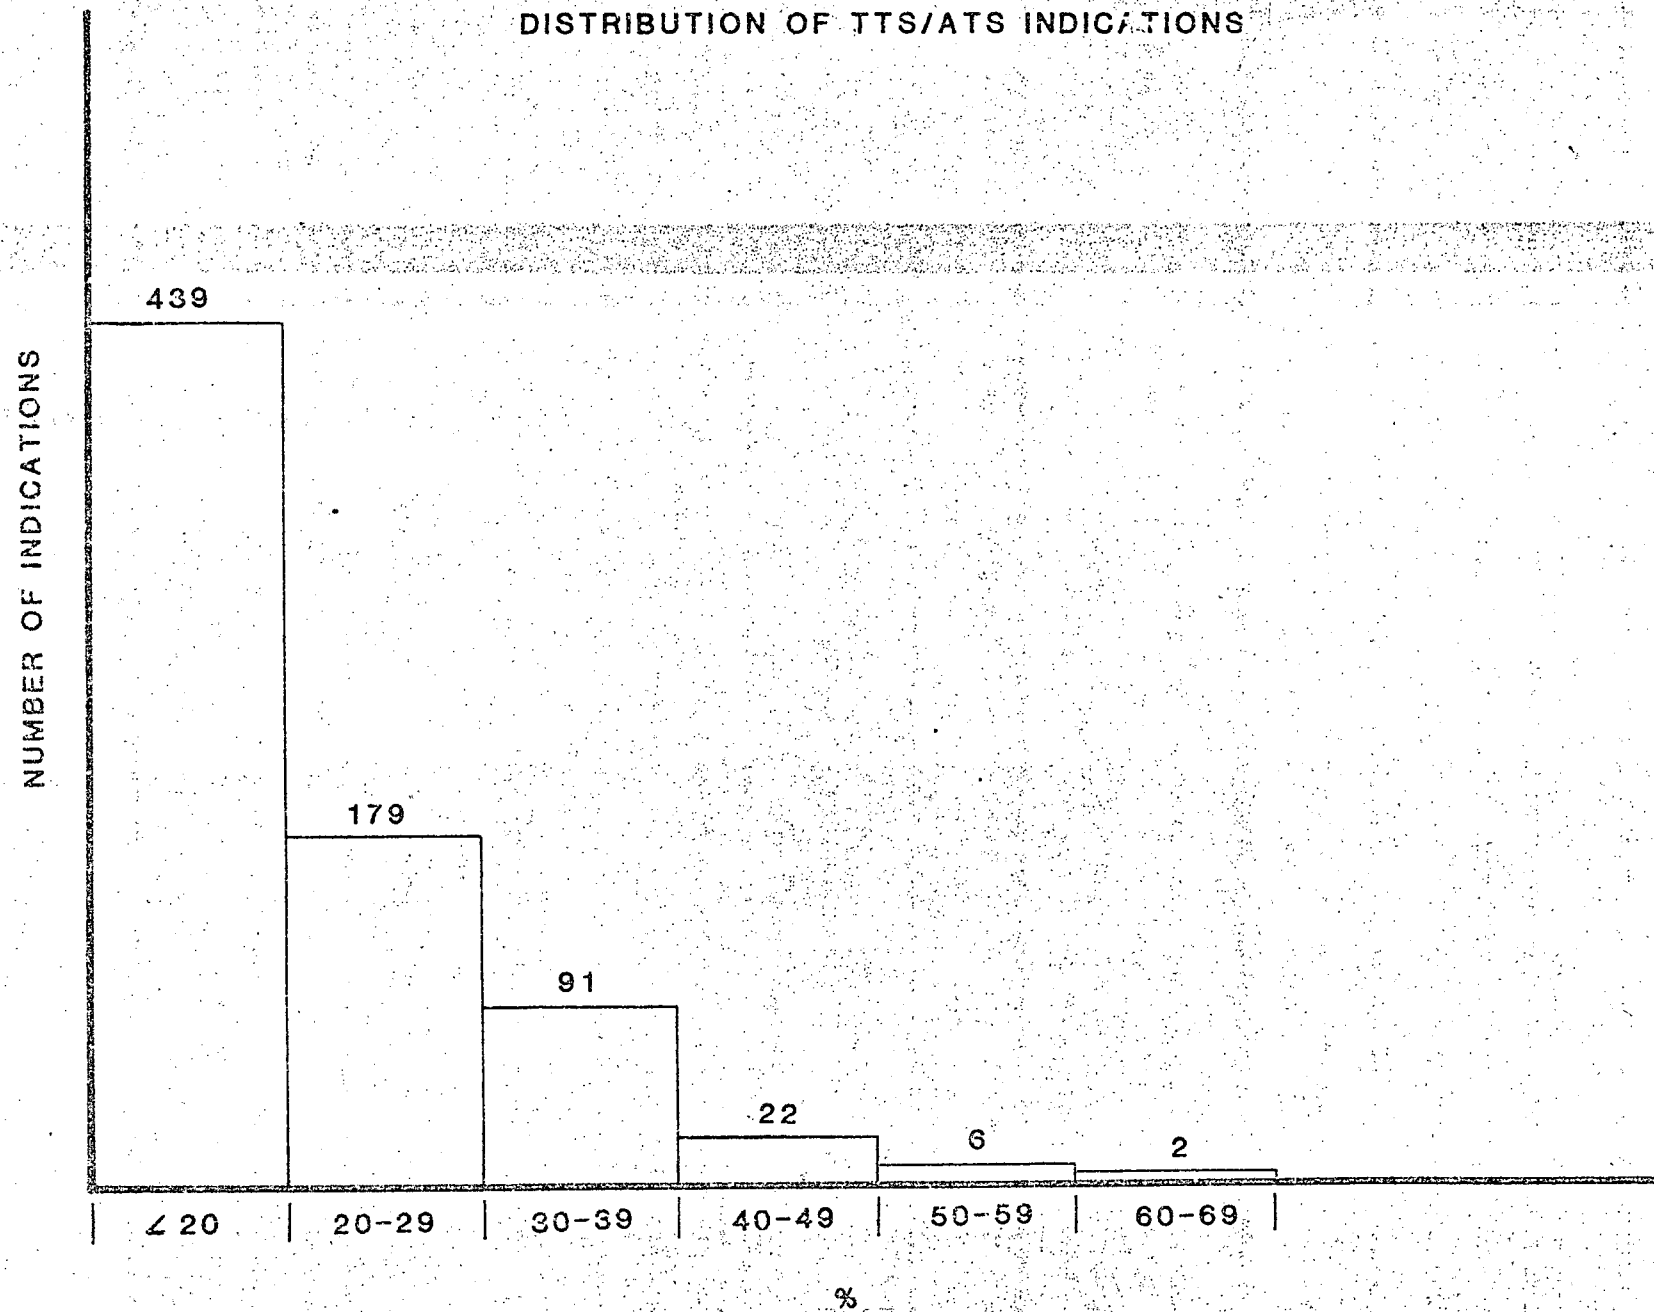
FIGURE I.1.4-3

B S/G INLET

DISTRIBUTION OF TTS/ATS INDICATIONS

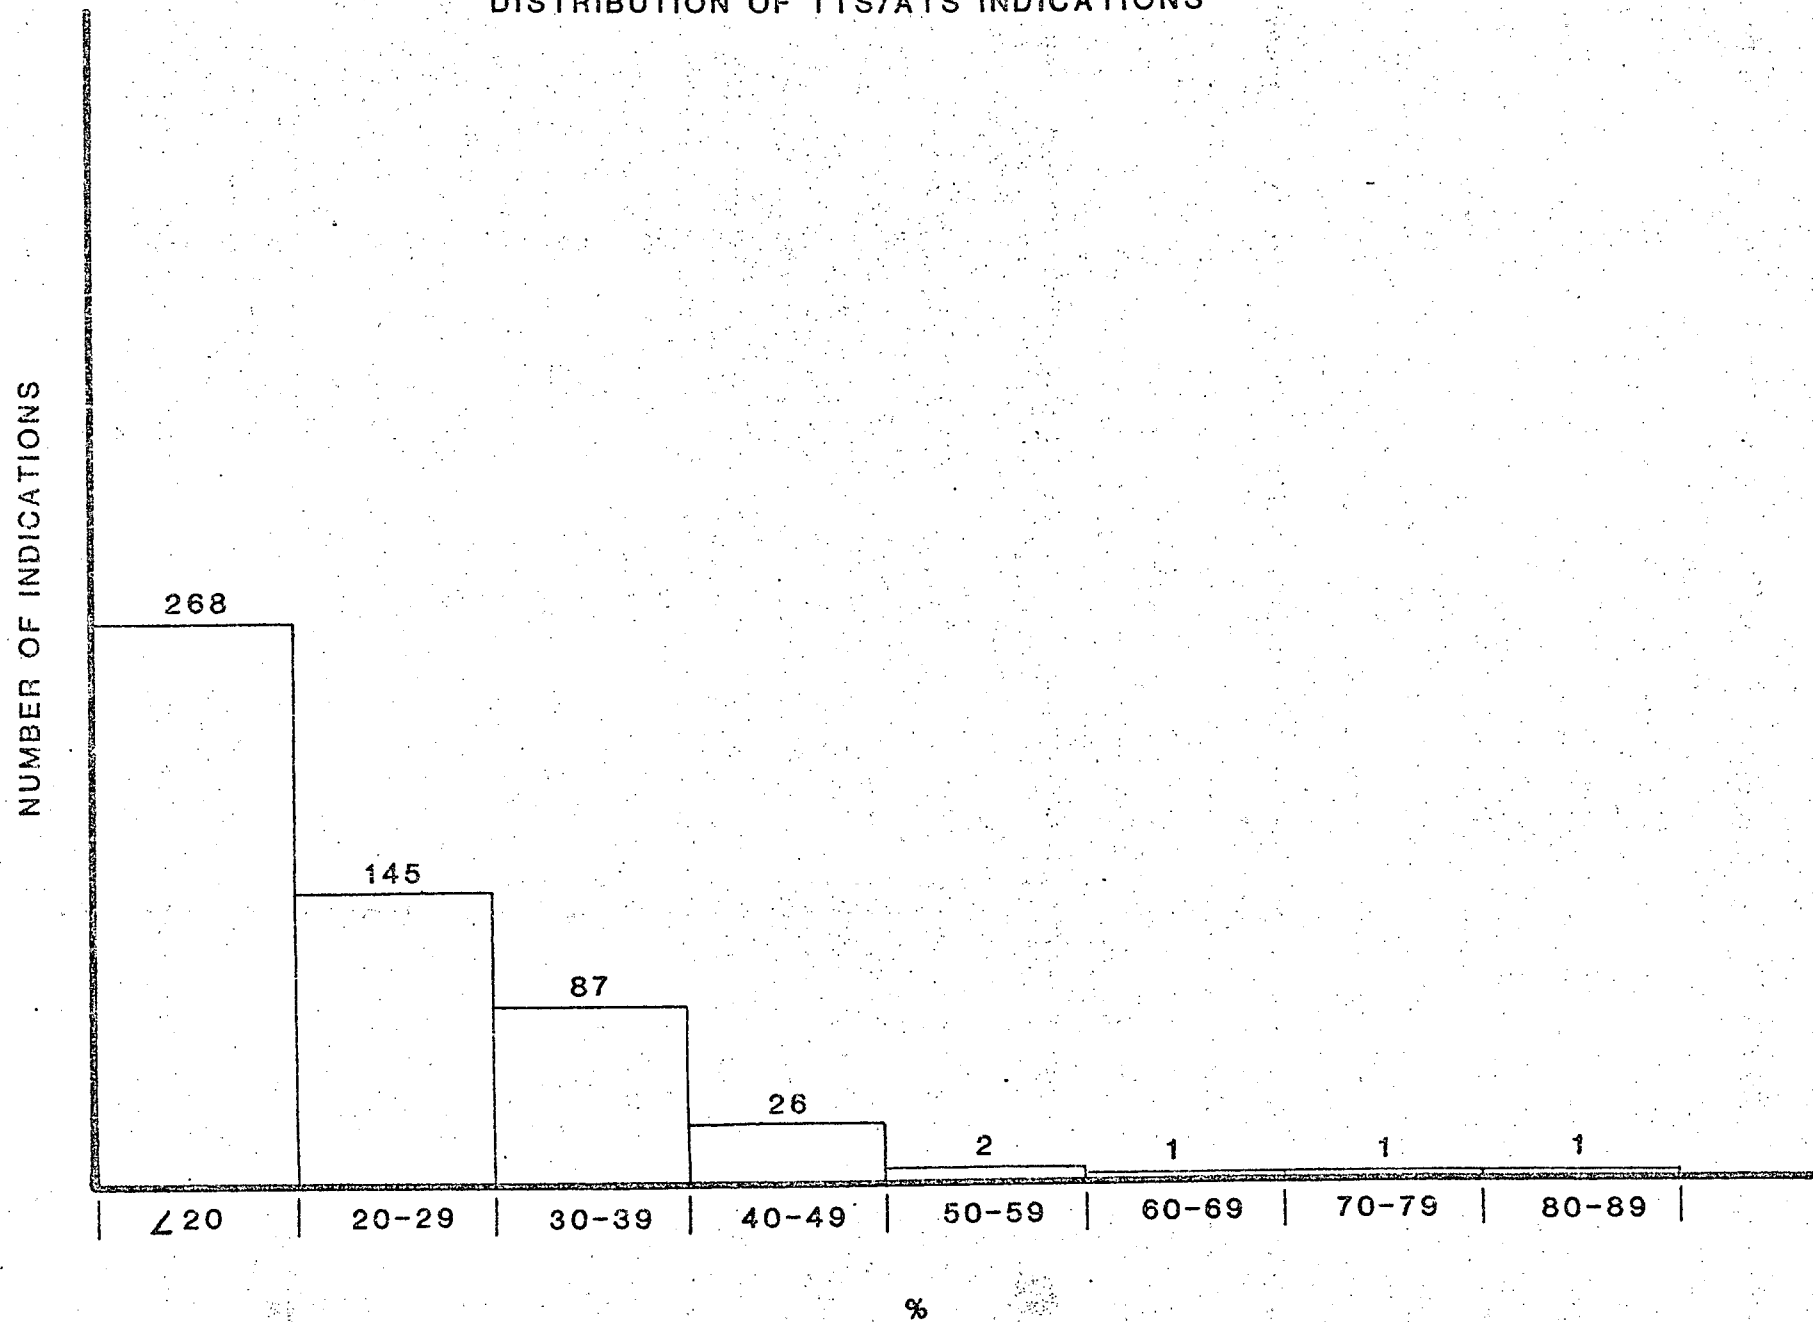
FIGURE I.1.4-5

C S/G INLET

DISTRIBUTION OF TTS/ATS INDICATIONS

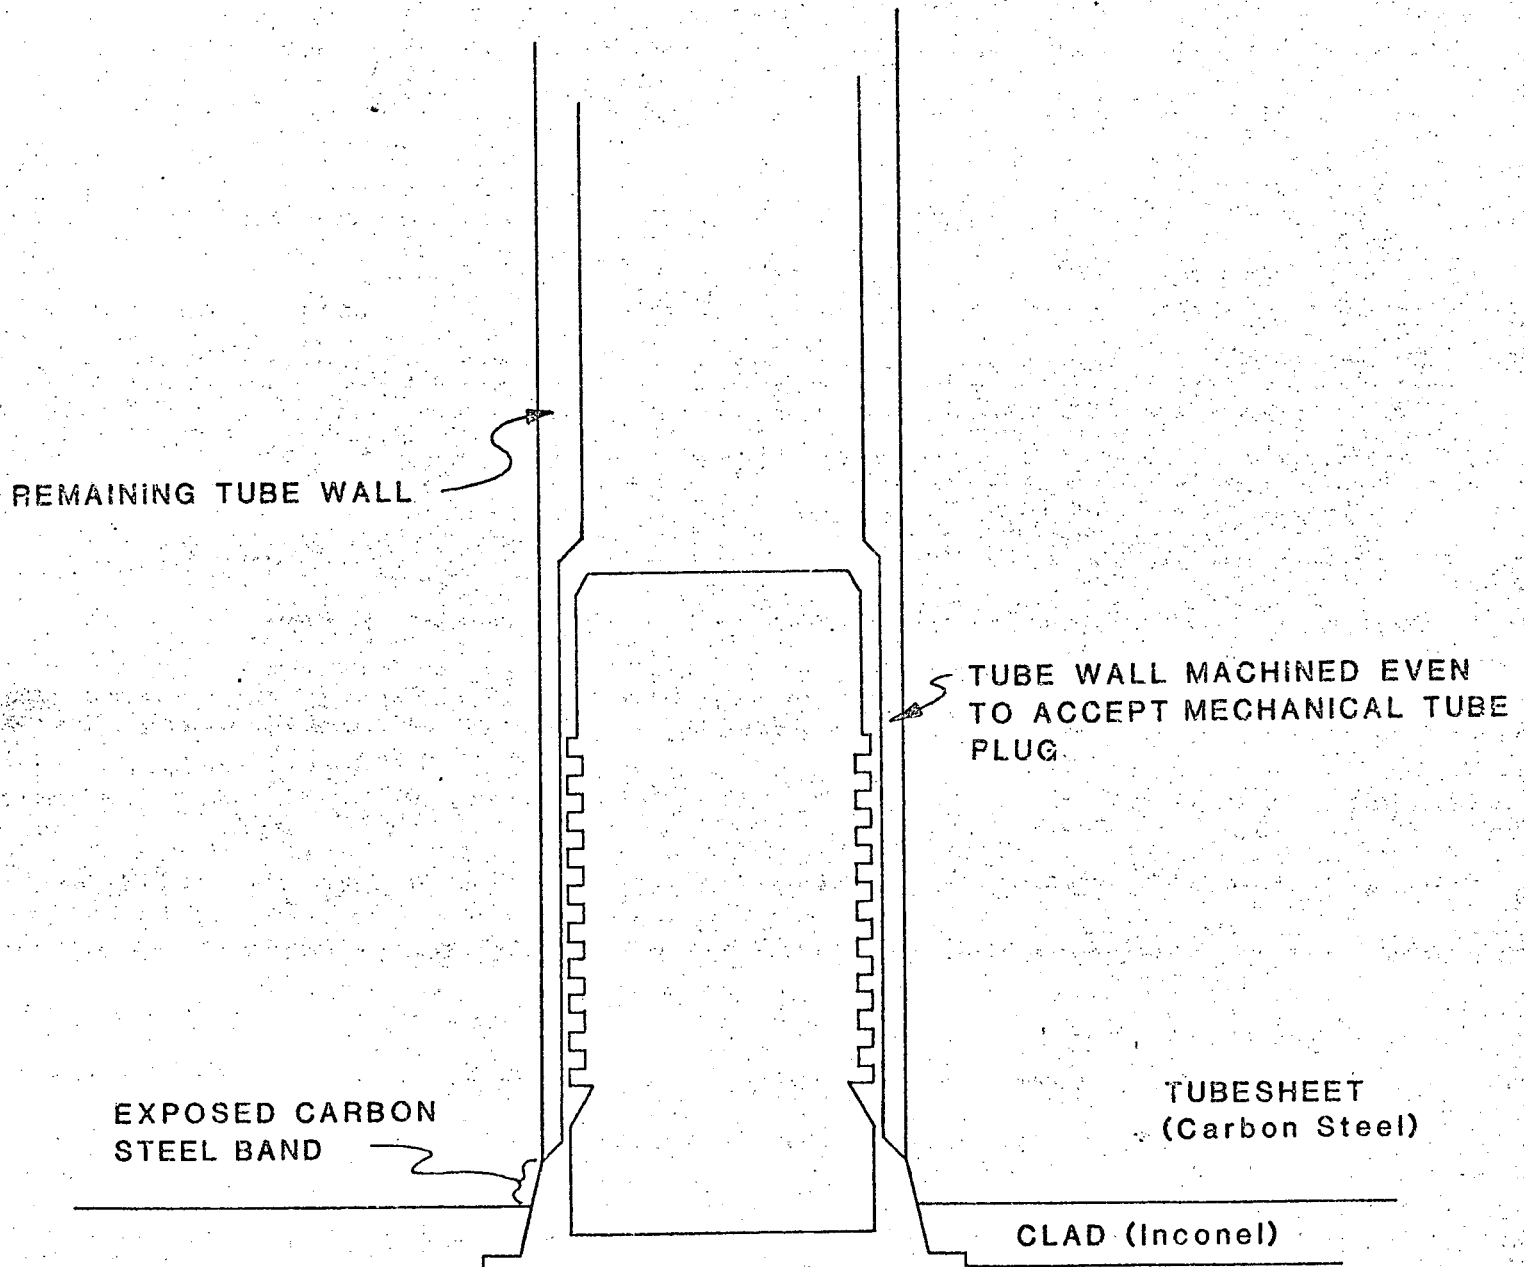
FIGURE II.3-1

Due to difficulties encountered in the performance of weld repairs on tube R8C52, a special repair technique was developed by CP&L and the S/G vendor and applied to this tube. The weld repair problems are attributed to the inclusion of contaminants in the weld. The source of these contaminants is assumed to be the tubesheet clad to tubesheet crevice. Additional weld repair attempts were not considered viable as the contaminated material could not be completely removed. Therefore, the repair technique applied was installation of a mechanical tube plug. The tube end was initially prepared in the same manner as for a weld repair. The remaining tube wall was then machined to accept the mechanical plug. A mechanical plug was then installed in the remaining rolled region of the tube sealing off both the inside of the tube and the tube to tubesheet interface. This eliminated all potential leak paths from R8C52.

This repair technique resulted in a small band (less than 3/16 inches wide) of carbon steel tubesheet material being exposed to primary coolant. The potential for corrosion of the carbon steel was evaluated via review of corrosion data. This evaluation performed from a primary coolant chemistry as well as tubesheet integrity standpoint revealed the following:

Subsequent to installation of the mechanical plug in tube R8C52, a 200 psi leak test was performed. This revealed slight leakage of approximately 5 drops per minute. This leakage was evaluated by CP&L and Westinghouse and determined not to pose an operational problem based on the observed leak rate. Therefore, the repair is considered acceptable and additional repair efforts are not planned at this time. However, this repair will be visually inspected, leak checked and re-evaluated concurrent with future inspection efforts in this S/G.

TUBE / TUBESHEET COUNTERBORE CONFIGURATION FOR MECHANICAL PLUG REPAIR

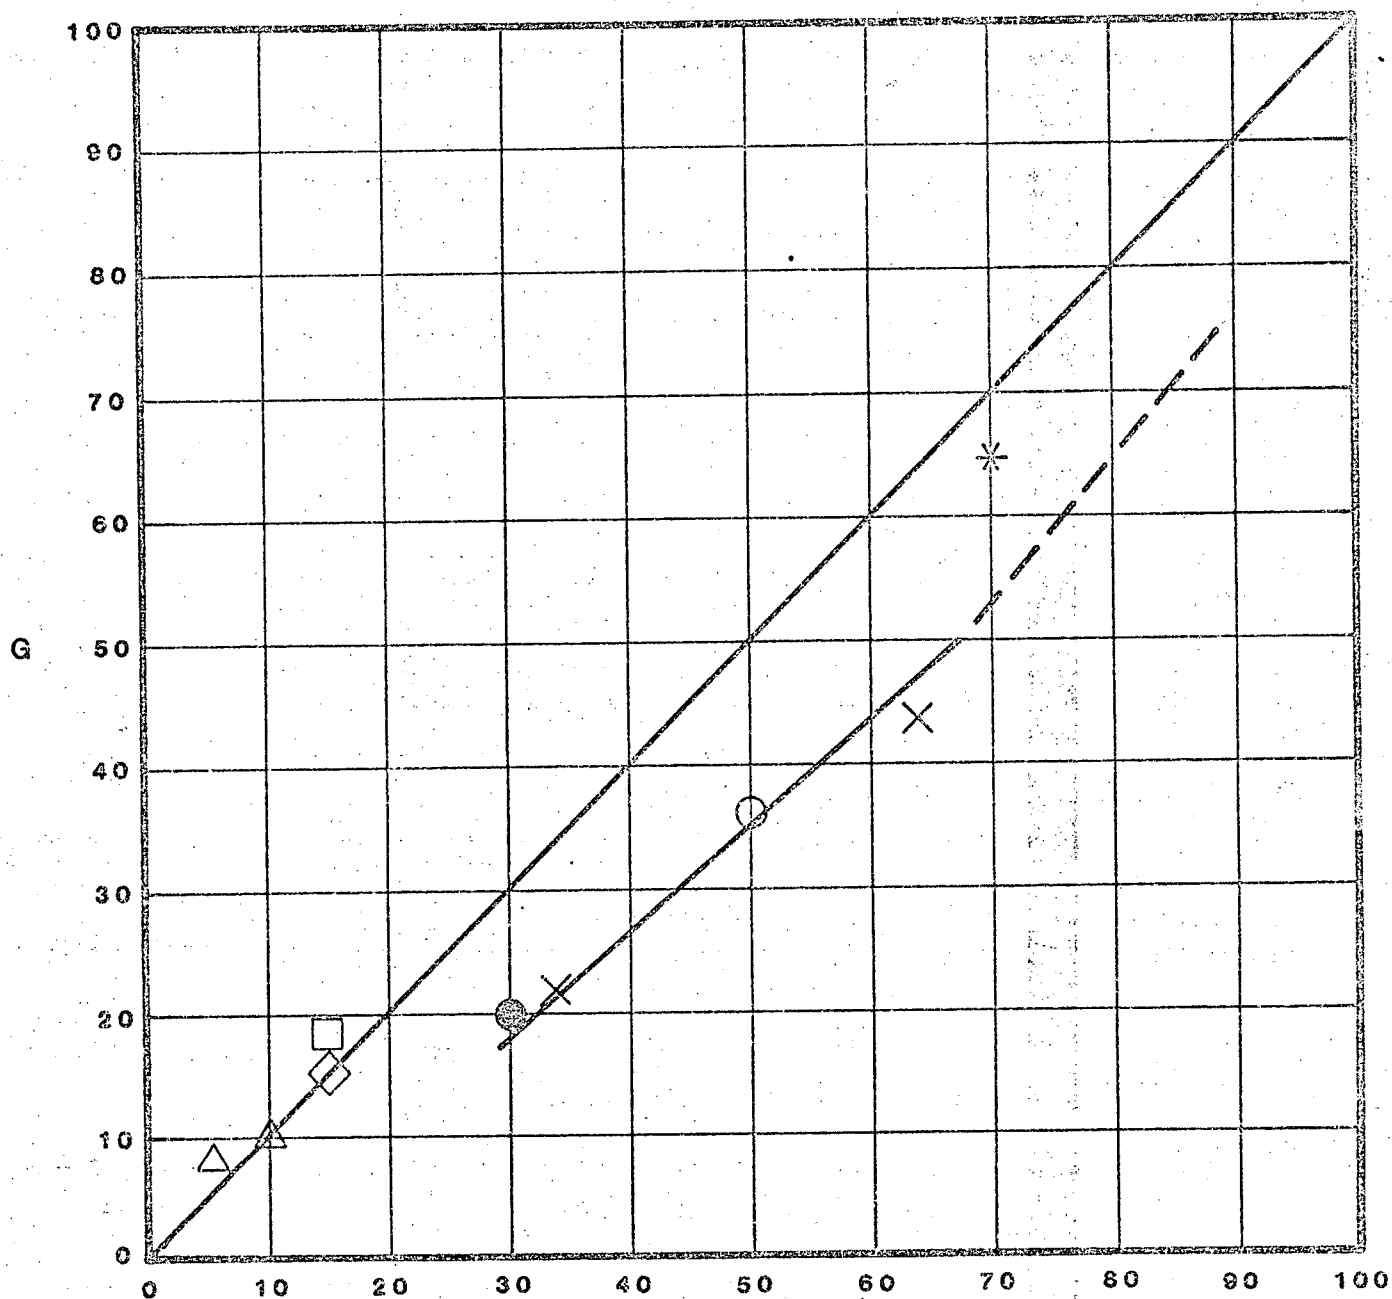
The data derived from the examination of tubes pulled from operating plants during several years shows that the eddy current technique, using the ASME calibration standard, yields overestimates of penetration depth when wastage type penetrations are involved. Figure 1 compares the depths measured by metallurgic method with the estimated depths by EC data for steam generator tube exhibiting wastage type penetrations. These tubes were pulled from several plants. The eddy current estimates for penetrations in the range of $\pm 20\%$ should be ignored since the confidence level here is very low. Excluding the $\pm 20\%$ signals, the data shows an overestimate of about 10 to 15% in the indicated signal range of 30 to 60% penetration. The experimental

1. The large uncertainty in using the $\pm 9\%$ error band for interpreting data, using the ASME standard is not valid in those cases of wastage flaws where penetrations of approximately $\pm 40\%$ are present.
2. The evidence of significant overestimation of penetrations due to wastage by EC procedures used in the field at this time as shown in Figure 1.

SUMMARY OF ACTUAL MEASUREMENTS OF WALL - THINNED STEAM GENERATOR TUBES FROM OPERATING PLANTS

It is recommended that the 9% conservatism factored into estimations of the margin for tube corrosion be eliminated when tube wastage is involved.

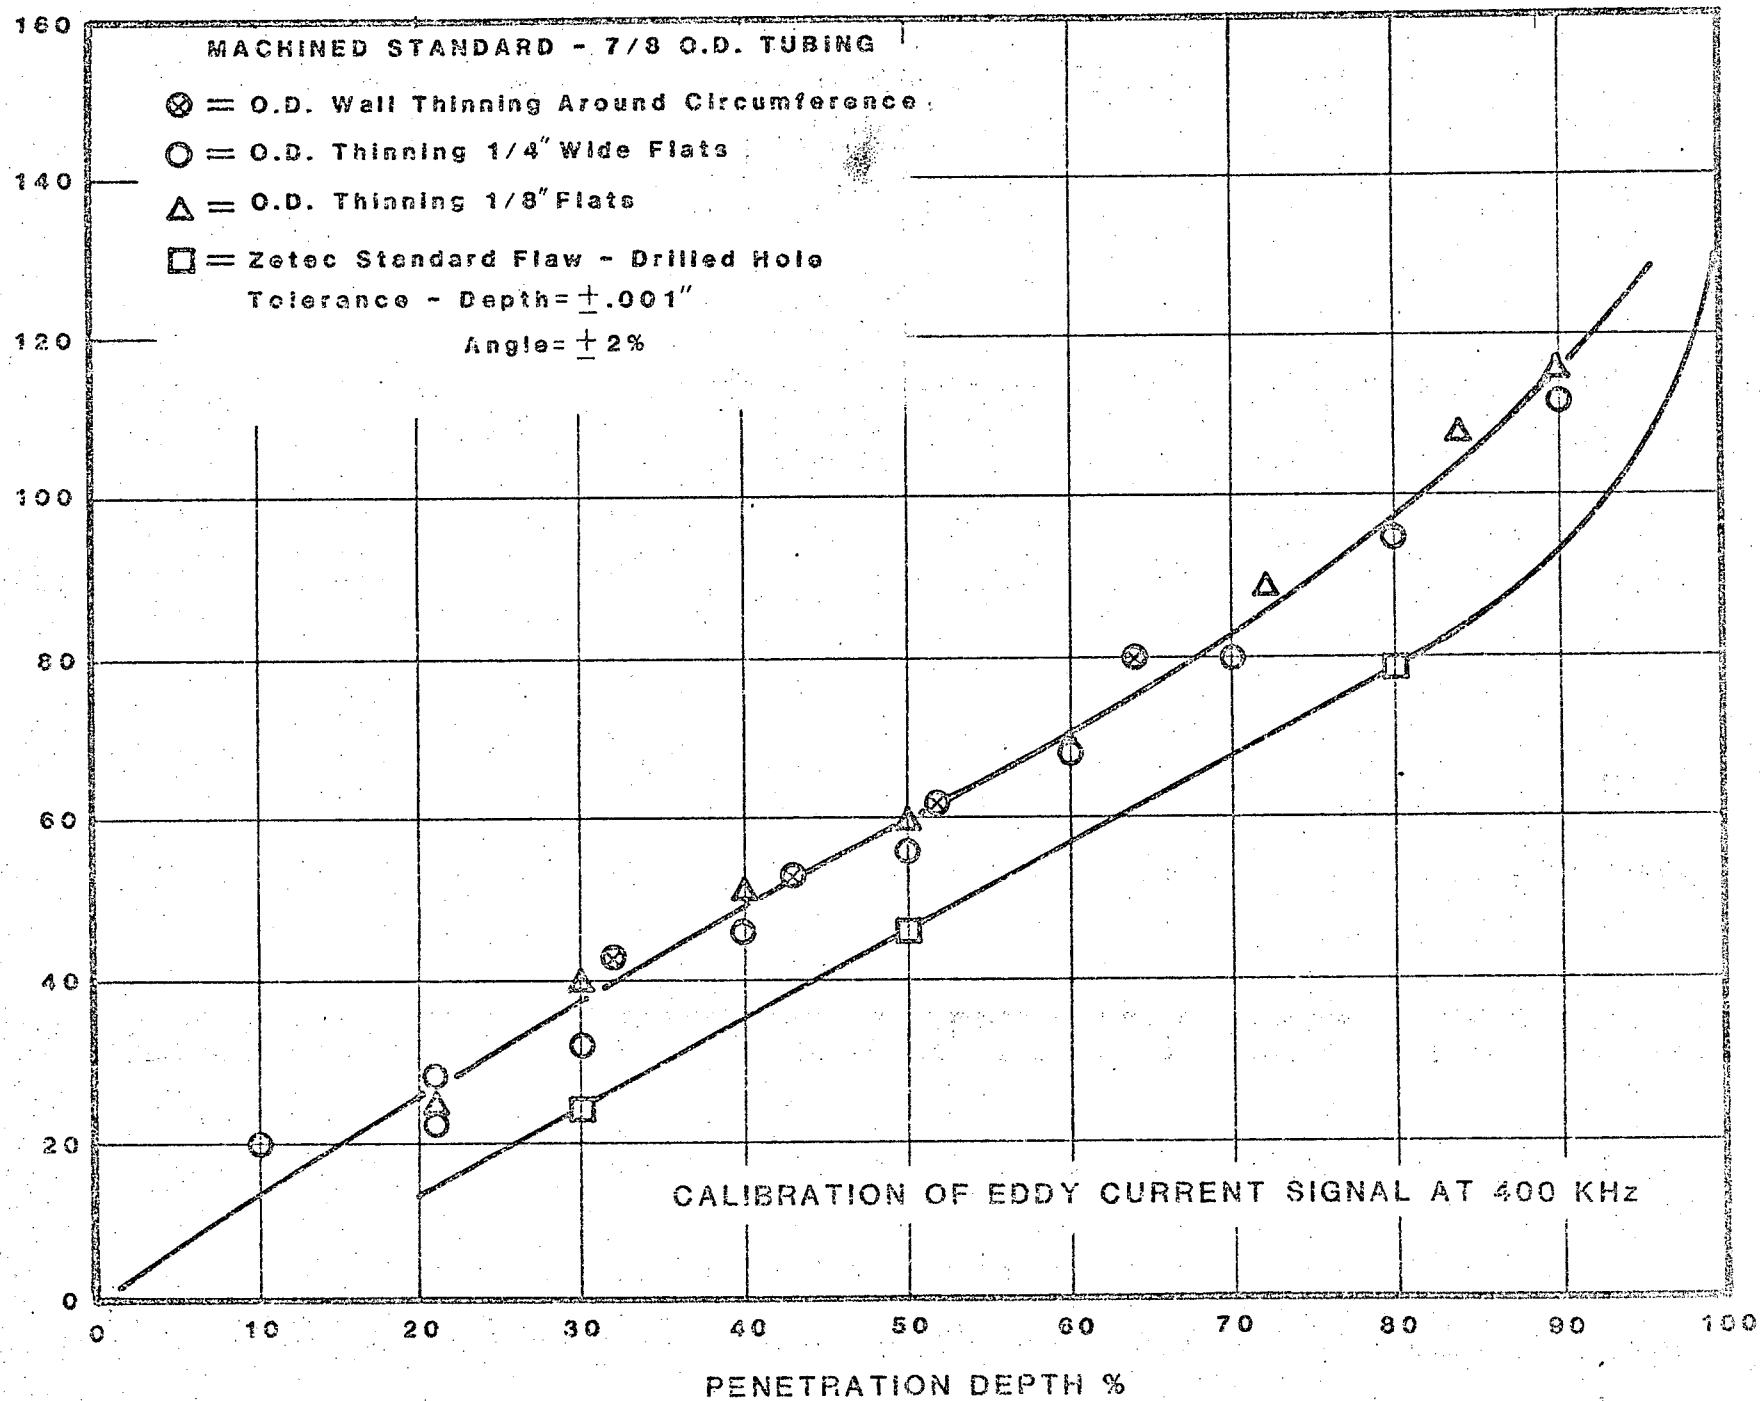
FIGURE 3

Figure 3 shows the signal phase angle vs. actual depth of penetration for various wastage type machined flaws along with the data on the ASME drilled hole calibration standard. These data indicate a consistent overestimate of depth on the basis of the ASME calibration standard. The results of the work done at Battelle Institute is shown in Figure 4. Here the actual depths are plotted against the depths estimated from the phase of the EC signals - again on the basis of calibration using the ASME standards. The geometry of the machined flaws simulated elliptical type wastage and the "compound wastage"

COMPARISON OF DEPTH ESTIMATES BY E.C. TECHNIQUE AND
THE ACTUAL DEPTHS OF MACHINED WASTAGE TYPE PENETRATIONS
