REGULATORY INFORMATION DISTRIBUTION SYSTEM (RIDS)

SUBJECT: Requests relief from ASME B&PV Code,Section XI to allow non-Code repair of welded pipe sleeve of svc water supply & return piping for containment fan cooler HVH-4 due to microbiologically-induced corrosion,per Generic Ltr 90-05.

H. B. ROBINSON STEAM ELECTRIC PLANT, UNIT NO. 2
DOCKET NO. 50-261/LICENSE NO. DPR-23
ASME CODE RELIEF REQUEST - SERVICE WATER

Containment Fan Coolers
Service Water
Relief Request

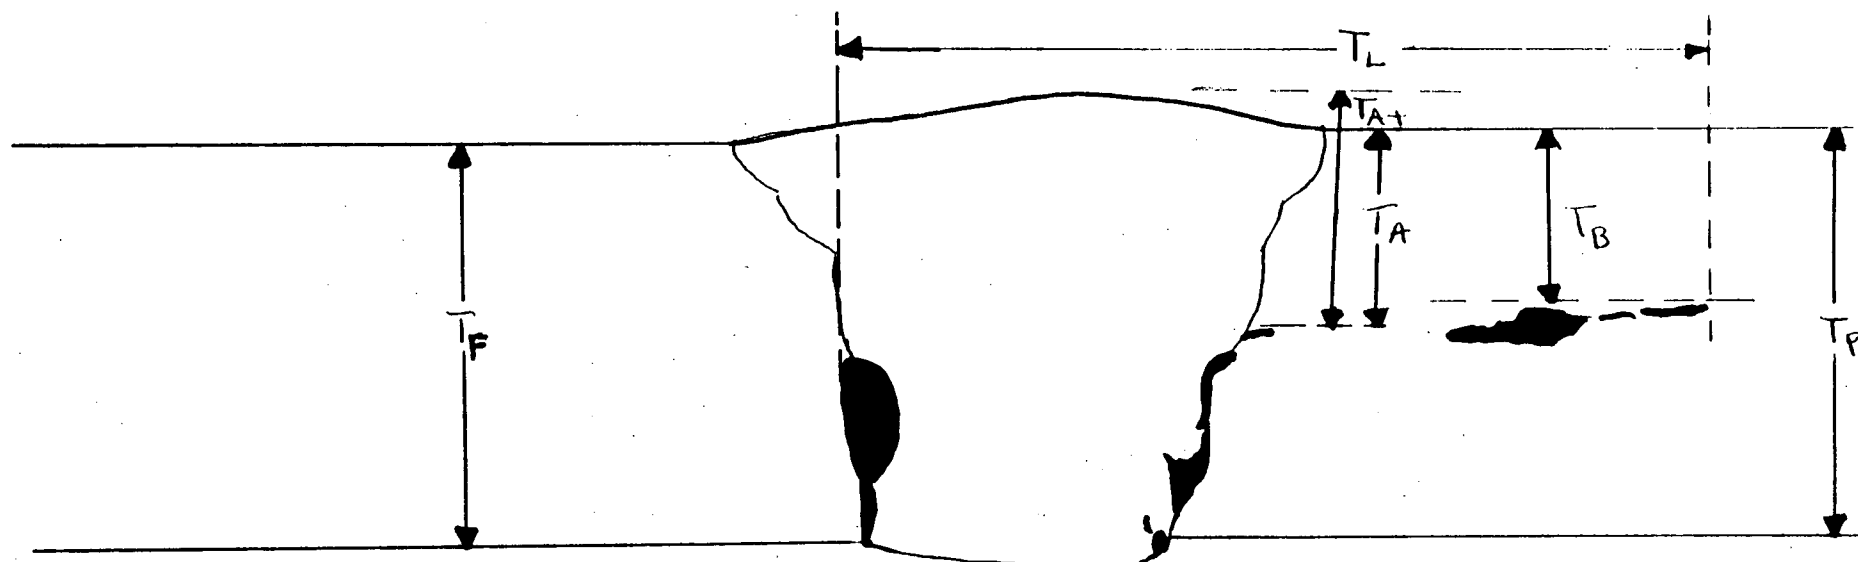
Figure 1

Metallographic cross-sections of the worst location identified by RT examination of the 316L piping revealed a cavity measuring approximately 7/8" long starting in the weld, extending axially into the adjacent pipe base metal, and 7/16" circumferentially in the weld metal (see attached Figure 1). The remaining wall measured 0.120" thick. The path of attack appeared to be the weld metal/base metal joint interface. The RT examinations show indications of an average size in length of 5/16 to 1/2" and the average number of indications ranging from two to four indications per joint. Since no baseline RT was made when the pipe was originally installed, some of the RT indications may be weld joint defect type indications; this was found to be the case for one location in the joint that was metallographically examined.

The worst pipe weld joint, cut out for a metallurgical lab analysis at the CP&L Harris Energy and Environmental Center (HE&EC) revealed, that the inside pipe surface had slime deposits high in manganese associated with MIC attack. Laboratory analysis has confirmed that the wall thinning resulted from MIC attack at the weld joints. The path of attack initiation for the 316L stainless steel was along the base metal/weld metal interface and the weld, whereas past MIC indications in 304 stainless steel piping were initiated in the weld joint heat-affected zone adjacent to the weld.

Met. Lab. Sample #1 of 91-32 of HBR-2 SW HVH-4 Type 316L pipe, 6" Sch. 40, Weld Joint #1544 (HBR2-CW-1544)

Since a flaw growth rate for the MIC in the HVH-4 Supply and Return Lines could not be established to show acceptable stress limits for a full fuel cycle, in accordance with flaw evaluation requirements outlined in NRC Generic Letter (GL) 90-05 and Code Case N-480, a decision was made to add welded sleeves over the flawed welds. An operability evaluation was performed for the worst as-found flawed condition utilizing the minimum wall with analyzed loads. This evaluation concluded that the piping system was in an operable condition at the time of the flaw detection (reference calculation RNP-C/STRS-1120).

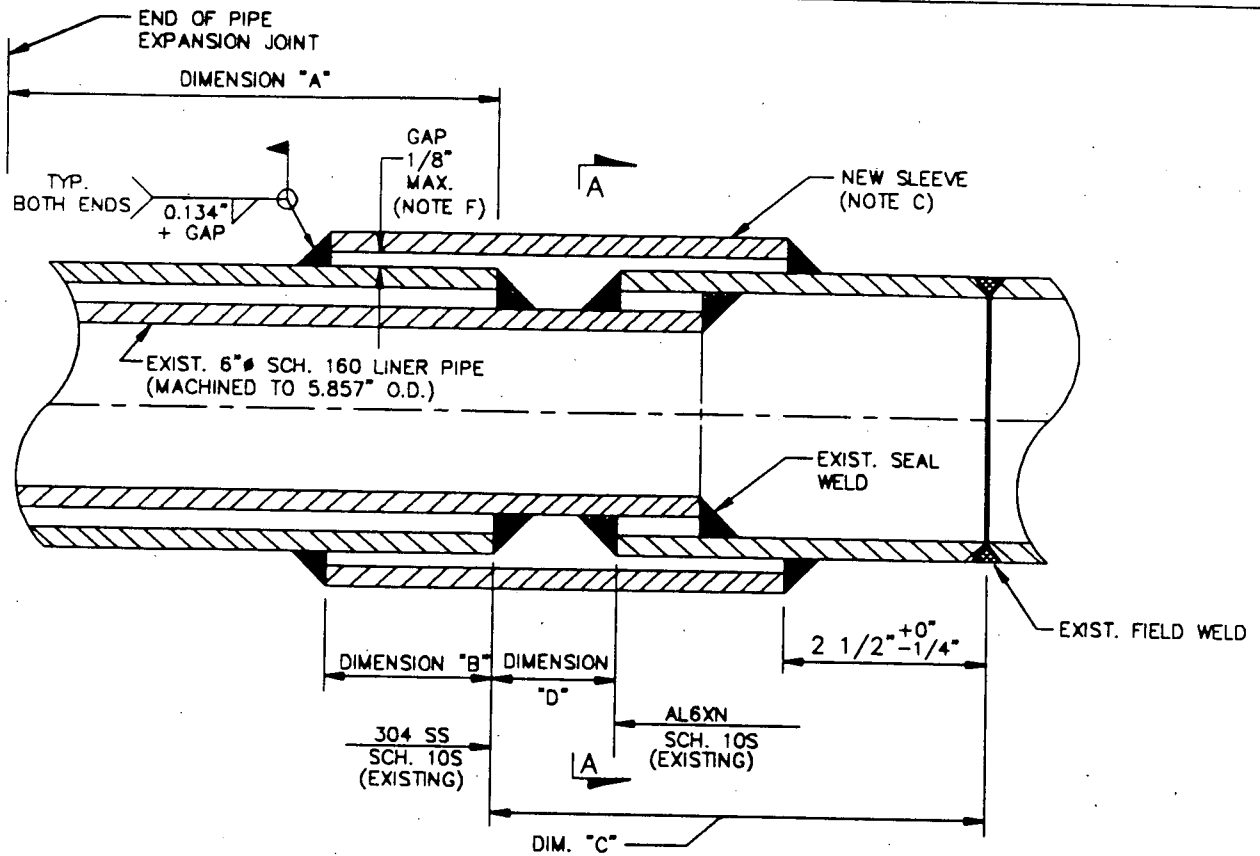
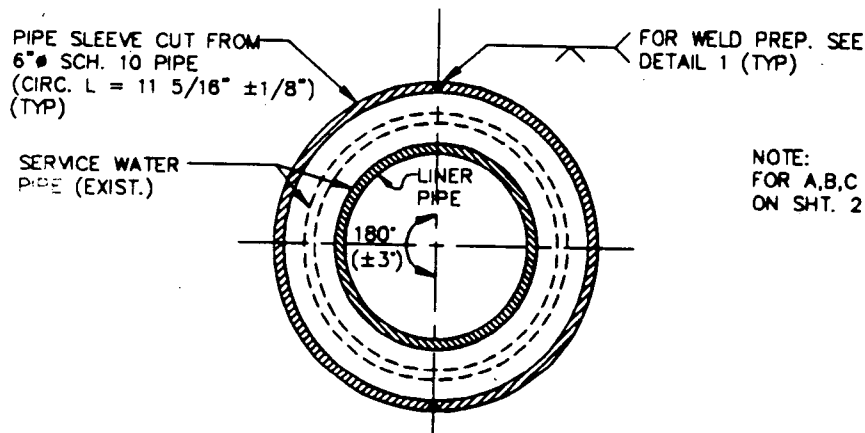
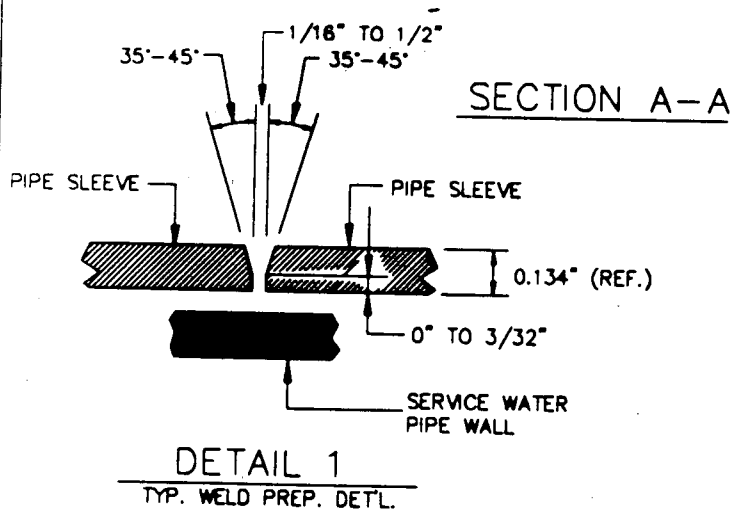
SLEEVE DETAIL

RT indications found in the penetration weld joints are similar to the piping indications but were of a smaller size.

The design of the welded sleeve to be installed on the penetrations containing MIC indications is contained in Attachment 2.
