SUBJECT: LER 87-023-00: on 870826 & 0908, diesel generator A
 automatically tripped on overspeed upon starting. Caused by
 relaxation of overspeed trip device weight spring due to
 age. Governor replaced & lubricant changed. W/870930 ltr.

FACILITY NAME (1) H. B. ROBINSON STEAM ELECTRIC PLANT, UNIT NO. 2	DOCKET NUMBER (2) 0 5 0 0 0 2 6 1	PAGE (3) 1 OF 1 5
--	--------------------------------------	----------------------

TITLE (4)
SHORT TERM LOSS OF AVAILABLE ONSITE EMERGENCY AC POWER DUE TO DIESEL GEN. OVERSPEED TRIPS

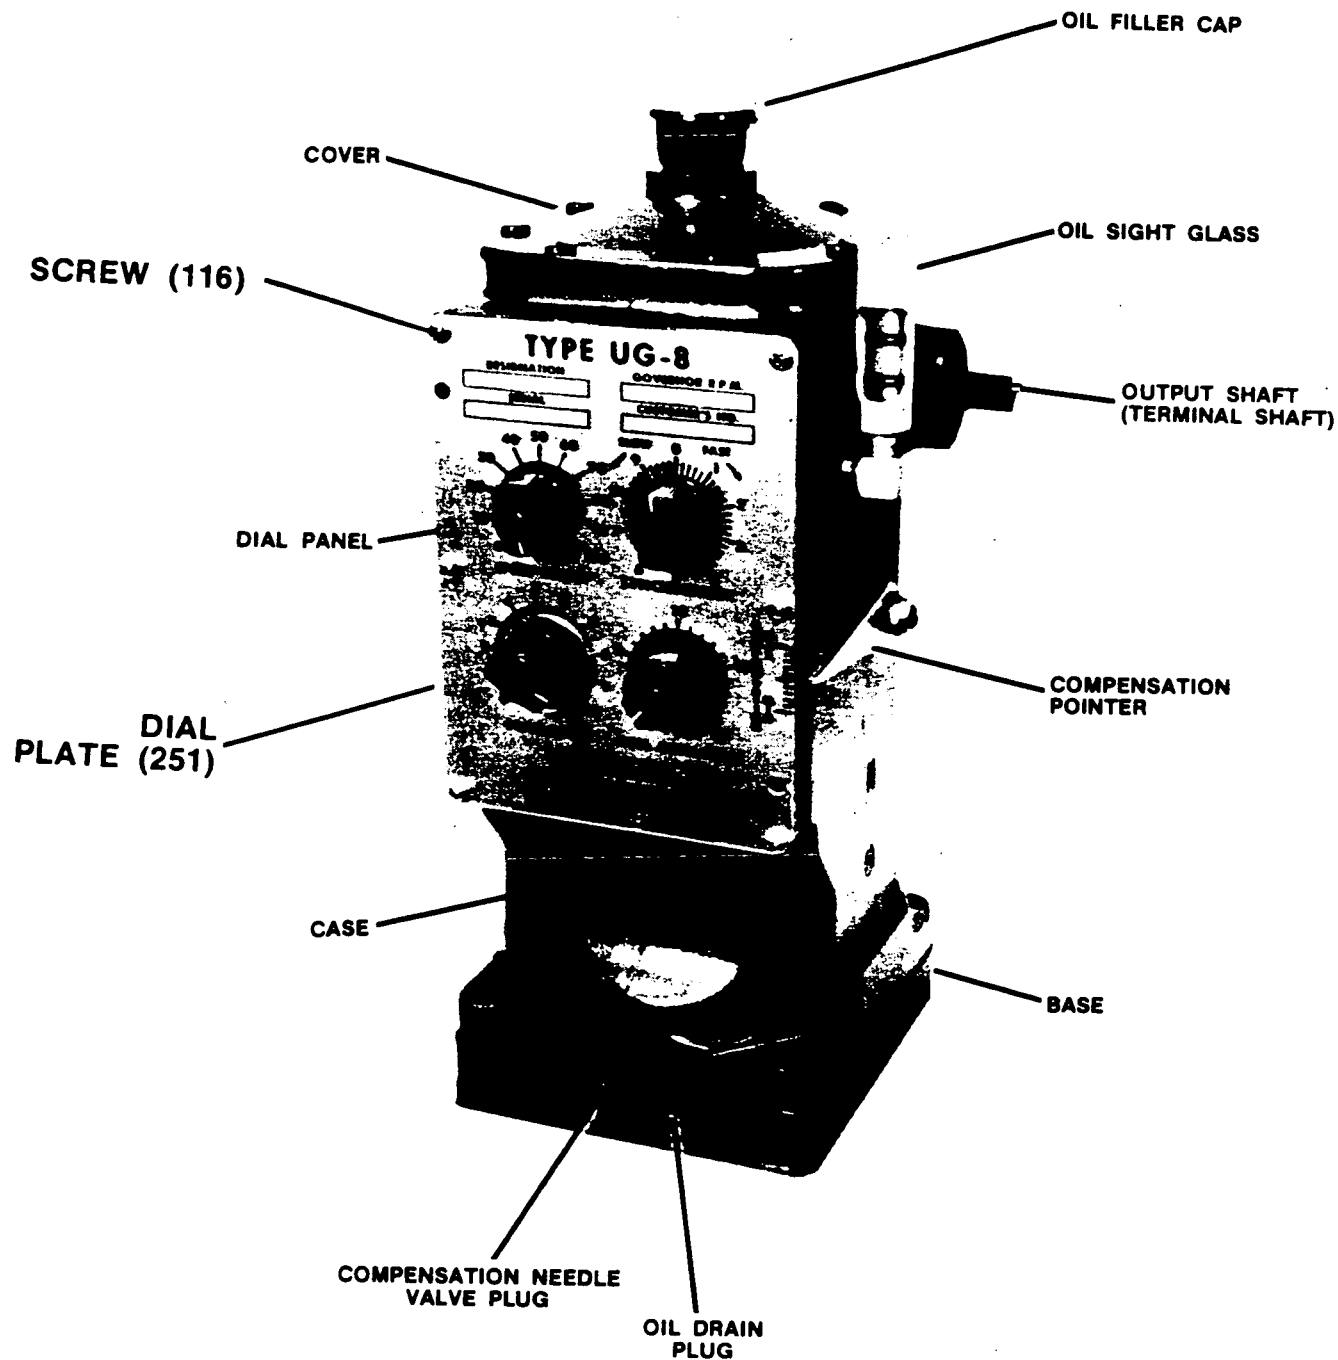
UG8 Dial Governor

Following installation of new or rebuilt fuel injection pumps and installation of a new governor with a load limit setting of 9.0, DG-A continued to trip on overspeed during starting. The engine, however, was operating more efficiently. The governor load limiter setting for 2750 kW (110 percent of continuous rating) was investigated and the limiter was reset from 9.0 to 8.1. Engine starts were then attempted while monitoring speed with an automatic trace-type tachometer which produced a tracing of rpm vs time. The overspeed trip setpoint was found to be low. The diesel manufacturer was contacted and recommended a setpoint between 990 and 1053 rpm, with an optimum of 1020 rpm. The manufacturer also suggested that the problem might be a relaxation of the overspeed trip device weight spring due to age.

The DG-A governor was replaced and its lubricant changed to one of lower viscosity to improve responsiveness. The governor compensation was adjusted for more responsive control of the engine during starting.

The governor load limiter setting was lowered from 9.0 to 8.1 to further restrict the stroke position of the injection pumps during starting of the engine.

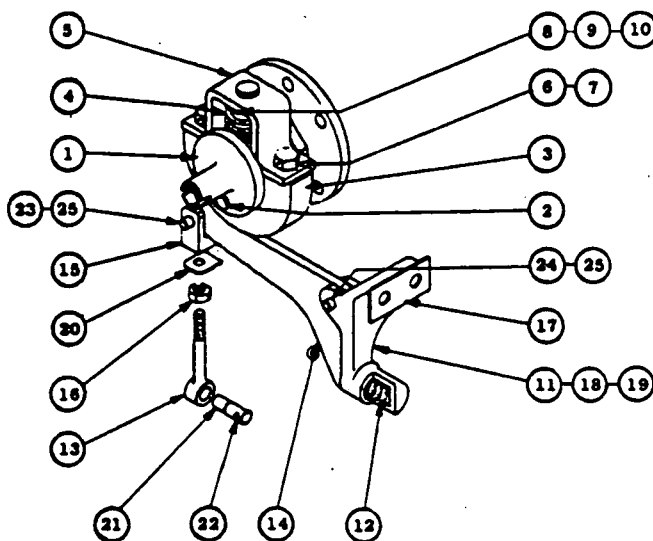
Overspeed Governor - Non-Reversible Engines

governor⁴ (hereinafter referred to as the overspeed trip device) had apparently relaxed with age; also, the shim washers used in the device to adjust the trip point were burred along the edges as a result of original fabrication. The relaxation of the spring may have caused the overspeed trip point to drift downward while the burred edges on the shim washers may have caused an intermittent variation to occur in the shimpack thickness, resulting in a large trip point variation. These two conditions, combined, apparently created a low overspeed trip point.

The automatic overspeed trips of DG-A on August 26 and September 8 were apparently caused by a relaxation of the overspeed trip device weight spring due to age and a high load limiter setting on the diesel governor. The normal variation in both the maximum rpm on starting and the overspeed trip point resulted in occasional, intermittent automatic overspeed trips. The sticking fuel injection pumps were a minor contributing factor to the situation and only slightly increased the maximum engine rpm on starting.

The DG-A overspeed trip device shim washers were reworked to remove the burred edges and additional shims were installed to compensate for the spring relaxation.

The DG-A overspeed trip setpoint was raised nearer to the optimum setpoint recommended by the diesel manufacturer.

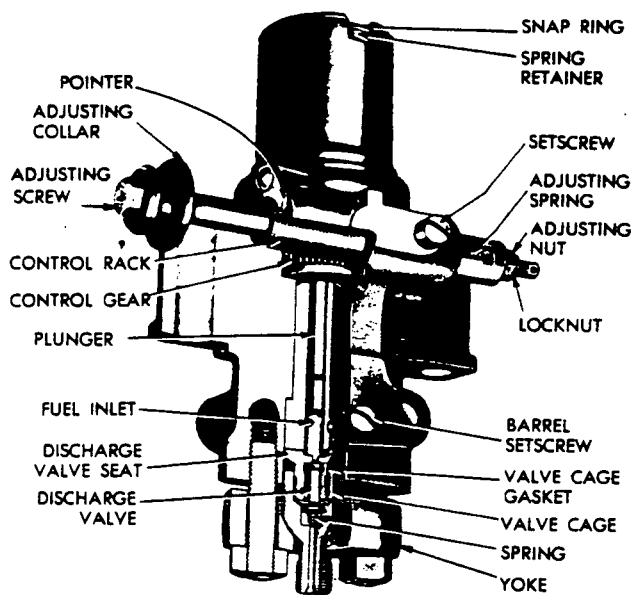
Injection Pump

Inspection by Plant Maintenance personnel found two fuel injection pumps which appeared to be sticking open: one on the number 5 cylinder and one on the number 9 cylinder. Both were replaced with pumps from Plant stock.

The 24 fuel injection pumps on DG-A were rebuilt or replaced although the sticking pump conditions were only a minor contributing factor to the automatic overspeed trips.
