SUBJECT: LER 87-028-00:on 871105,diesel generator B air start failure
 while diesel generator A inoperable.

FACILITY NAME (1) H. B. ROBINSON STEAM ELECTRIC PLANT, UNIT NO. 2	DOCKET NUMBER (2) 0 5 0 0 0 2 6 1	PAGE (3) 1 OF 0 5
--	--------------------------------------	----------------------

TITLE (4) DIESEL GENERATOR "B" AIR START FAILURE WHILE DIESEL GENERATOR "A" INOPERABLE

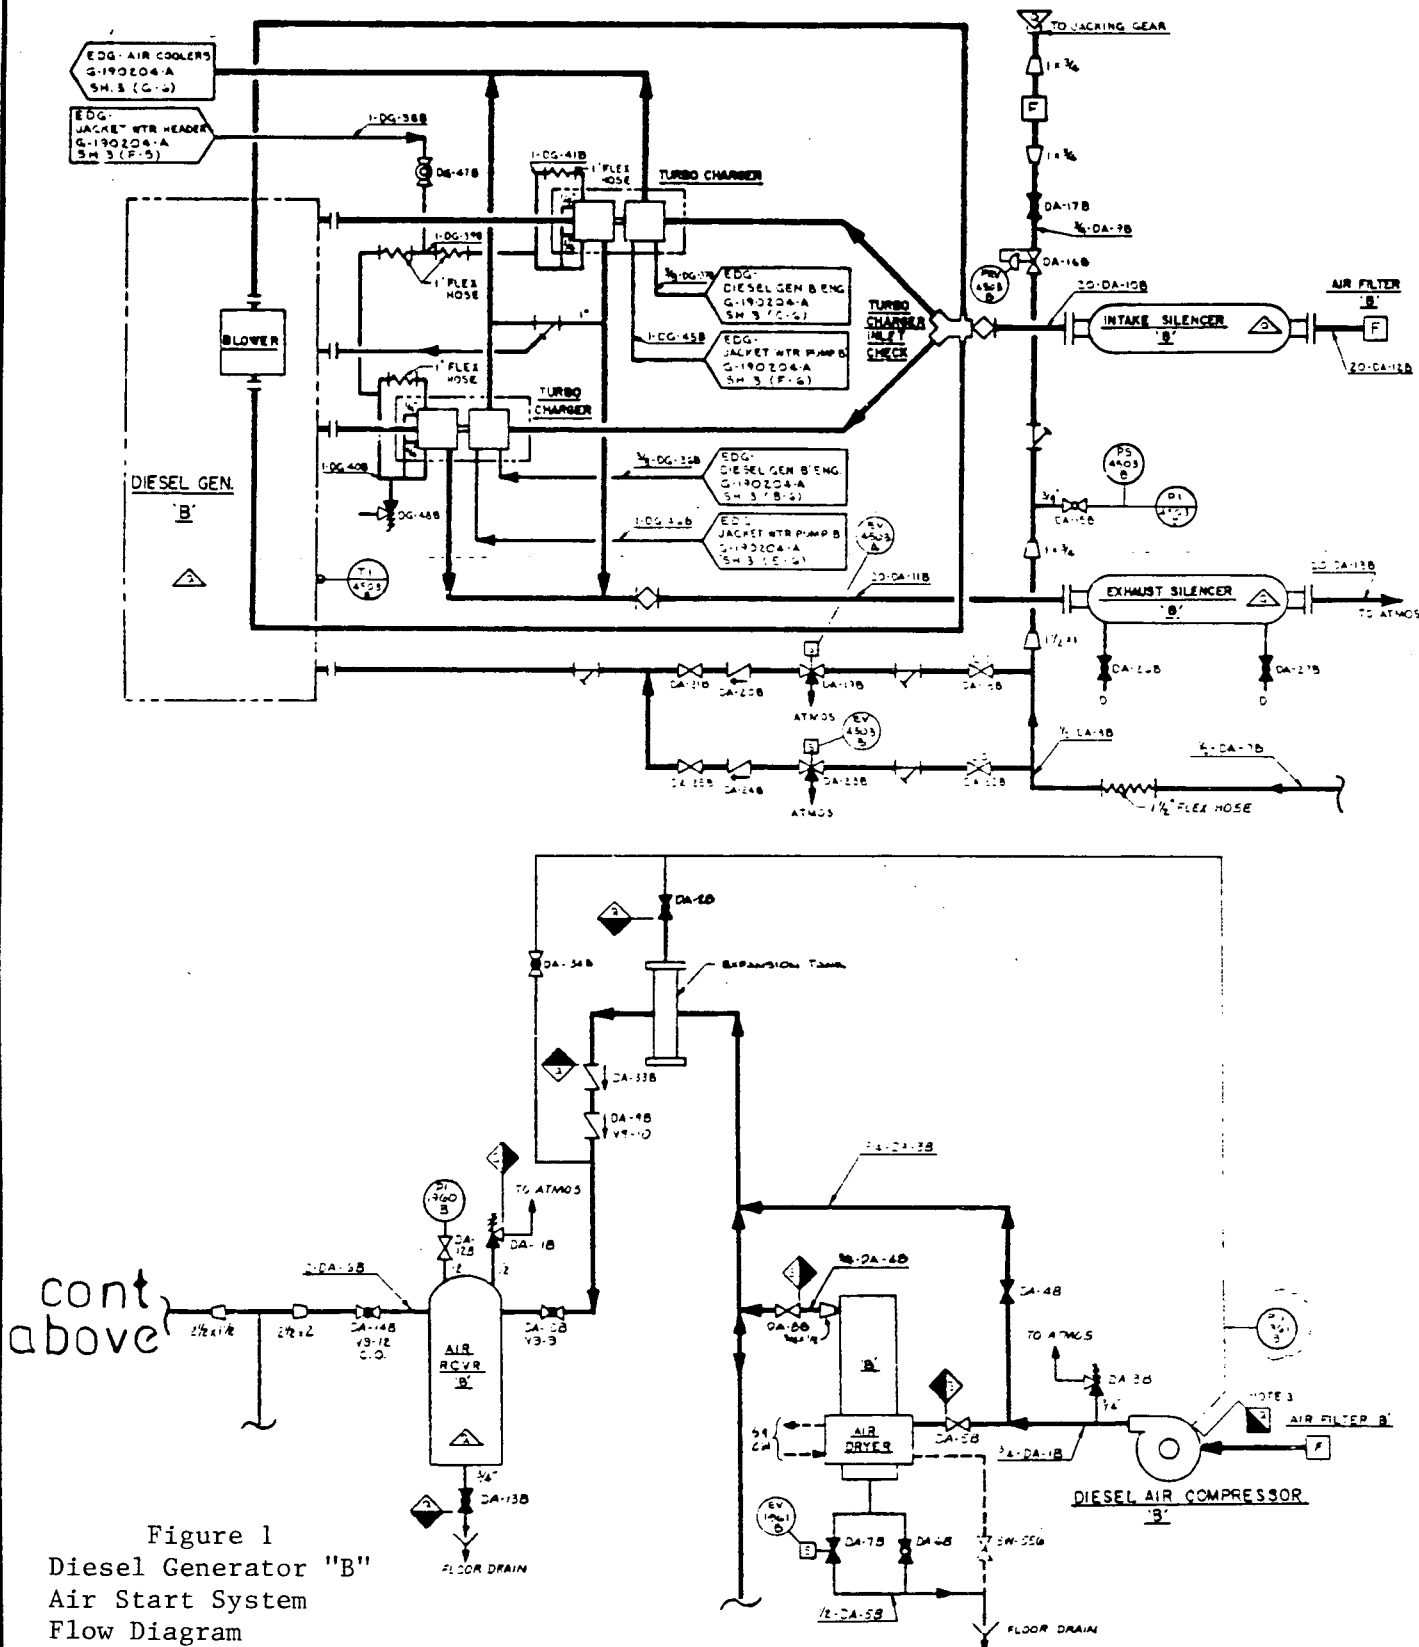
Figure 1 provides a flow diagram of the DG-B air start system.

The Operations surveillance test provides verification of operability of the two pilot-actuated air start solenoid valves for the diesel air start system. When the test is performed, one of the two parallel solenoid valves is isolated at its inlet isolation valve to allow independent testing of the opposite solenoid. The solenoids are three-way valves normally energized in a standby condition. Downstream of each solenoid is a check valve, to prevent backpressure, and another isolation valve (normally open). The solenoids vent to atmosphere. When the pilot of either valve is de-energized, the starting air to that solenoid repositions the valve to close the vent and to align the other two ports to the starting air manifold.

It is suspected that the solenoid under test (one of two) may not have repositioned fully.

The air start system has been thoroughly examined by licensee Maintenance personnel. Both solenoid valves and the two downstream check valves have been inspected. The valves have been reinstalled and tested to operate properly. New solenoid valves have been ordered and upon receipt,⁶ the solenoid valve aligned for the air start of DG-B at the time of the event will be removed, disassembled, and examined by licensee Maintenance personnel. The results of their investigation will determine additional actions to be taken. A Supplemental Report will be submitted to document these continuing activities.⁷

The Operations Surveillance Test procedure has been revised to require a different testing configuration than when the air start failure occurred. This revision was made to enhance the procedure following review of the event to minimize the potential that the test configuration may have contributed to the air start failure.
