SUBJECT: LER 87-030-00: on 871202, nonredundant power supply to  
 redundant vital equipment due to original sys design.

## LICENSEE EVENT REPORT (LER)

FACILITY NAME (1) H. B. ROBINSON STEAM ELECTRIC PLANT, UNIT NO. 2										DOCKET NUMBER (2) 0 5 0 0 0 2 6 1										PAGE (3) 1 OF 0 6																																																																				
TITLE (4) NON-REDUNDANT POWER SUPPLY TO REDUNDANT VITAL EQUIPMENT DUE TO ORIGINAL SYSTEM DESIGN																																																																																								
EVENT DATE (5)									LER NUMBER (6)									REPORT DATE (7)									OTHER FACILITIES INVOLVED (8)																																																													
MONTH			DAY			YEAR			YEAR			SEQUENTIAL NUMBER			REVISION NUMBER			MONTH			DAY			YEAR			FACILITY NAMES													DOCKET NUMBER(S)																																																
1			2			0			2			8			7			8			7			-			0			3			0			-			0			0			1			2			1			7			8			7			0 5 0 0 0													0 5 0 0 0												
OPERATING MODE (9)									THIS REPORT IS SUBMITTED PURSUANT TO THE REQUIREMENTS OF 10 CFR §: (Check one or more of the following) (11)

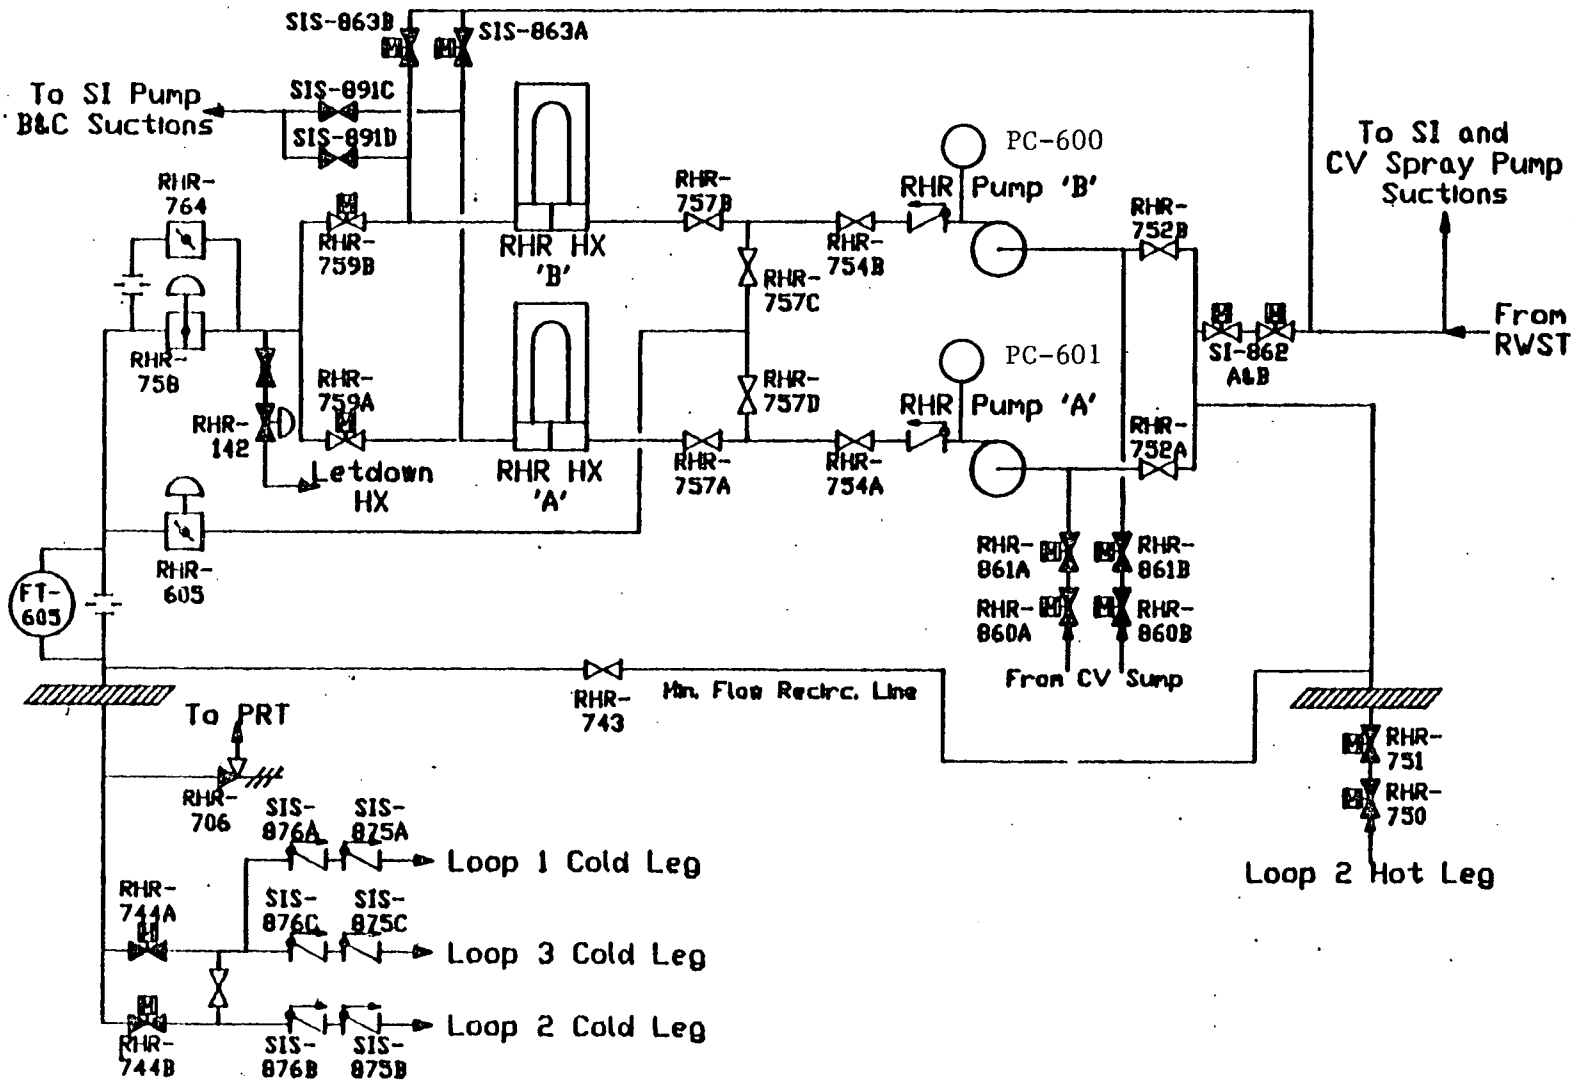
FIGURE 1  
Residual Heat Removal System  
Standby Lineup

The cause of this condition, which existed since original construction, is attributed to inadequate design of the systems' interlock logic power arrangement.

In the recirculation mode, the Residual Heat Removal (RHR) pumps take suction from the containment sump and supply the Safety Injection (SI) and Containment Spray (CS) pumps<sup>3</sup> (see Figure 1). In order to set up this arrangement, valves SIS-862A and B<sup>4</sup> must close to prevent backflow to the Refueling Water Storage Tank<sup>5</sup>, and valves SIS-863A and B<sup>6</sup> must open to provide water to the SI and CS pumps. A pressure interlock<sup>7</sup> is installed in this system to avoid depressurizing the Reactor Coolant System to the Refueling Water Storage Tank and/or overpressurizing the low pressure portions of the SI System during normal cooldown operation with the RHR system. This interlock is intended to prevent these valves from opening until RHR system pressure is below 210 psig as measured by Pressure Control Instrument PC-600 (for valves SIS-862A and B) and Pressure Control Instrument PC-601 (for valves SIS-863A and B). It should be noted that the interlock does not affect valve closure and that reopening of SIS-862A and B is not required in any credible accident situation. Therefore, the interlock has no effect on the post-accident function of these valves.

PC-600 and PC-601 are supplied from Instrument Bus 4, Circuit 18<sup>8</sup>. This instrument bus is normally supplied power from Motor Control Center MCC-6<sup>9</sup> which receives its power from Emergency Bus E2. Therefore, although vital, a single failure to Instrument Bus 4 could potentially prevent valves SIS-863A and B from remotely opening from the Unit No. 2 Control Room as the valve interlocks rely on relays which must be energized for the valves to open.

With Pressure Control Instrument PC-601 supplied from Instrument Bus 4, a loss of that bus would necessitate manual operation to open SIS-863A and B. Therefore, loss of power to or failure of either the relay or the pressure switch in the circuit would prevent remote opening of both valves.

Upon determination that there was not reasonable assurance that the failure of the valves to remotely function as required would be recognized, an Auxiliary Operator was immediately assigned the specific responsibility to manually operate the valves if needed under accident conditions. Since approximately 30 minutes transpires prior to switchover, this would assure that at least one valve could be opened within the three minute period during switchover.

In addition, a temporary repair was implemented to place a jumper for valves SIS-863A and B. The jumper will be removed when a more permanent corrective action is implemented. This will be accomplished during an outage of sufficient length once the modification has been developed.
