SUBJECT: LER 87-029-00: on 871118, svc water flange leak identified in  
 containment air recirculation cooling unit HVH-2 &  
 containment integrity breached during repair. Caused by  
 corroded bolts. Flange repaired. W/871218 ltr.

## LICENSEE EVENT REPORT (LER)

FACILITY NAME (1) H. B. ROBINSON STEAM ELECTRIC PLANT, UNIT NO. 2										DOCKET NUMBER (2) 0   5   0   0   0   2   6   1				PAGE (3) 1 OF 08					
TITLE (4) SERVICE WATER FLANGE LEAK IN CONTAINMENT; MINIMUM COMPONENT REDUNDANCY VIOLATION																			
EVENT DATE (5)			LER NUMBER (6)				REPORT DATE (7)			OTHER FACILITIES INVOLVED (8)									
MONTH	DAY	YEAR	YEAR	SEQUENTIAL NUMBER	REVISION NUMBER	MONTH	DAY	YEAR	FACILITY NAMES				DOCKET NUMBER(S)						
1	1	8	8	7	0	2	9	0	0	1	1	7	8	7	0	5	0	0	0
OPERATING MODE (9)		THIS REPORT IS SUBMITTED PURSUANT TO THE REQUIREMENTS OF 10 CFR §: (Check one or more of the following) (11)																	
N		20.402(b)				20.405(c)				50.73(a)(2)(iv)				73.71(b)					
POWER LEVEL (10)		1   0   0				20.405(a)(1)(i)				X 50.73(a)(2)(v)				73.71(c)

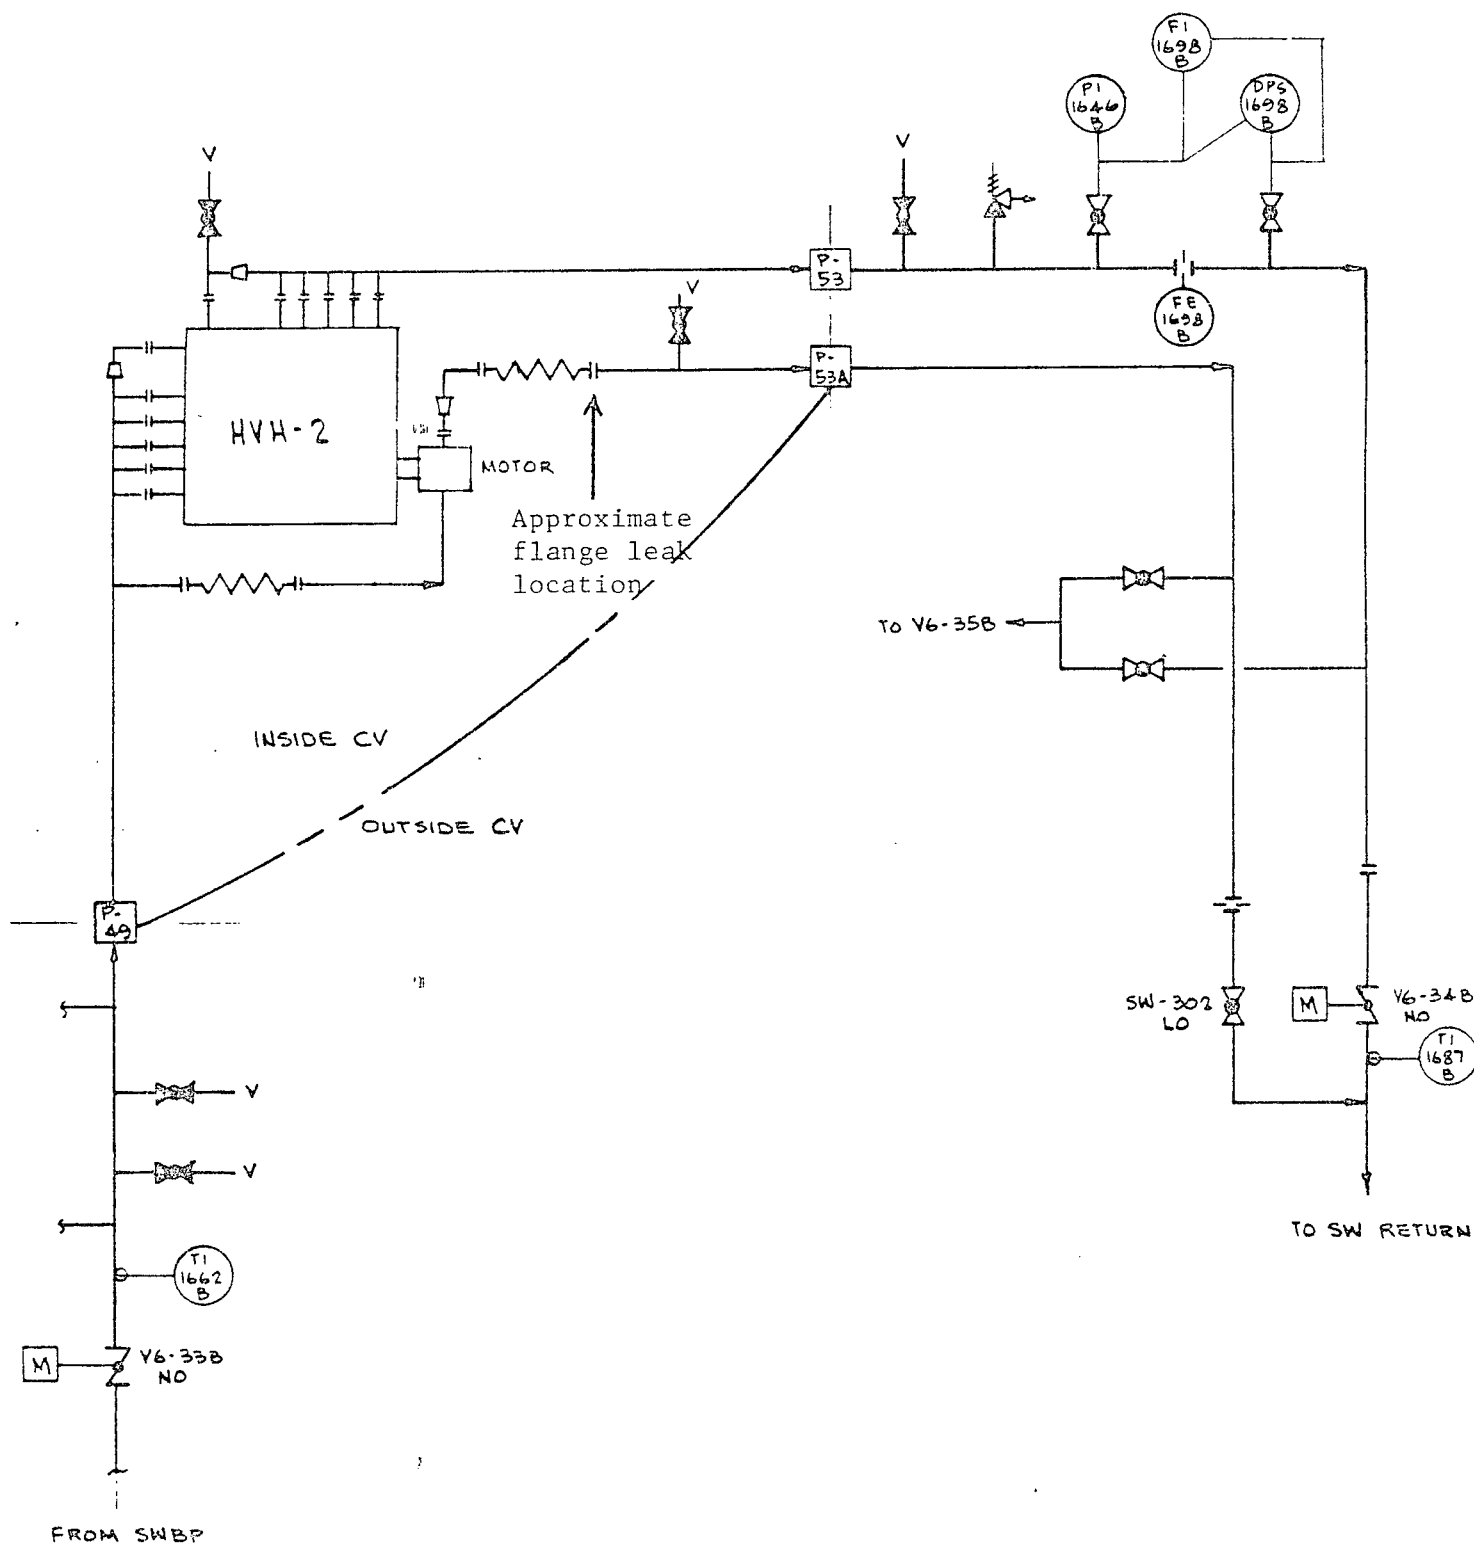
On Wednesday, November 18, 1987, at 1230 hours, H. B. Robinson Unit No. 2 was operating at 100 percent power.<sup>1</sup> A leak was identified in a flexible two-inch Service Water System line from the motor cooler of Containment Air Recirculation Cooling Unit HVH-2.<sup>2,3</sup> The inlet and outlet Service Water lines were isolated and HVH-2 was removed from service by utility licensed Operators to allow for repair of the leak. At 2000 hours, licensee Maintenance personnel entered containment and discovered that a flange on the line was leaking. The flanged spool piece was removed to replace the flange gasket and bolting. At 2400 hours repair of the leaking flange was completed. During performance of post-maintenance pressure testing, test pressure could not be established. It was discovered that outlet isolation valve V6-34B, which is an automatic motor operated butterfly valve,<sup>4</sup> was in the open position, although Control Room indication on the Reactor Turbine Generator Board (RTGB) showed the valve closed.

Figure 1 provides a flow diagram of the Service Water System serving HVH-2.

Upon inspection of the service water line leak, it was discovered that both carbon steel and stainless steel bolts had been used in the leaking flange. The use of two different types of bolting material is acceptable in this application and should not have contributed to the flange leak. The carbon steel bolts, however, showed evidence of corrosion (apparently due to normal condensation from the SW pipe) which prevented further tightening of the flange in an initial attempt to stop the leak. The flange gasket was removed and inspected and appeared to be in satisfactory condition, although not as pliable as new material. Therefore, the cause of this event may have been due to a combination of the corroded bolts, normal vibration at the flange, age of the gasket, or due to the previous installation of the flange. No obvious cause of the leak however, could be determined. Routine weekly inspection in the containment by Operations personnel detected no evidence of flange leakage prior to the event.

The breach of containment integrity resulted from the leak in the Service Water discharge pipe flange from the HVH-2 motor cooler. This system forms one of the principal safety barriers for containment. Investigation of the event determined that the breach was further aggravated by inadequate alignment between the valve and motor operator on the outlet isolation valve, V6-34B, resulting from an error during reinstallation of the valve following a flushing procedure in May, 1987.<sup>7,8</sup>

The HVH-2 motor cooler two-inch Service Water pipe spool flange leak was repaired by replacing the flange gasket and corroded bolts. This repair corrected the breach in containment integrity. Other similar flanges were inspected, and no problems were noted. As a precautionary measure however, these flanges will be disassembled and installed with new gasket material and bolting material as necessary during the next refueling outage.

The repair of the HVH-2 outlet isolation valve, V6-34B, actuator added additional assurance to maintaining containment integrity whenever the cooling unit or its Service Water line is isolated. Following its repair, licensee Maintenance personnel inspected all other similar Service Water outlet isolation valves and found one other actuator, on V6-34C, also installed inadequately. This actuator was immediately corrected.
