SUBJECT: LER 88-003-00: on 880128, design single-failure discrepancy that may result to loss of safety injection pump autostart & seven more similar scenarios found. Caused by original design deficiency. Mod implemented & review planned. W/880227 ltr.

## LICENSEE EVENT REPORT (LER)

FACILITY NAME (1) H. B. ROBINSON STEAM ELECTRIC PLANT, UNIT NO. 2										DOCKET NUMBER (2) 0 5 0 0 0 2 6 1										PAGE (3) 1 OF 0 6				
TITLE (4) LOSS OF SAFETY INJECTION PUMP AUTOSTART DUE TO EIGHT SINGLE-FAILURE SCENARIOS																								
EVENT DATE (5)			LER NUMBER (6)				REPORT DATE (7)			OTHER FACILITIES INVOLVED (8)														
MONTH	DAY	YEAR	YEAR	SEQUENTIAL NUMBER	REVISION NUMBER	MONTH	DAY	YEAR	FACILITY NAMES						DOCKET NUMBER(S)									
0 1	2 8	8 8	8 8	0 0 3	0 0	0 2	2 7	8 8							0 5 0 0 0									
THIS REPORT IS SUBMITTED PURSUANT TO THE REQUIREMENTS OF 10 CFR §: (Check one or more of the following) (11)																								
OPERATING MODE (9)		N		20.402(b)				20.406(c)				50.73(a)(2)(iv)				73.71(b)								
POWER LEVEL (10)		1 0 0		20.406(a)(1)(i)				50.38(c)(1)				50.73(a)(2)(v)				73.71(c)

H. B. ROBINSON STEAM ELECTRIC PLANT, UNIT NO. 2  
DOCKET NO. 50-261  
LICENSE NO. D

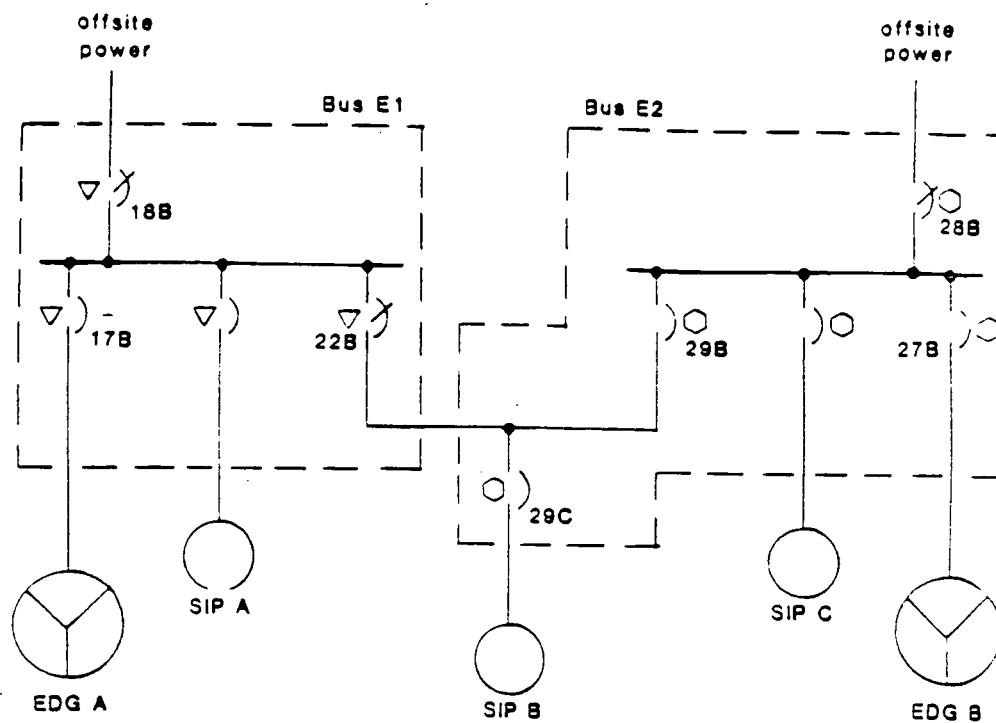
Figure 1

During review of Plant documents in response to an NRC Request for Additional Information on the automatic transfer scheme for Safety Injection Pump "B" (SIP-B), the licensee identified a design discrepancy.<sup>1,2</sup> As originally designed, a single failure of the "B" Battery during a safety injection could result in only one SI pump (SIP-A) being available for automatic start on a Safeguards signal.<sup>3,4,5</sup> The tie bus between the E-1 and E-2 emergency busses would be energized from the E-1, but there would be no control power to close the breakers for SI pumps "B" and "C".<sup>6,4</sup> The closing power for the SIP-B breaker comes from the "B" Battery.

The cause of the single-failure susceptibility appears to be inherent in the design of SIP-"B" and the emergency ac and dc distribution systems in how they provide control power and motor power for SIP-"B". Specifically, the SIP-"B" was designed to be powered automatically from either the "A" or "B" Train (480V emergency power) via a tie bus arrangement (Figure 1). Power would be preferentially supplied by the "A" Train (bus E-1) through a tie breaker. If power was unavailable, the selection logic would sense this tie breaker open and the opposite tie breaker would be closed by the SI sequencer, providing power from the "B" Train (bus E-2). However, control power for SIP-"B" would be provided by only the "B" Train ("B" dc distribution system). It was this configuration (two trains of power, one train of control) and the interrelation of the "A" and "B" Train logics associated with automatic starting of SIP "B" that created the various combinations of single-failure scenarios.

Normal Emergency Bus Lineup

(Before Jan 28, 1988)

The condition placed the Plant into Technical Specification 3.0 which required the reactor to be in hot shutdown by 0100 hours, January 29, 1988, if the condition could not be corrected. An alternative breaker alignment and related procedure changes were pursued as an interim approach to eliminate the common mode failure.

Corrective action for each of the scenarios identified are detailed in the previously referenced correspondence.<sup>7,8</sup> Permanent corrective action for one scenario required more extensive engineering review. Accordingly, as a interim measure to return the Plant to operation, analyses have been performed to establish a power level at which operation with only two available automatically initiated SI pumps (and assuming a single failure of one) could be justified. That power level has been determined to be 60% of rated power (1380 Megawatts thermal). Accordingly, a modification has been implemented to remove the automatic start feature of SIP-"B" and thus eliminate the single failure. As a longer term solution and as additional corrective actions are implemented, appropriate licensing action will be initiated. These actions will be detailed in a supplement to this LER.
