SUBJECT: LER 88-018-00:on 880901,inoperable cable tray penetration
 seals due to inadequate installation procedure.

FACILITY NAME (1) H. B. Robinson Steam Electric Plant, Unit No. 2	DOCKET NUMBER (2) 0 5 0 0 0 2 6 1	PAGE (3) 1 OF 0 5
--	--------------------------------------	----------------------

TITLE (4)
Inoperable Cable Tray Penetration Seals due to Inadequate Installation Procedure

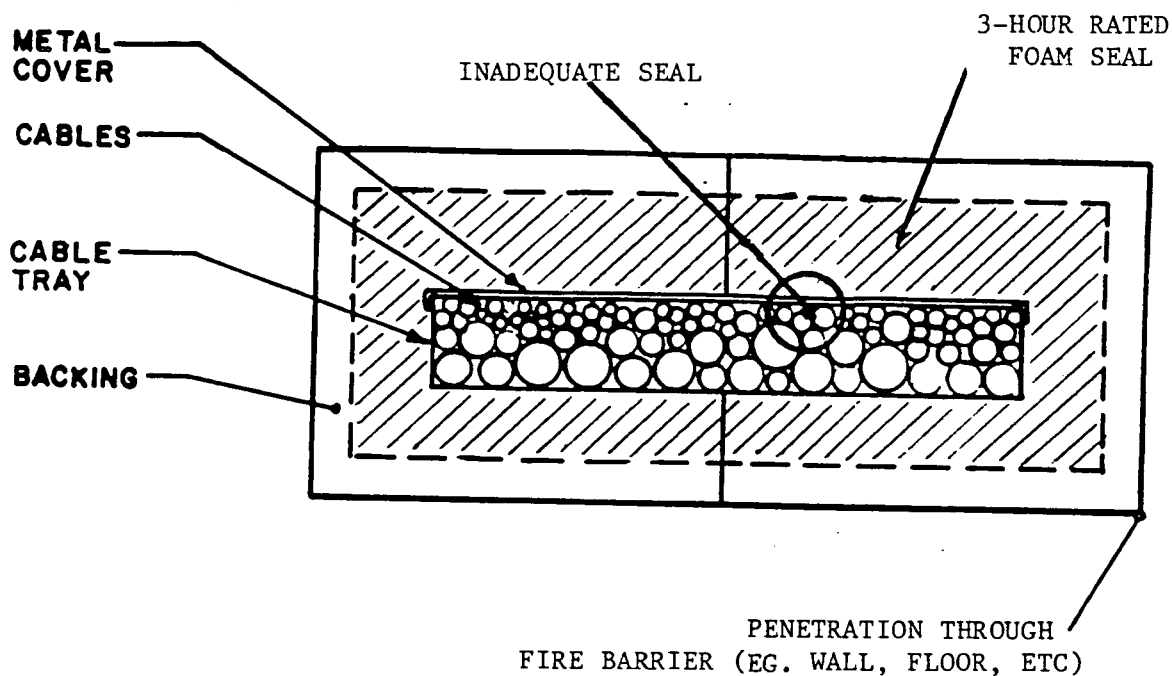
ELECTRICAL CABLE TRAY PENETRATION
WITH TRAY COVER

On Thursday, September 1, 1988, during the QC inspection of the repaired penetration, the licensee QC inspector detected what appeared to be air leakage through other cable tray penetrations in the vicinity. The penetrations affected were those that contained a cable tray cover, as shown in the attached illustration, in the through-wall area of the penetration, resulting in a leak path between the cables and the cable tray cover. As a result, a comprehensive inspection was initiated to inspect all cable tray penetrations to determine the scope of the problem, and to formulate necessary corrective actions.

Procedure CM-621 under which silicone foam seals were installed in fire barriers at electrical cable tray penetrations, did not specifically address cable trays with covers. Thus, the seal installers did not remove the tray covers and in some cases, no seal material was installed around the cables underneath the cover, or in the space between the cables and the cover. Verification that silicone foam was installed under the cable tray covers was not included in inspection procedures for these penetration seals.

All cable tray penetration seals have been repaired and restored to operable status. Where possible, cable tray covers were removed to allow proper sealing. For the six (6) penetrations where cable tray covers could not be removed or the penetration seal could not otherwise be repaired to a (3) hour tested configuration in accordance with Plant Procedures, an Engineering Evaluation was performed, which included a technical evaluation by a Fire Protection Engineer, that an adequate fire barrier seal was provided for the fire hazard present. Throughout the time when the seals were declared inoperable and being repaired, the fire detection systems covering the areas on either side of the penetrations were verified operable in accordance with Technical Specification 3.14.7.2a. or appropriate compensatory action was taken.
