SUBJECT: LER 88-003-01: on 880128, loss of safety injection pump  
autostart due to eight single-failure scenarios. W/8 ltr.

FACILITY NAME (1) H. B. Robinson Steam Electric Plant, Unit No. 2	DOCKET NUMBER (2) 0 5 0 0 0 2 6 1	PAGE (3) 1 OF 10
--	--------------------------------------	---------------------

Loss of Safety Injection Pump Autostart Due to Eight Single-Failure Scenarios

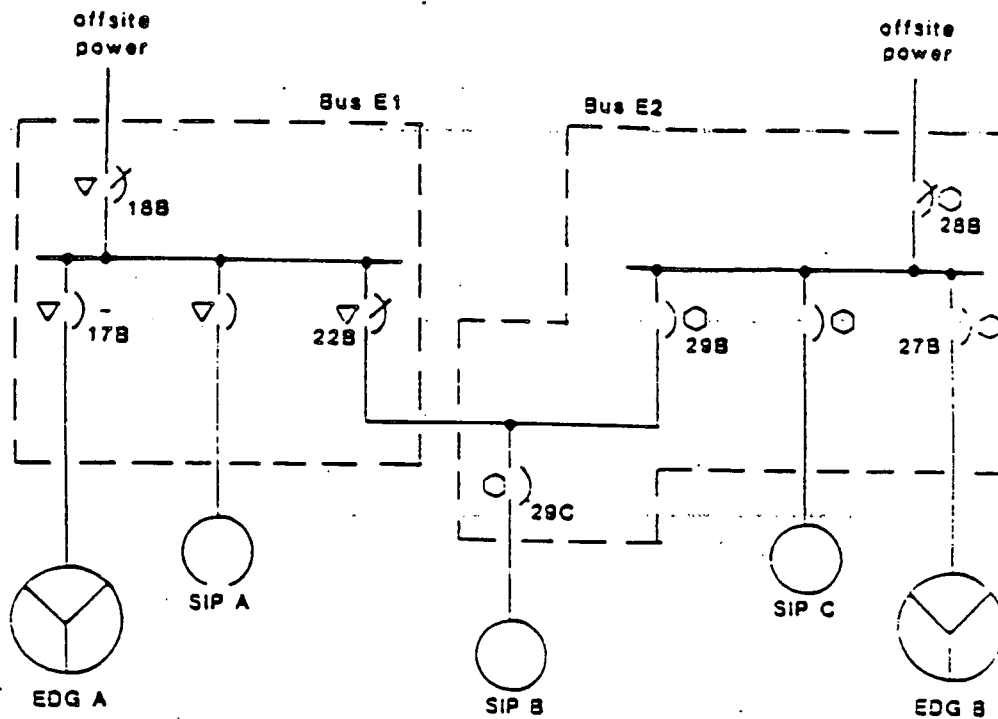
Figure I

During review of Plant documents in response to an NRC Request for Additional Information on the automatic transfer scheme for Safety Injection Pump "B" (SIP-B), the licensee identified a design discrepancy.<sup>1,2</sup> As originally designed, a single failure of the "B" Battery during a safety injection could result in only one SI pump (SIP-A) being available for automatic start on a Safeguards signal.<sup>3,4,5</sup> The tie bus between the E-1 and E-2 emergency busses would be energized from the E-1, but there would be no control power to close the breakers for SI pumps "B" and "C".<sup>6,4</sup> The closing power for the SIP-B breaker comes from the "B" Battery.

The cause of the single-failure susceptibility appears to be inherent in the design of SIP-B and the emergency AC and DC distribution systems in how they provide control power and motor power for SIP-B. Specifically, the SIP-B was designed to be powered automatically from either the "A" or "B" Train (480V emergency power) via a tie bus arrangement (Figure 1). Power would be preferentially supplied by the "A" Train (bus E-1) through a tie breaker. If the "A" Train power was unavailable, the selection logic would sense this tie breaker open and the opposite tie breaker would be closed by the SI sequencer, providing power from the "B" Train (bus E-2). However, control power for SIP-B is provided by only the "B" Train ("B" DC distribution system). It was this configuration (two trains of power, one train of control) and the interrelation of the "A" and "B" Train logics associated with automatic starting of SIP-B that created the various combinations of single-failure scenarios.

Normal Emergency Bus Lineup

(Before Jan 28, 1986)
