SUBJECT: LER 89-015-00: on 891103, EQ conduit seal deficiency due to inadequate wire use range installation instructions. W/8 1tr.

H. B. ROBINSON STEAM ELECTRIC PLANT, UNIT NO. 2
DOCKET NO. 50-261
LICENSE NO. DPR-23
LICENSEE EVENT REPORT 89-015-00

FACILITY NAME (1) H. B. Robinson Steam Electric Plant, Unit No. 2										DOCKET NUMBER (2) 0 5 0 0 0 2 6 1 1					PAGE (3) 1 OF 5	
TITLE (4) EQ Conduit Seal Deficiency Due to Inadequate Wire Use Range Installation Instructions																
EVENT DATE (5)			LER NUMBER (6)				REPORT DATE (7)			OTHER FACILITIES INVOLVED (8)						
MONTH	DAY	YEAR	YEAR	SEQUENTIAL NUMBER	REVISION NUMBER	MONTH	DAY	YEAR	FACILITY NAMES				DOCKET NUMBER(S)			
11	03	89	89	013	001	12	01	89					0 5 0 0 0			
OPERATING MODE (9) N		THIS REPORT IS SUBMITTED PURSUANT TO THE REQUIREMENTS OF 10 CFR §: (Check one or more of the following) (11)														
POWER LEVEL (10) 0 10 0		20.402(b)				20.405(c)				50.73(a)(2)(iv)				73.71(b)

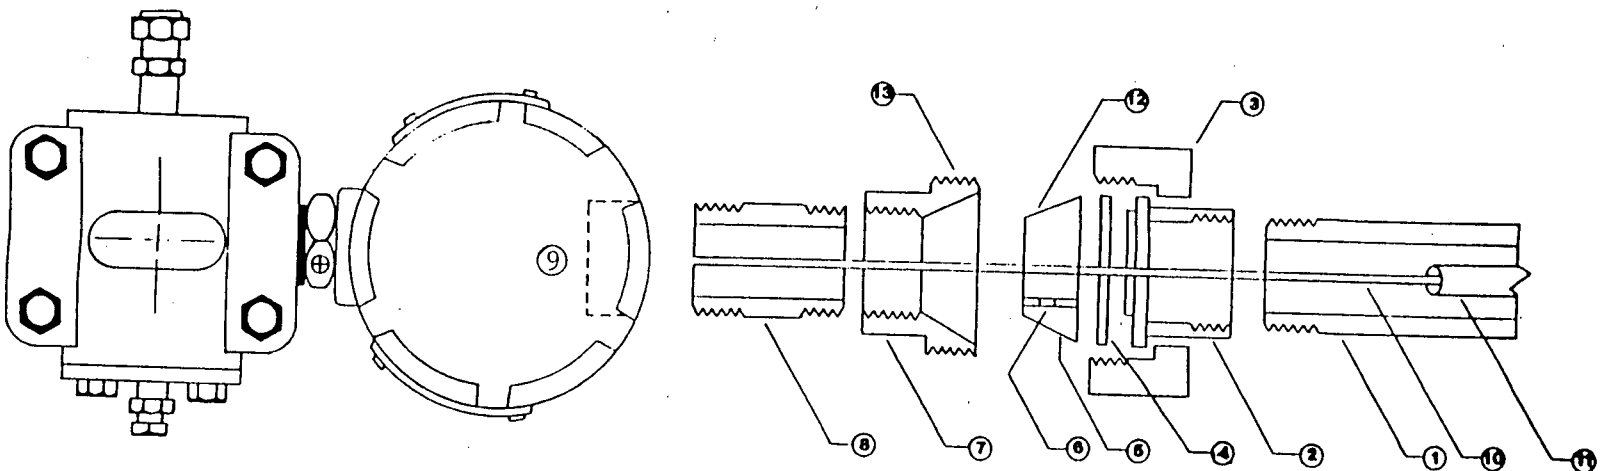
On November 7, 1989, it was identified that as a result of conduit seal torquing performed on November 3, the potential for an additional leakage path had been created. This path was at the seal connection to the instrument housing. No specific motion of the pipe nipple was documented, but it was suspected. The conduit seal to instrument housing seal integrity was, therefore, considered to be indeterminate.

While verifying the torque on the conduit seal union nut, in approximately one half of the seals, the union nut moved about one quarter inch when 50 ft. lb. torque was applied. One of the ninety seals inspected was found to have a significantly loose union nut.

Three modifications installed the conduit seals during 1986 and 1987. A review of these modifications was performed to determine the root cause of this condition. This review demonstrated that the installation instructions provided in each modification were consistent with the manufacturer's instructions available at the time. These instructions specified the following as a maximum wire diameter use range for the conduit seal grommet:

Regarding the loosening of the union nuts, the manufacturer has stated that the one-quarter inch movement upon application of 50 ft. lb. torque does not indicate a degraded seal. The one incident of a significantly loose union nut is an isolated condition.

Therefore, the cause of the wire use deficiency in conduit seals is attributed to the failure of the manufacturer to supply adequate installation instructions for the conduit seal.

Conduit seals in EQ applications were inspected for proper wire use range. Where proper use range did not exist, the grommet was replaced except for certain applications associated with ASCO solenoid valves. In these applications, drain holes were drilled at an elevation lower than the solenoid to conform to the ASCO tested configuration in lieu of replacing the conduit seal.

Plant procedures have been revised to specify the appropriate wire use range for conduit seal grommets. In addition, procedures now require a formal evaluation of EQ documentation prior to implementation of a modification. This evaluation will serve to preclude repetition of the condition described in the report. No further corrective action is necessary.
