SUBJECT: LER 90-003-00:on 900118,inoperable fire barrier penetration  
 seals due to installation deficiency.

H. B. ROBINSON STEAM ELECTRIC PLANT, UNIT NO. 2:  
DOCKET NO. 50-261  
LICENSE NO. DPR-23  
LICENSEE EVENT REPORT NO. 90-003-00

FACILITY NAME (1) H. B. ROBINSON STEAM ELECTRIC PLANT, UNIT NO. 2										DOCKET NUMBER (2) 0   5   0   0   0   2   6   1				PAGE (3) 1 OF 0   6		
TITLE (4) INOPERABLE FIRE BARRIER PENETRATION SEALS DUE TO INSTALLATION DEFICIENCY																
EVENT DATE (5)			LER NUMBER (6)				REPORT DATE (7)			OTHER FACILITIES INVOLVED (8)						
MONTH	DAY	YEAR	YEAR	SEQUENTIAL NUMBER	REVISION NUMBER	MONTH	DAY	YEAR	FACILITY NAMES				DOCKET NUMBER(S)			
0   1	1   8	9   0	9   0	0   0   3	0   0	0   2	1   4	9   0					0   5   0   0   0			
OPERATING MODE (9) N		THIS REPORT IS SUBMITTED PURSUANT TO THE REQUIREMENTS OF 10 CFR §: (Check one or more of the following) (11)														
POWER LEVEL (10) 1   0   0		20.402(b)				20.405(c)				50.73(a)(2)(iv)				73.71(b)

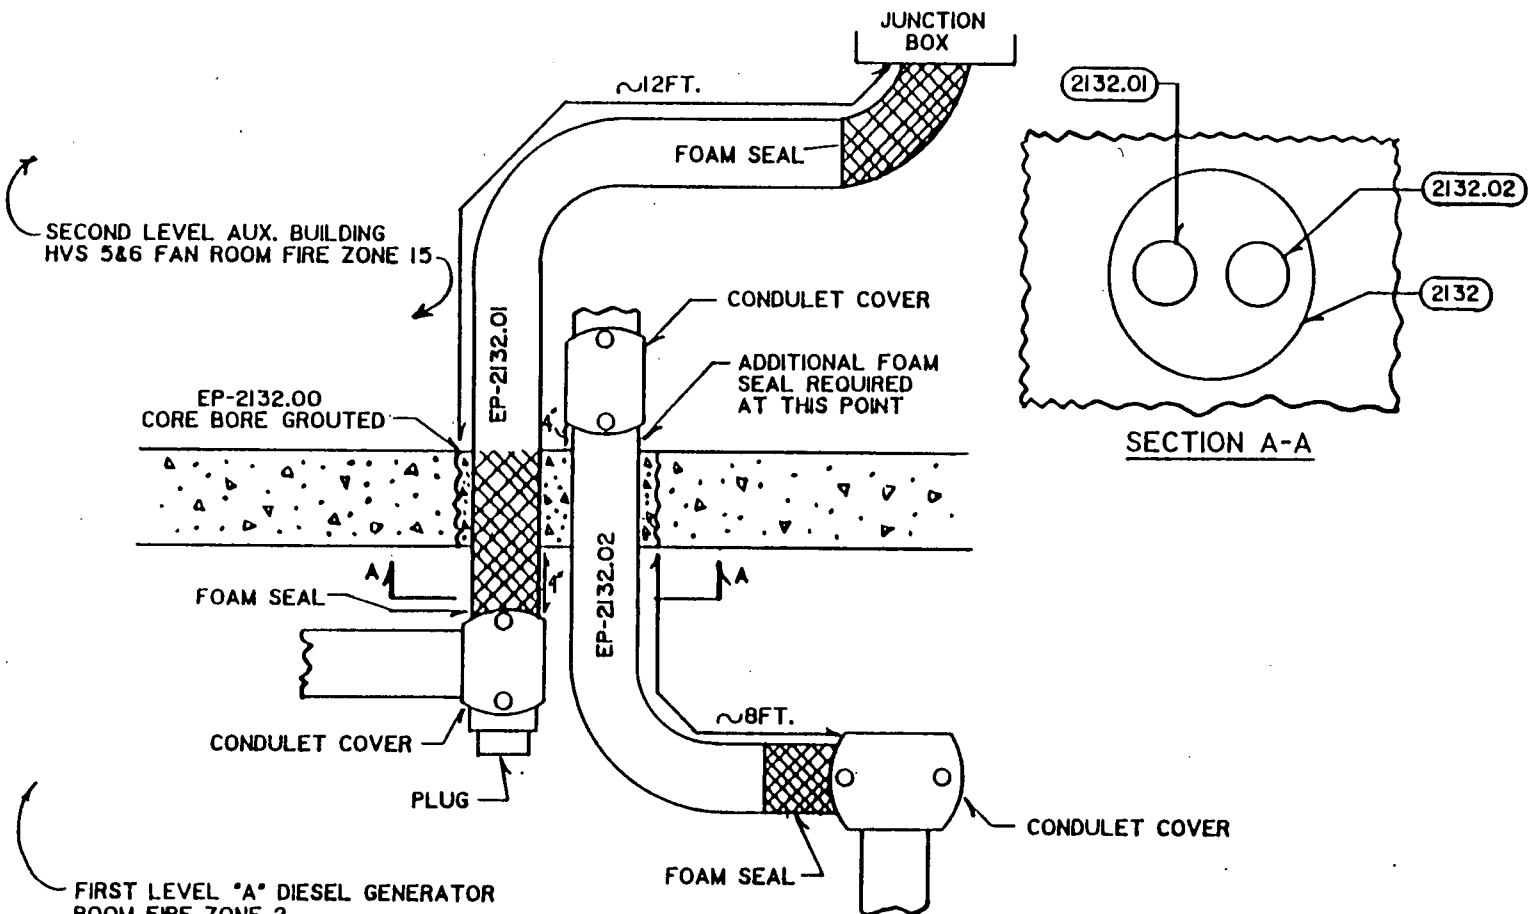
With regard to EP-2132.02-FL-15, as shown on the attached illustration, electrical penetrations EP-2132.01 and EP-2132.02 pass through the same core bore from zone 2 ("A" Emergency Diesel Room ceiling) into zone 15 (second floor Auxiliary Building, HVS-5&6 Fan Room). EP-2132.02-FL-15 is a one-inch conduit which on the zone 2 side has been sealed with foam approximately eight feet from the fire barrier. However, because this seal is not at the barrier, it must be sealed on both sides of the barrier. The investigation revealed that during performance of OST-623 on August 28, 1987, the EP-2132.02-FL-15 penetration had been found to be without an internal seal. At that time, the penetration was declared inoperable, and a repair effort was conducted. Following repair, the penetration was

returned to service. Therefore, with this conflicting data, it is evident that the work performed in 1987 was inadequate in that, due to the close proximity of the conduits in the penetration area, EP2132.01 was sealed instead of EP-2132.02. This could have easily occurred if the individual locating the penetration for repair became misoriented within the fan room (turned south to north), which is believed to have occurred.

BOTH CONDUITS ARE ~ 1" DIA.  
THIS DRAWING IS NOT TO SCALE

Penetration EP-2132.02 was repaired and returned to service on January 18, 1990, at 1705 hours. Penetration EP 6001.00-FL-18 was repaired and returned to service at 1500 hours on January 29, 1990. The licensee is currently performing an inspection of fire barrier penetration seals in accordance with Technical Specification 4.14.5.1. This inspection, which will include 100% of the penetration seals, is scheduled to be completed prior to startup from the 1990 refueling outage, and will identify any similar circumstances if they exist.
