SUBJECT: Special rept:on 900118,steam-driven auxiliary feedwater pump
 inoperable for greater than 72 h.

H. B. ROBINSON STEAM ELECTRIC PLANT, UNIT NO. 2
DOCKET NO. 50-261
LICENSE NO. DPR-23
SPECIAL REPORT - SD AFW PUMP INOPERABLE FOR GREATER THAN 72 HOURS

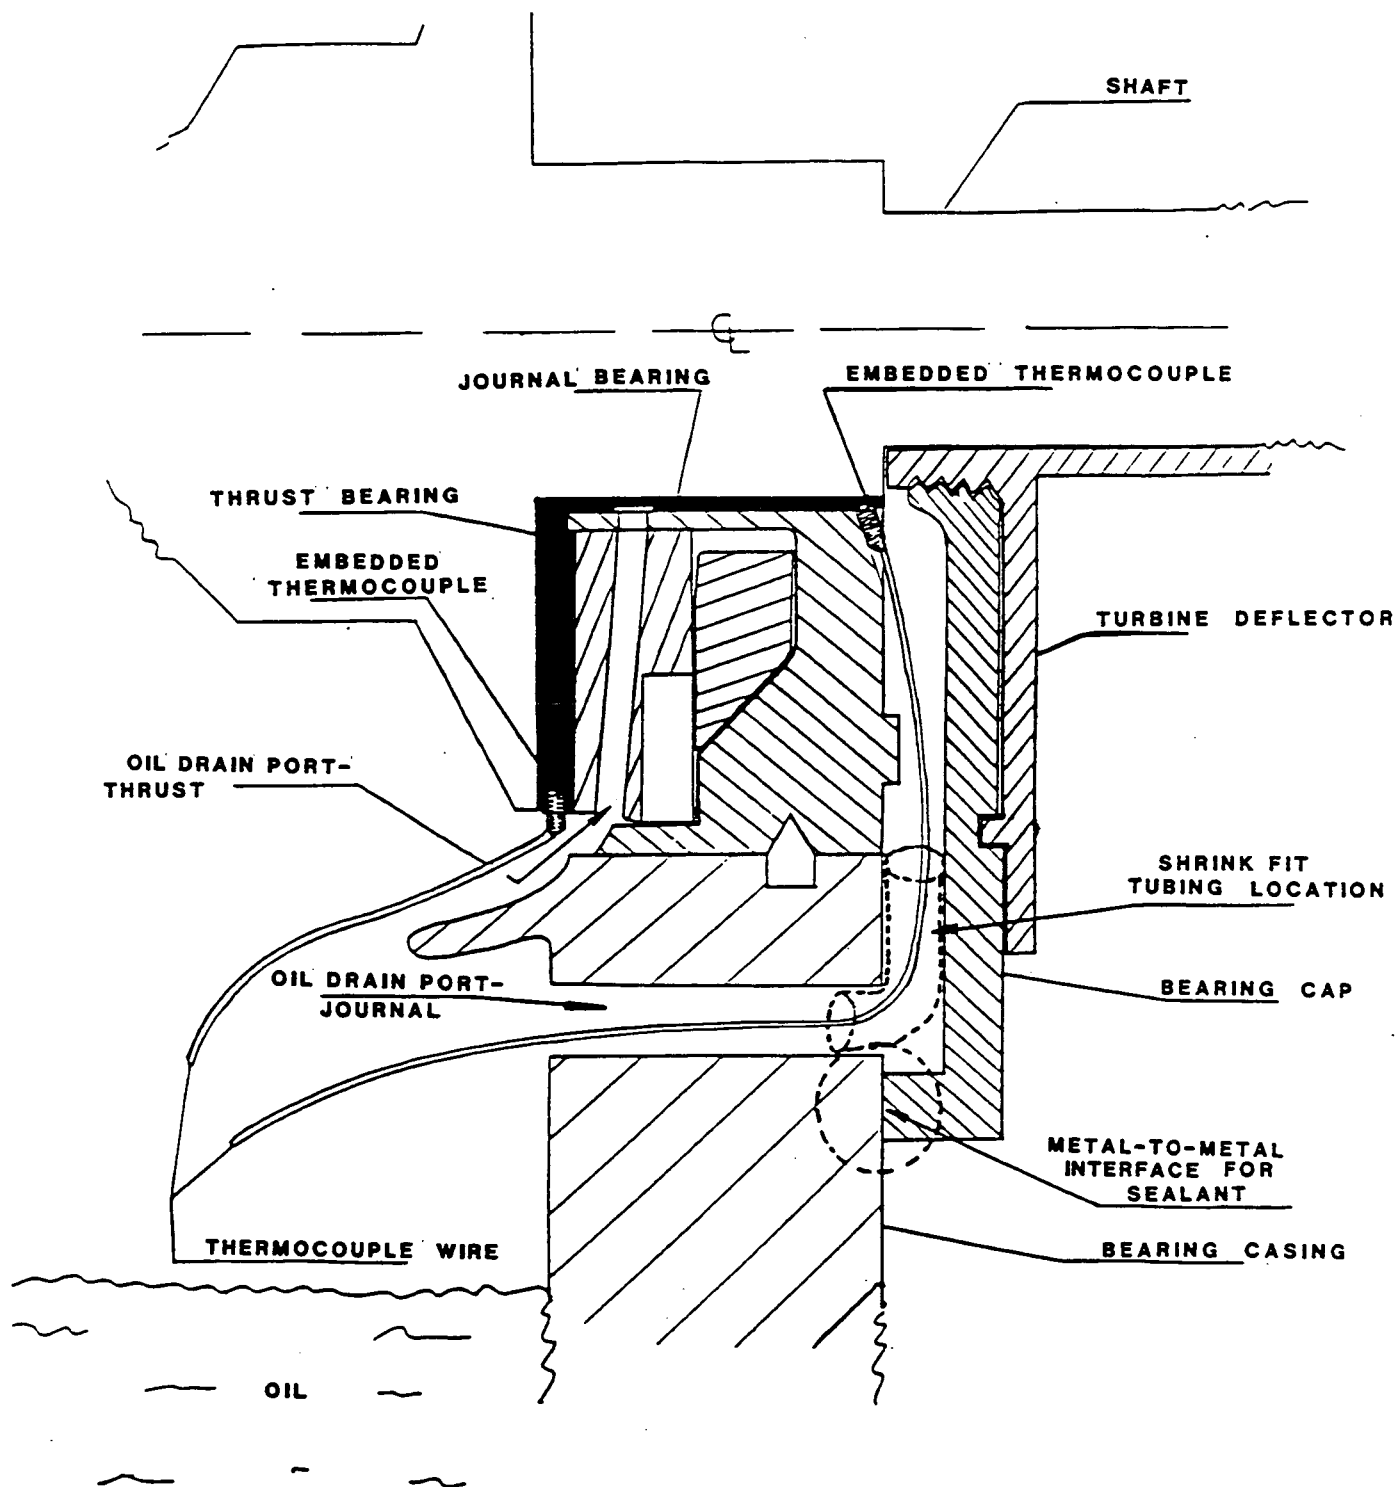
FIGURE 1

On January 20, 1990, after the appropriate tools and vendor assistance were obtained, the turbine-end of the pump was disassembled. It was determined during disassembly that the oil drain port for the turbine-end journal bearing was blocked. This blockage was caused by shrink fit tubing covering wiring to an embedded thermocouple in the journal bearing (Reference Figure 1). This wiring runs from the journal bearing, through the oil drain port, and into the bearing casing. The shrink fit tubing had apparently swelled when exposed to the oil environment, which blocked the oil drain port and resulted in the oil leakage. An evaluation of this shrink fit tubing was performed. It was determined that this tubing was not required for pump operation or protection of the thermocouple wiring and was, therefore, removed.

To determine the reason for the recurrence of the lubricating oil leak, the turbine-end of the pump was again disassembled. When the bearing cap was removed, it was observed that the journal bearing oil drain port was blocked with bearing cap sealant. This sealant was used to seal the metal-to-metal surface between the bearing cap and the bearing casing (Reference Figure 1). This sealant has a thick consistency when applied, but flows more freely when heated. It requires heat to cure, and after heating begins to solidify. When the pump was reassembled following maintenance, it is believed that this sealant was

The cause of the initial lubricating oil leak was the shrink fit tubing which was found to be blocking the journal bearing oil drain port. The associated thermocouple wiring had been replaced during a rebuild of the SD AFW pump which was performed during a recent forced outage. The shrink fit tubing had apparently swelled when exposed to oil and blocked the oil drain port, which ultimately resulted in the oil leak. This shrink fit tubing was removed and the other bearing thermocouple wires were inspected. The shrink fit tubing on other wires inspected was left as found. However, during the next available opportunity for major SD AFW pump maintenance, this wiring will be re-evaluated and the shrink fit tubing removed, if appropriate.

The cause of the second lubricating oil leak was the blockage created in the journal bearing oil drain port by the bearing cap sealant. The method of application and the amount of sealant applied resulted in the sealant flowing from the proper sealing surface into the oil drain port. The bearing cap was removed, the sealant cleared from the oil drain port, and the bearing cap was reinstalled and properly sealed. To ensure that future maintenance activities do not result in a similar occurrence, applicable maintenance instructions will be reviewed and enhancements made as needed.

BEARING ARRANGEMENT - TURBINE END

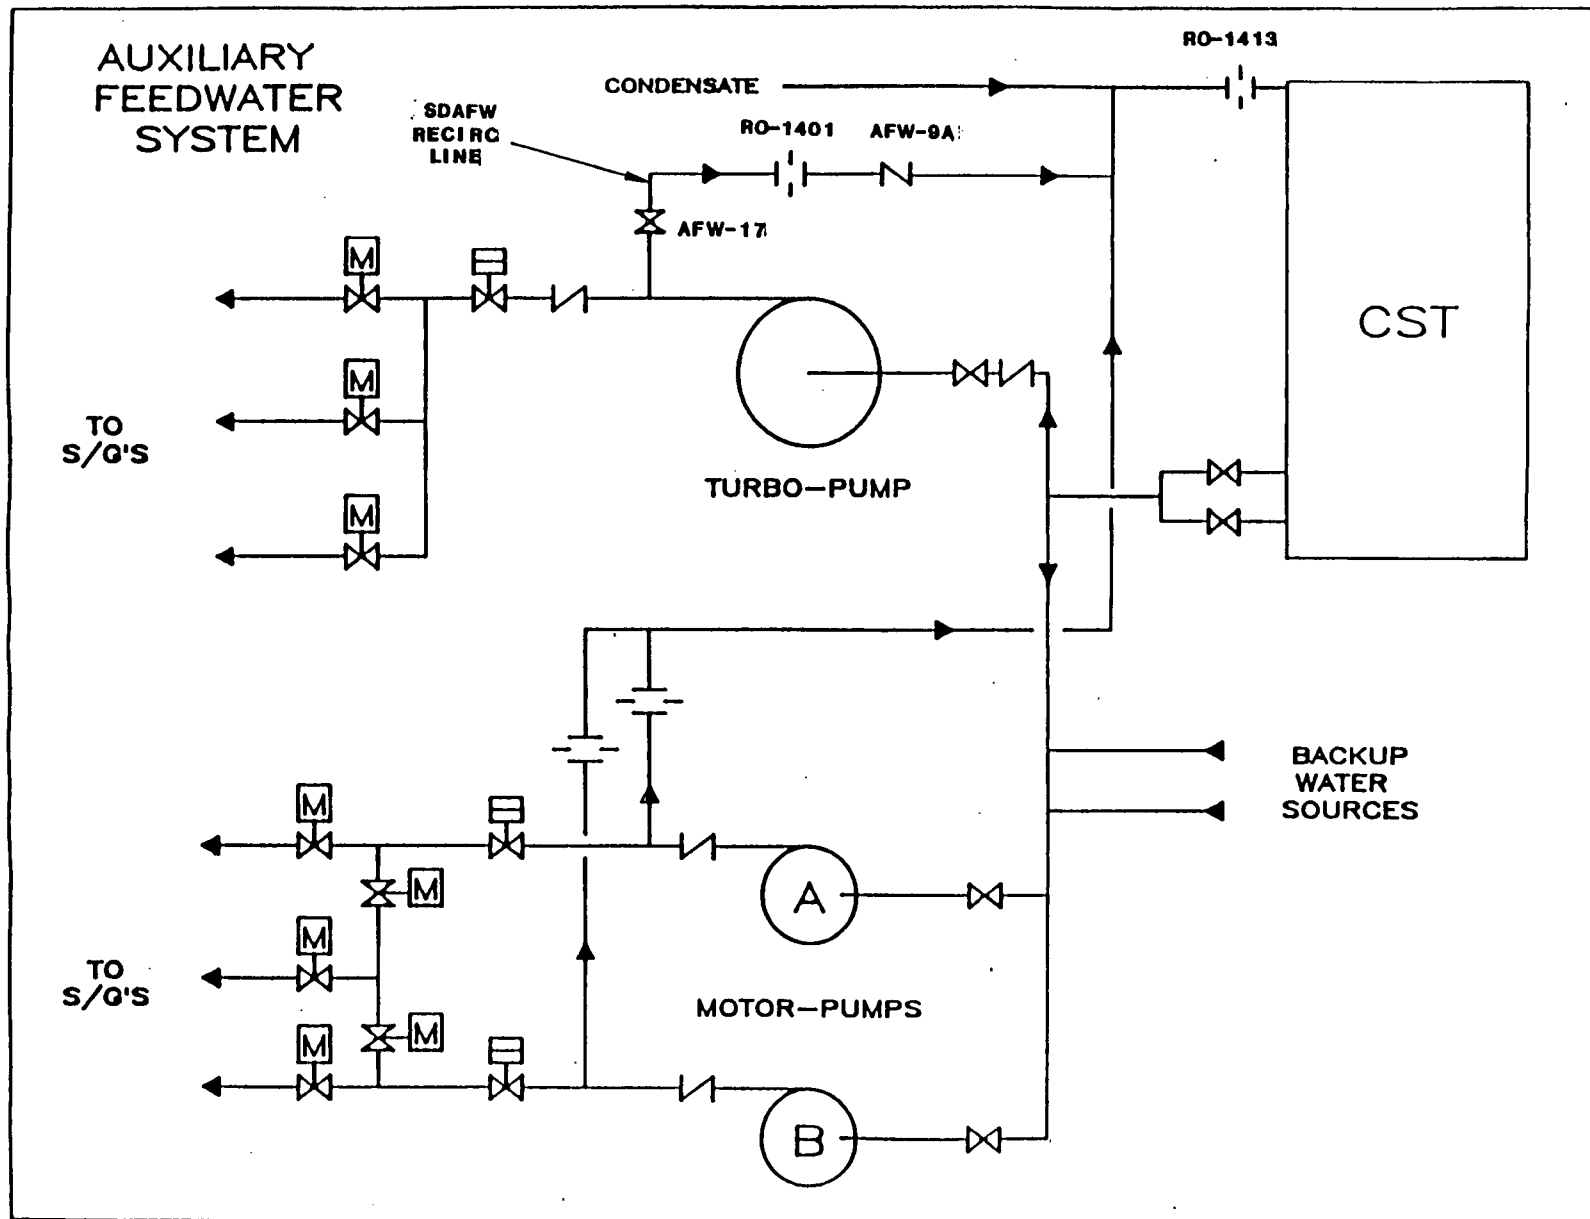
FIGURE 2

Since the increased vibration was an expected result of reduced recirculation flow, the investigation was directed at the recirculation piping and components. It was initially expected that a check valve in the recirculation line, AFW-9A, might be malfunctioning in a manner which was restricting flow (Reference Figure 2). This valve was disassembled and inspected. No problems were noted during this inspection, and the valve was reassembled without the internals for further testing of the recirculation piping. The SD AFW pump was subsequently started on the evening of January 21, 1990, and the reduced recirculation flow was still present, which indicated that AFW-9A was not the source of the flow restriction. During this same test, lubricating oil leakage was observed in the location of the previous oil leak.

Further examination of the recirculation line included fiber-optic inspection of various sections of piping downstream of AFW-9A. These inspections revealed no evidence of flow blockage. The pump recirculation orifice, RO-1401, was disassembled. Inspection of this orifice revealed a small wafer on the upstream side of the orifice which had been partially blocking the orifice and restricting flow. A fiber-optic inspection was then performed of a manual isolation valve, AFW-17, which is located upstream of this orifice. During this inspection, it was noticed that the valve disc appeared to be separated from the disc union (Reference Figure 3). The valve was disassembled and the disc was verified to be separated from the disc union. This allowed the disc to rotate, resulting in partial separation of the disc from the disc union, which in turn allowed the wafer to leave the valve and be carried downstream to the orifice. This wafer normally acts as a bearing surface for the stem so that the stem can rotate without causing the disc to rotate. Rotation of the valve disc into the valve seat would result in scoring of the valve seat. On the morning of January 23, 1990, after receiving required information from the valve vendor, reassembly of the valve began.

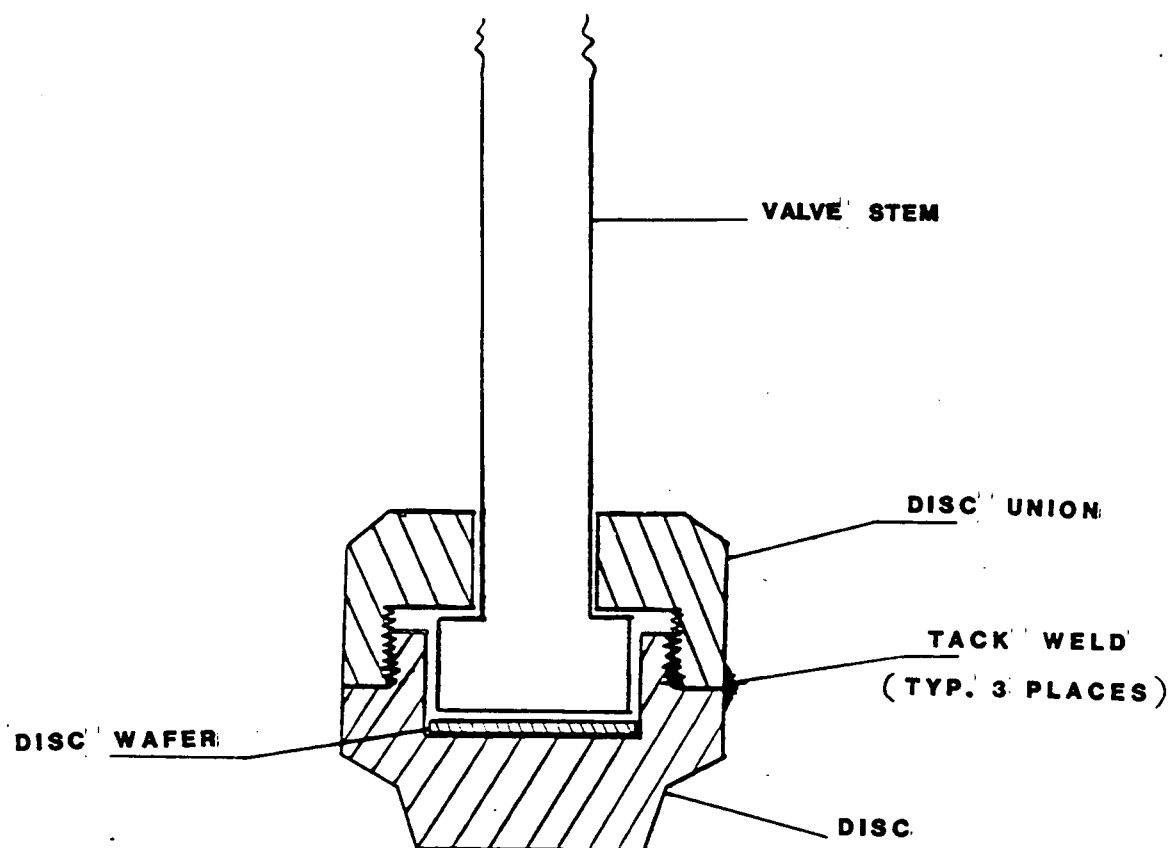
FIGURE 3

The low recirculation flow and the resultant elevated pump vibration were the result of flow blockage caused by the wafer partially blocking the recirculation flow orifice. This wafer was carried by recirculation flow from the recirculation isolation valve, AFW-17. The tack welds which secured the valve disc to the disc union failed, resulting in the partial separation of the disc from the disc union. This in turn allowed the wafer to leave the valve and move to the flow orifice. Since there had been no prior indication of elevated pump vibration or reduced recirculation flow, it is believed that the recirculation flow blockage occurred during testing of the pump on the morning of January 21, 1990. The valve was repaired, reinstalled, and was observed to be operating satisfactorily during subsequent pump tests. During the next available opportunity, but no later than the next scheduled refueling outage, this valve will be removed and inspected with further repairs or upgrades made as needed.

GLOBE VALVE

AFW-17
