SUBJECT: LER 90-004-00:on 900204,breach of containment integrity due to failure of personnel airlock door.

H. B. ROBINSON STEAM ELECTRIC PLANT, UNIT NO. 2
DOCKET NO. 50-261
LICENSE NO. DPR-23
LICENSEE EVENT REPORT 90-004-00

TITLE (4) BREACH OF CONTAINMENT INTEGRITY DUE TO FAILURE OF THE PERSONNEL AIRLOCK DOOR

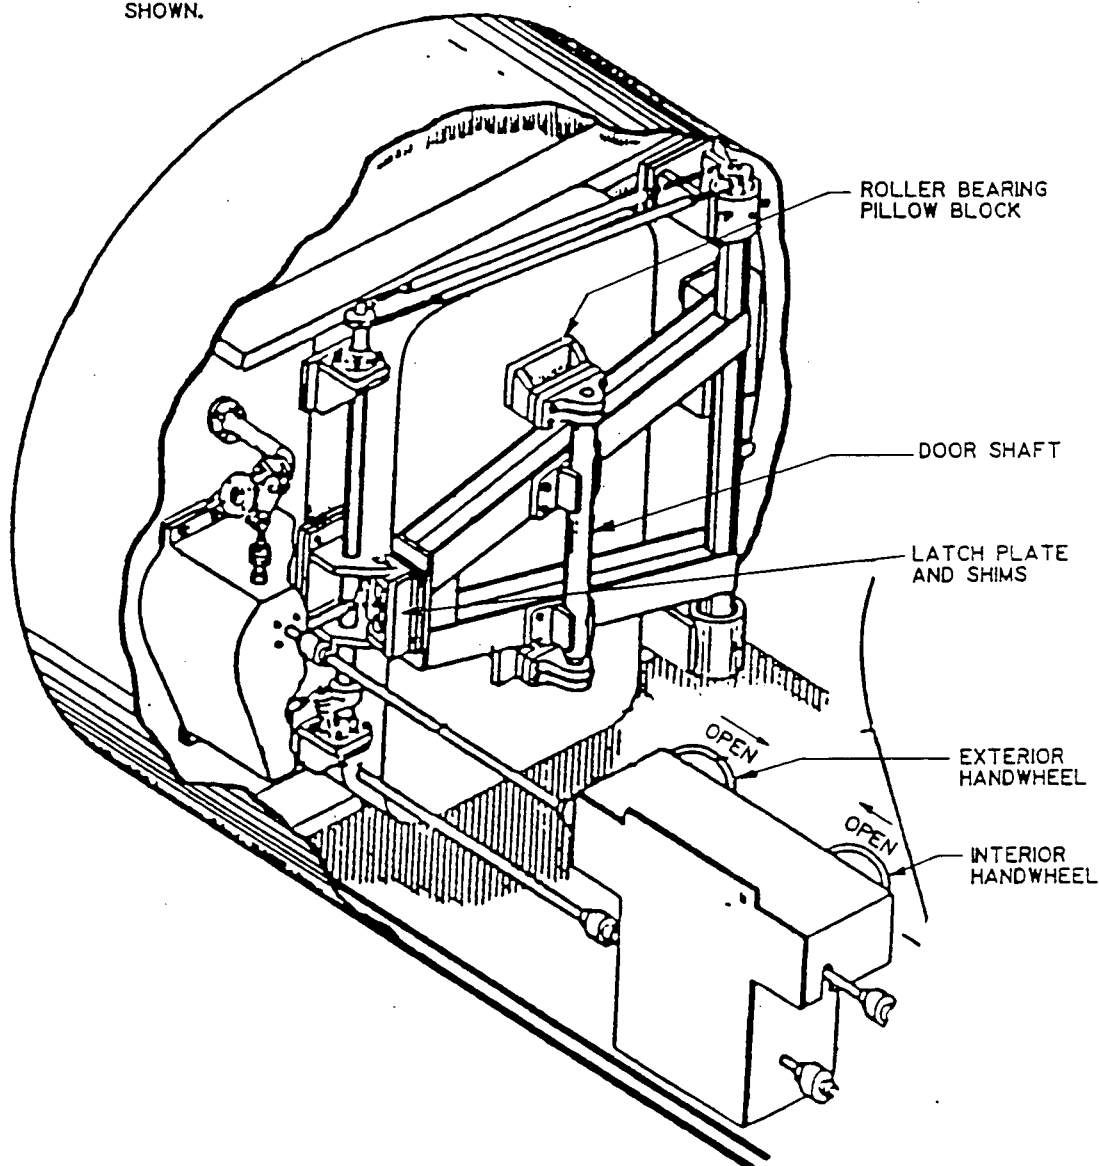
PERSONNEL AIR LOCK DOOR ASSEMBLY
(OUTER DOOR SHOWN)GASKET & SEATING
SURFACE NOT
SHOWN.

The primary cause of this event is attributed to failure of the Personnel Air Lock inner door assembly adjustment to center the door seal knife edge on the door gasket. Contributing to this was the roller bearing pillow block bolts becoming loose enough for the door to move approximately one-eighth inch, thus becoming misaligned on the seal.

The following corrective actions were taken during the repair of the air lock door seal leakage. Refer to the attached diagram.

On February 4, 1990, the latching mechanism and shims on the inner air lock door were removed. The shims were replaced using a one-piece shim. The latching mechanism bolts were replaced and torqued. The raised door seating surface (knife edge) was examined, and minor repairs were made per the manufacturers specifications. On February 9, licensee Maintenance personnel and the manufacturers' technical representative entered air lock and discovered that the inner door seals were being forced out of position by PPS pressure. The inner door seals were removed and the gasket seating surface was cleaned. With the gasket removed, door gaps and settings were measured for any possible door warpage or defect, and no concerns were found. With new gaskets installed, measurements were made to determine if the door was seating properly on the gaskets. The door was found to be mispositioned approximately one-eighth inch. The eight roller bearing pillow block bolts on the inner door were then loosened, the door was adjusted approximately one-eighth inch so the knife edges fit into the center of the gaskets, and the pillow block bolts were re-tightened and torqued as required. The door latch bolts were loosened and the latch readjusted to ensure that the door would seat harder onto the gaskets. The door was tested, and left in satisfactory condition.
